**ASBESTOS INSPECTION REPORT**  
**At**  
**Former White Plains Linen Site**  
**418 North Division Street**  
**Peekskill, New York 10566**

**November 26, 2024**

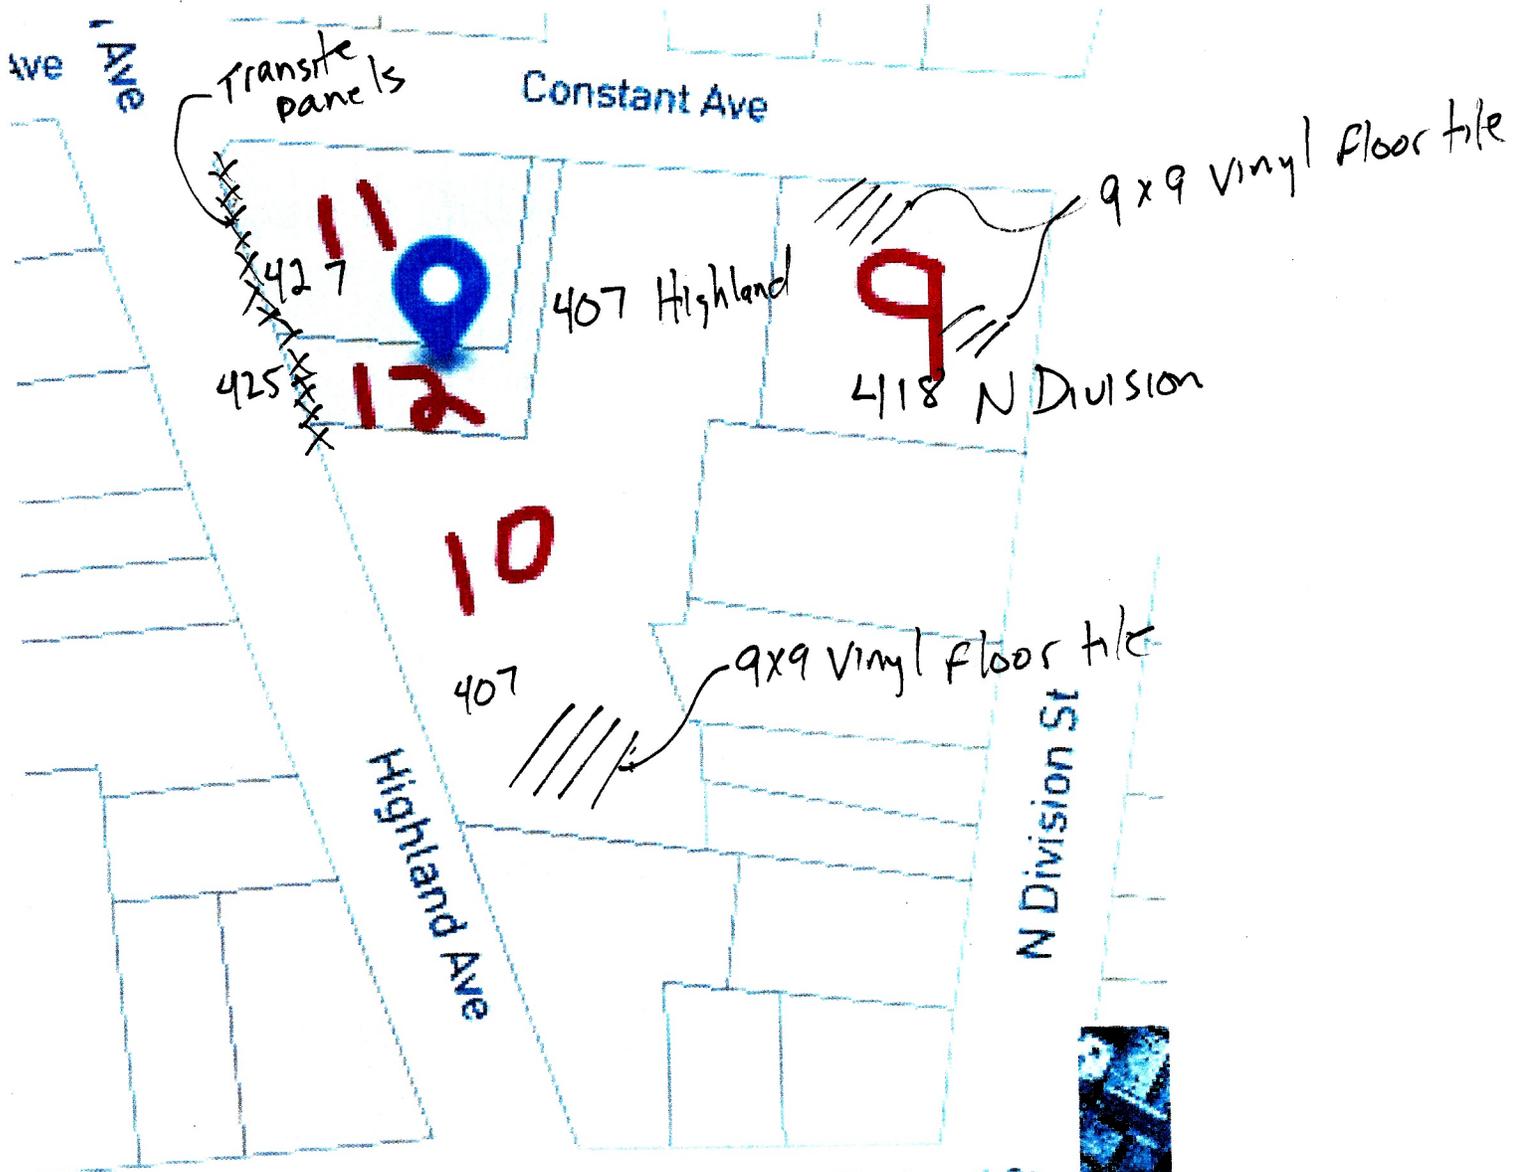
## 418 North Division Street

**LOT 9 - 23.78-1-9 BUILDING IS 5,383 SQUARE FEET AKA 418 NORTH DIVISION ST PEEKSKILL NY 10566**
