Re: South Island Apartments – 2023 Periodic Review Report
Site No. C401074

On behalf of South Island Apartments, LLC (SIA), Envirospec Engineering, PLLC (Envirospec) has prepared the enclosed 2023 Periodic Review Report for the South Island Apartments Site. The Institutional and Engineering Controls Certification Form is also enclosed.

Enclosure 2
NEW YORK STATE DEPARTMENT OF ENVIRONMENTAL CONSERVATION
Site Management Periodic Review Report Notice
Institutional and Engineering Controls Certification Form

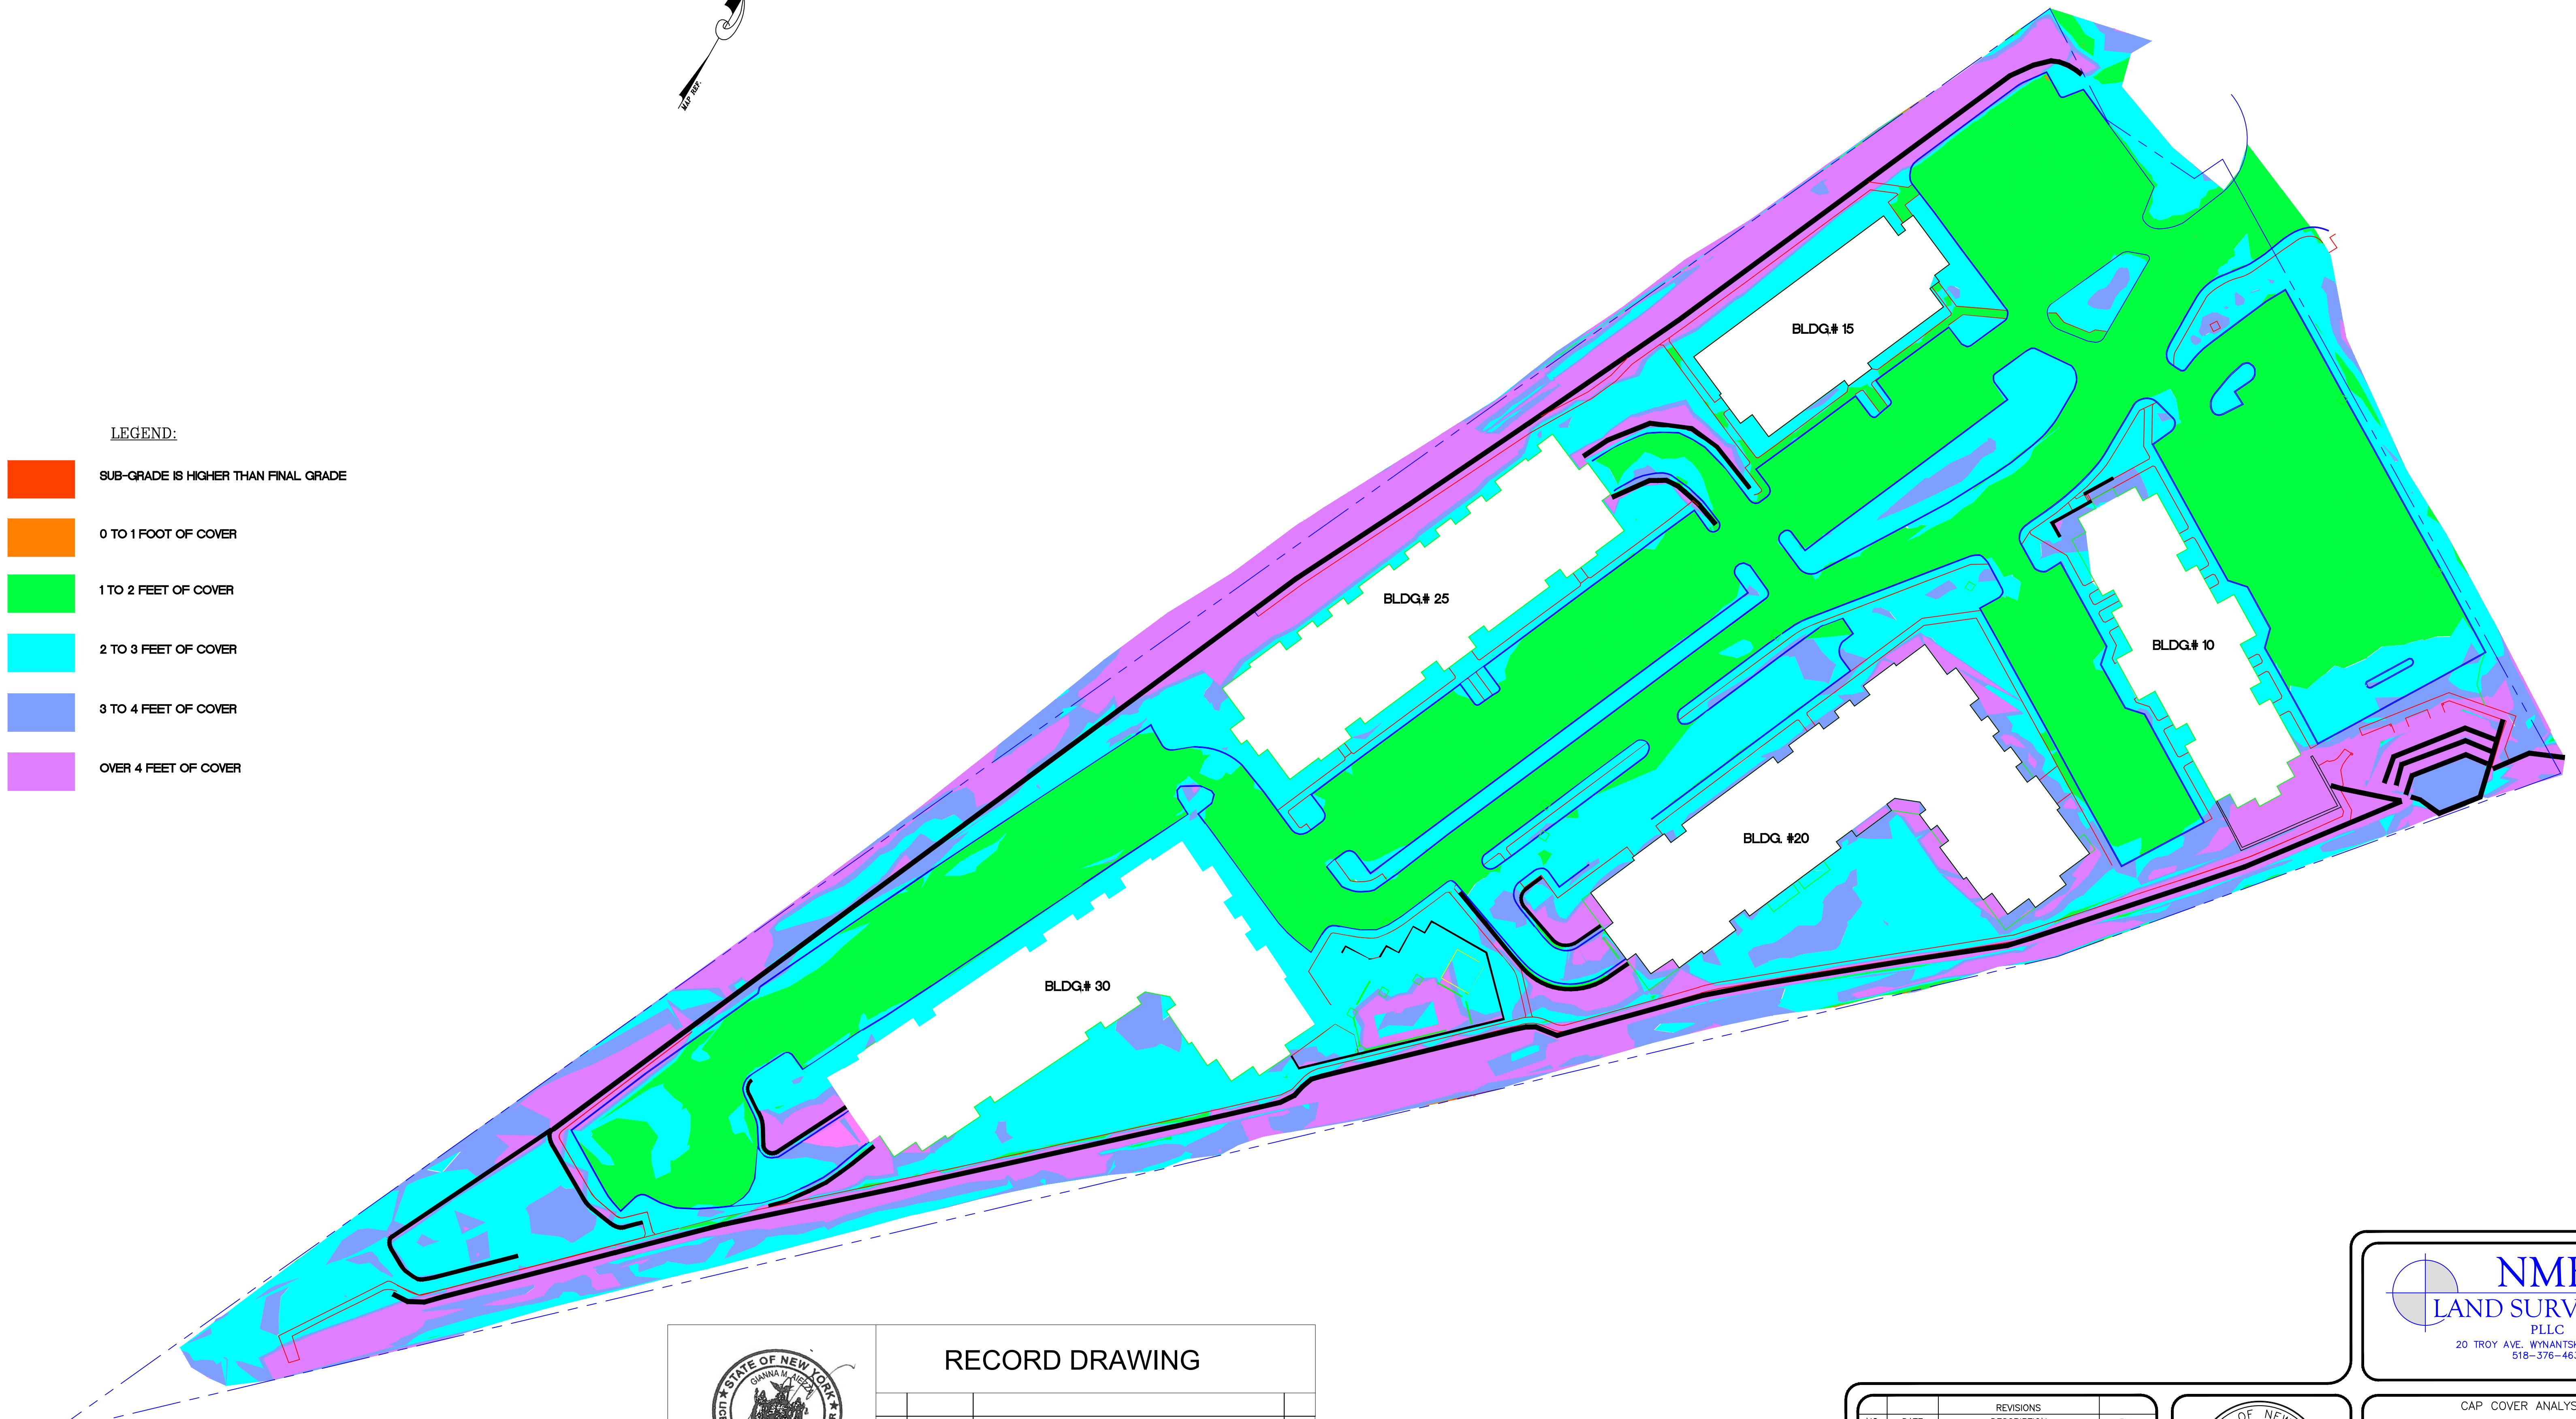
CAP COVER ANALYSIS		STARBUCK ISLAND	
SURVEYED BY: NMB DRAWN BY: GJC	CHECKED BY: NMB JOB NO. NB17-001	VILLAGE OF GREEN ISLAND COUNTY OF ALBANY STATE OF NEW YORK	SCALE: 1"=50' SHEET 1 OF 1

- TOP OF CAP SURVEY PERFORMED ON DECEMBER 23, 2019, FEBRUARY 20, 2020, JULY 3, 2020 AND DECEMBER 11, 2020.
- SURVEY SUBJECT TO ANY SUBSURFACE CONDITIONS THAT MAY EXIST, IF ANY.
- ALL SUB-GRADE INFORMATION WAS PROVIDED BY PETER LUIZZI AND BROS CONTRACTING. NMB LAND SURVEYING PLLC PERFORMED NO FIELD CHECKS OR CONFIRMATION OF SUB-GRADE.

- █ SUB-GRADE IS HIGHER THAN FINAL GRADE
- █ 0 TO 1 FOOT OF COVER
- █ 1 TO 2 FEET OF COVER
- █ 2 TO 3 FEET OF COVER
- █ 3 TO 4 FEET OF COVER
- █ OVER 4 FEET OF COVER

1. Construction and maintenance of a site cover system consisting of building foundations, asphalt pavement, concrete, or 2' of clean fill in open areas across the site and a cover system along the banks of the site consisting of rip-rap and a block wall along the eastern bank and retaining walls and rip-rap along the western bank to prevent human exposure to remaining contaminated soil/fill remaining at the site;

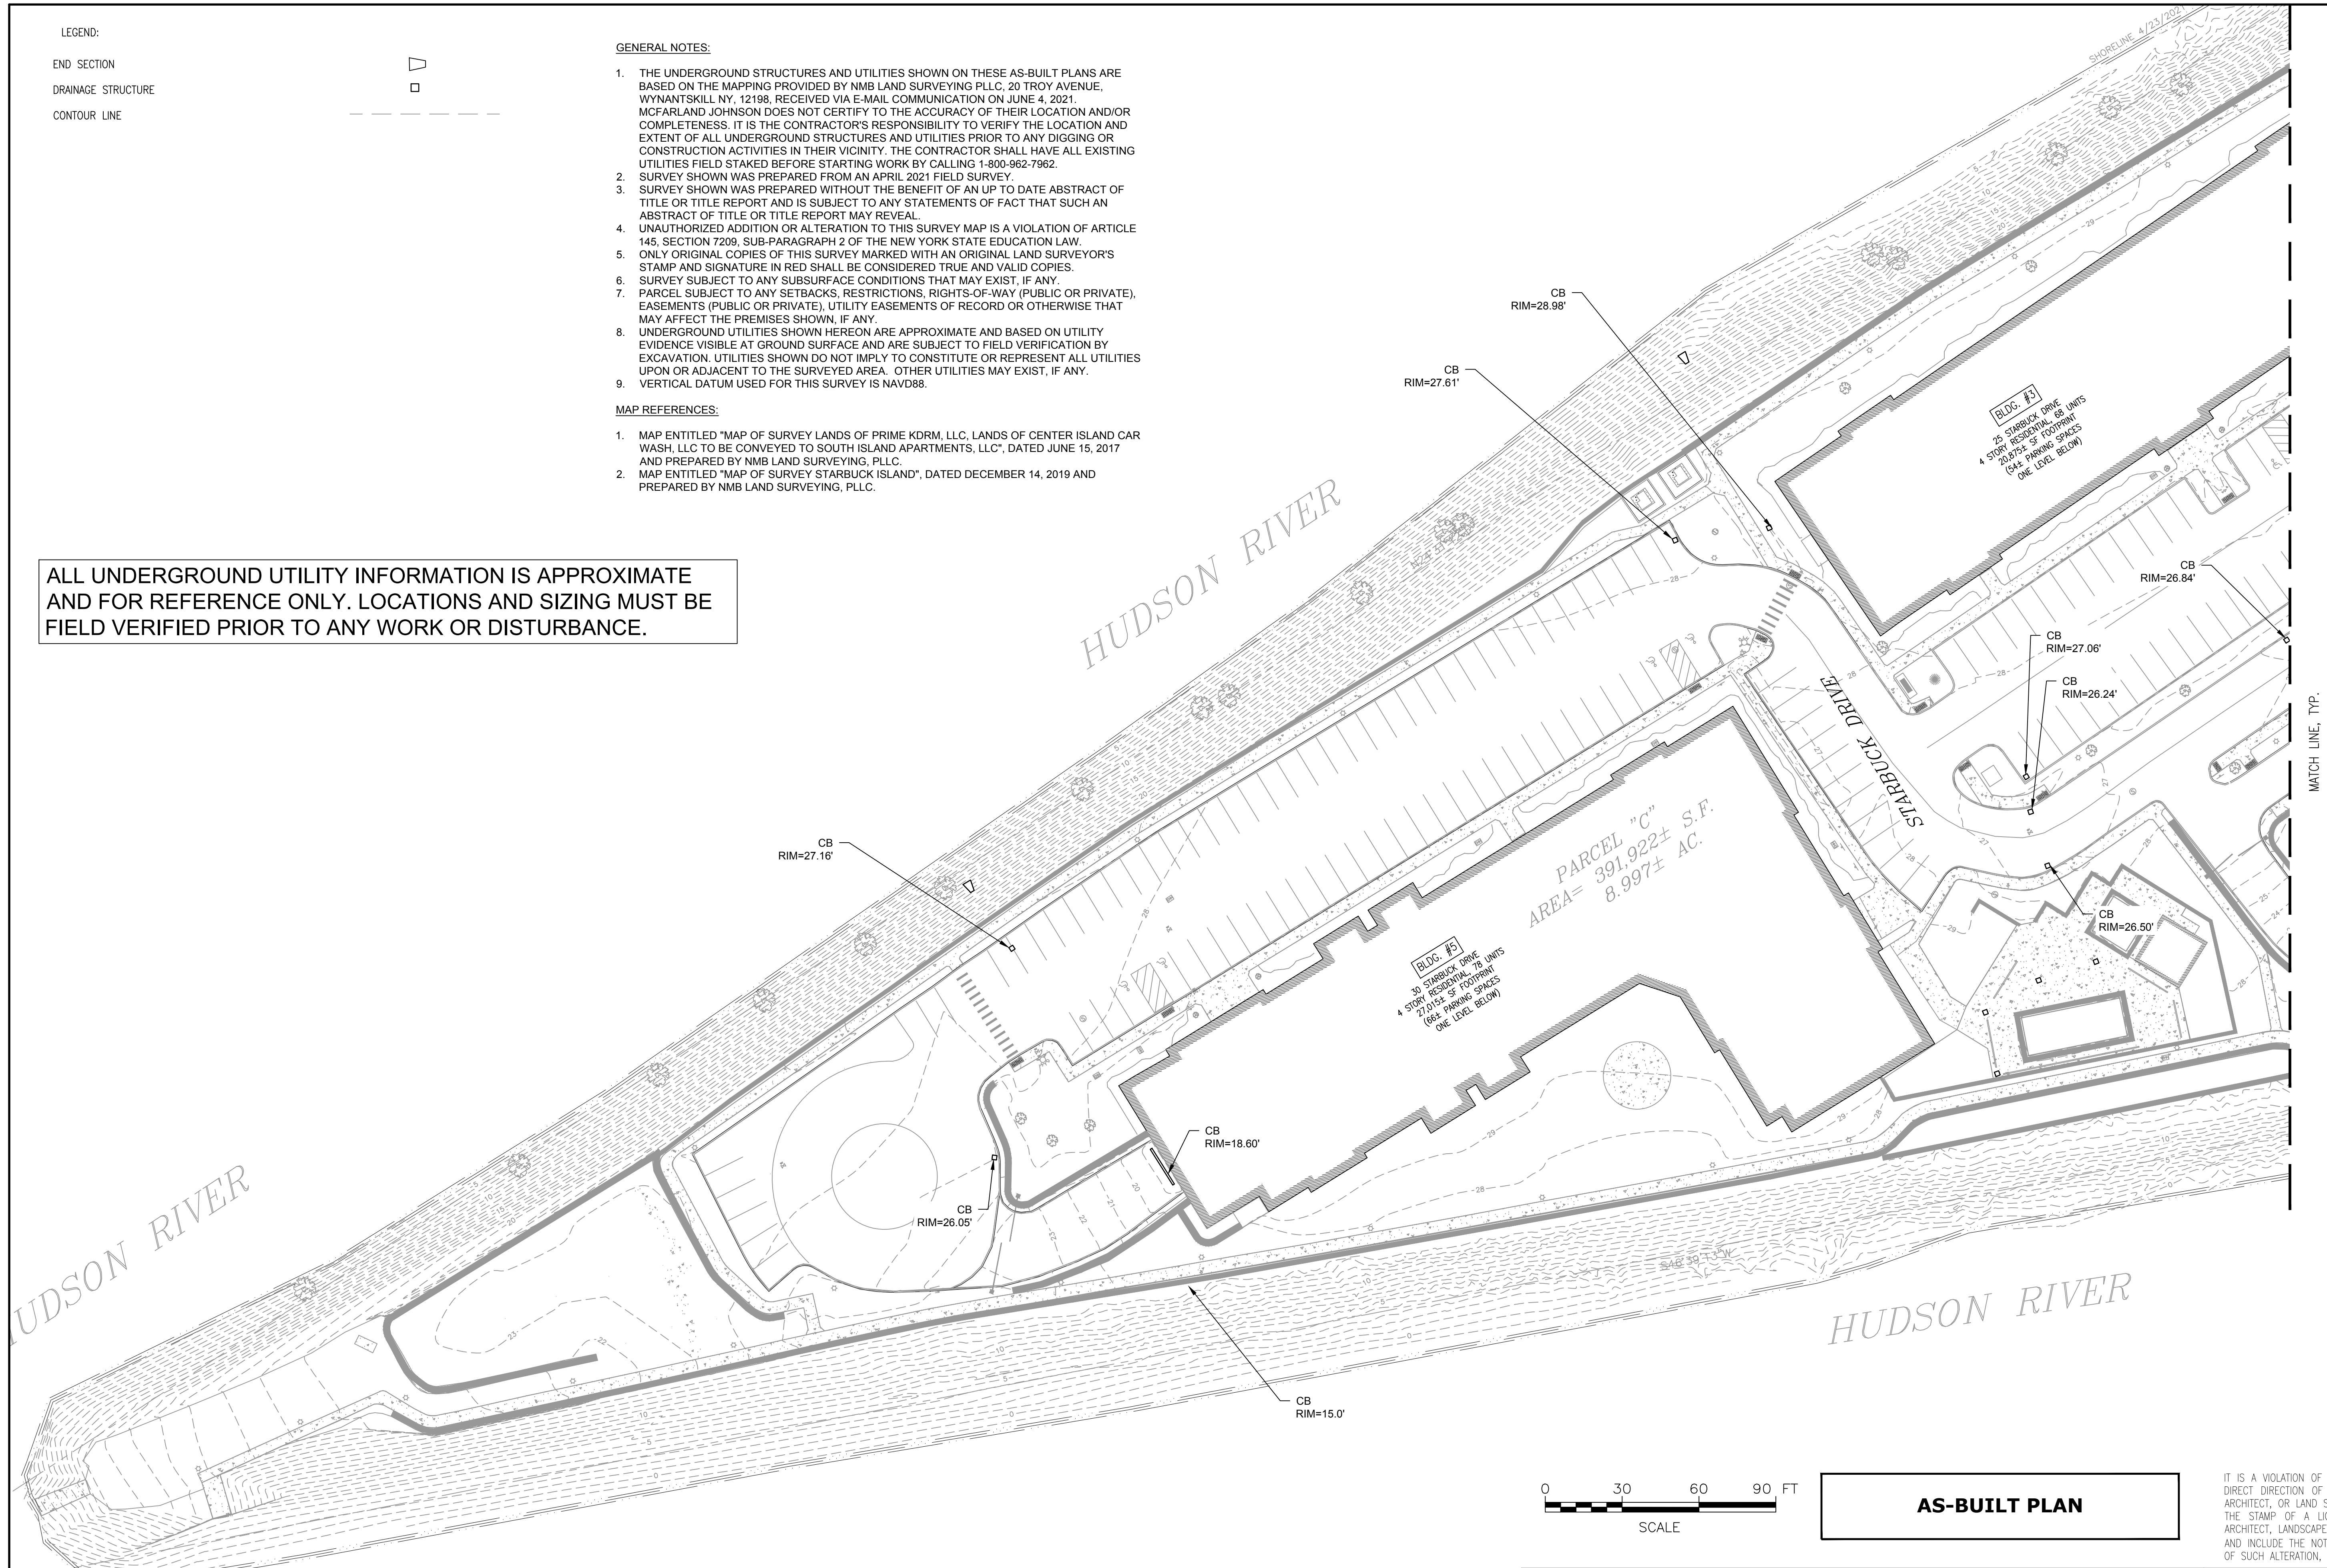
GR-01

0 30 60 90 FT
SCALE
AS-BUILT PLAN

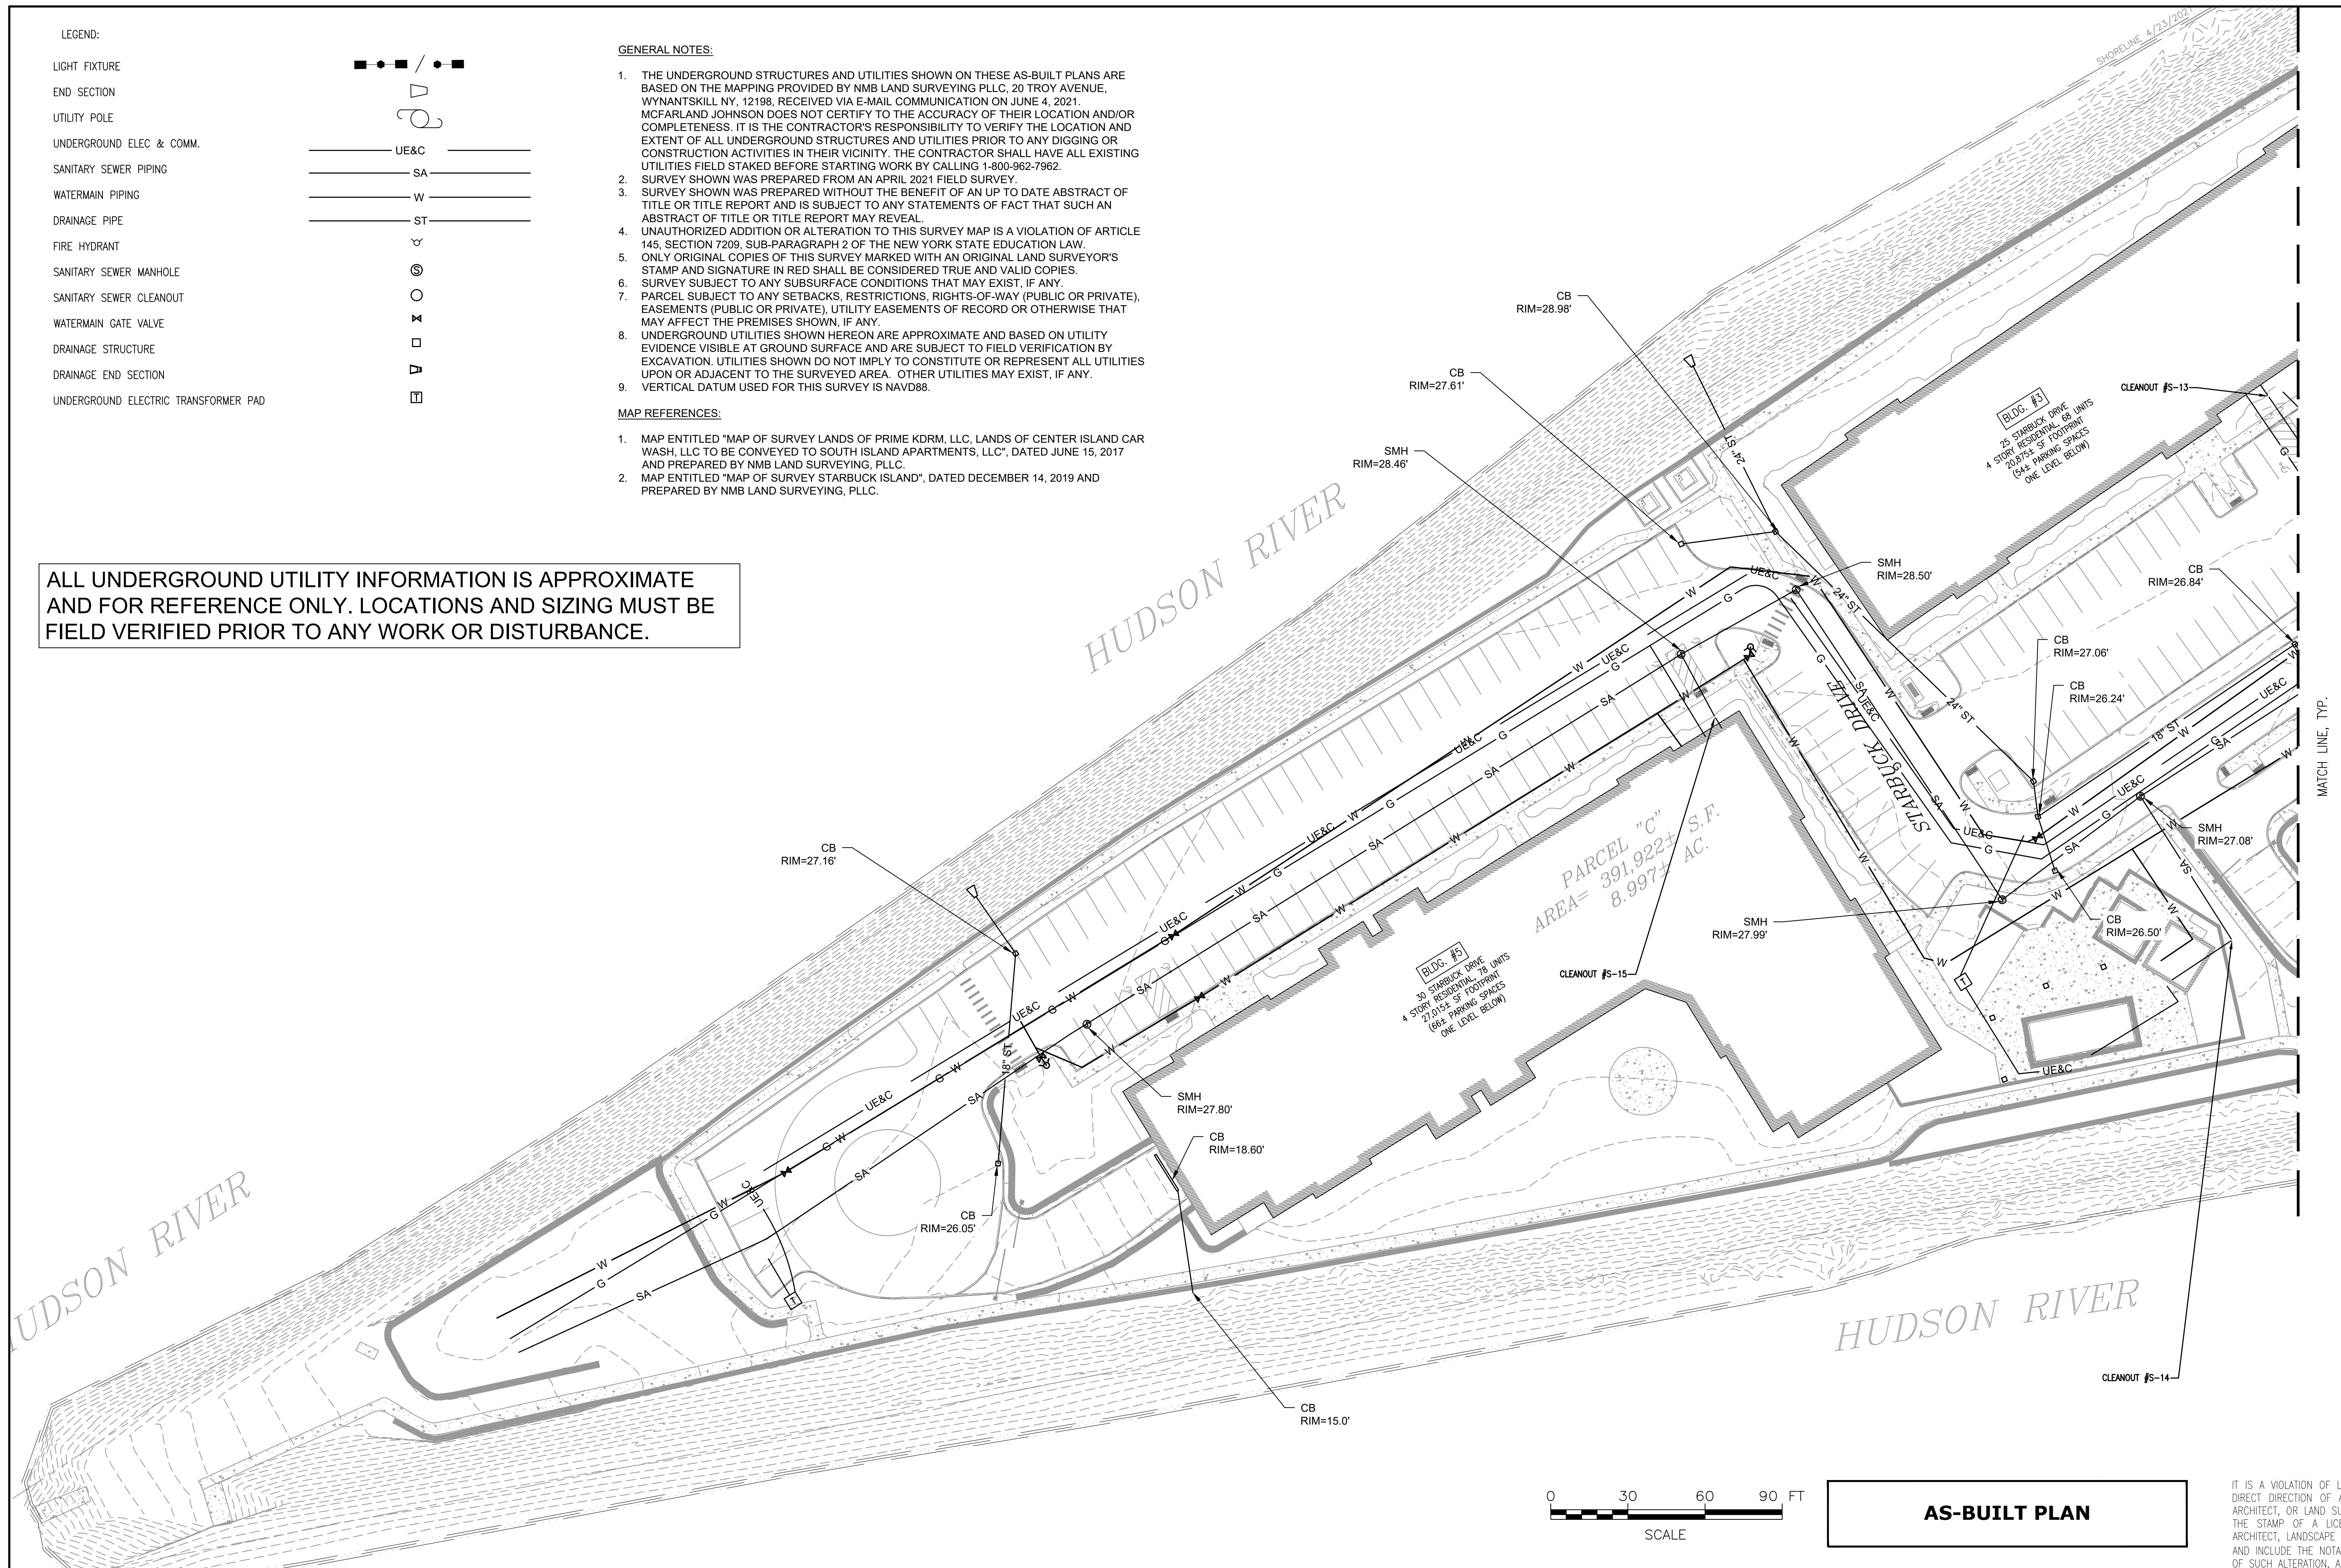
UT-01

AS-BUILT PLAN

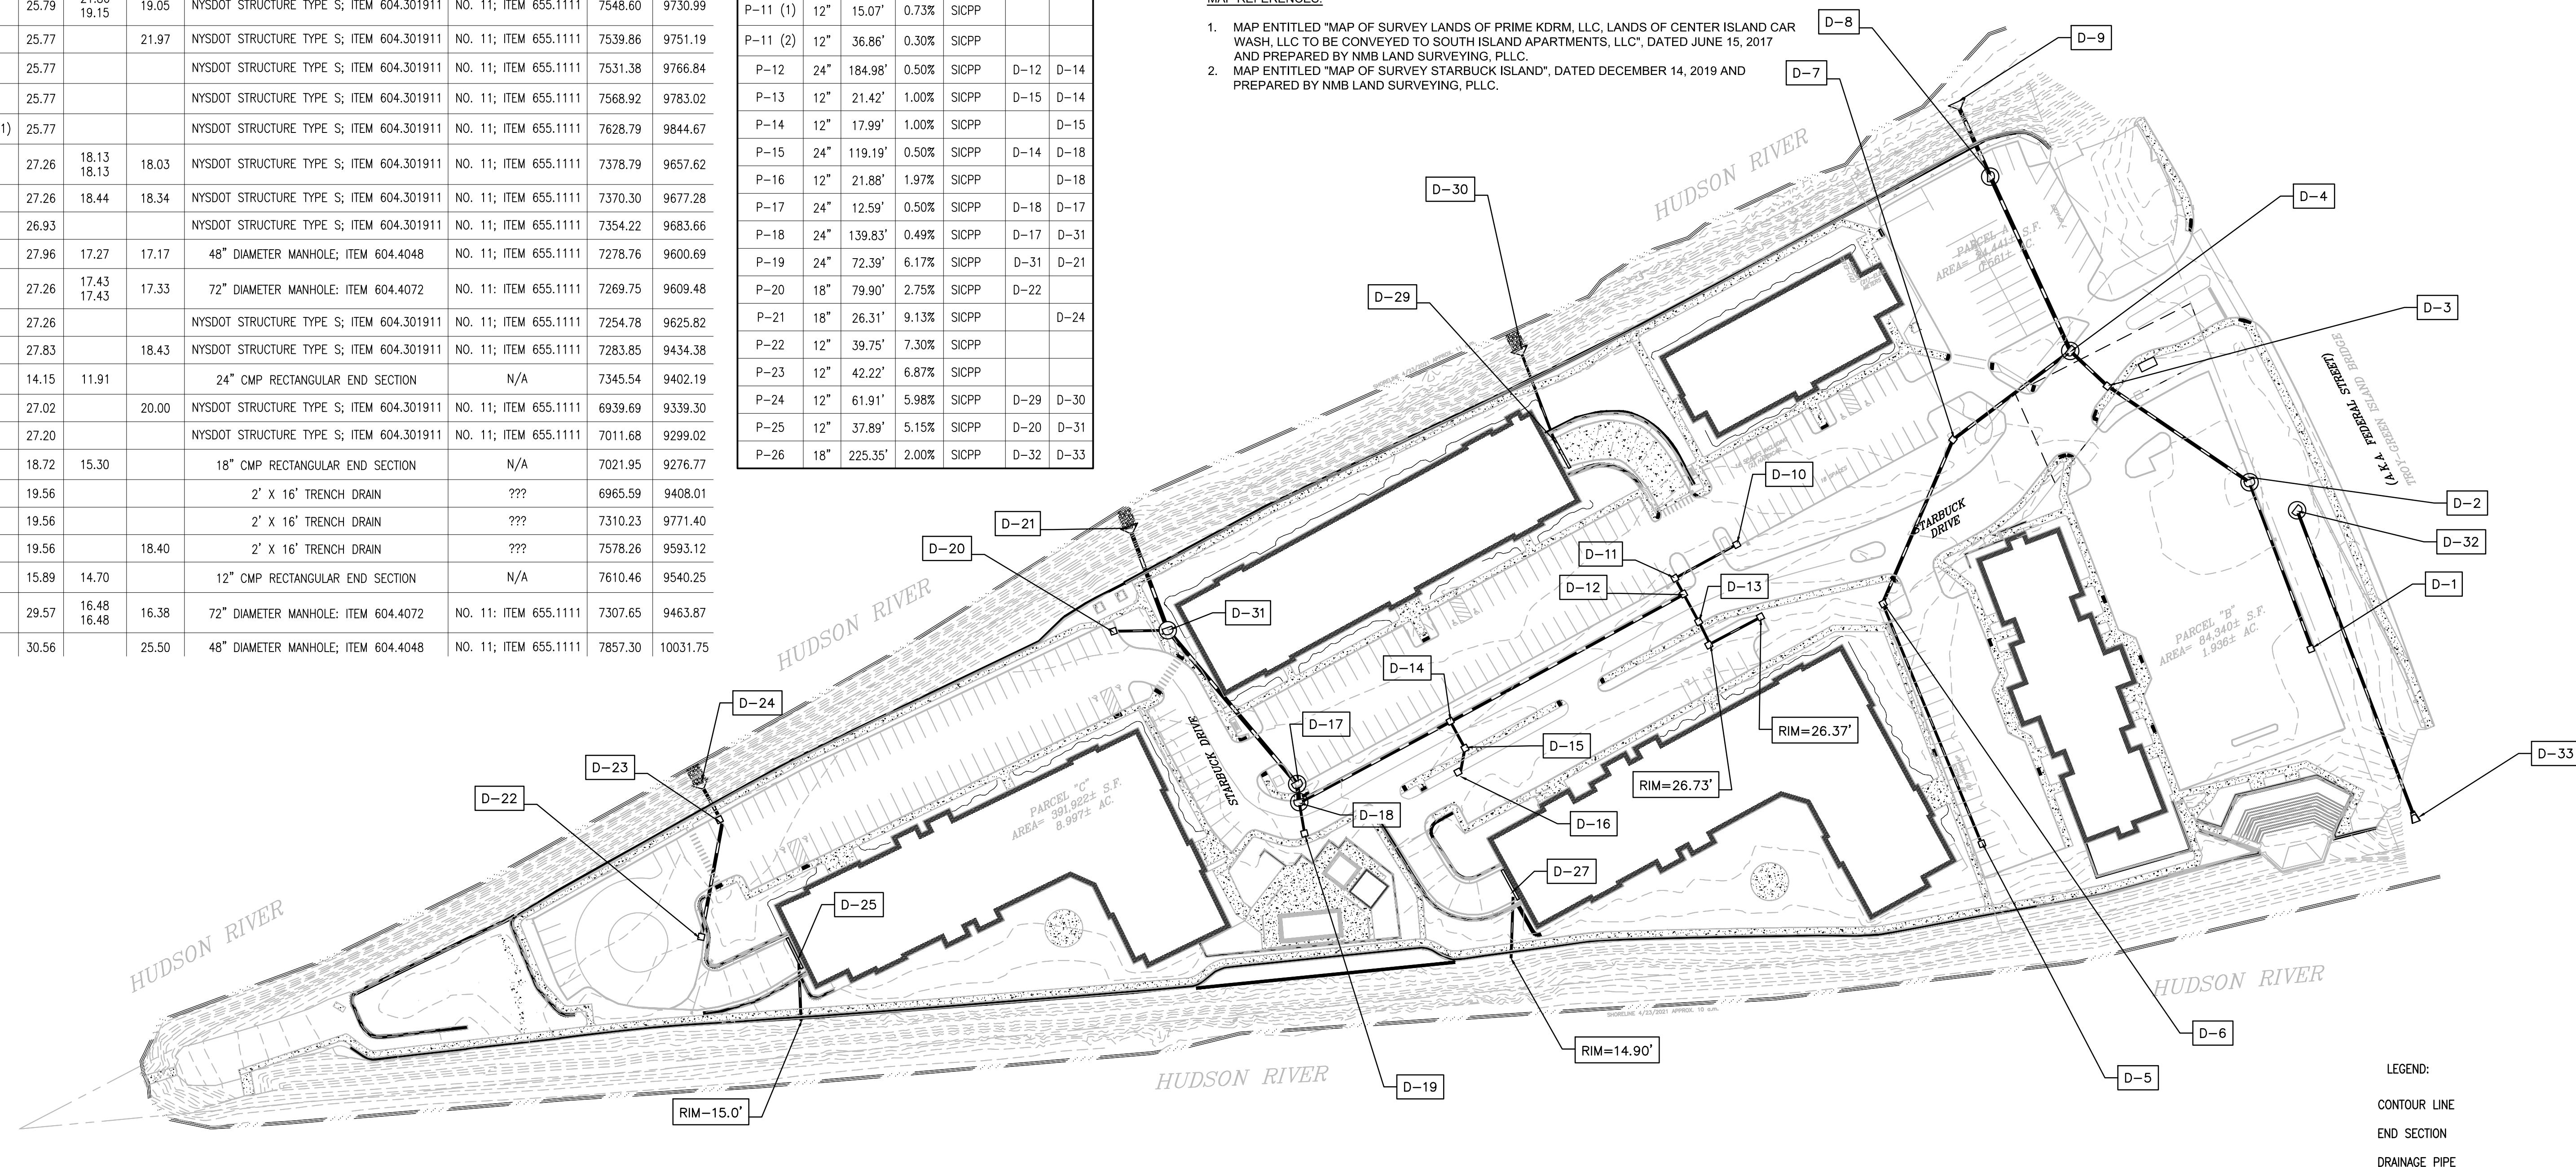
SCALE: 1" = 60' DESIGN: TCH
 DRAWN: TCH PROJECT: 1832.00
 CHECKED: AJF DATE: SEPT. 14, 2021
 DR-01

LEGEND:
 CONTOUR LINE
 END SECTION
 DRAINAGE PIPE
 DRAINAGE STRUCTURE
