Re: South Island Apartments – 2024 Periodic Review Report  
Site No. C401074

**Enclosure 2**  
**NEW YORK STATE DEPARTMENT OF ENVIRONMENTAL CONSERVATION**  
**Site Management Periodic Review Report Notice**  
**Institutional and Engineering Controls Certification Form**

**Site Name** **South Island Apartments**

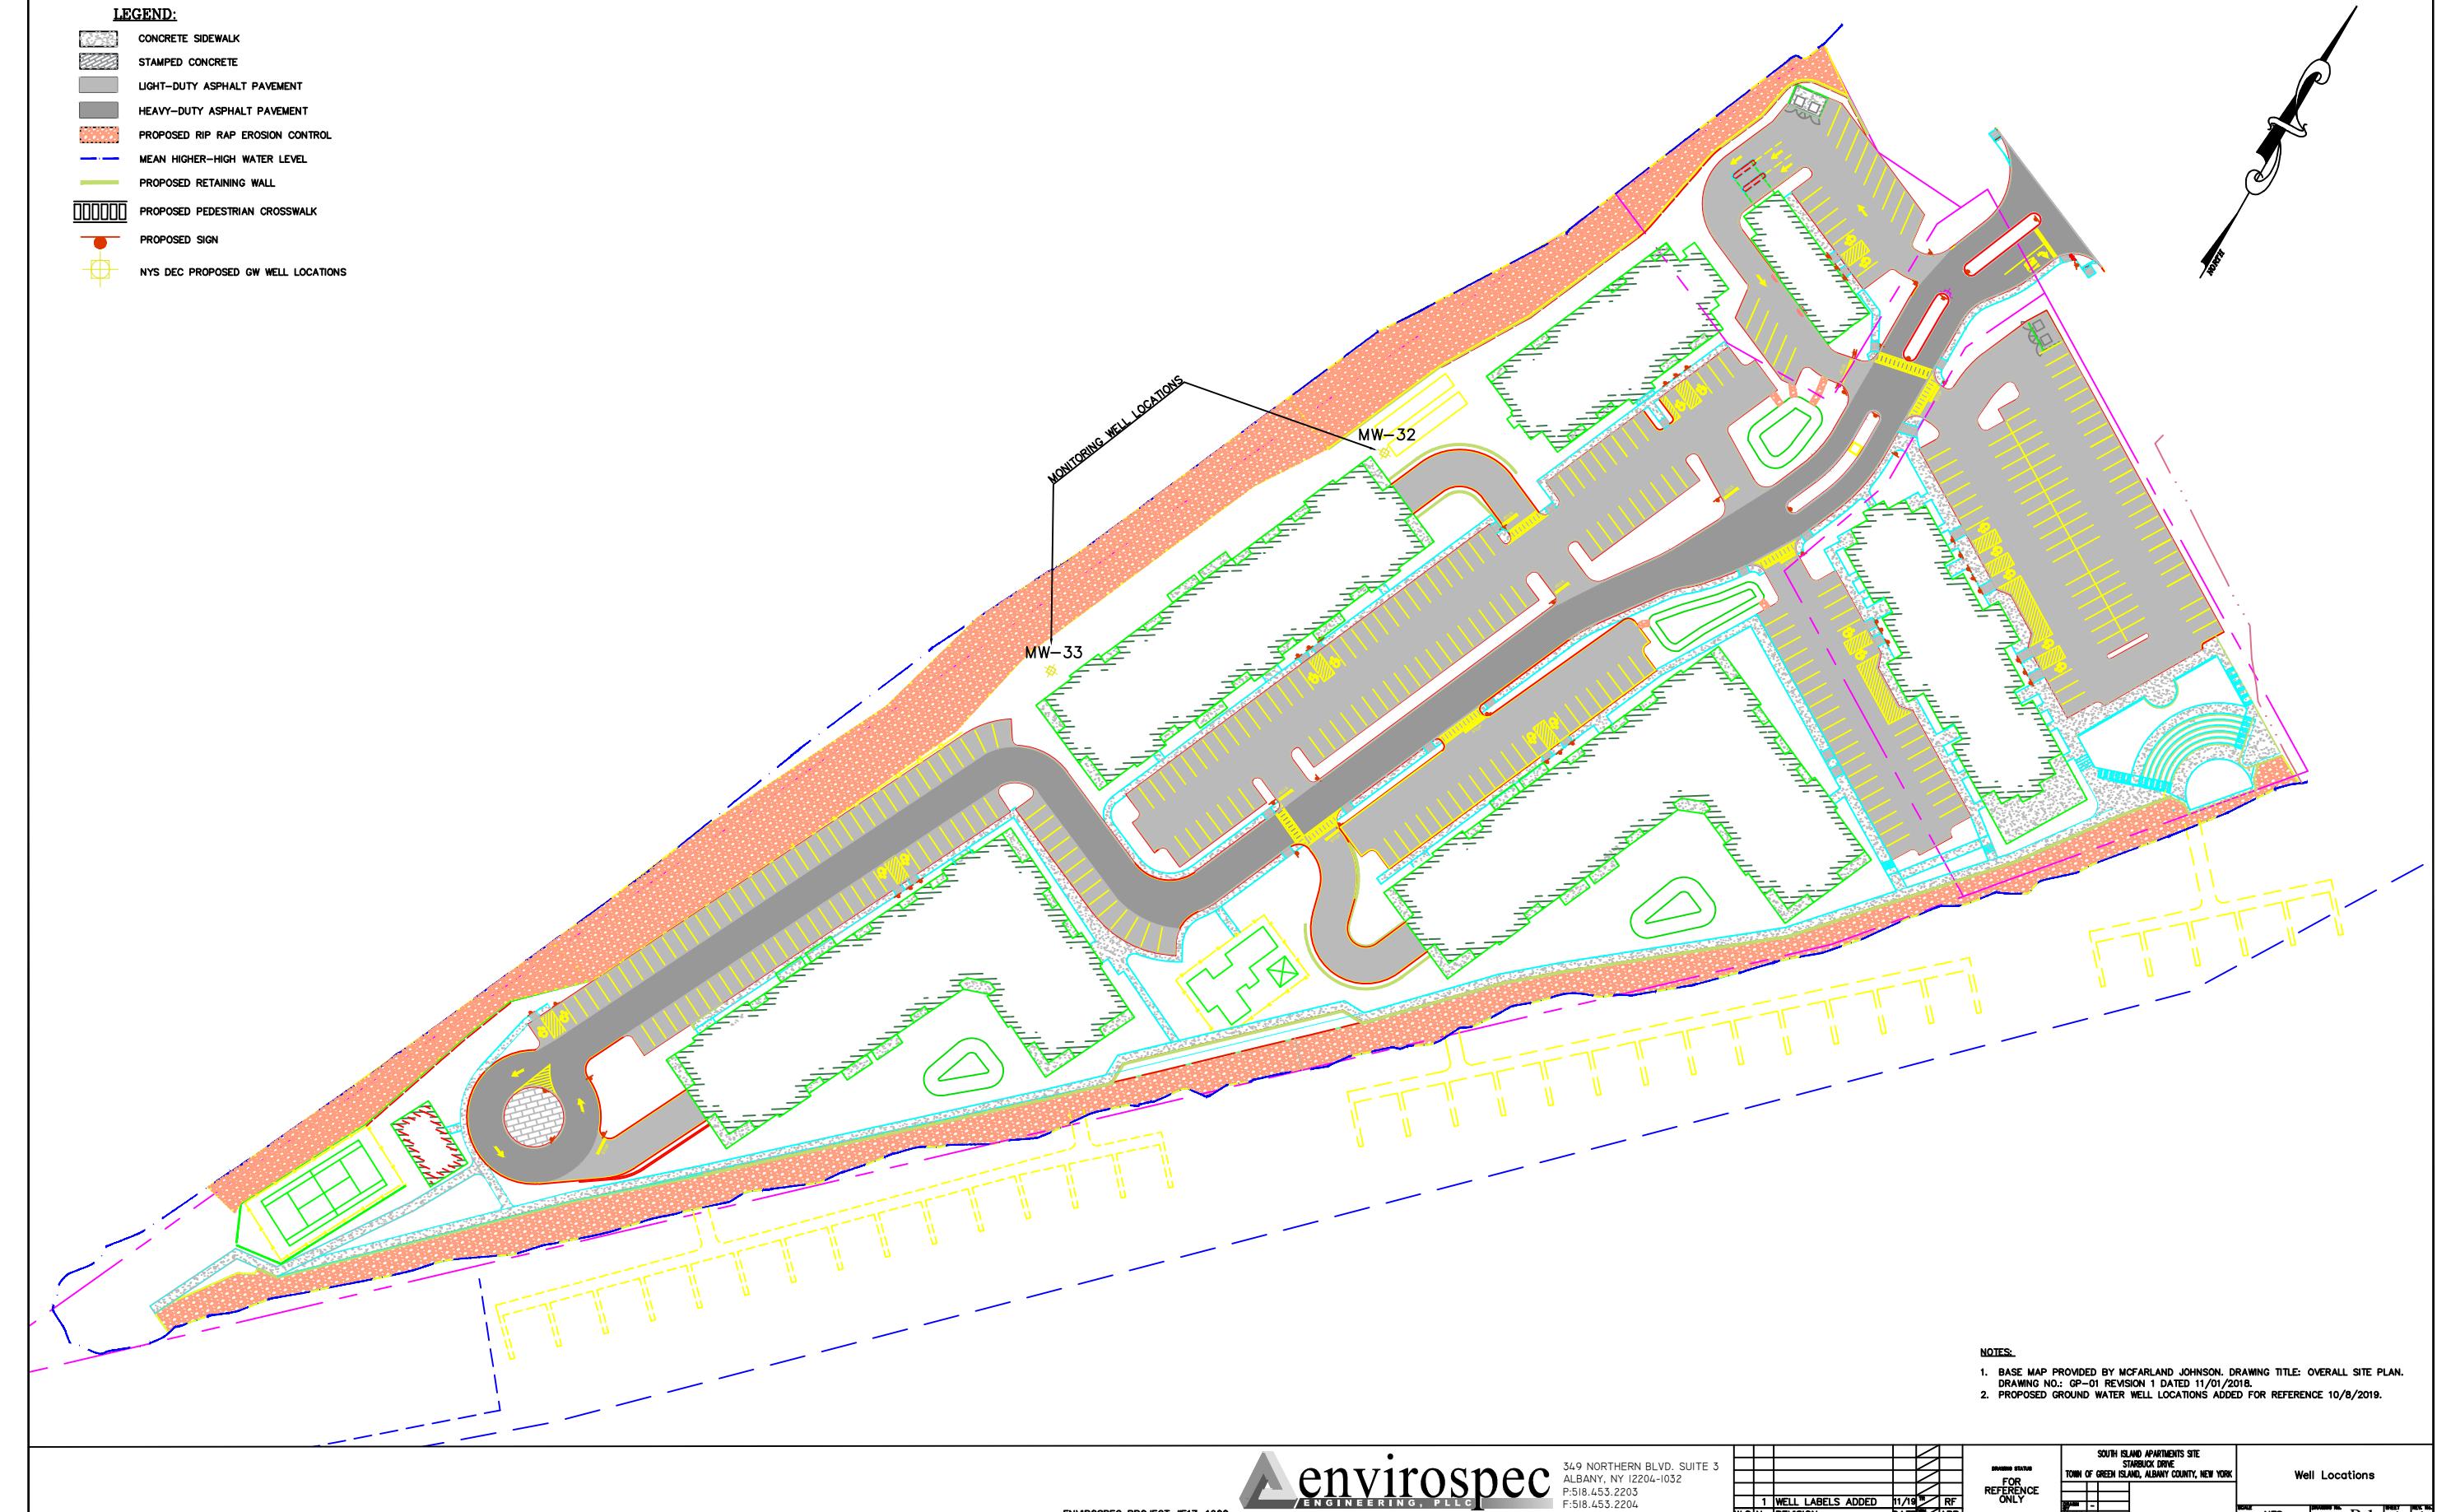
1. BASE MAP PROVIDED BY MCFARLAND JOHNSON. DRAWING TITLE: OVERALL SITE PLAN.  
DRAWING NO.: GP-01 REVISION 1 DATED 11/01/2018.
2. PROPOSED GROUND WATER WELL LOCATIONS ADDED FOR REFERENCE 10/6/2019.
