**Destiny – Brownfield Site Cleanup - Phase I Site**

Periodic Review Report and Annual Certification - July 2015 - July 2016

Site Name: Oil City/Carousel Center - Phase I

Site No.: C734104

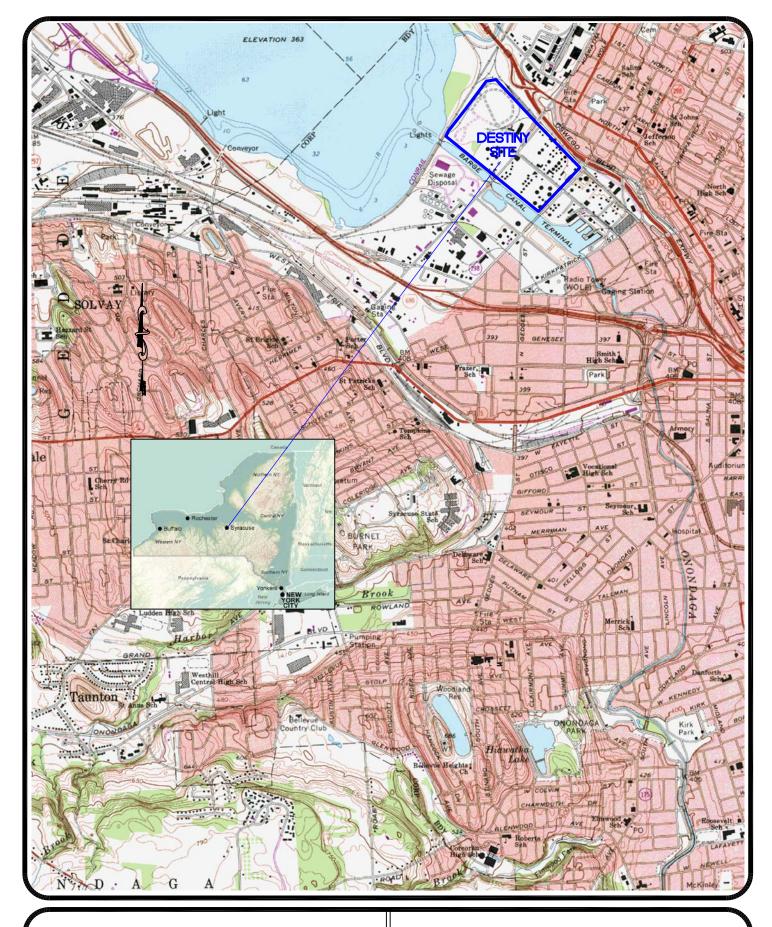
PROJ. No.: 06448 DATE: 08/24/2010 SCALE:NOT TO SCALE DWG. NO.06448SLMAP.DWG FIGURE 1

FIGURE 1 SITE L	LOCATION MAP
-----------------	--------------

Destiny USA Holdings, LLC and or its affiliates (Destiny) has remediated a 10.3 acre property located in Onondaga County, Syracuse, New York (the "Phase I Site") to address subsurface soil, groundwater and vapor contamination present within the Phase I Site boundaries. The Remedial Party, Destiny, was required to investigate and remediate contaminated media at the Phase I Site. The site location of the 10.3 acre area subject to this report is provided in Figure 1.

The overall Destiny Site consists of approximately 152 acres at the southeast end of Onondaga Lake (a Class C water body). It is generally bounded by: Onondaga Lake and Conrail tracks to the northwest; Interstate 81 (I-81) to the north and northeast; Bear Street on the south and southeast; and the New York State Barge Canal to the south and southwest. See Figures 1 and 2.

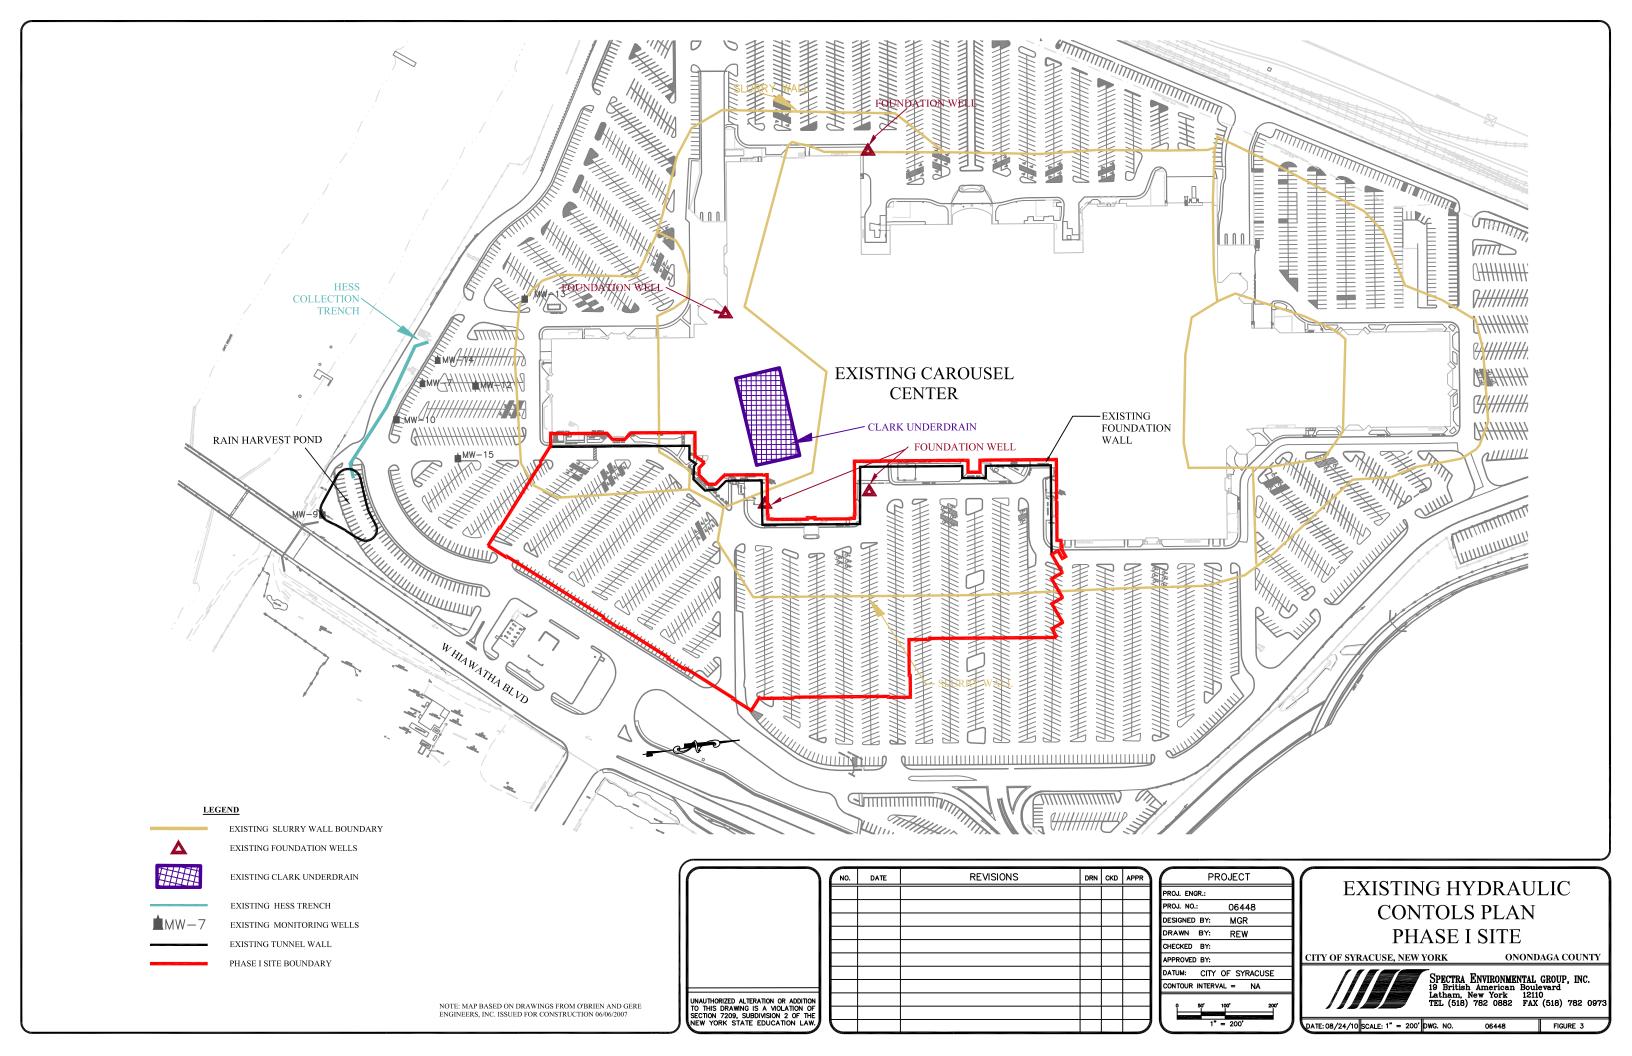
FIGURE 3 HYDRAULIC CONTROLS

Notwithstanding these protections, in the event contaminated groundwater leaves the Phase I Site it is captured and appropriately treated by an existing groundwater control and treatment facility located downgradient of the Phase I Site (See Figure 3). These controls include:

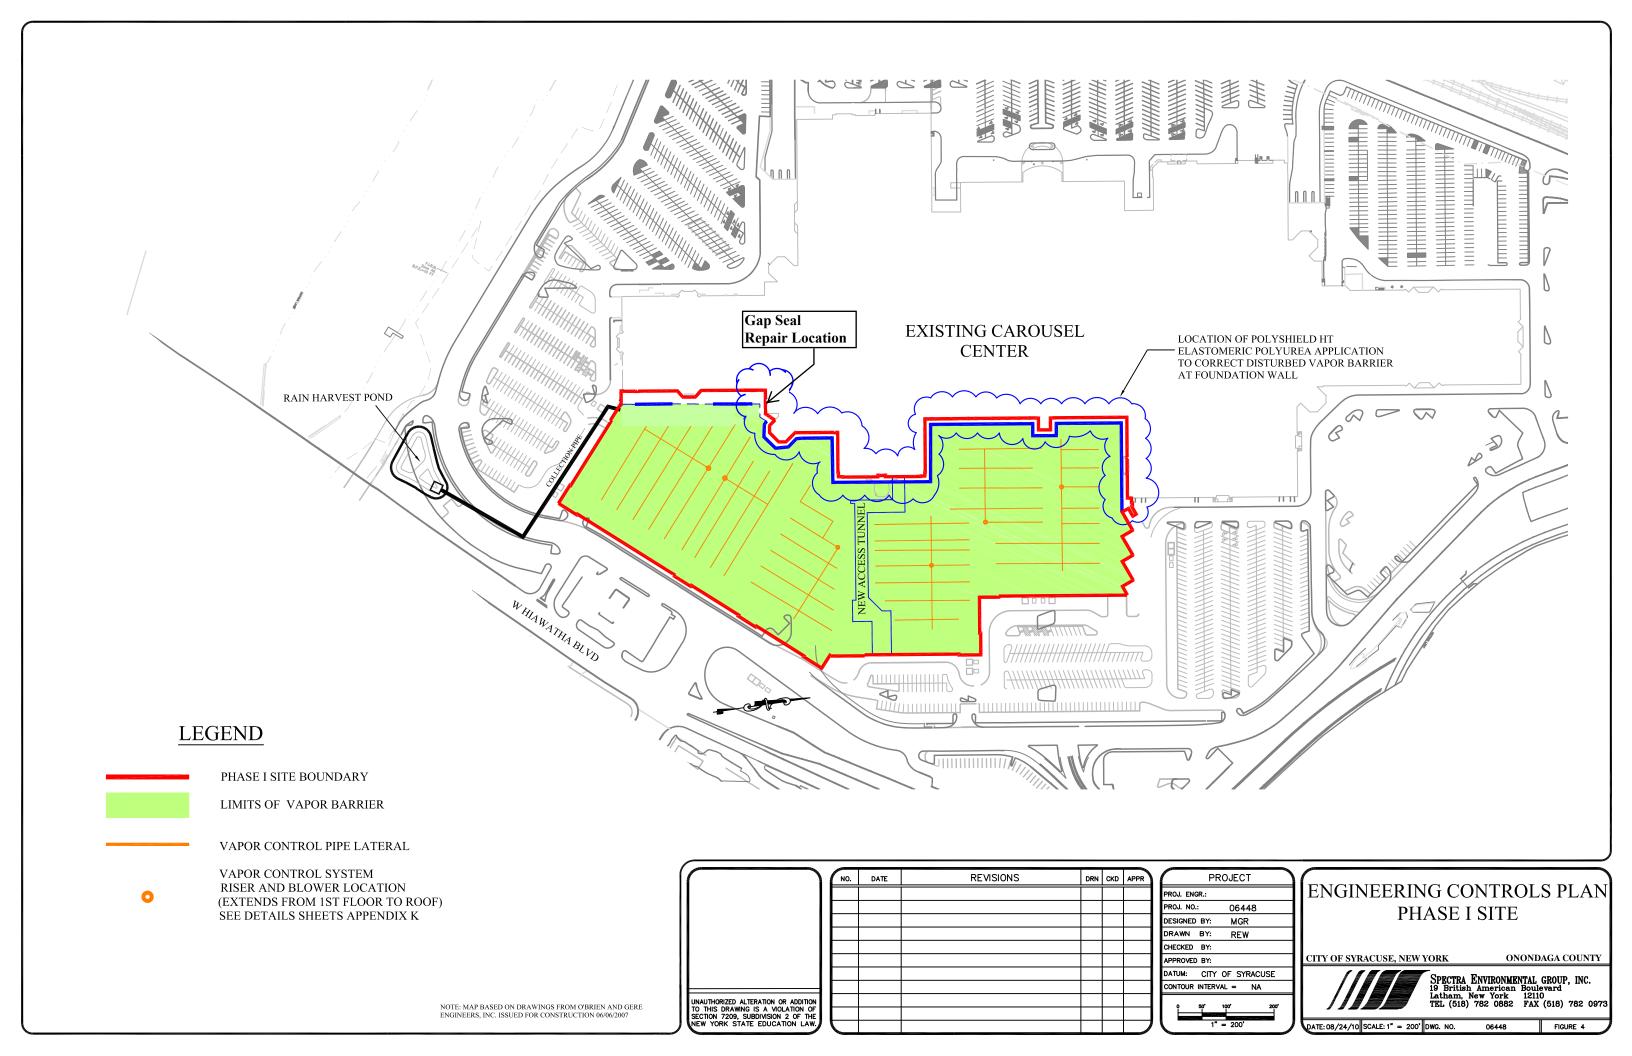
FIGURE 4 ENGINEERING CONTROLS

Prior to pouring the floor slab, the vapor barrier was inspected for the integrity of joints and membrane material, and for proper tension relief construction. Membrane tension was relieved by splicing additional sheet material, using the lap seal requirements above (See Figure 4).
