**PERIODIC REVIEW REPORT
AND
ANNUAL CERTIFICATION (REVISED)
FOR JULY 2017 – APRIL 2021**

**OIL CITY/CAROUSEL CENTER - PHASE I SITE (#C734104)
DESTINY USA, SYRACUSE, NEW YORK**

**AUGUST 2020
REVISED MAY 2021**

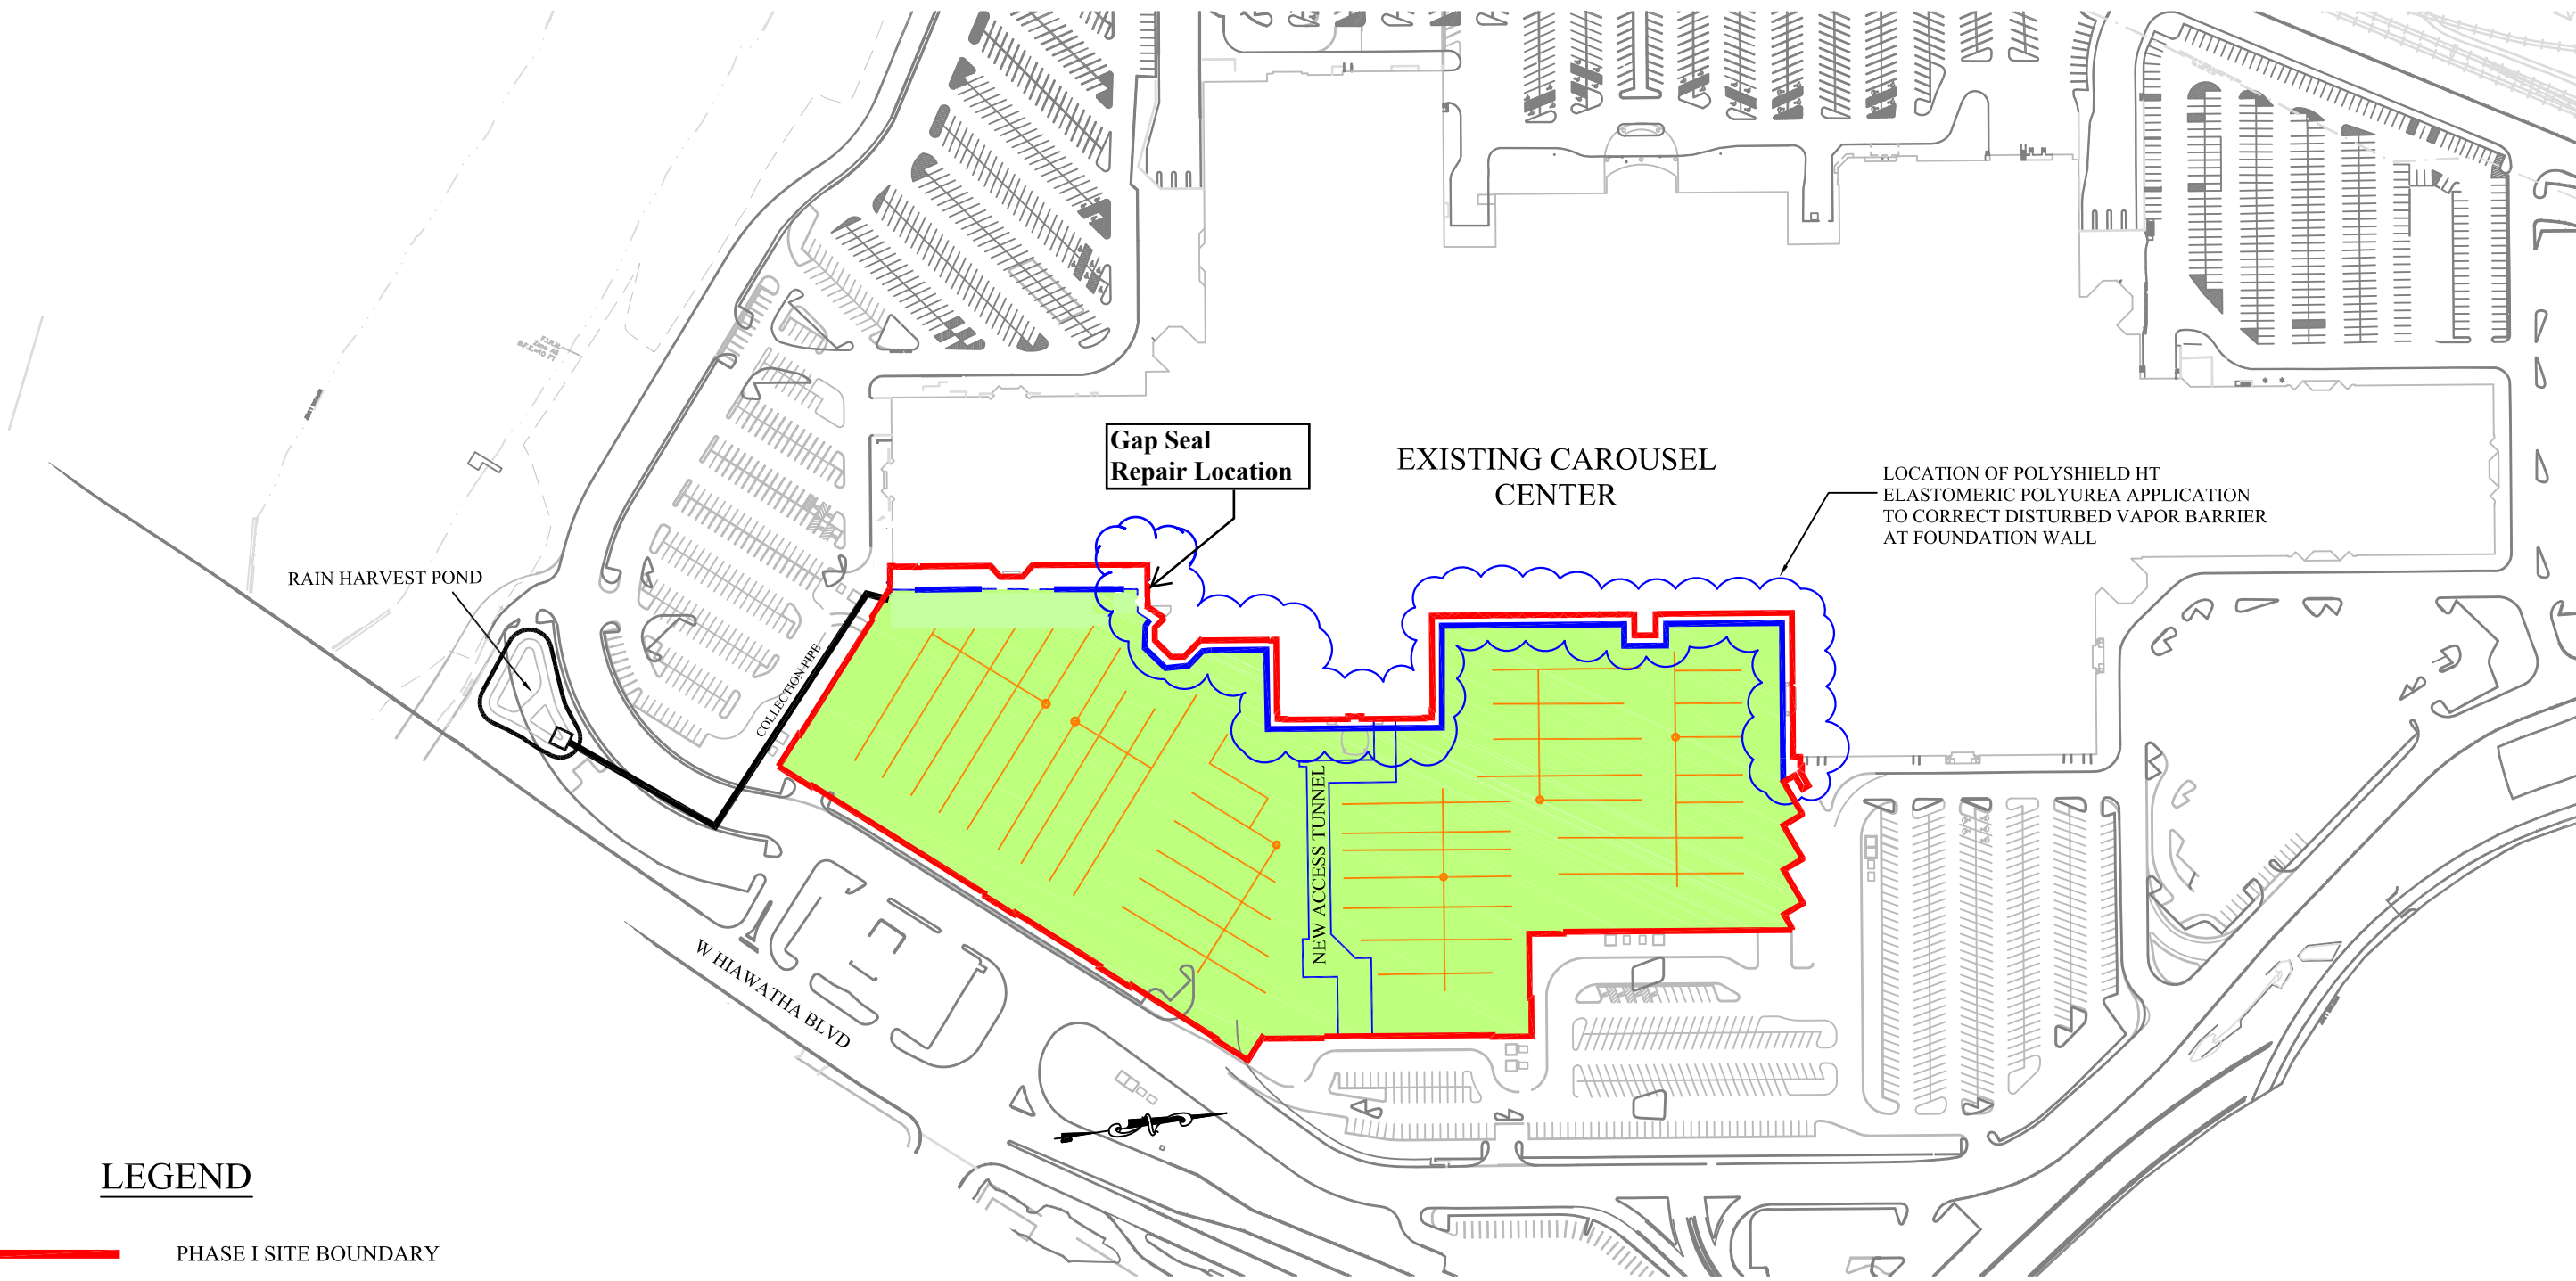
DATE: 08/24/10SCALE: 1" = 200'DWG. NO. 06448FIGURE 4

- PHASE I SITE BOUNDARY
- LIMITS OF VAPOR BARRIER
- VAPOR CONTROL PIPE LATERAL
- VAPOR CONTROL SYSTEM RISER AND BLOWER LOCATION (EXTENDS FROM 1ST FLOOR TO ROOF) SEE DETAILS SHEETS APPENDIX K

Prior to pouring the floor slab, the vapor barrier was inspected for the integrity of joints and membrane material, and for proper tension relief construction. Membrane tension was relieved by splicing additional sheet material, using the lap seal requirements above (See Figure 4).
