**SPDES INVESTIGATION REPORT
TENNECO PACKAGING
MACEDON, NEW YORK**

SPDES Permit #NY0245992

**TENNECO PACKAGING
MACEDON, NEW YORK**

August 31, 1999

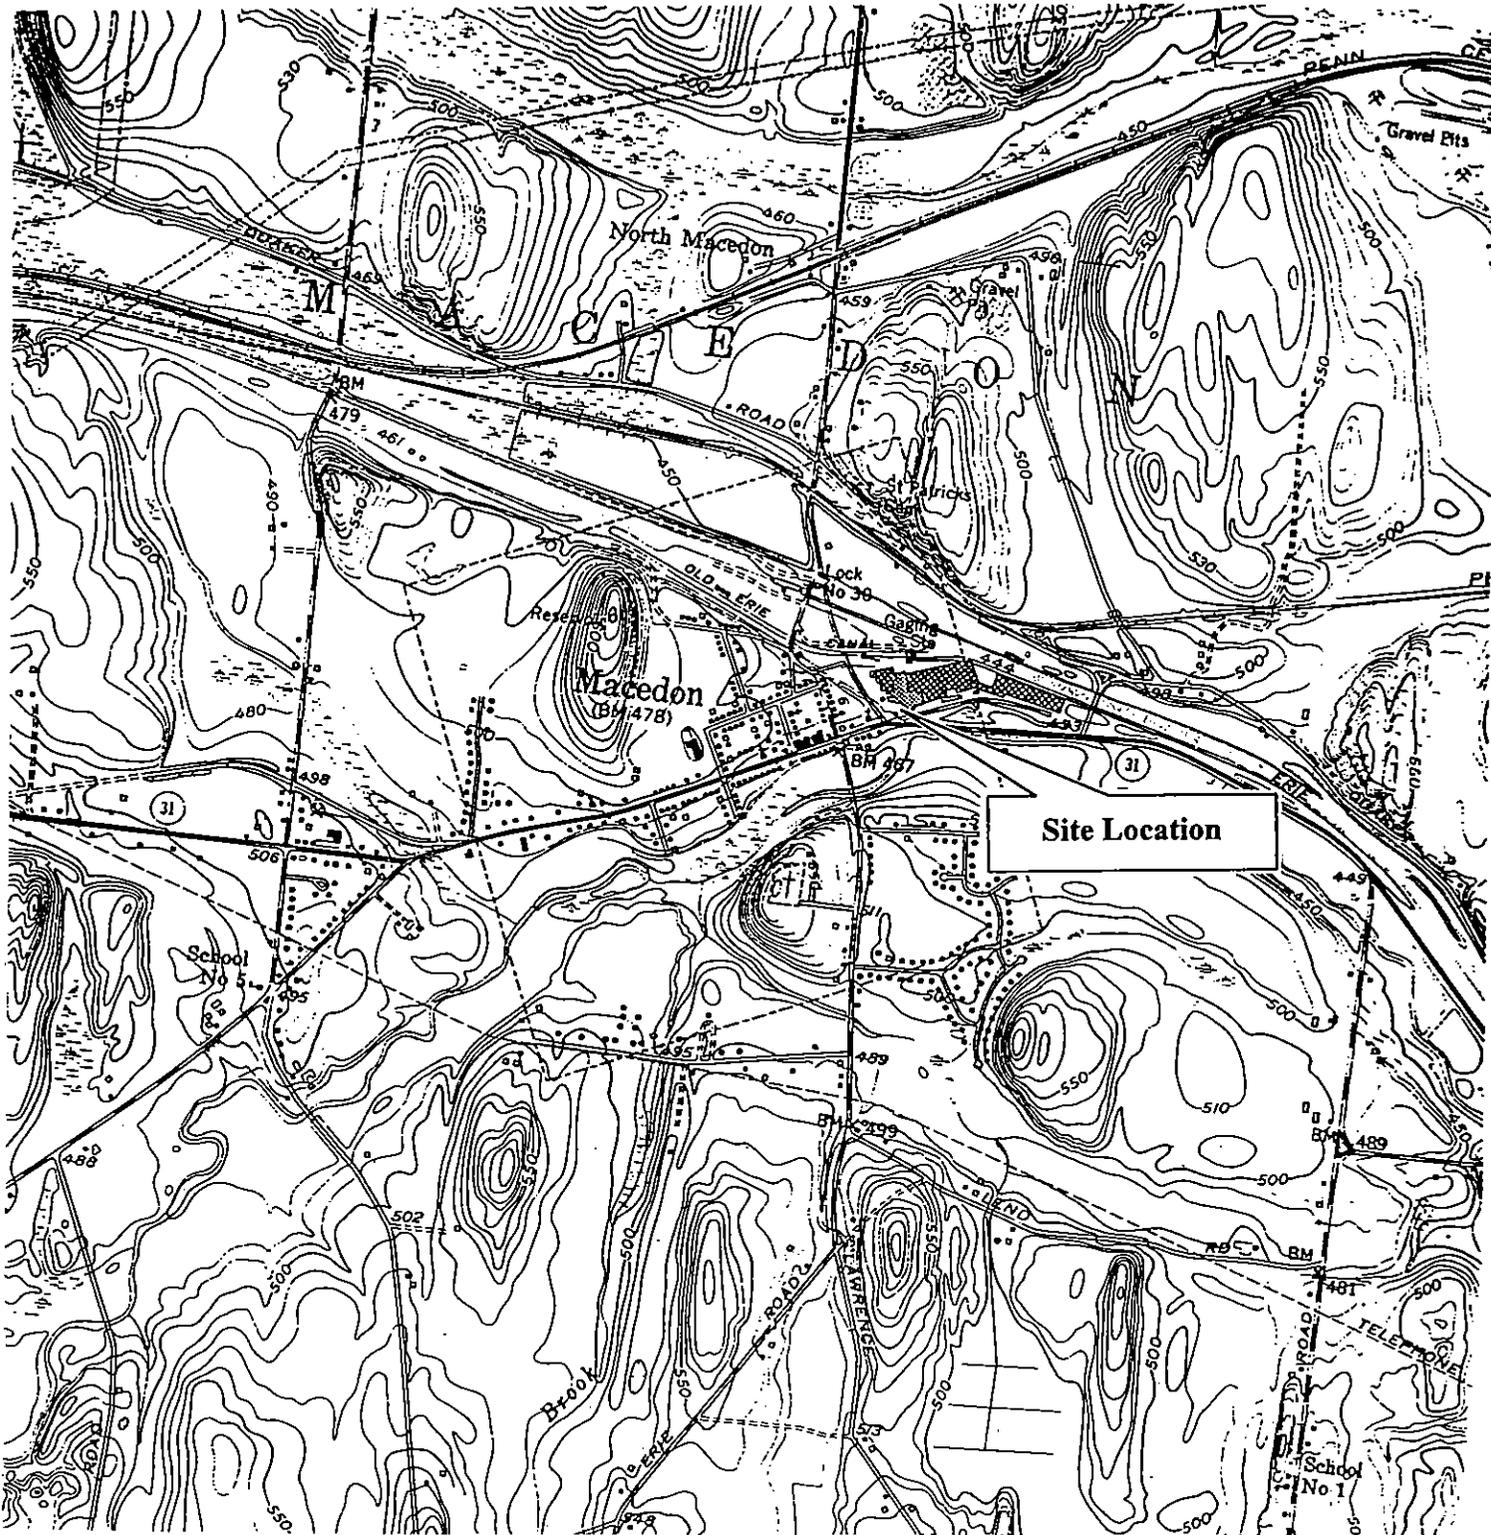
CONTOUR INTERVAL = 10 FEET
 REFERENCE:
 7.5 MINUTE TOPOGRAPHIC MAP
 MACEDON, N.Y., QUADRANGLE
 1951 (PHOTO REVISED 1969)

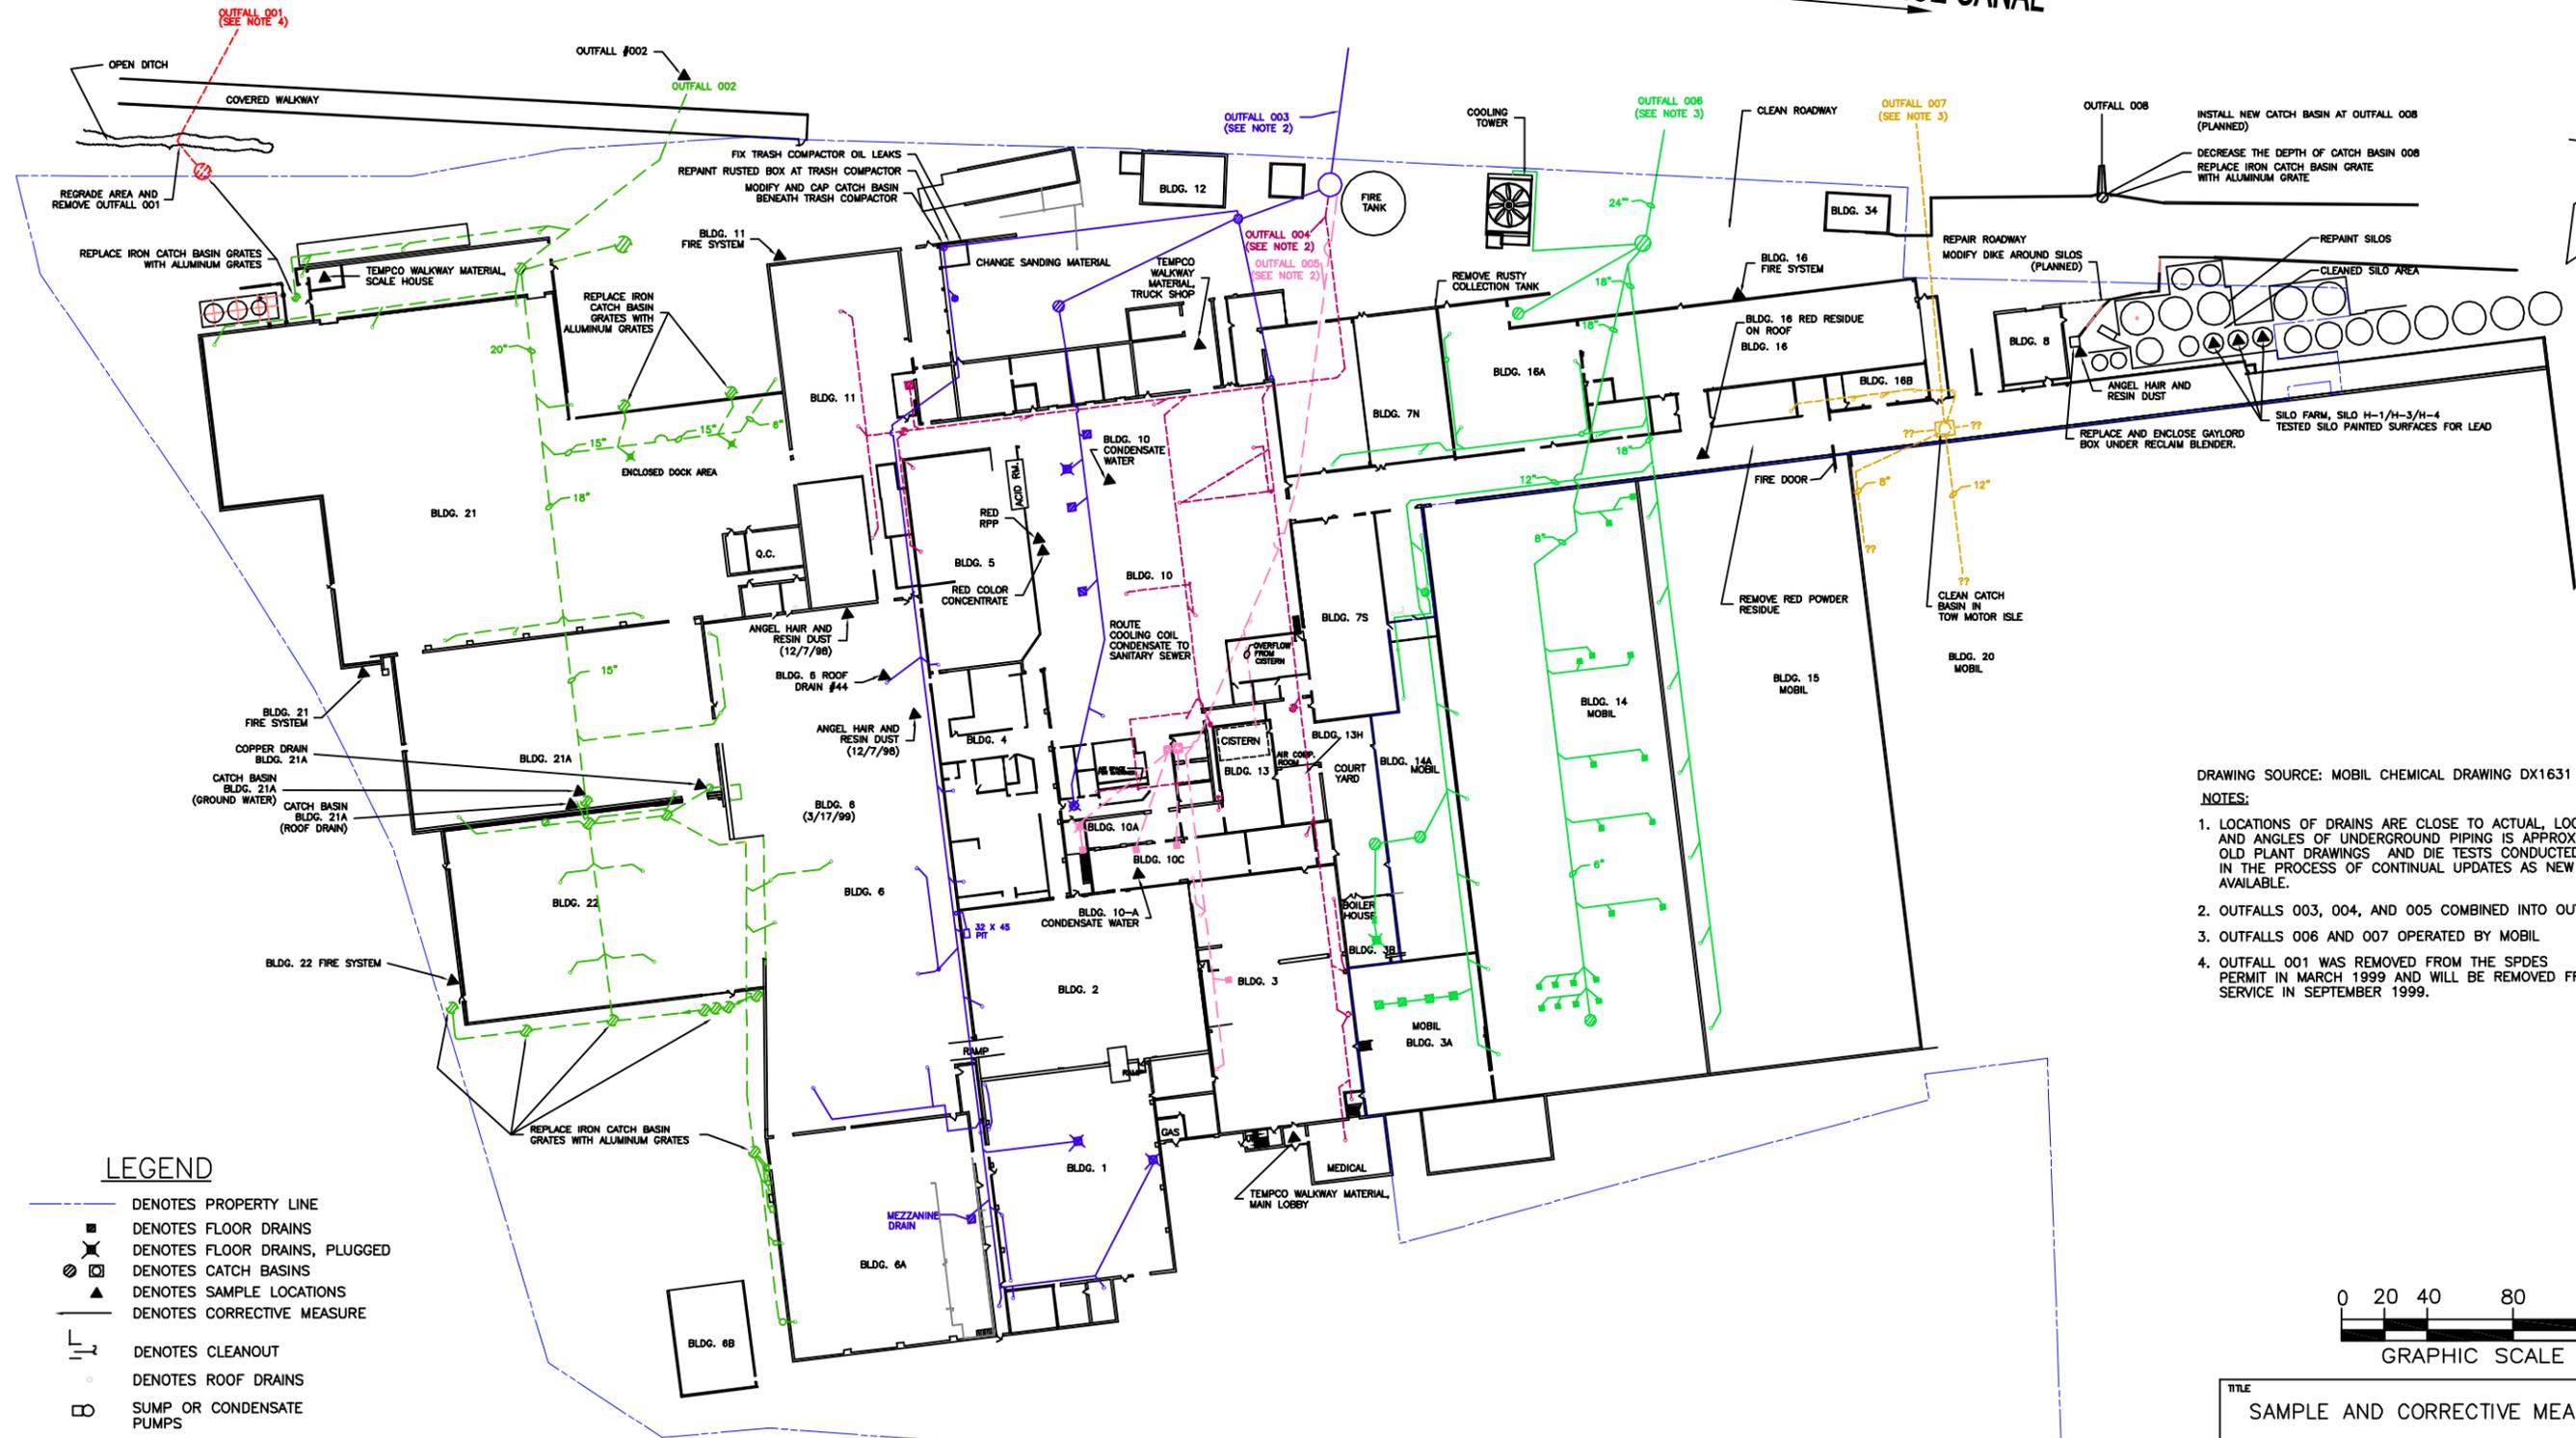
- DRAWING SOURCE: MOBIL CHEMICAL DRAWING DX1631 (SPCC DRAWING) 3/94
- NOTES:
1. LOCATIONS OF DRAINS ARE CLOSE TO ACTUAL, LOCATIONS, DIRECTIONS AND ANGLES OF UNDERGROUND PIPING IS APPROXIMATE AS TAKEN FROM OLD PLANT DRAWINGS AND DIE TESTS CONDUCTED SINCE 1984 AND ARE IN THE PROCESS OF CONTINUAL UPDATES AS NEW INFORMATION IS MADE AVAILABLE.
 2. OUTFALLS 003, 004, AND 005 COMBINED INTO OUTFALL 003 IN APRIL 1997
 3. OUTFALLS 006 AND 007 OPERATED BY MOBIL
 4. OUTFALL 001 WAS REMOVED FROM THE SPDES PERMIT IN MARCH 1999 AND WILL BE REMOVED FROM SERVICE IN SEPTEMBER 1999.
