Pre-Design Investigation Work Plan

Brownfield Cleanup Program Site #C915196B

1001 East Delavan Avenue

Buffalo, New York

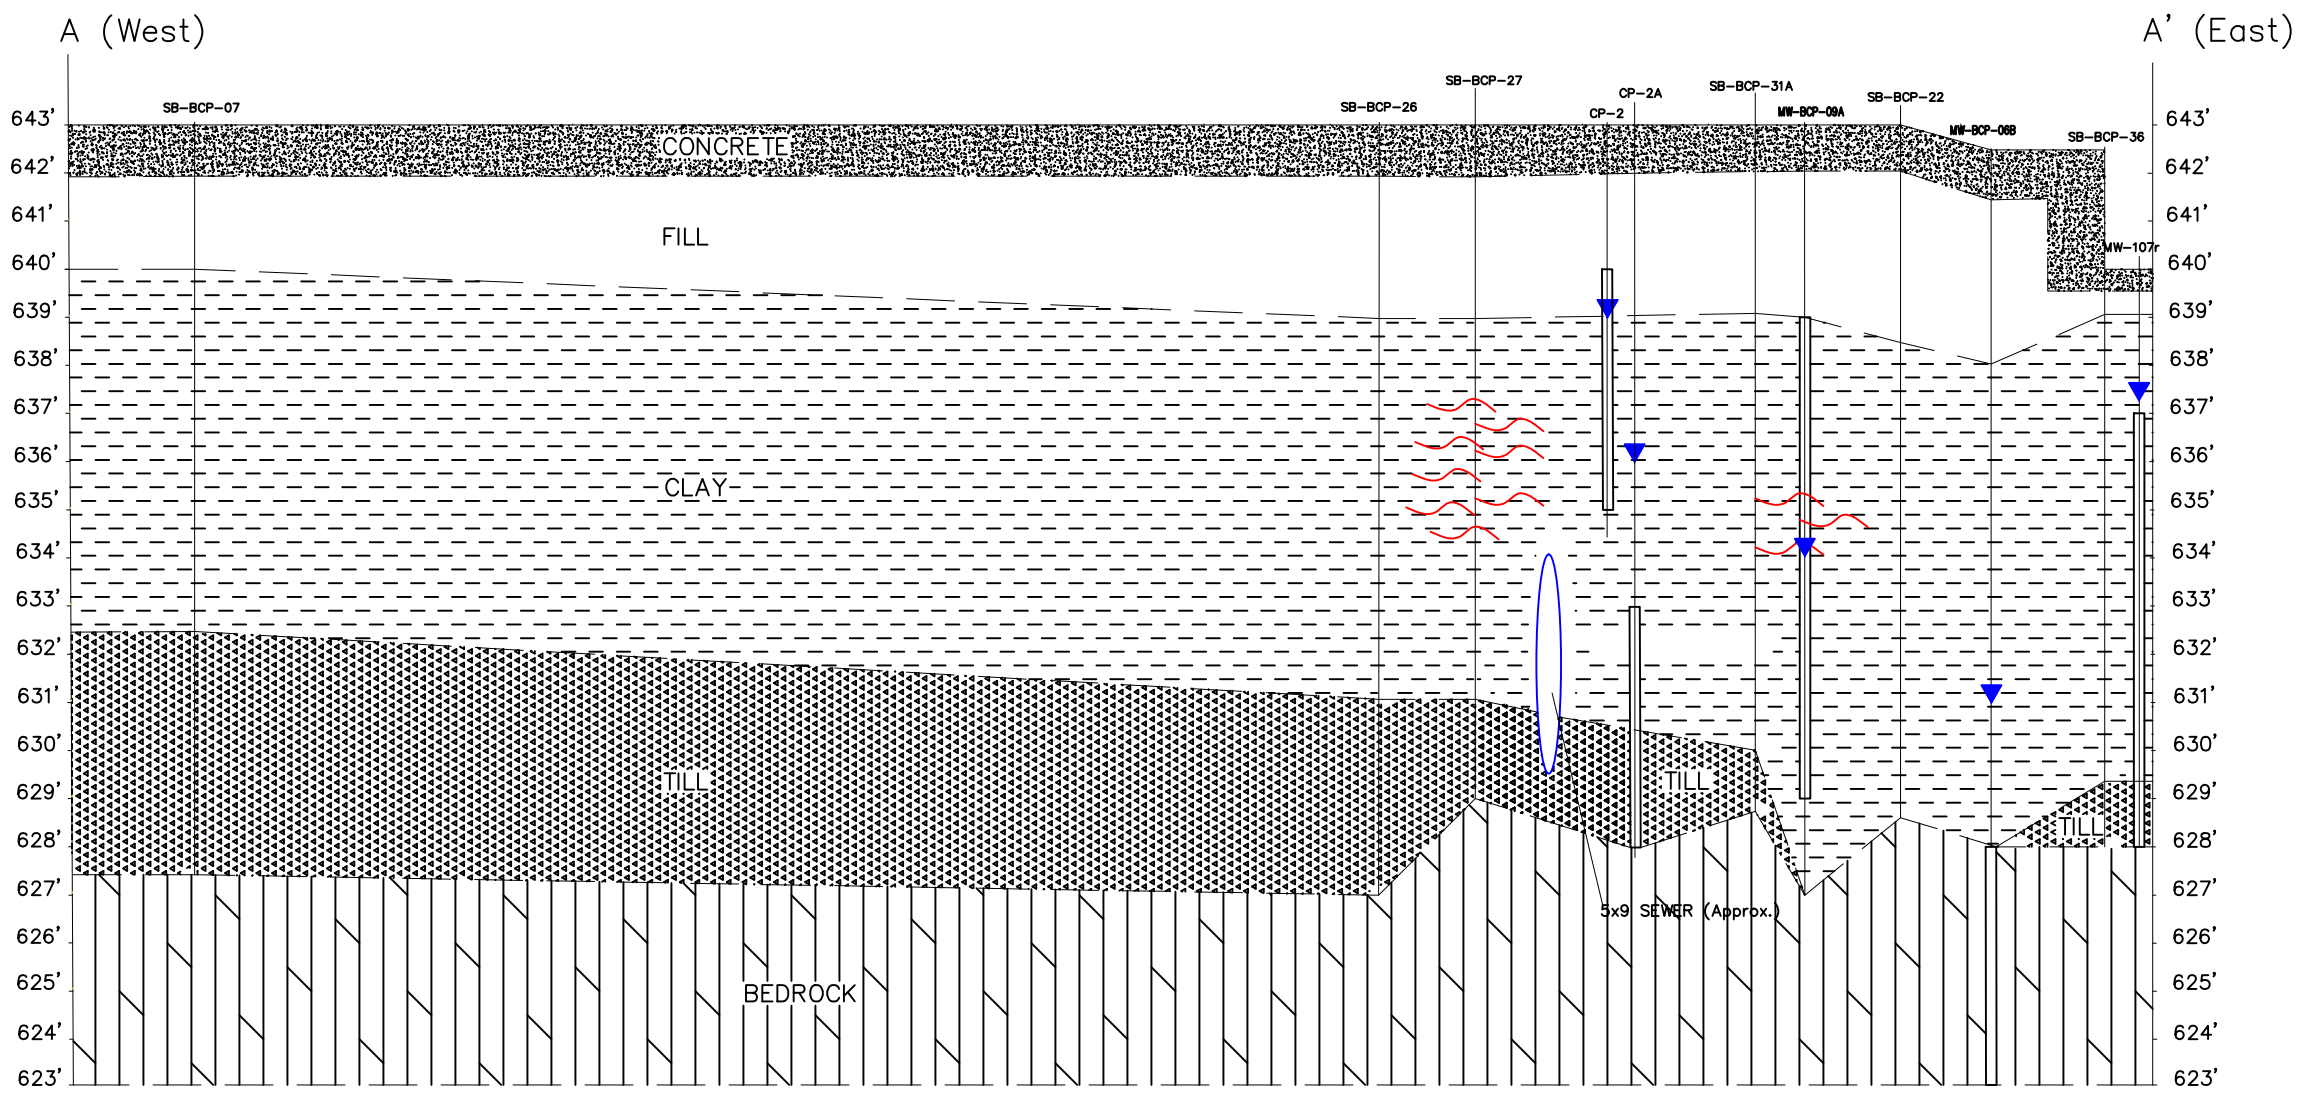
FIGURE 3
GEOLOGIC CROSS SECTION
A - A'

- POTENTIAL LNAPL PRESENCE
- SCREEN INTERVAL OR OPEN BOREHOLE (BEDROCK WELL)
- WATER LEVEL

Notes:
1. Groundsurface elevations are approximated from monitoring well survey.
2. 5x9 Sewer Depth approximated from July 2017 GHD Consulting Services Drawing, Buffalo Sewer Authority, Colorado Ave. Sewer, Sheet No. 111-37297-C008. Elevation coordinate conversion BSA Datum + 575.45 feet ASML.

The general composition of each of the three distinct overburden layers (Fill, Clay, and Bedrock) are described in more detail below. The geology of the BCP Site is well documented from historical site investigations and the BCP Site RI. A generalized geologic cross section of the BCP Site through the proposed PDI work area is provided in Figures 3. The cross-section profile location is shown on Figure 2.

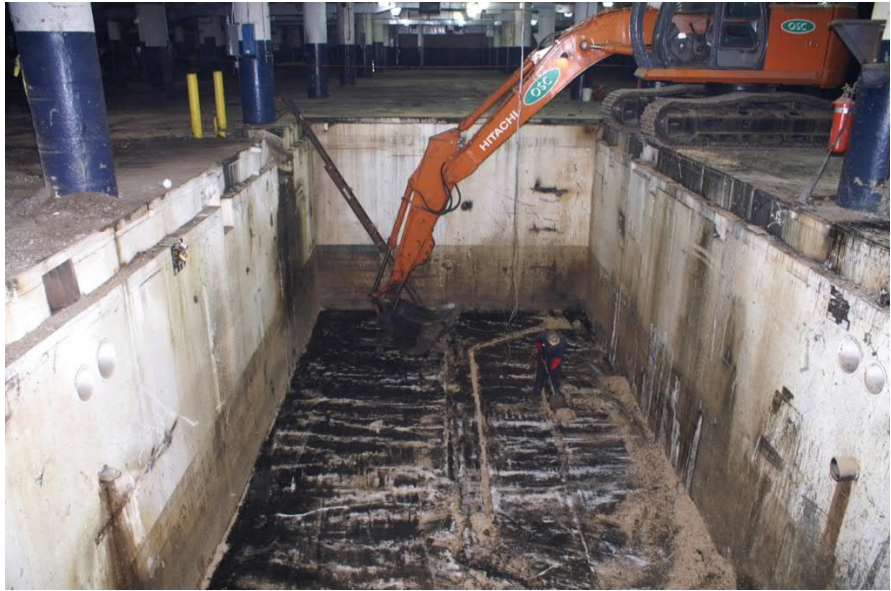
Client Name: East Delavan Avenue LLC	Photo Date: Sept. 2009	Project: East Delavan Avenue BCP Site No. C915196B
Photo No. 1

Direction Photo Taken: Unknown		
Description: Typical. Cleaning of pit/sump in former machining area. Scale of personnel and equipment indicate base of pit/sump is close to clay/bedrock interface (~12 to 14- feet bgs).		
Client Name: East Delavan Avenue LLC	Photo Date: June 2009	Project: East Delavan Avenue BCP Site No. C915196B
Photo No. 2

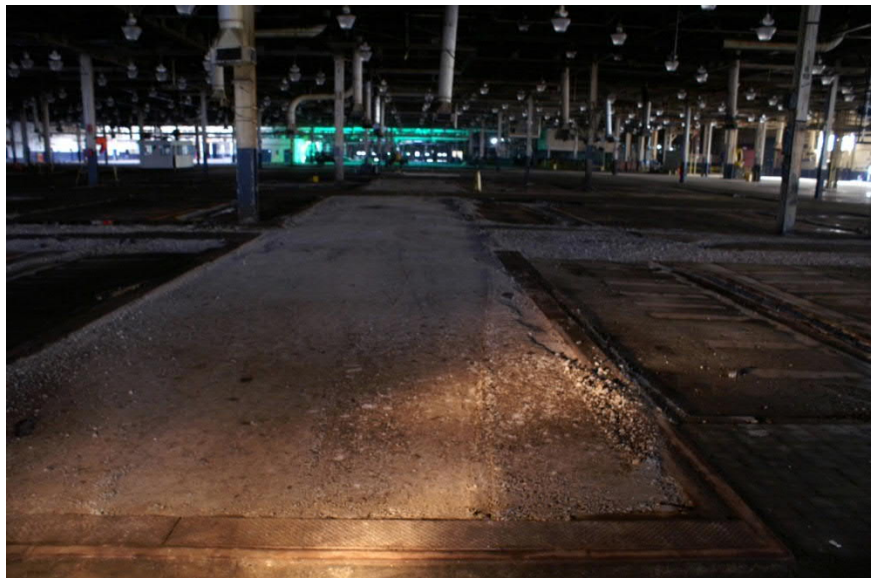
Direction Photo Taken: Looking west		
Description: Typical. Backfilled trenches and pits in former machining area after cleaning.

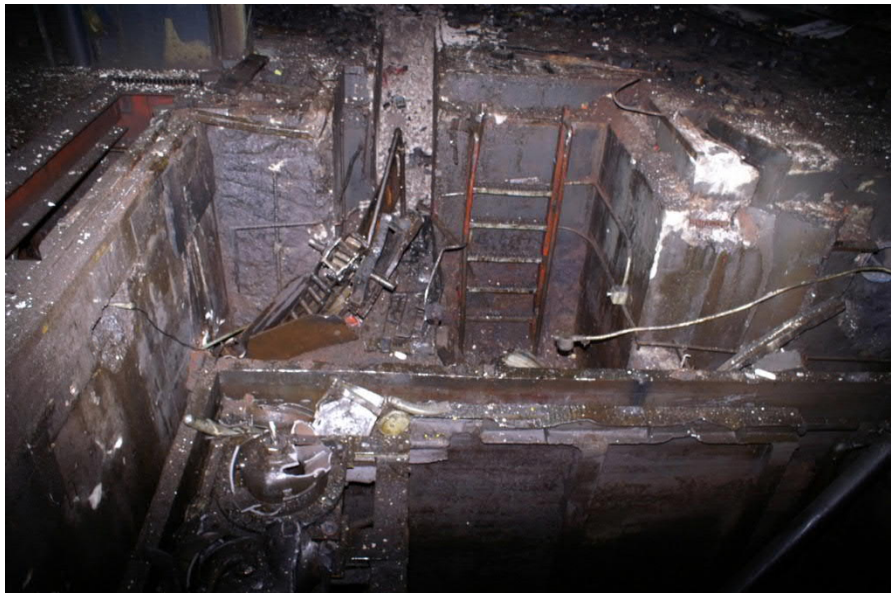
Client Name: East Delavan Avenue LLC	Photo Date: July 2009	Project: East Delavan Avenue BCP Site No. C915196B
Photo No. 3

Direction Photo Taken: N/A		
Description: Former machining area. Pit under former equipment prior to cleaning by EDP.		
Client Name: East Delavan Avenue LLC	Photo Date: July 2009	Project: East Delavan Avenue BCP Site No. C915196B
Photo No. 4

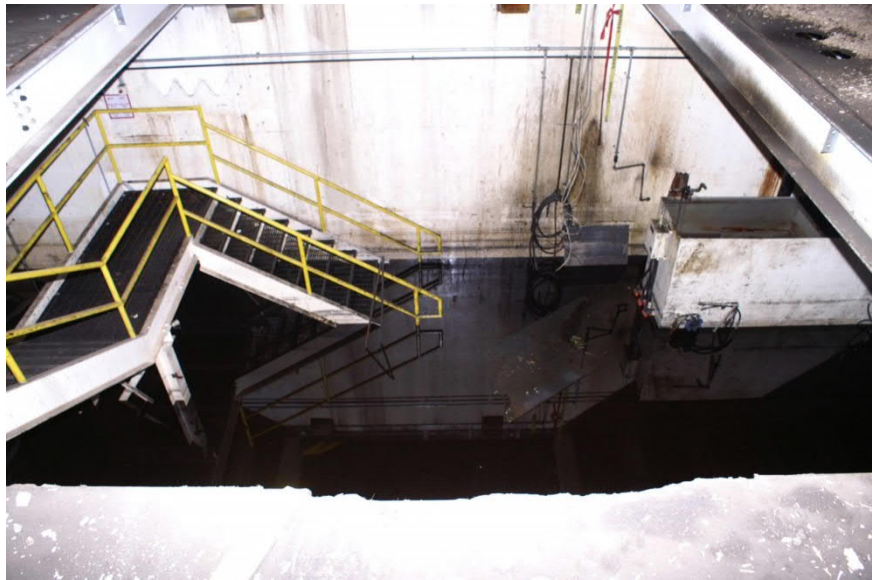
Direction Photo Taken: N/A		
Description: Former machining area. Water/LNAPL in pit. Prior to removal, cleaning, and backfilling by EDP

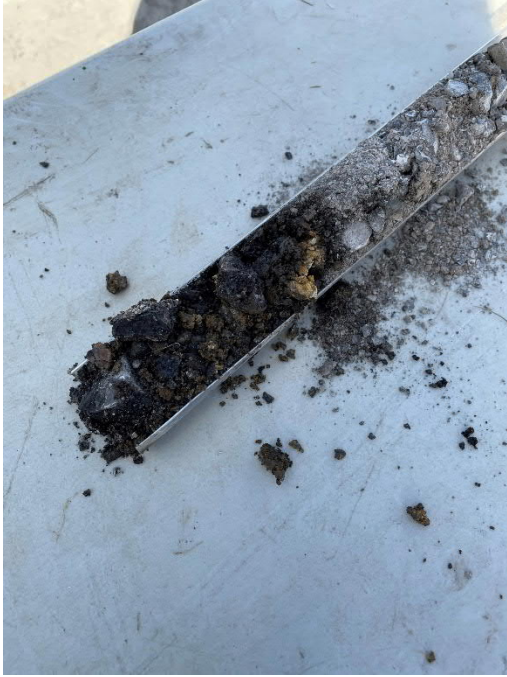
Client Name: East Delavan Avenue LLC	Photo Date:	Project: East Delavan Avenue BCP Site No. C915196B
Photo No. 5

Direction Photo Taken: N/A		
Description: Typical coal and industrial urban debris in Fill.		
Client Name: East Delavan Avenue LLC	Photo Date:	Project: East Delavan Avenue BCP Site No. C915196B
Photo No. 6

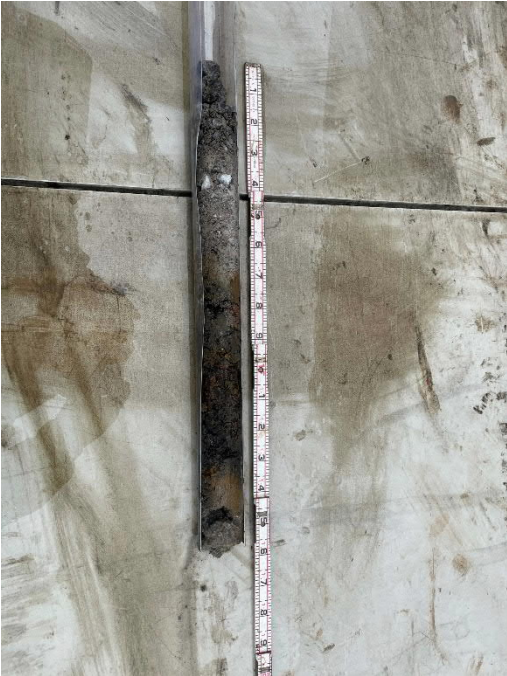
Direction Photo Taken: N/A		
Description: Typical Fill column. Coal and industrial urban debris and reworked native clays.

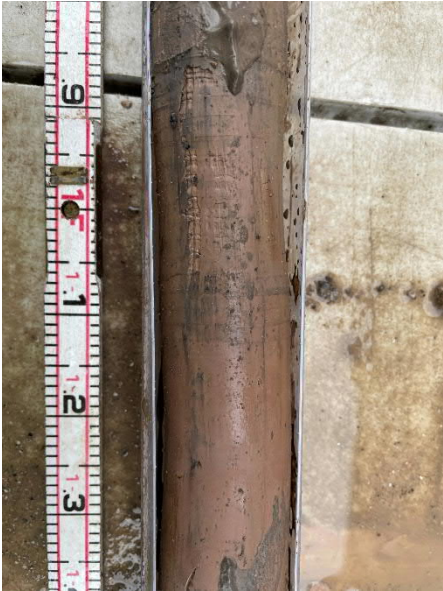
Client Name: East Delavan Avenue LLC	Photo Date: July 2009	Project: East Delavan Avenue BCP Site No. C915196B
Photo No. 7

Direction Photo Taken: N/A		
Description: Typical brownish-red clay.		
Client Name: East Delavan Avenue LLC	Photo Date:	Project: East Delavan Avenue BCP Site No. C915196B
Photo No. 8

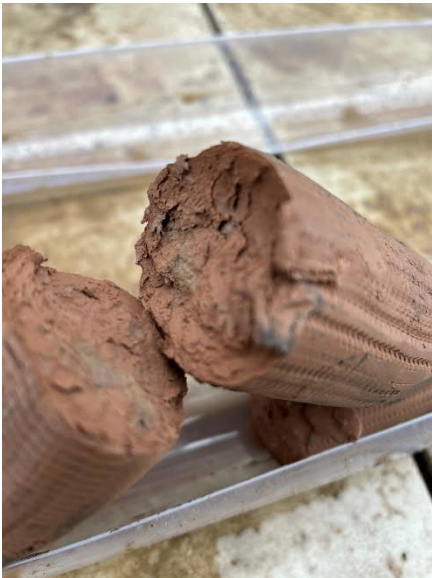
Direction Photo Taken: N/A		
Description: Typical brown-red clay.

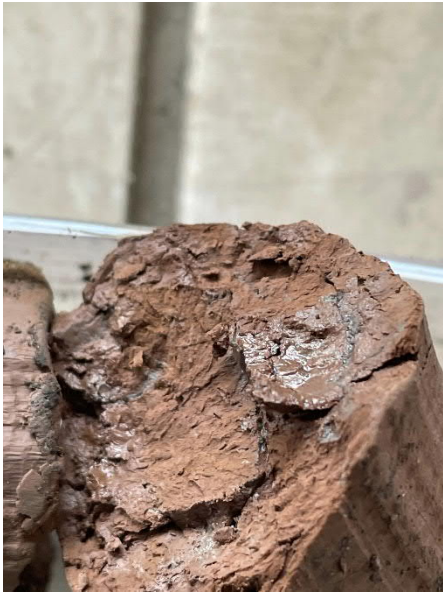
Client Name: East Delavan Avenue LLC	Photo Date:	Project: East Delavan Avenue BCP Site No. C915196B
Photo No. 9

Direction Photo Taken: N/A		
Description: LNAPL Sheen in clay core at SB-BCP-25		
Client Name: East Delavan Avenue LLC	Photo Date: June 2009	Project: East Delavan Avenue BCP Site No. C915196B
Photo No. 10

West of the 5x9 Sewer, LNAPL was visually identified in the clay unit in samples from two borings (SB-BCP-25 and SB-BCP-25A). The LNAPL was present in the recovered soil cores as a discontinuous and spotty sheen and did not appear to be as prevalent in the soil column as the borings east of the 5x9 Sewer. Similar to the borings on the east side of the sewer, there was no staining or smearing observed on the outside of the tooling or on the Macro-Core liners.

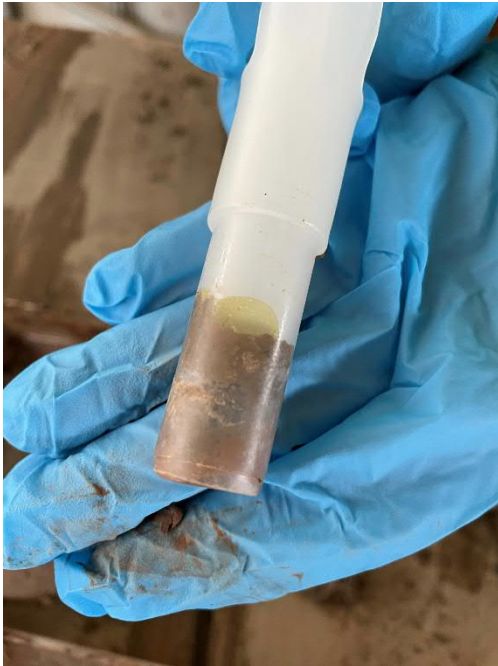
Direction Photo Taken: N/A		
Description: LNAPL in TerraCore (VOC Sample collection) at SB-BCP- 31

In the former machining area east of the 5x9 Sewer LNAPL was visually identified in the clay unit in borings SB-BCP-31 and SB-BCP-32 completed during the RI. The LNAPL was present in the recovered soil cores as a spotty sheen and was not continuous across the vertical length of the core. Additionally, there was no staining or smearing observed on the outside of the direct-push tooling or on the Macro-Core liners. Aliquots of the impacted soil from these cores were placed in 4-oz glass jars with deionized water and allowed to sit undisturbed for over 24 hours. There was no separation of a separate phase liquid observed in the jars over that time. Step-out borings from SB-BCP-31 were completed west (SB-BCP-31A) and north (SB-BCP-30) in response to the visual detection of LNAPL. No LNAPL was identified in either of these step-out borings.

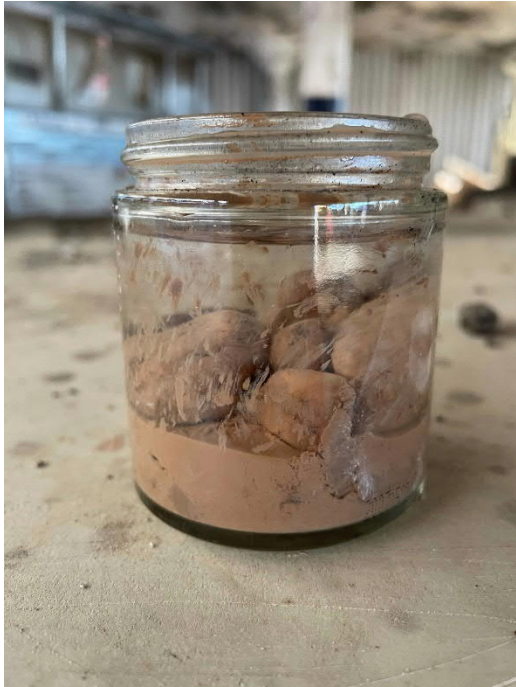
Client Name: East Delavan Avenue LLC	Photo Date:	Project: East Delavan Avenue BCP Site No. C915196B
Photo No. 11

Direction Photo Taken: N/A		
Description: LNAPL containing clay in water after 24- hours. Note no separation or LNAPL in the water.		
Client Name: East Delavan Avenue LLC	Photo Date:	Project: East Delavan Avenue BCP Site No. C915196B
Photo No. 12

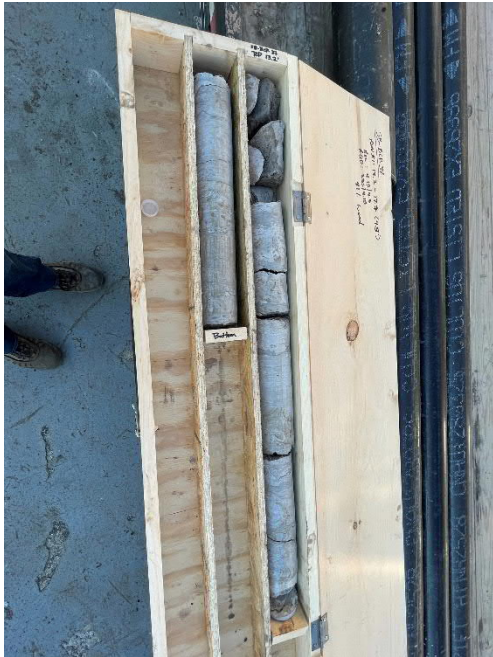
Direction Photo Taken: N/A		
Description: Limestone bedrock core. Typical.
