1132-1146 Seneca Street Site

Final Engineering Report

NYSDEC Site Number: C915228

Malcolm Pirnie, Inc.

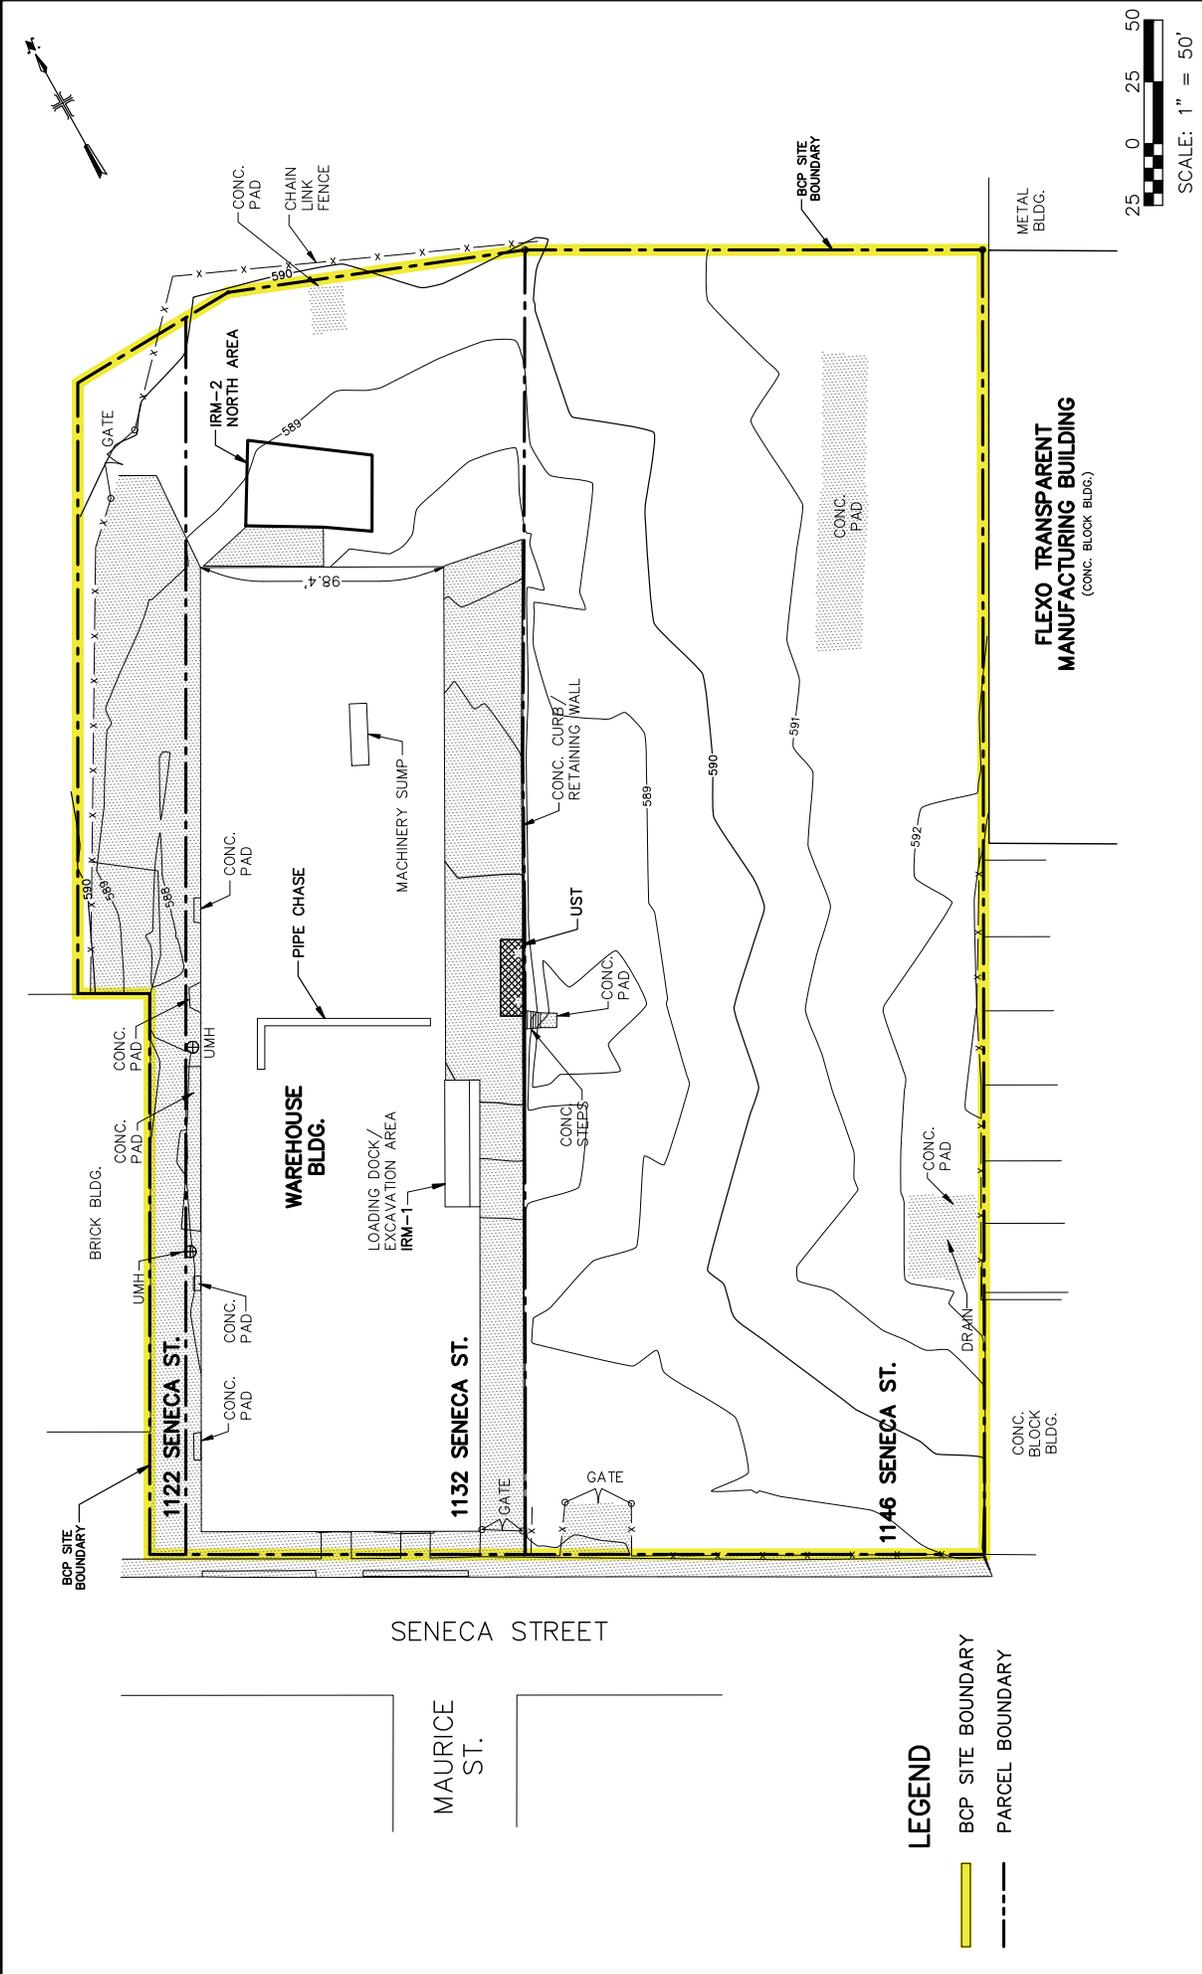
MALCOLM PIRNIE, INC.
 NOVEMBER 2010
 FIGURE 2

SITE BASE MAP
 SCALE: 1"=50'

This FER presents all remedial work completed under the BCP, including that which was reported previously in the RI/RWP. The site base map (Figure 2) shows the location of impacted soil/fill removals including IRM-1, IRM-2 as well as the UST and pipe chase remedial focus areas. Although not specifically designated as IRMs, the work completed at the UST and pipe chase are IRM-type actions and therefore are presented in this IRM Section.

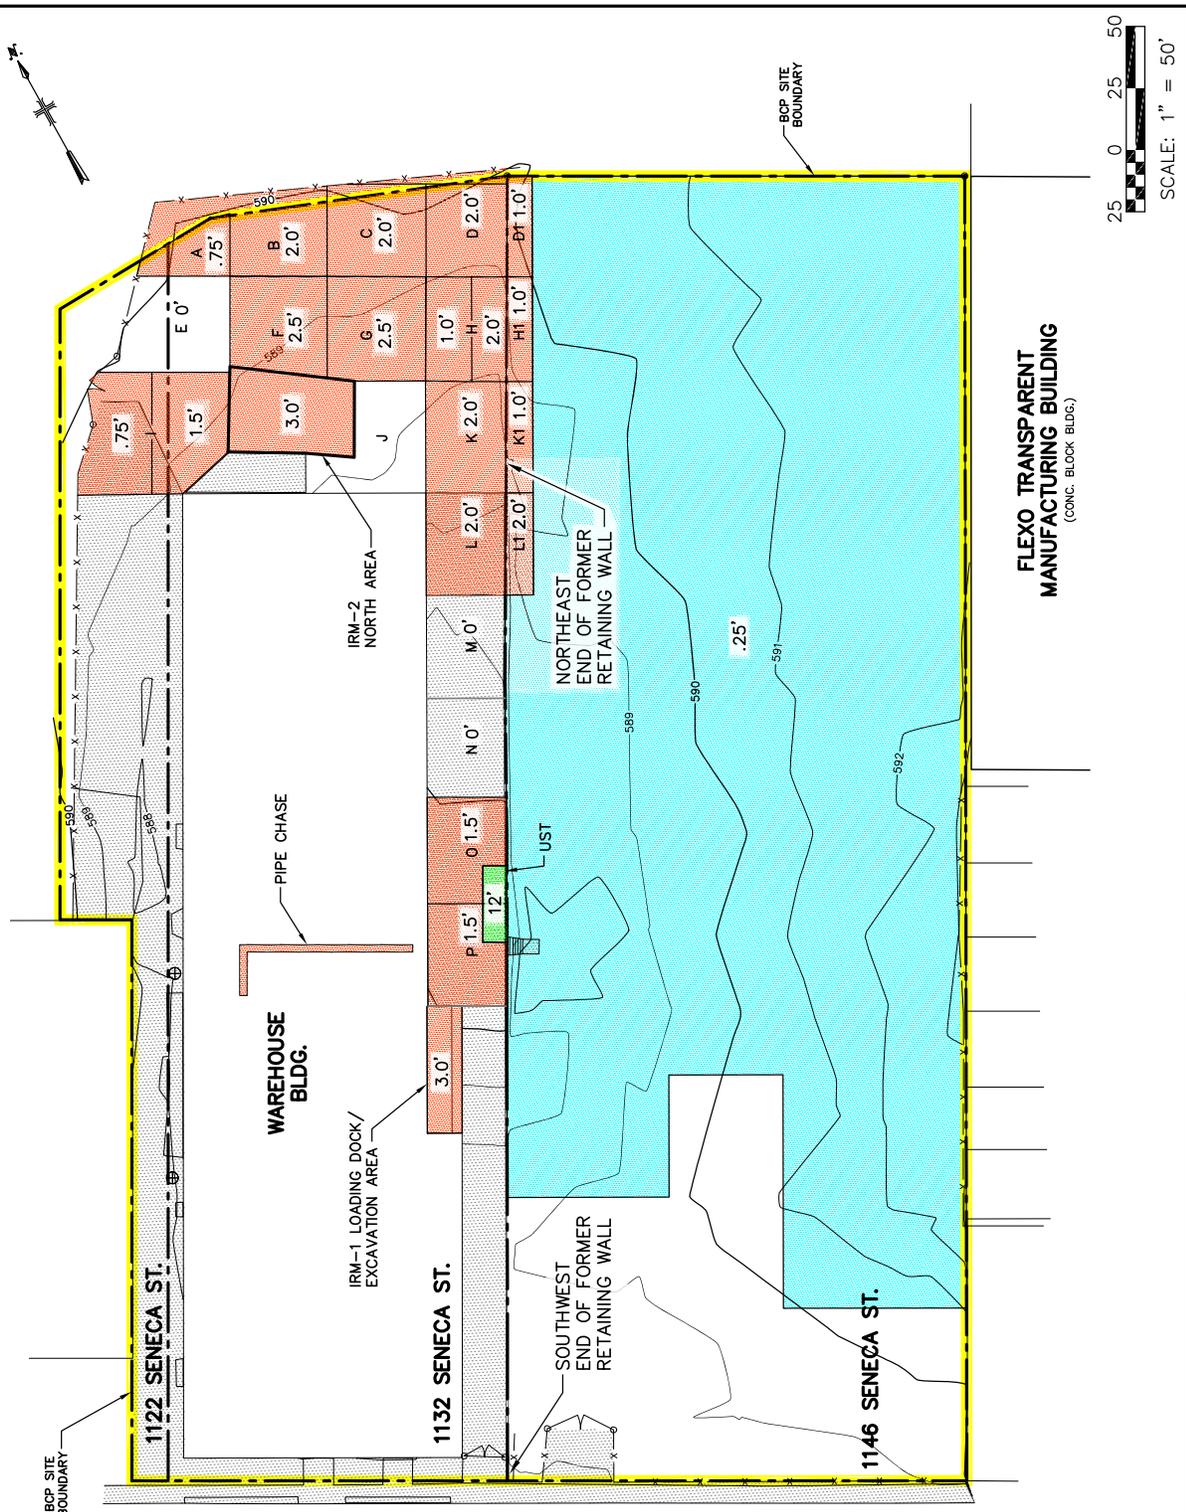
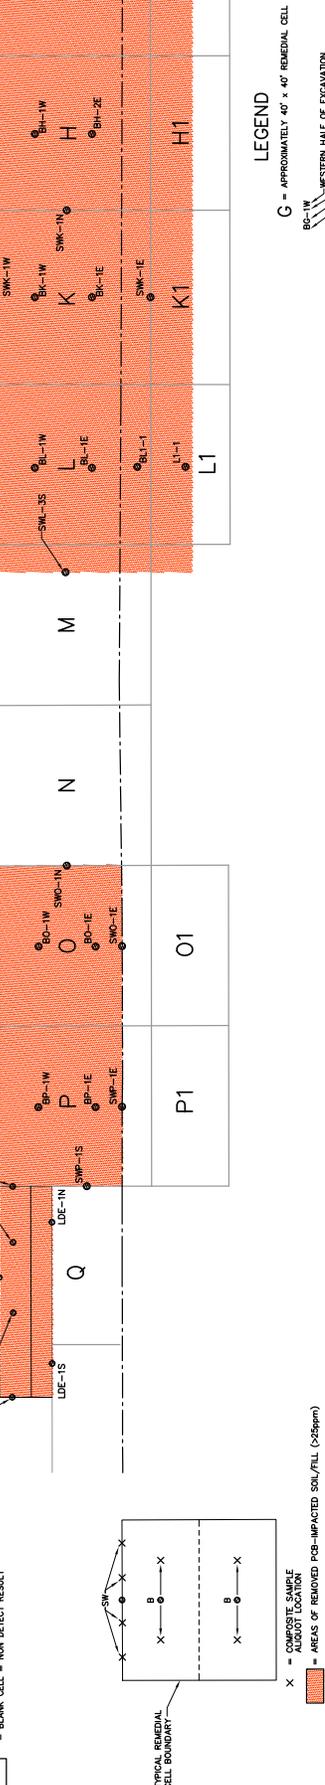
SWK-1S	0 - 2.00	14.12	LD-SOUTH	2.5 - 3.0	1.42
BB-1E	0.50	1.50	LD-E-N	2.5 - 3.0	9.14
BB-1W	0.50	1.50			
RMZ-NORTH	2.50	1.80			
RMZ-EAST	2.50	1.00			
RMZ-WEST	2.50	0.27			
RMZ-BTM	3.00	0.01

SWA-1E - INDICATIVE OF COMPOSITE BOTTOM SAMPLE COLLECTED FROM EAST WALL IN GRID A
 BA-1E - INDICATIVE OF COMPOSITE BOTTOM SAMPLE COLLECTED FROM EASTERN HALF OF GRID A
 SWK-1E - NON DETECT RESULT
 - BLANK CELL = NON DETECT RESULT

- G = APPROXIMATELY 40' x 40' REMEDIAL CELL
- BP-1W WESTERN HALF OF EXCAVATION CELL 1
- BP-1E EASTERN HALF OF EXCAVATION CELL 1
- BP-2W WESTERN HALF OF EXCAVATION CELL 2
- BP-2E EASTERN HALF OF EXCAVATION CELL 2
- SW-1W NORTH WALL OF EXCAVATION CELL 1
- SW-1E NORTH WALL OF EXCAVATION CELL 1
- SW-2W NORTH WALL OF EXCAVATION CELL 2
- SW-2E NORTH WALL OF EXCAVATION CELL 2
- SW-1W EXCAVATION SIDE WALL SAMPLE
- SW-1E EXCAVATION SIDE WALL SAMPLE
- SW-2W EXCAVATION SIDE WALL SAMPLE
- SW-2E EXCAVATION SIDE WALL SAMPLE

samples collected as part of the IRMs and the overall Site remedy. Figure 4 illustrates the locations of the confirmation samples collected from the 1132 Seneca Street property and a summary of total PCB concentrations detected in these samples. Figure 5 includes the locations and results of sidewall samples collected in relation to the UST removal.

The loading dock IRM involved the removal of PCB impacted soil/fill and concrete and was completed in two phases, the first of which was completed in October 2009 and reported in the RIR/RWP dated September 2010. OP-TECH removed and disposed of approximately 72.9 tons of hazardous PCB-impacted soil/fill and concrete at the Chemical Waste Management facility in Model City, New York during the first phase of this IRM. Also, PCB-impacted water from the loading dock excavation was temporarily staged on site in a holding tank which was later also disposed at Chemical Waste Management in Model City. A second phase of excavation was performed at the loading dock in September 2010. The lateral extent of excavation along the eastern perimeter of the loading dock IRM was limited to the concrete building sidewall and supporting pier structure(s). The north and south limits of excavation were limited to the areal extent of the loading dock within the warehouse building. The depth of the excavation was at the base of the fill unit at the top of the underlying native clayey silt unit identified at approximately 3 feet below the loading dock original floor grade. During Phase II of IRM-1, an estimated 20 tons of PCB-impacted soil and concrete were removed, transported, and disposed as hazardous waste at the Chemical Waste Management facility in Model City, New York. The soil/fill and concrete were excavated all the way to the easternmost building wall of the loading dock. All final post-excavation confirmation samples were below the industrial SCO for total PCBs of 25 mg/kg. See Table 1 and Figure 4.

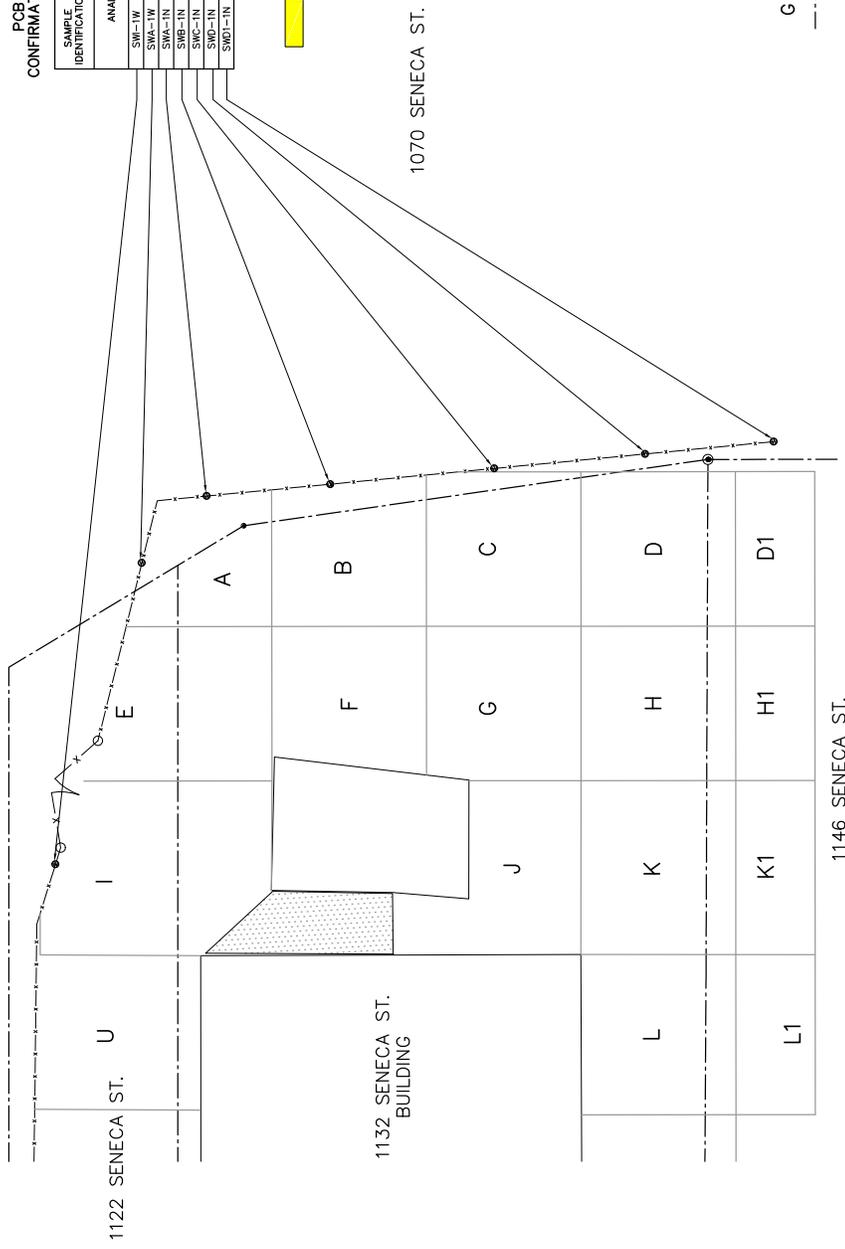
SAMPLE COMPOSITE SCHEME
NOT TO SCALE

X = COMPOSITE SAMPLE ALIQUOT LOCATION
