March 2019 Buffalo Color

Remedial Action Work Plan for Buffalo Color Corporation Site Areas A and B Off-site: NYSDEC Site No. C915230A

Honeywell International Inc. 115 Tabor Road Morris Plains, New Jersey 07950

Anchor QEA Engineering, PLLC 290 Elwood Davis Road, Suite 340 Liverpool, New York 13088

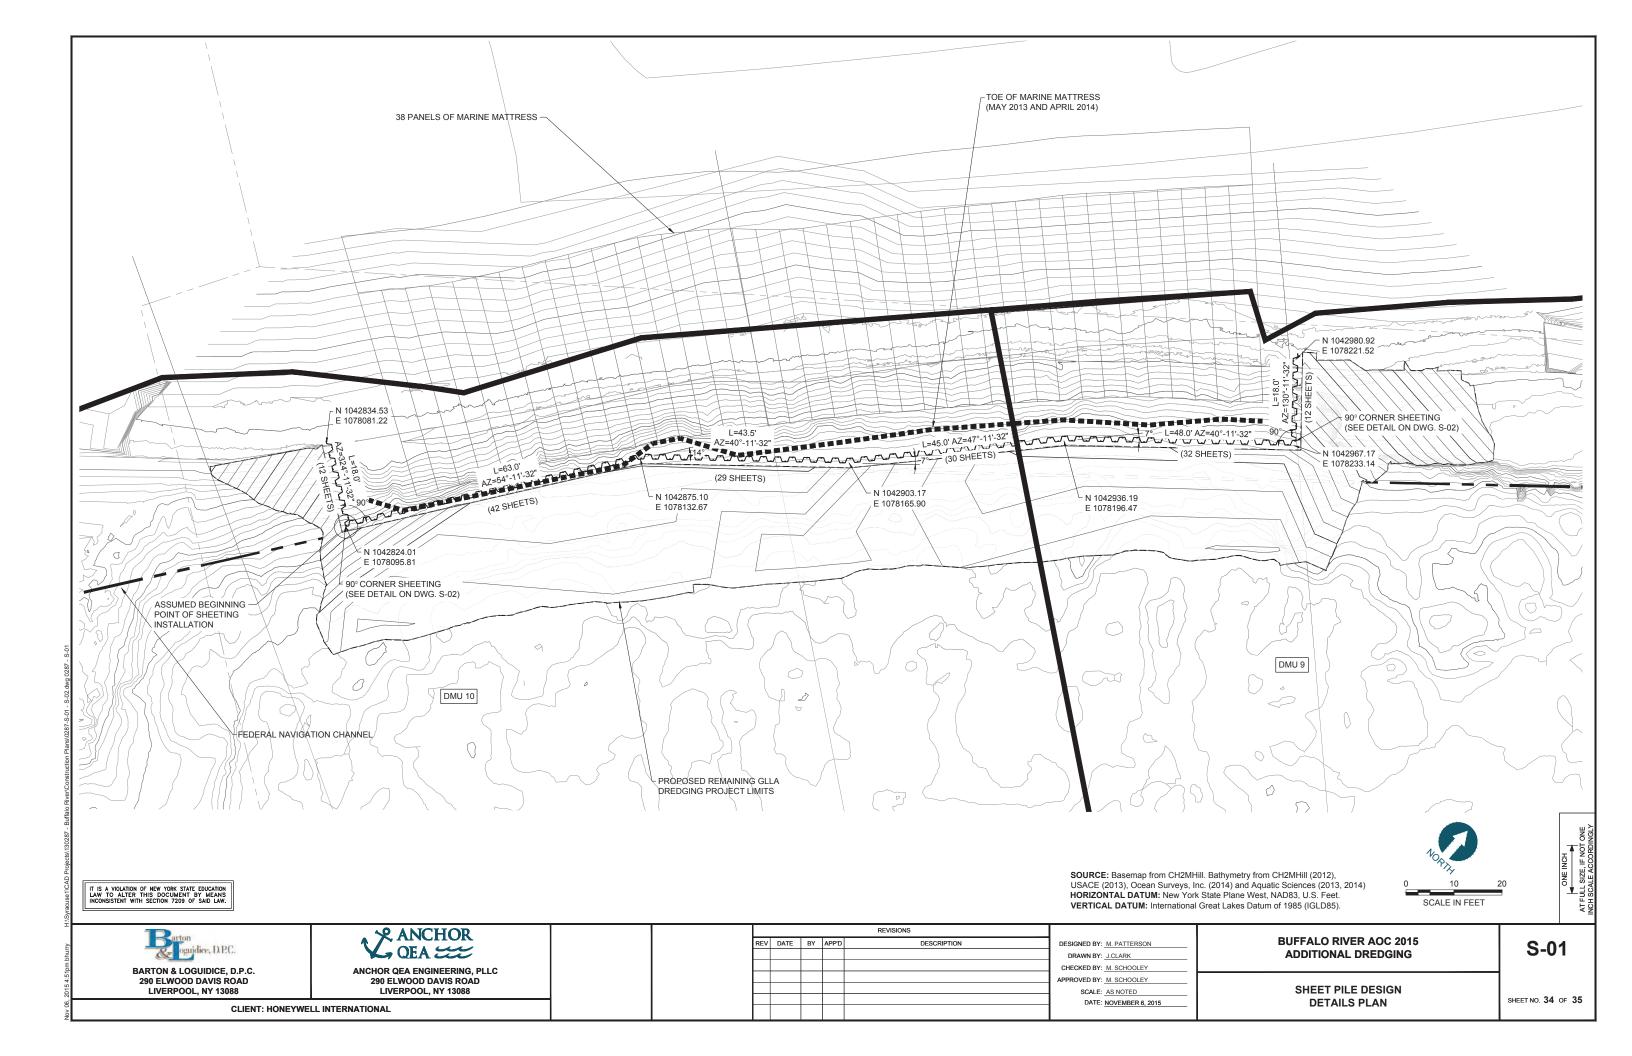
PERMANENT STEEL SHEETING SECTION

NOT TO SCALE
