**Re: 1827 Fillmore Avenue Site, Buffalo, NY (BCP Site No. C915279)
Supplemental Remedial Investigation (RI) Work Plan for Bedrock Drilling
Activities**

SUPPLEMENTAL INVESTIGATION PLAN

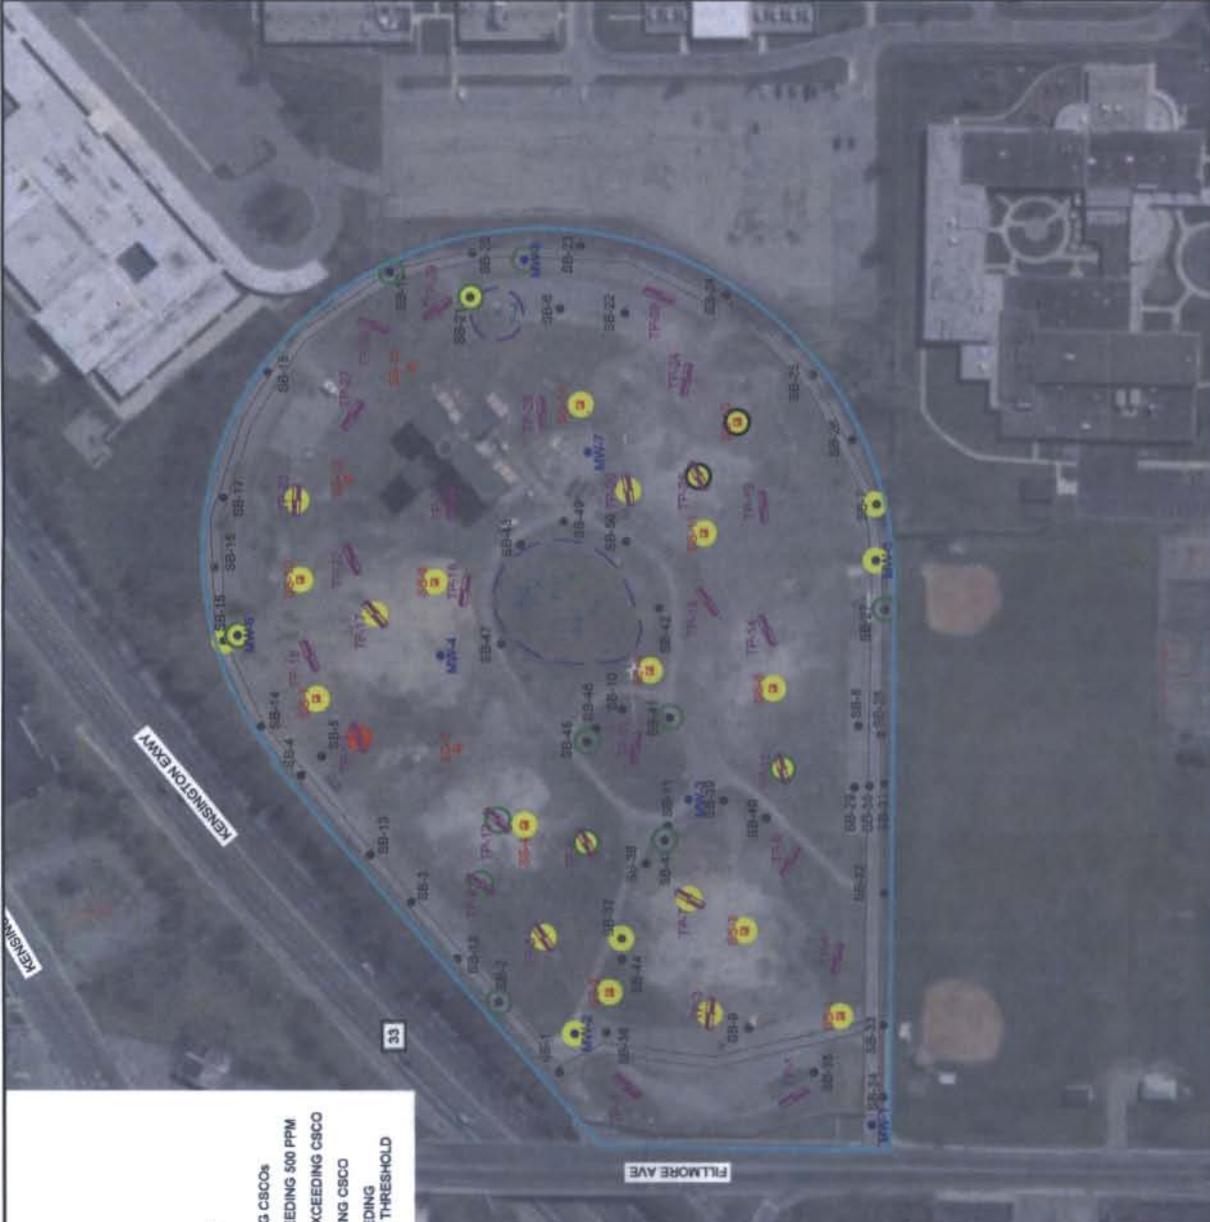
FIGURE 3

SCALE: 1 INCH = 150 FEET
SCALE IN FEET
(approximate)

An auger rig will be used to re-advance borings in the areas of RI locations MW-1, -2 and -3 (see the attached Figure outlining MW-1 through MW-3 locations) where bedrock refusal was previously encountered at 5.4 feet below ground surface (fbgs), 14 fbgs, and 15.6 fbgs, respectively. As overburden soil/fill conditions are known from previous sampling work at all three locations, no soil/fill sampling will be completed during the work.
