Periodic Review Report

441 Ohio Street Site (BCP Site No. C915285) Buffalo, New York

August 2018

PERIODIC REVIEW REPORT

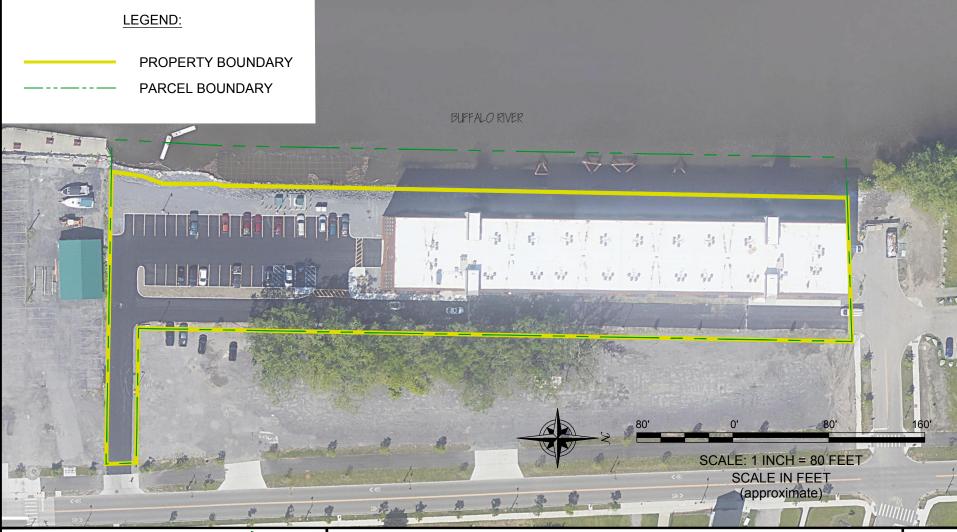
SITE PLAN (AERIAL)

Figure 2 Site Plan

The 1.8 acre BCP Site is bounded by South Street to the north, roadway access and parking lot area to the south, parking lot with Ohio Street beyond to the east, and the Buffalo River to the west (see Figures 1 and 2).

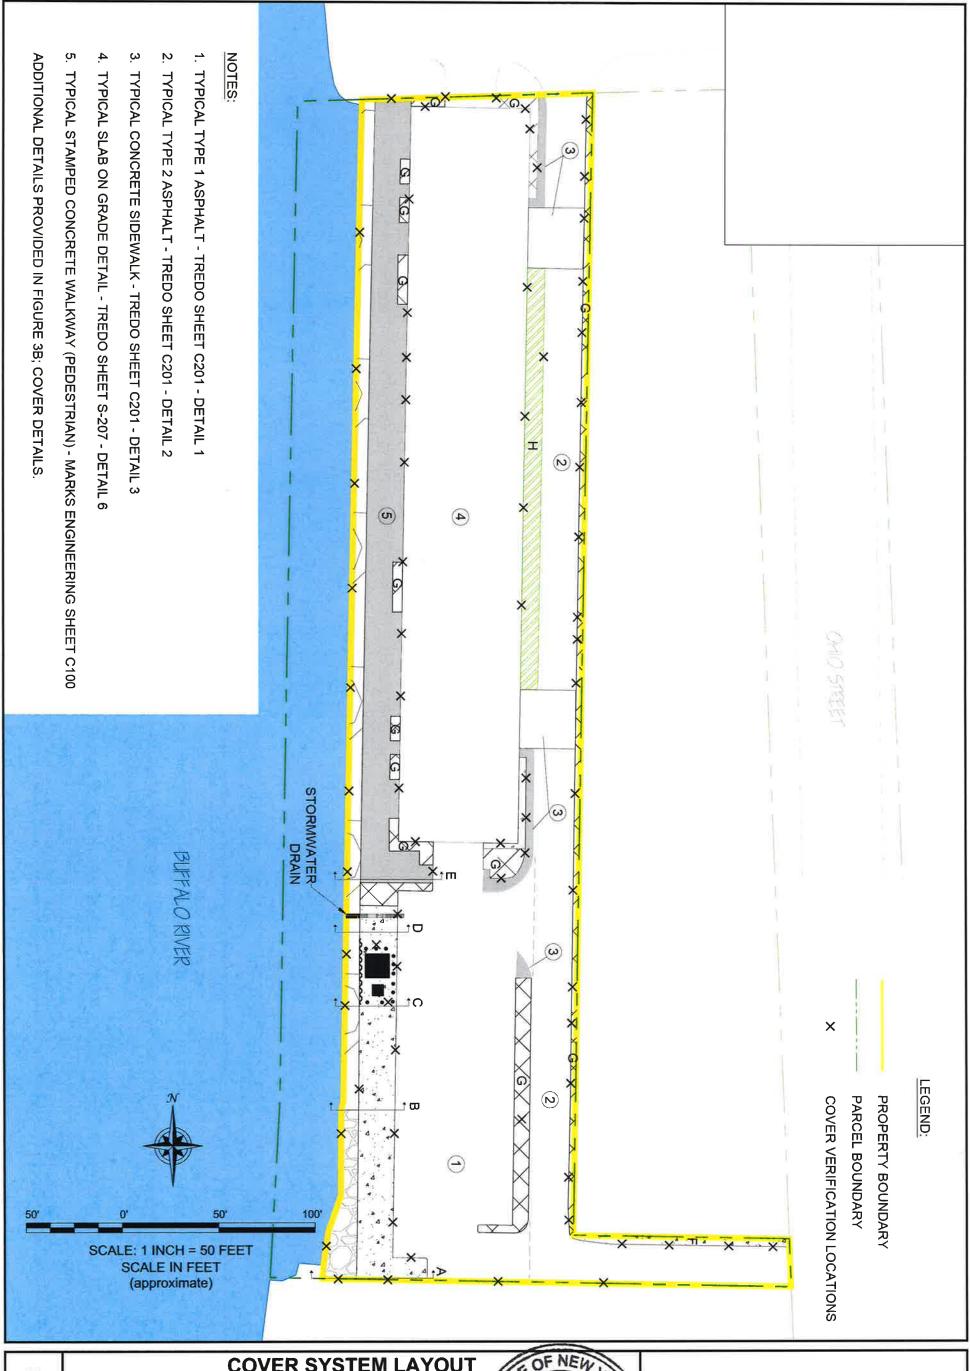
COVER SYSTEM LAYOUT (RECORD DRAWING)

During this reporting period, modification of the cover system was completed. As previously noticed to the Department, modification was primarily limited to completion of redevelopment design elements, including concrete patio along the western side of the building, and landscape plantings that were previously unable to be completed due to seasonal weather limitation. It should be noted that there was no disturbance beneath the demarcation layer as part of the surface cover modification.

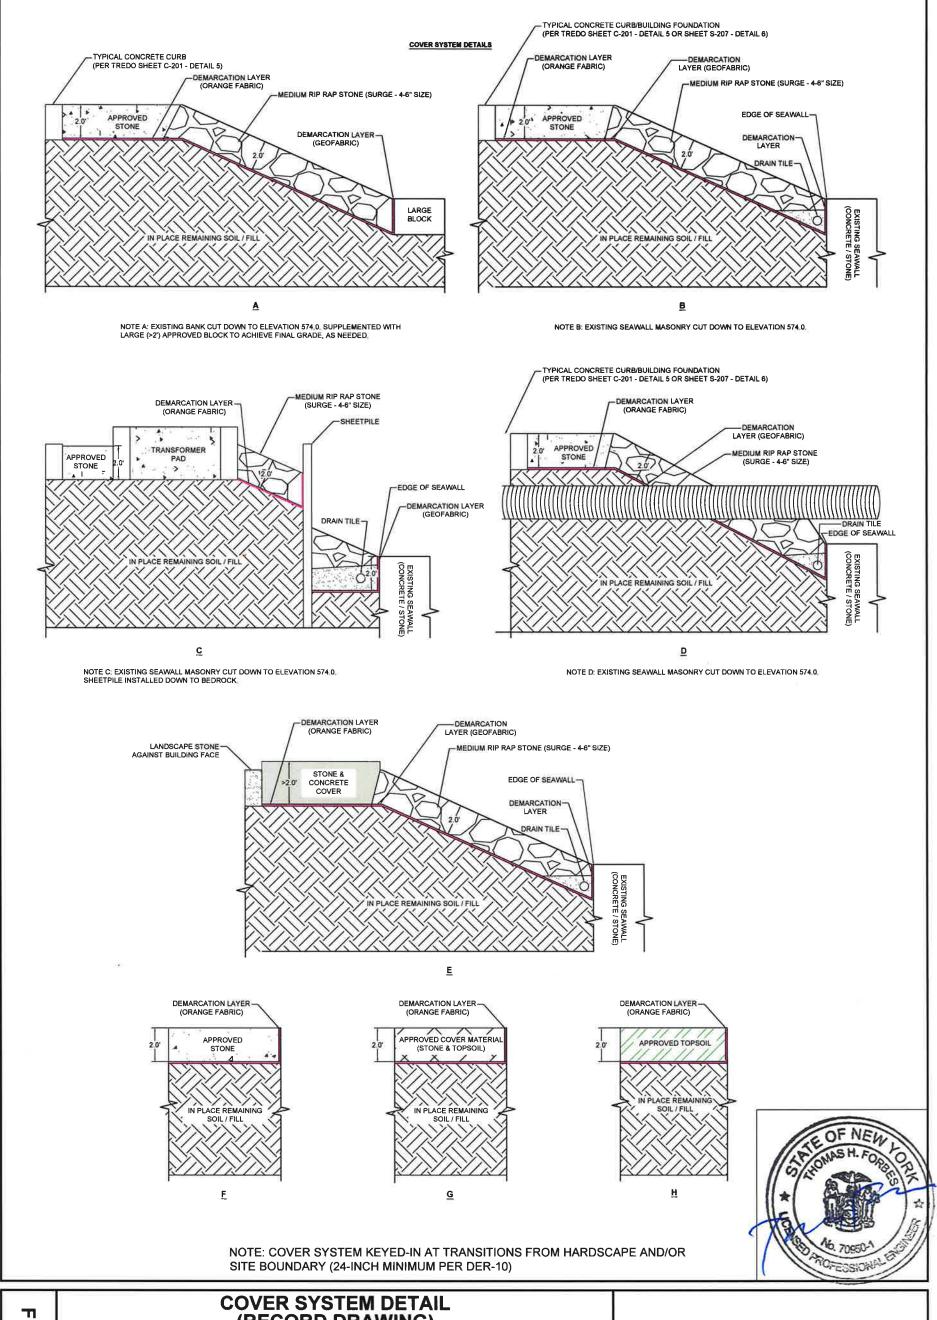
COVER SYSTEM DETAIL (RECORD DRAWING)
