**REMEDIAL INVESTIGATION/ INTERIM
REMEDIAL MEASURES WORK PLAN**

**1360 NIAGARA STREET SITE
CITY OF BUFFALO, ERIE COUNTY, NEW YORK**

C&S ENGINEERS, INC.

JANUARY 2017

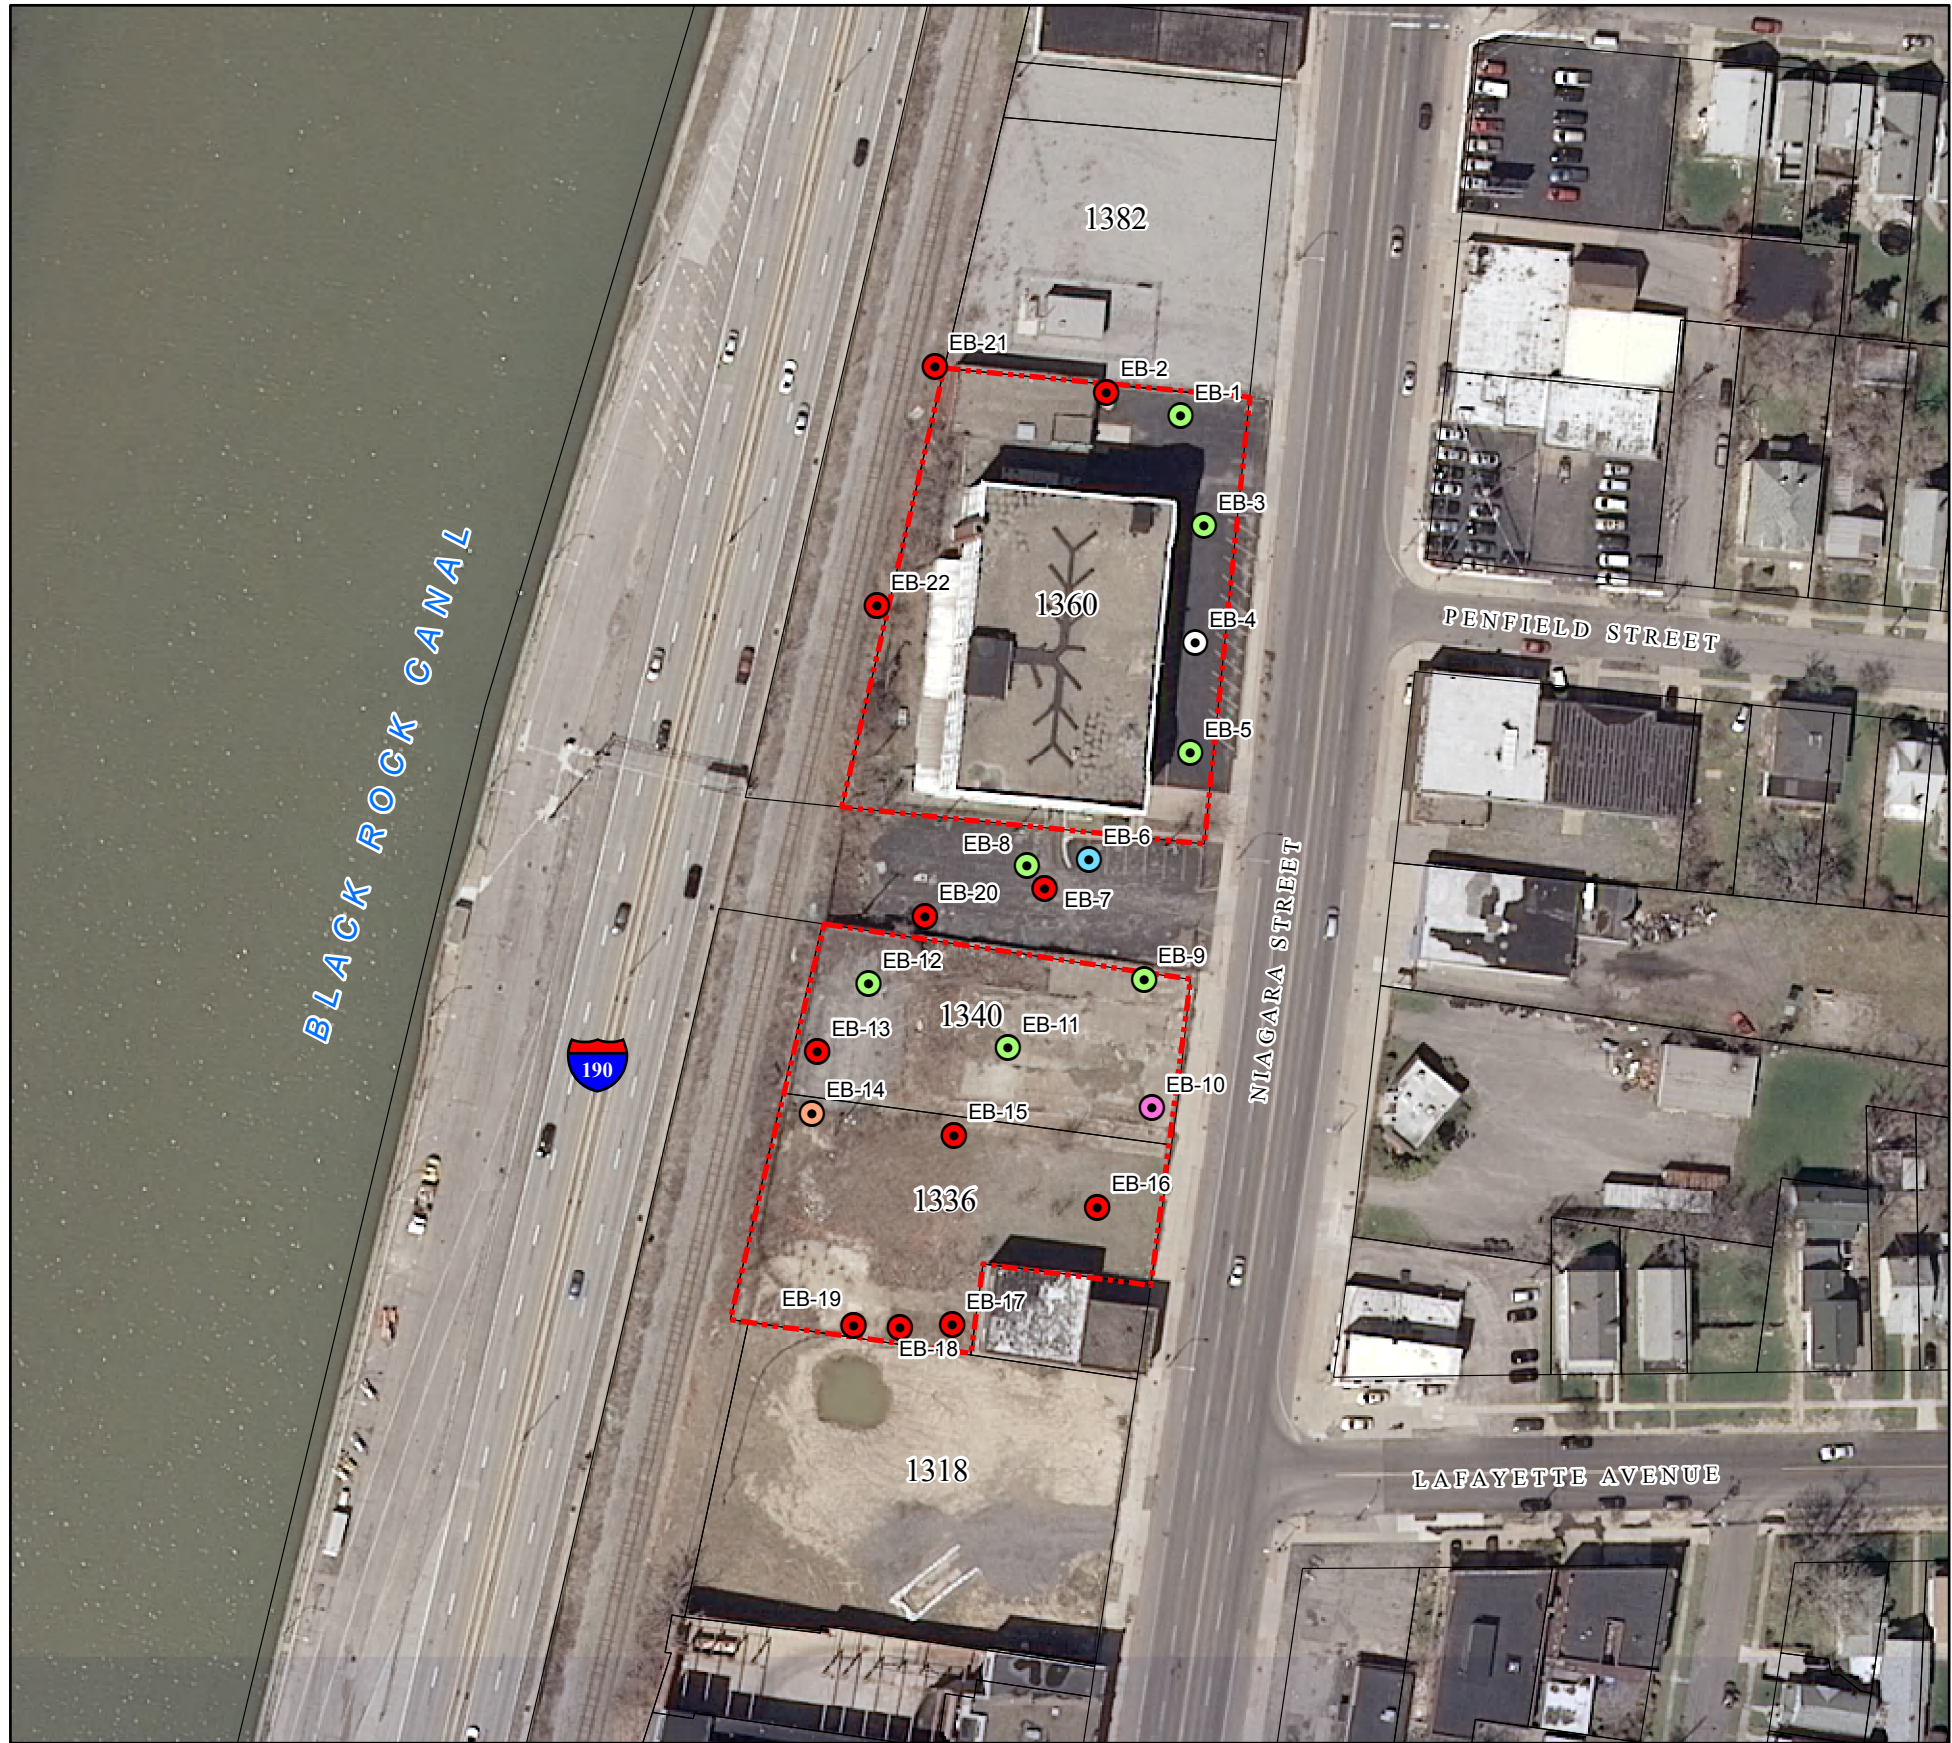
FIGURE 3

- BCP Boundary
- PROPERTY BOUNDARIES
- NOT SAMPLED
- SAMPLE EXCEEDED UNRESTRICTED USE CRITERIA FOR AT LEAST ONE COMPOUND
- SAMPLE EXCEEDED RESIDENTIAL USE CRITERIA FOR AT LEAST ONE COMPOUND
- SAMPLE EXCEEDED RESTRICTED RESIDENTIAL USE CRITERIA FOR AT LEAST ONE COMPOUND
- SAMPLE EXCEEDED COMMERCIAL USE CRITERIA FOR AT LEAST ONE COMPOUND
- SAMPLE EXCEEDED INDUSTRIAL USE CRITERIA FOR AT LEAST ONE COMPOUND

**2015 SITE
CHARACTERIZATION
MAP**

Site characterization efforts were recently conducted to assess contaminant concentrations at the Site and the results are summarized on **Figure 3**. This site characterization was conducted as a Phase I and Phase II Environmental Site Assessment. **Appendix A** contains these previous environmental reports.

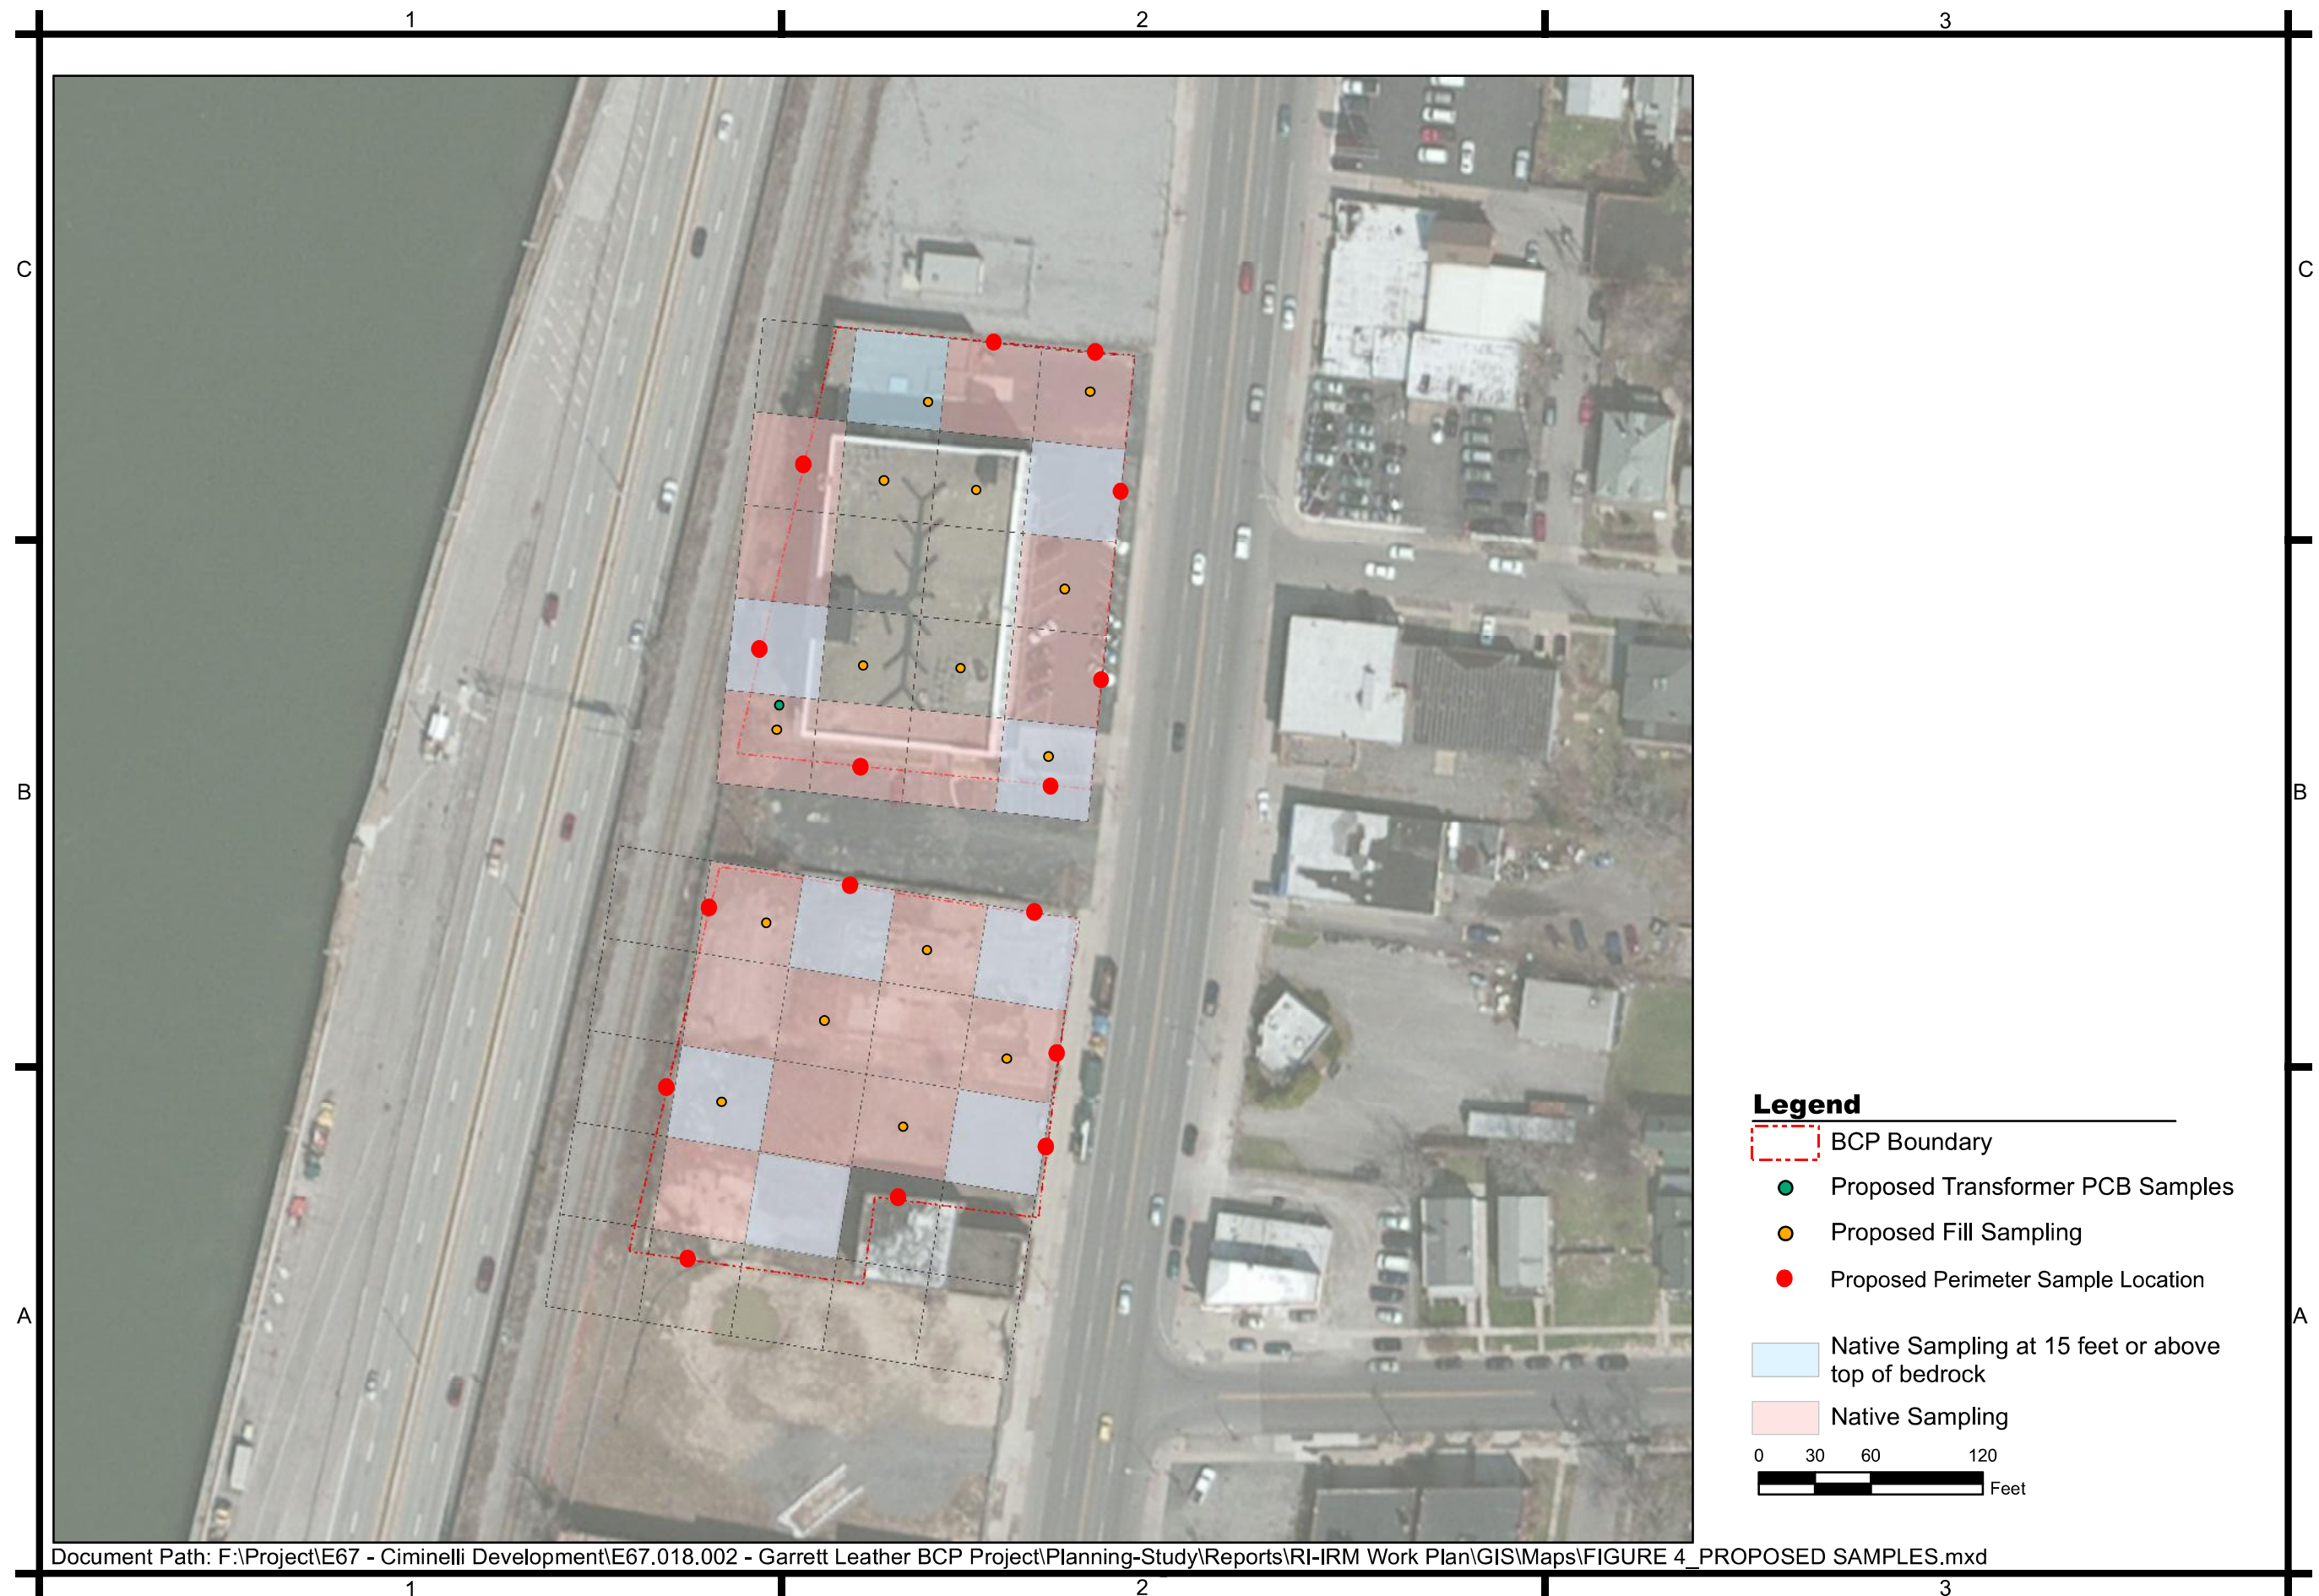
FIGURE 4

PROPOSED SOIL SAMPLE LOCATIONS

The advancement of soil borings across the Site will facilitate sampling of native material and fill material. To ensure complete coverage of the Site, a 50-foot by 50-foot grid will be established across the Site, as shown on **Figure 4**, resulting in 26 grid locations. From the borings, fill and native soil samples will be collected to document Site conditions.

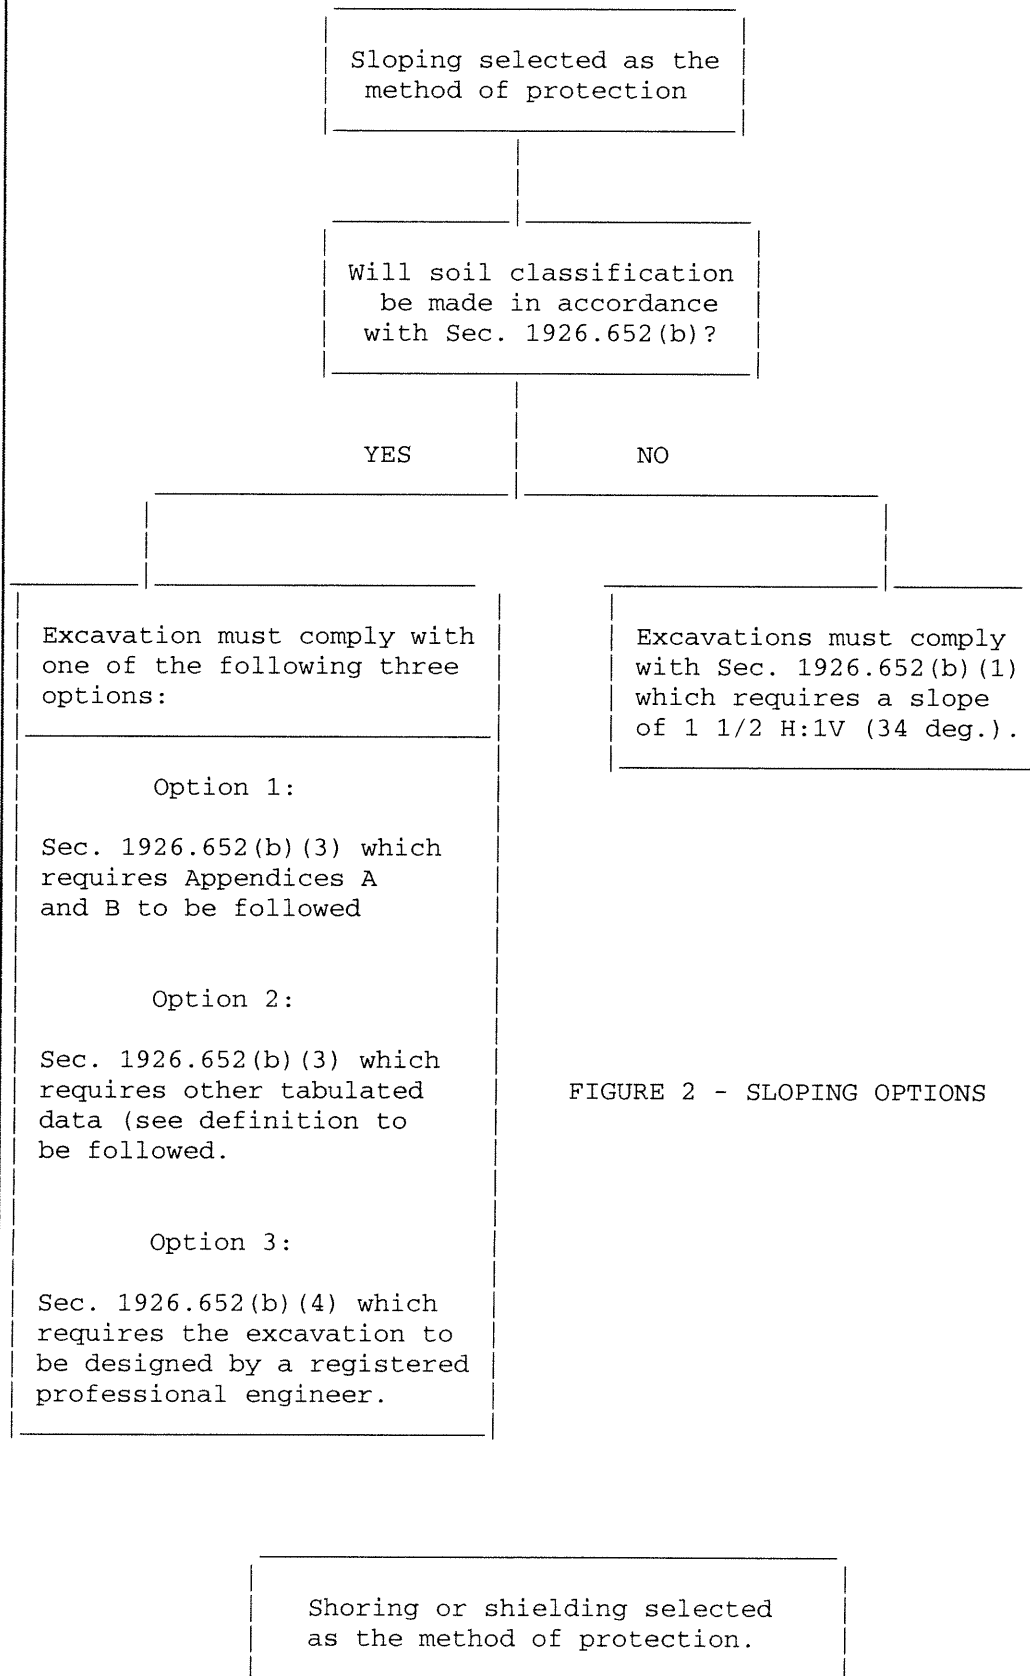
FIGURE 2 - SLOPING OPTIONS

Soil Classification is required when shoring or shielding is used. The excavation must comply with one of the following four options:
