**C&S Companies**  
141 Elm Street  
Suite 100  
Buffalo, NY 14203  
p: (716) 847-1630  
f: (716) 847-1454  
www.cscos.com

*Re: Sub-slab Soil Vapor Sampling Work Plan  
1360 Niagara Street Site, Buffalo, New York*

On behalf of 1360 Niagara Street Owner, LLC, C&S Engineers (C&S) is providing this Work Plan to collect sub-slab soil vapor sample within the building located at 1360 Niagara Street in Buffalo, New York.

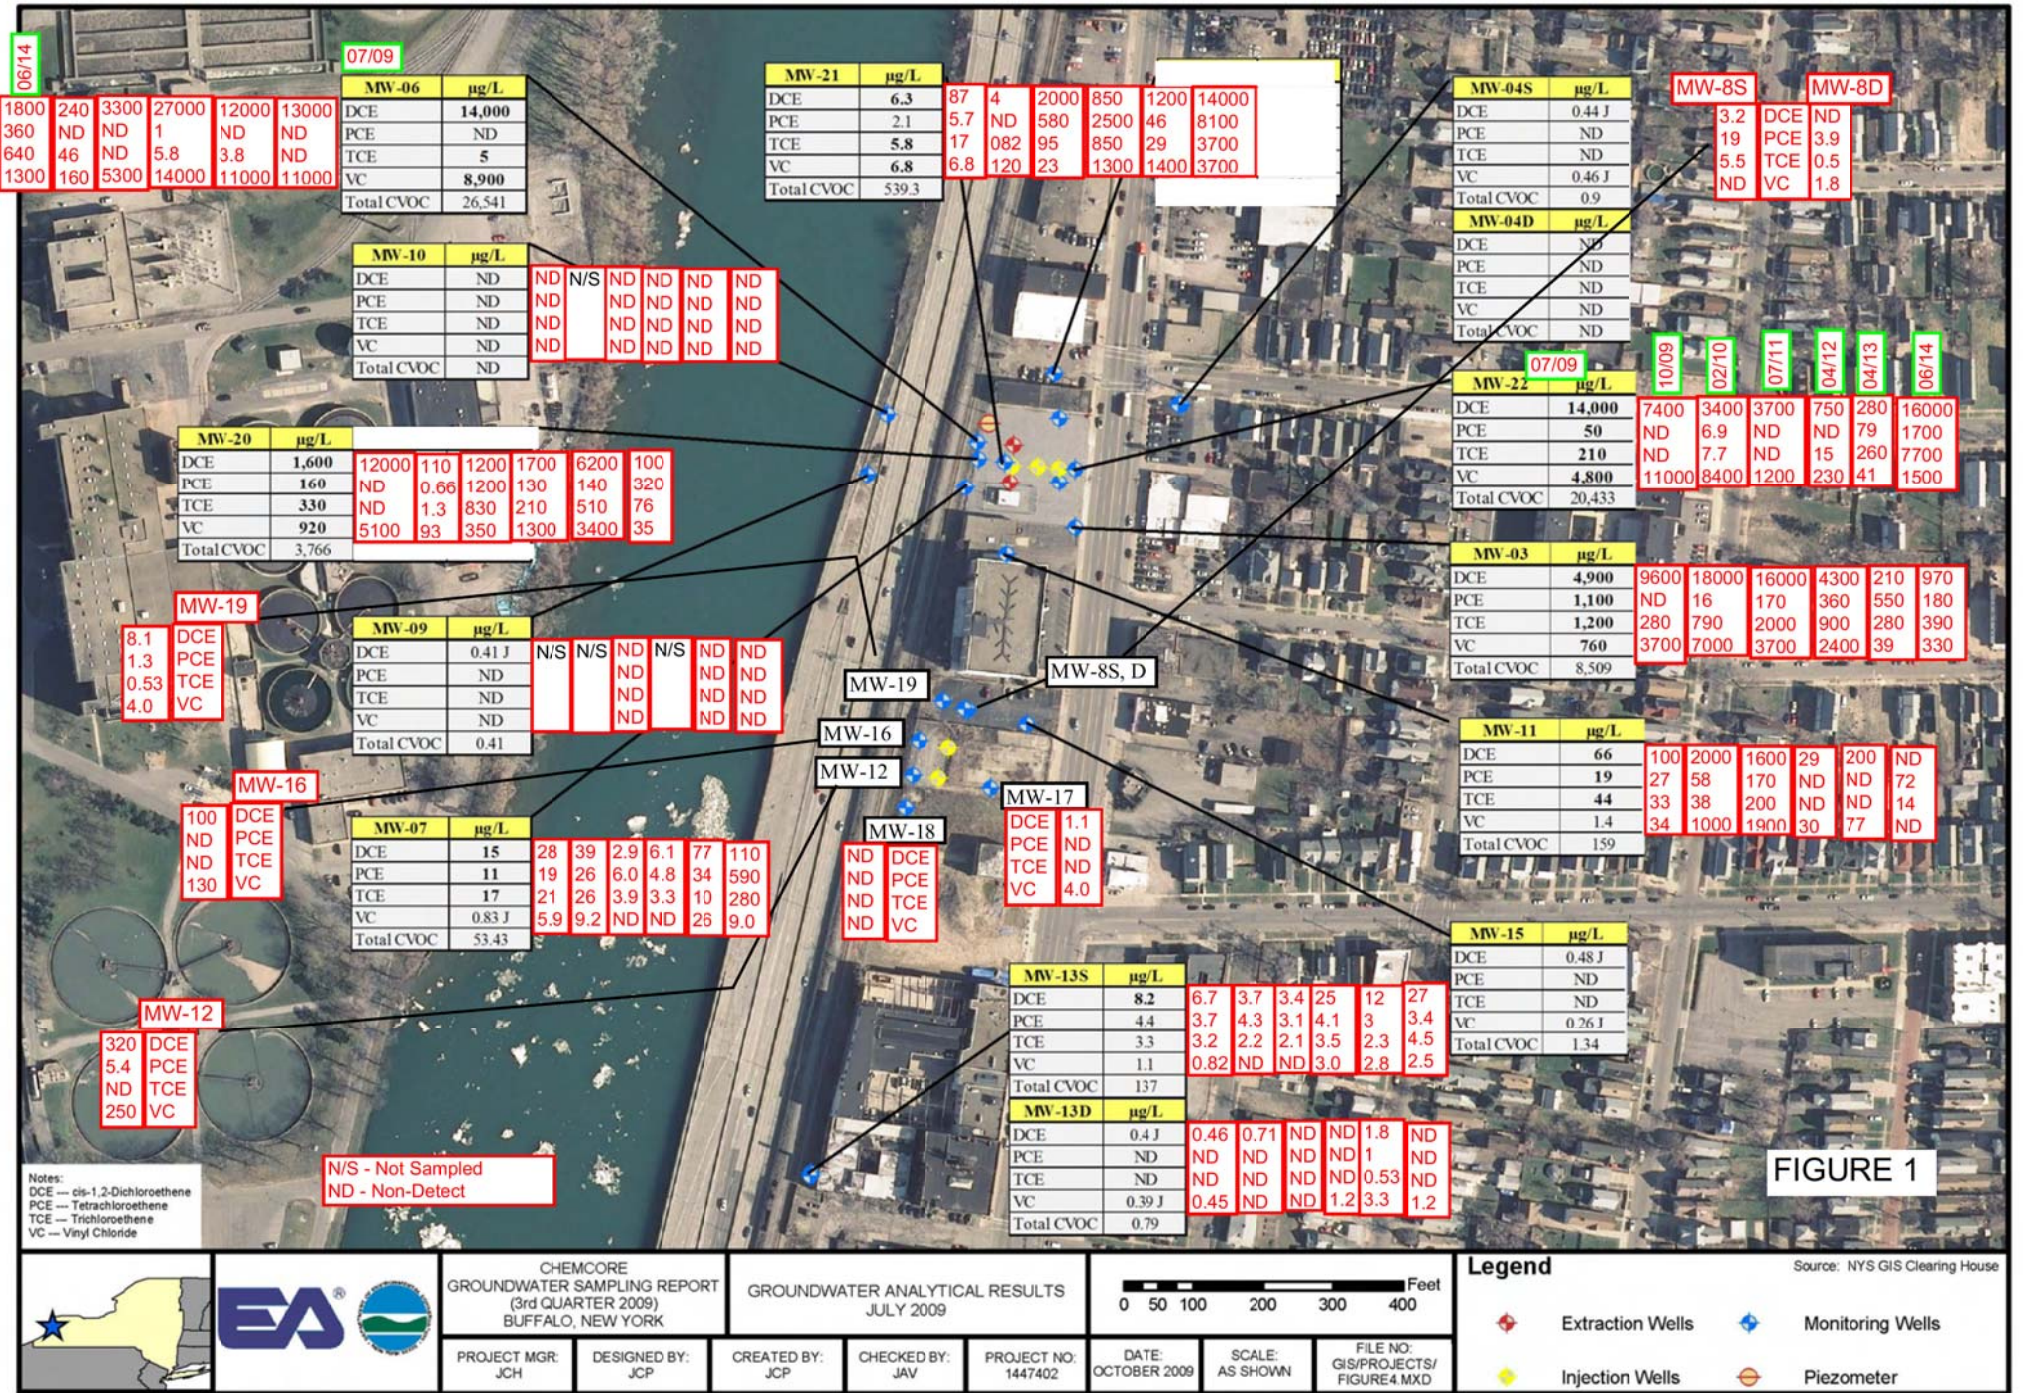
FIGURE 1

CHMCORE  
 GROUNDWATER SAMPLING REPORT  
 (3rd QUARTER 2009)  
 BUFFALO, NEW YORK

The pump and treat system was turned off in Sept. 2011 after approximately five years of operation. The November 2011 injections were done in 3 infiltration galleries (1 drum each) and MW-3, 6, 11, 20 (1 drum equally distributed). August 2012 injections were done in 3 infiltration galleries (1 drum each); MW-3, 6, 20, 21 and 22 (1.5 drum equally distributed) and MW-11, 12, 16 and 19 (0.5 drum equally distributed). June 2013 injections were in 3 infiltration galleries (2 drums each), MW-6, 20 and 21 (two drums each), MW-3 and 22 (one drum each), and MW-7, 11, 12, 16 and 19 (0.5 drum each).

**Figure 1** presents the groundwater sampling data compiled by SJB and obtained by C&S through a FOIL Request. This is the most recent groundwater sampling data C&S has obtained from sampling associated with the ChemCore Site.

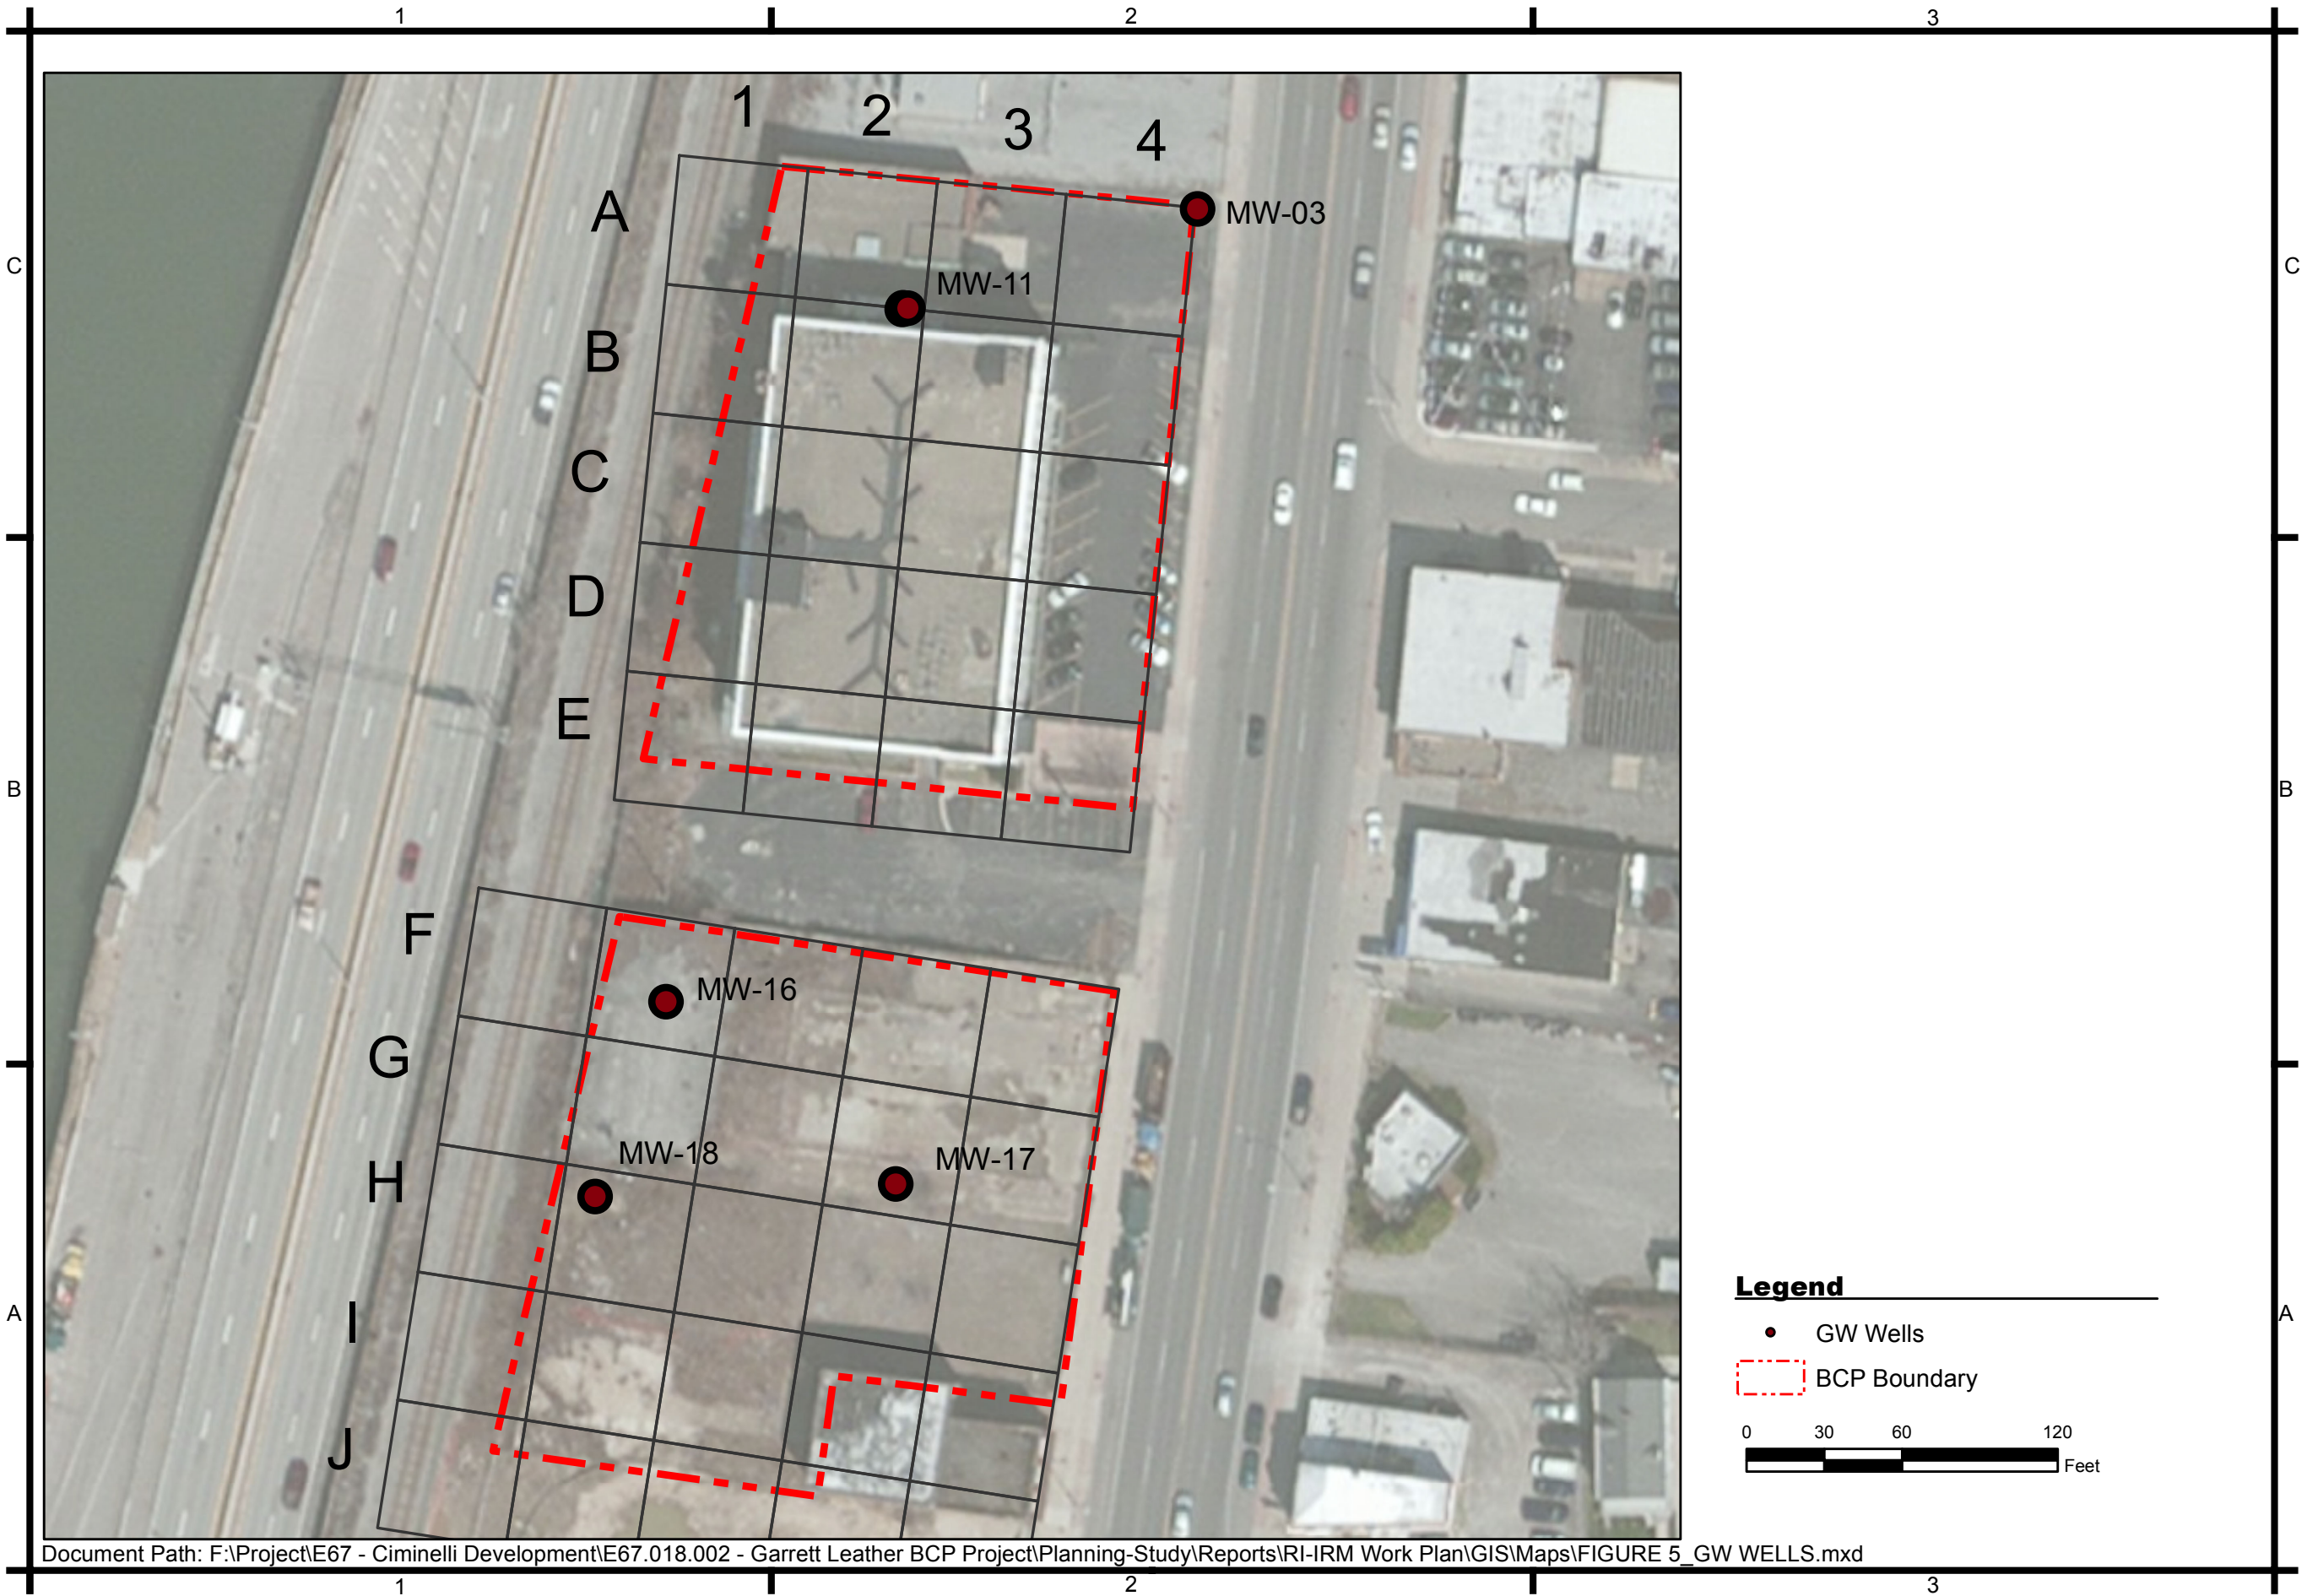
**FIGURE 2**

**GROUNDWATER  
 WELL  
 LOCATIONS**

- ) A hammer drill will be used to puncture ½ inch hole through the concrete slab floor at the three locations shown on Figure 2.
- ) Polyethylene tubing will be inserted one to two inches into each hole and the floor penetration around the tubing will be sealed at each location using soft, pliable, VOC-free clay.

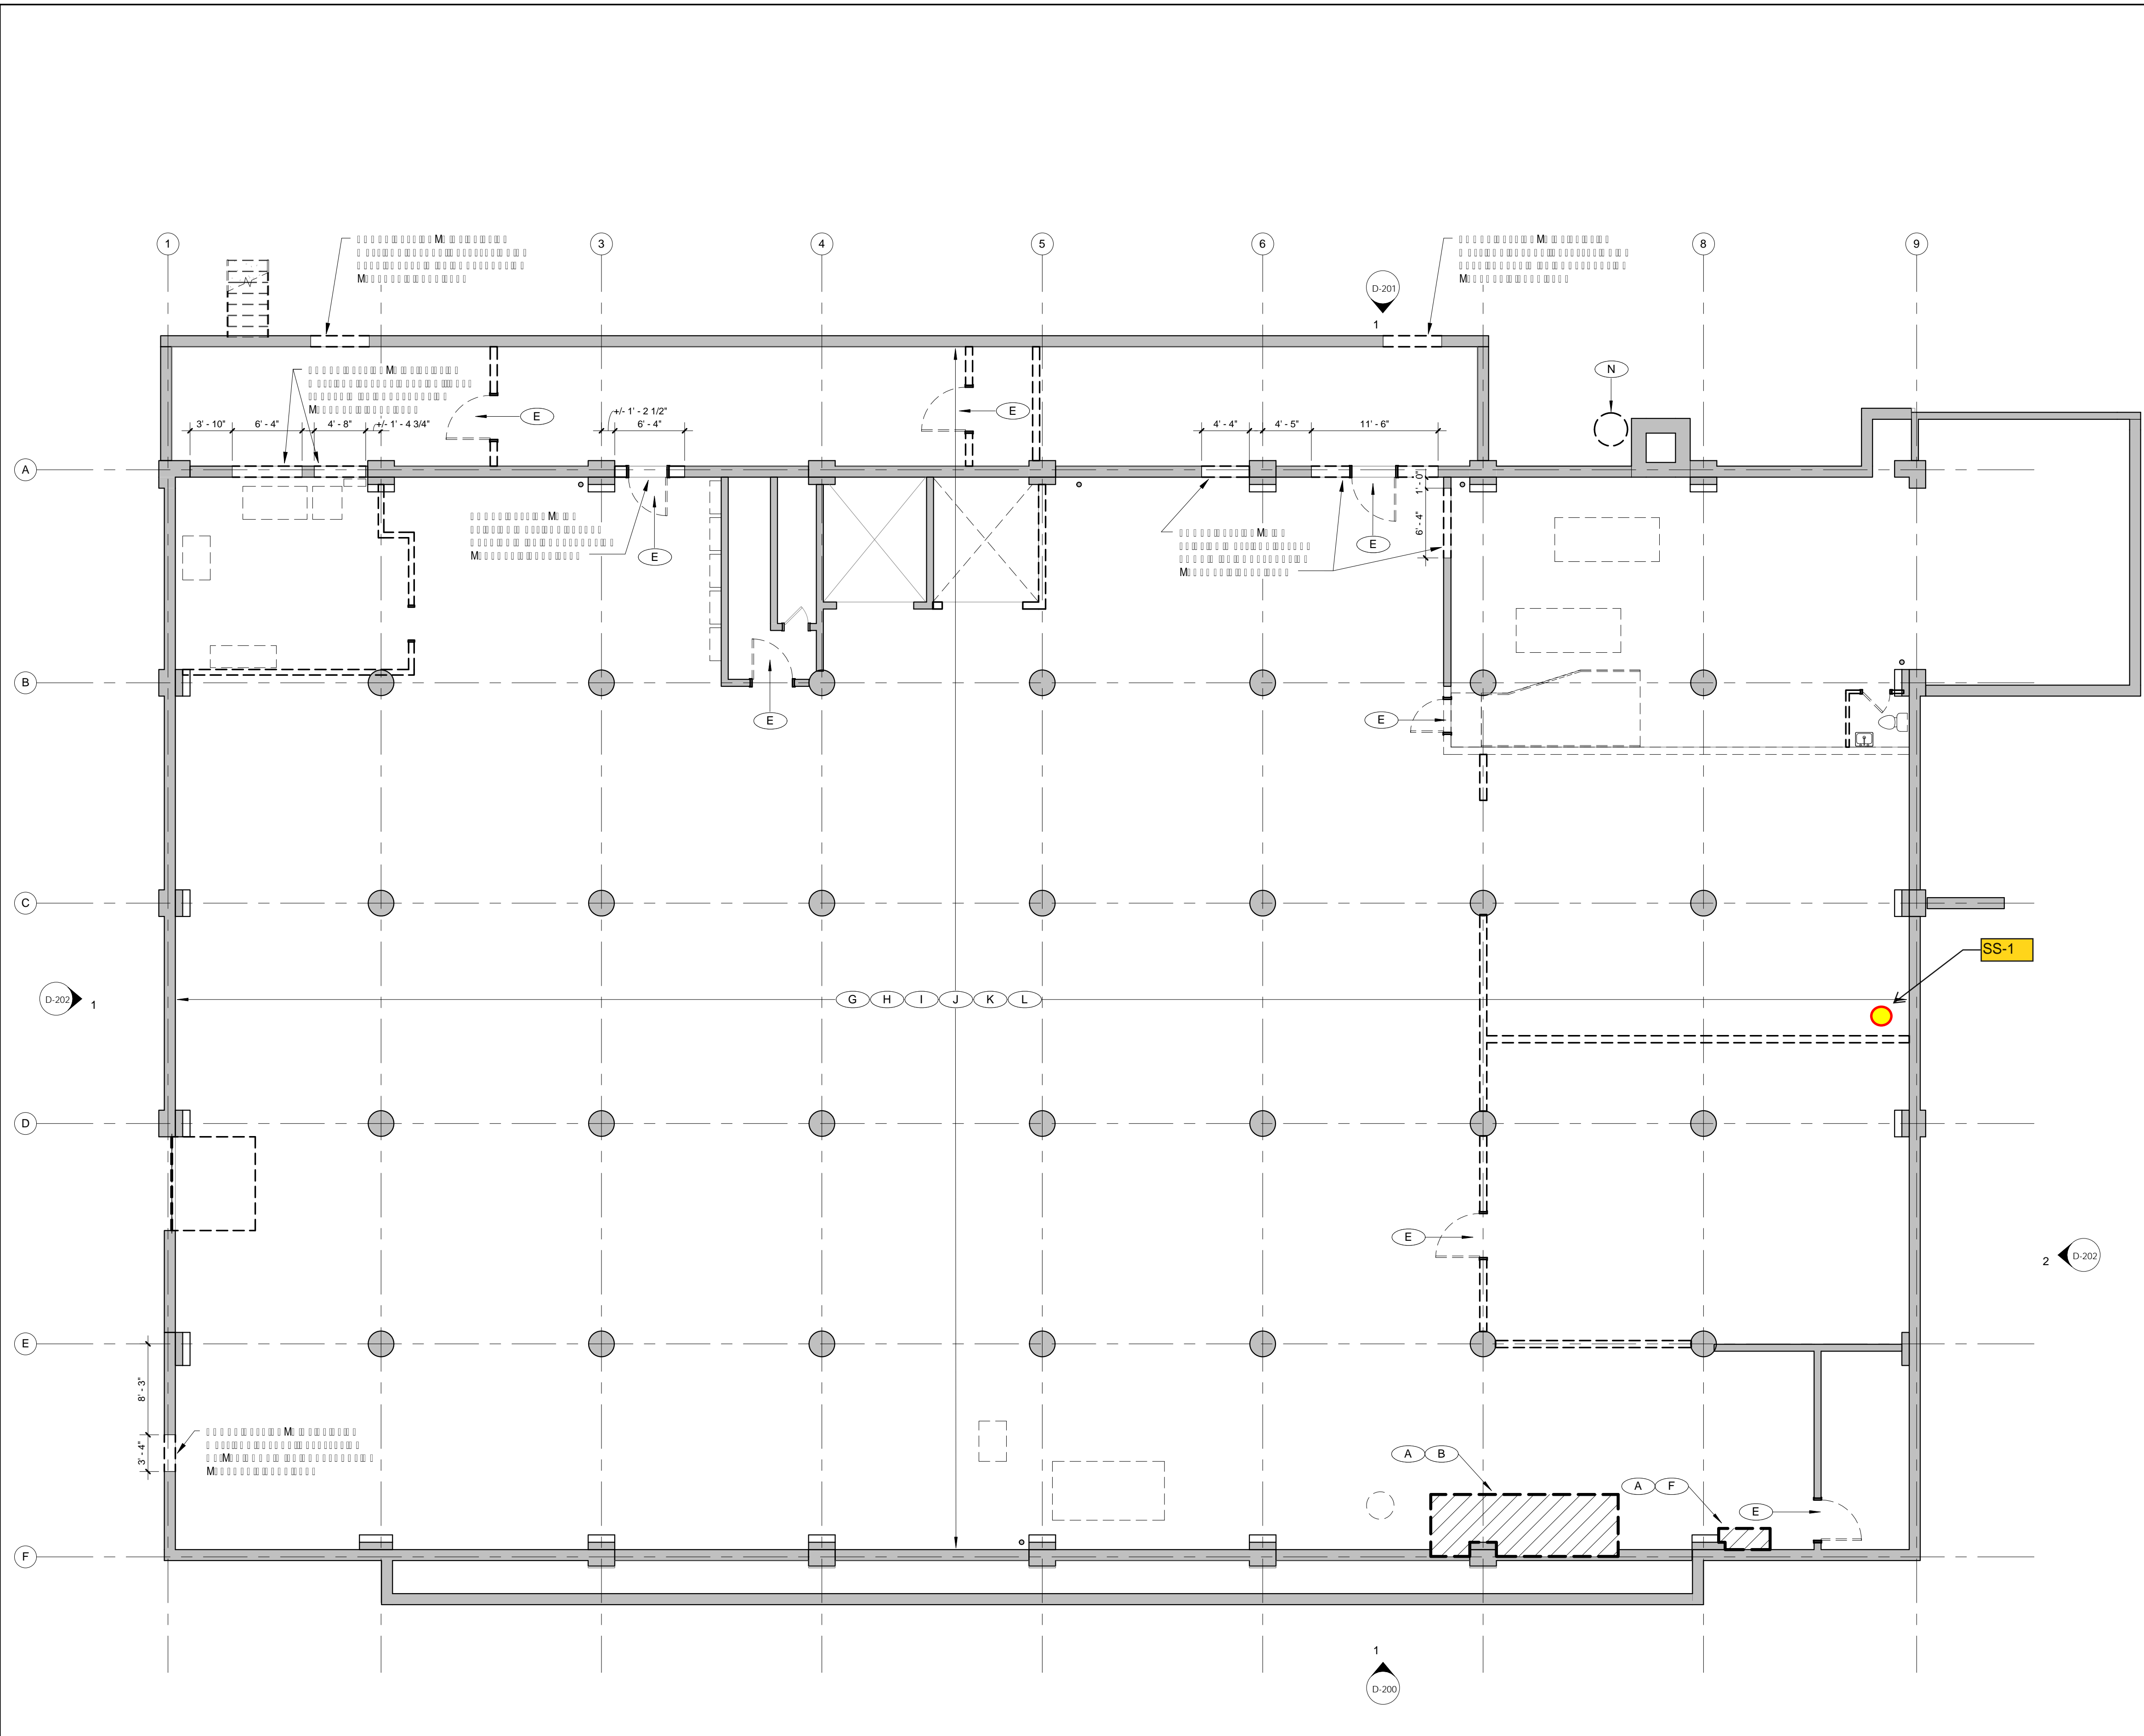
FIGURE 3

1 D-100 BASEMENT FLOOR PLAN  
1/8" = 1'-0"

Soil vapor samples will be collected to characterize potential impacts under the building slab. This work will be completed in accordance with the NYSDOH, “Guidance for Evaluating Soil Vapor Intrusion in New York State, 2006.” The air sampling locations recommended for this investigation are shown on **Figure 3 and 4**. However, these locations may be modified based on field observations and NYSDOH input.

One sub-slab air sample will be collected within the basement/parking garage along the northern property line, and two samples at the northern section of the building. **Figure 3 and 4** generally shows the proposed sample locations, although these locations may be modified based on field conditions and NYSDOH input. The following approach will be used to collect the sub-slab samples:

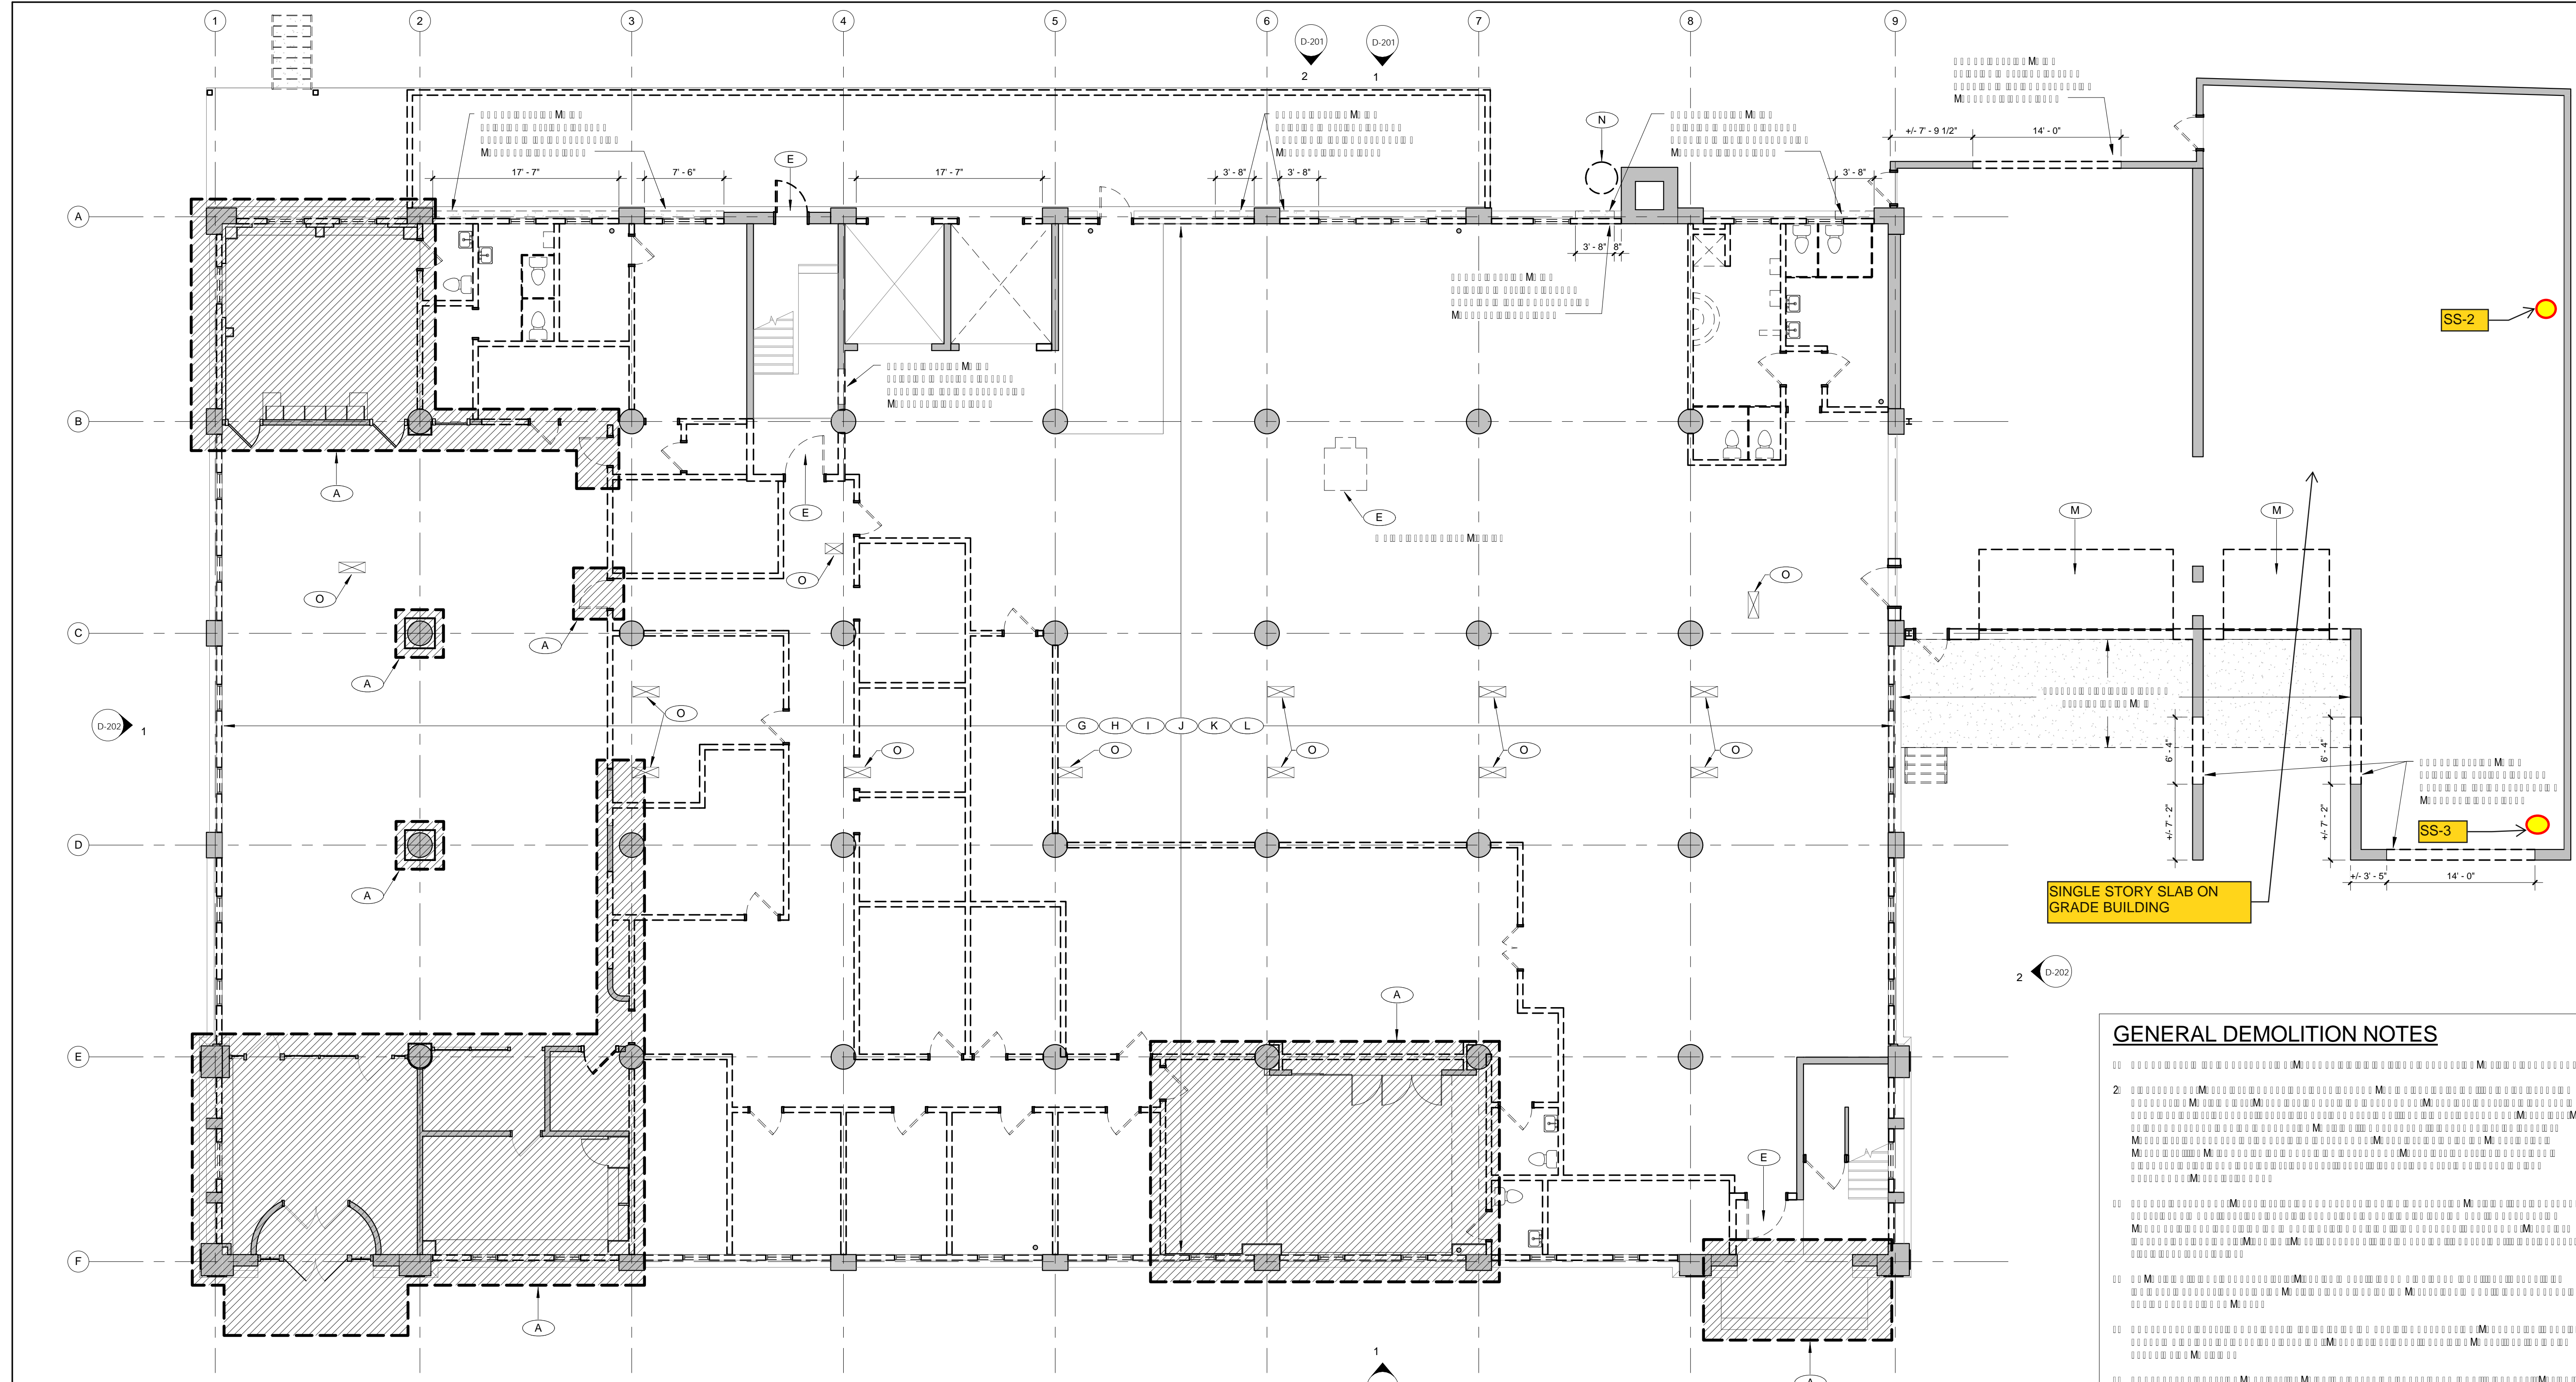
1 FIRST FLOOR DEMO PLAN  
D-101 1/8" = 1'-0"
