# **REMEDIAL INVESTIGATION/ INTERIM REMEDIAL MEASURES WORK PLAN**

**PIERCE ARROW SITE  
1695, 1721, AND 1723 ELMWOOD AVENUE  
CITY OF BUFFALO, ERIE COUNTY, NEW YORK  
SITE No. C915308**

**C&S ENGINEERS, INC.**  
141 ELM STREET, SUITE 100  
BUFFALO, NEW YORK 14203

**MARCH 2017**

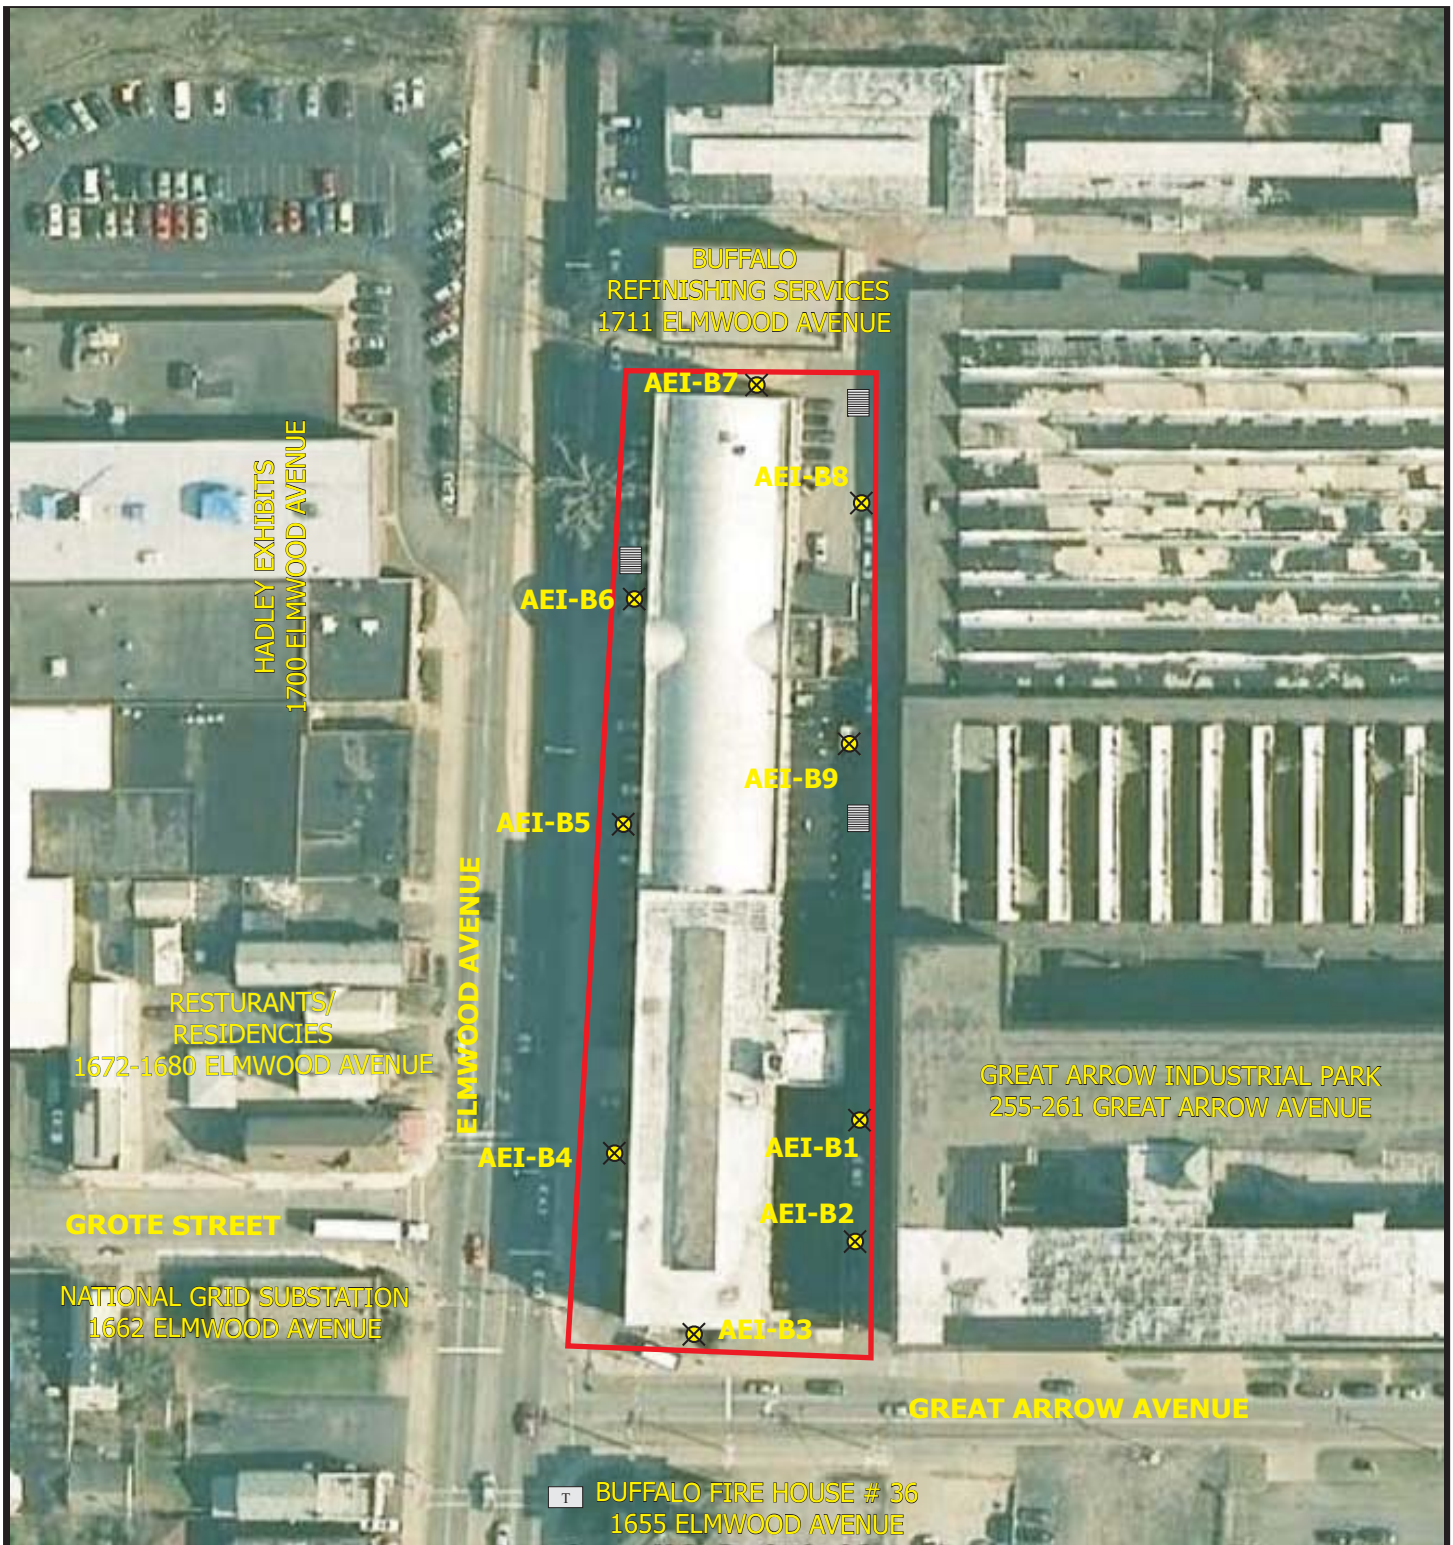
## BORING LOCATION MAP

1695 Elmwood Avenue, Buffalo, NY 14207

Please refer to Figure 2: Boring Location Map for a representation of boring locations.
