# Cover System Investigation Work Plan

## NYSDEC Site # C932134

Location: 1501 College Avenue,  
Niagara Falls, New York 14304

LaBella Project No. 2250425

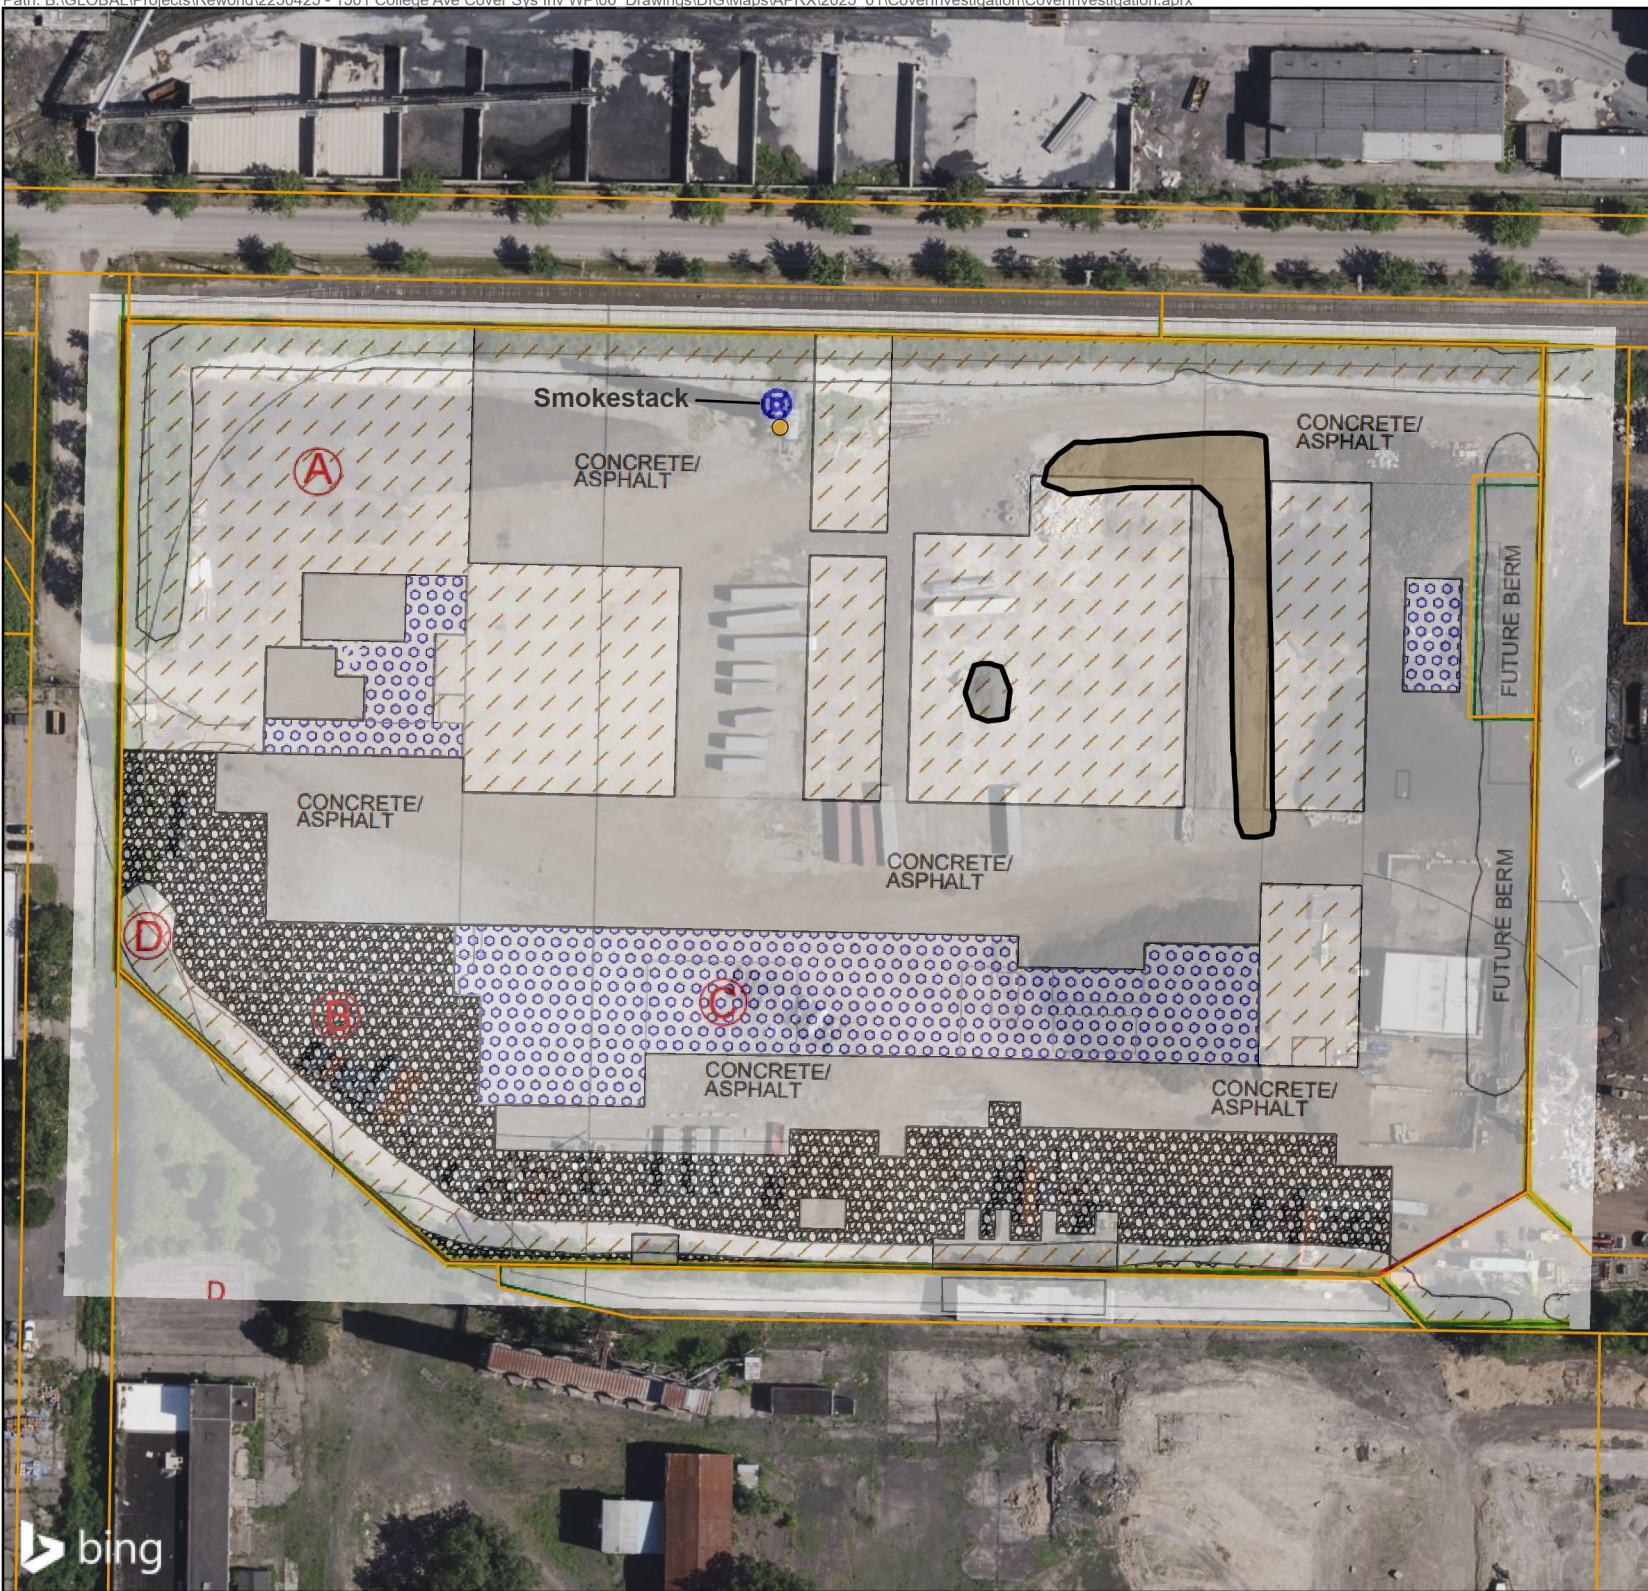
**1501 College Ave  
BCP Cover Investigation  
Work Plan**

Of special interest for the hardscaped surfaces is the approximate 3-foot breach of the concrete cover system near the smokestack. The approximate location of the breach is identified in Figure 2. During the investigation, the plan area of the breach will be outlined on the site map. This area will be well-documented including depth of breach, a description of the exposed materials below the concrete, the condition of the concrete at the perimeter of the breach, and any other useful information that could be used to assist in developing an appropriate method to restore this deficiency.
