**Re: Addendum to the IRM Work Plan
402 and 430 Buffalo Avenue Site (C932164)**

INTERIM REMEDIAL MEASURES WORK PLAN
401, 402, & 430 BUFFALO AVENUE SITE
BCP SITE No. C932164
NIAGARA FALLS, NEW YORK
PREPARED FOR
MERANI HOSPITALITY

RI-IRM-AA REPORT
 402 & 430 BUFFALO AVENUE SITE
 BCP SITE No. C932164
 NIAGARA FALLS, NEW YORK
 PREPARED FOR
 MERANI HOSPITALITY, INC.

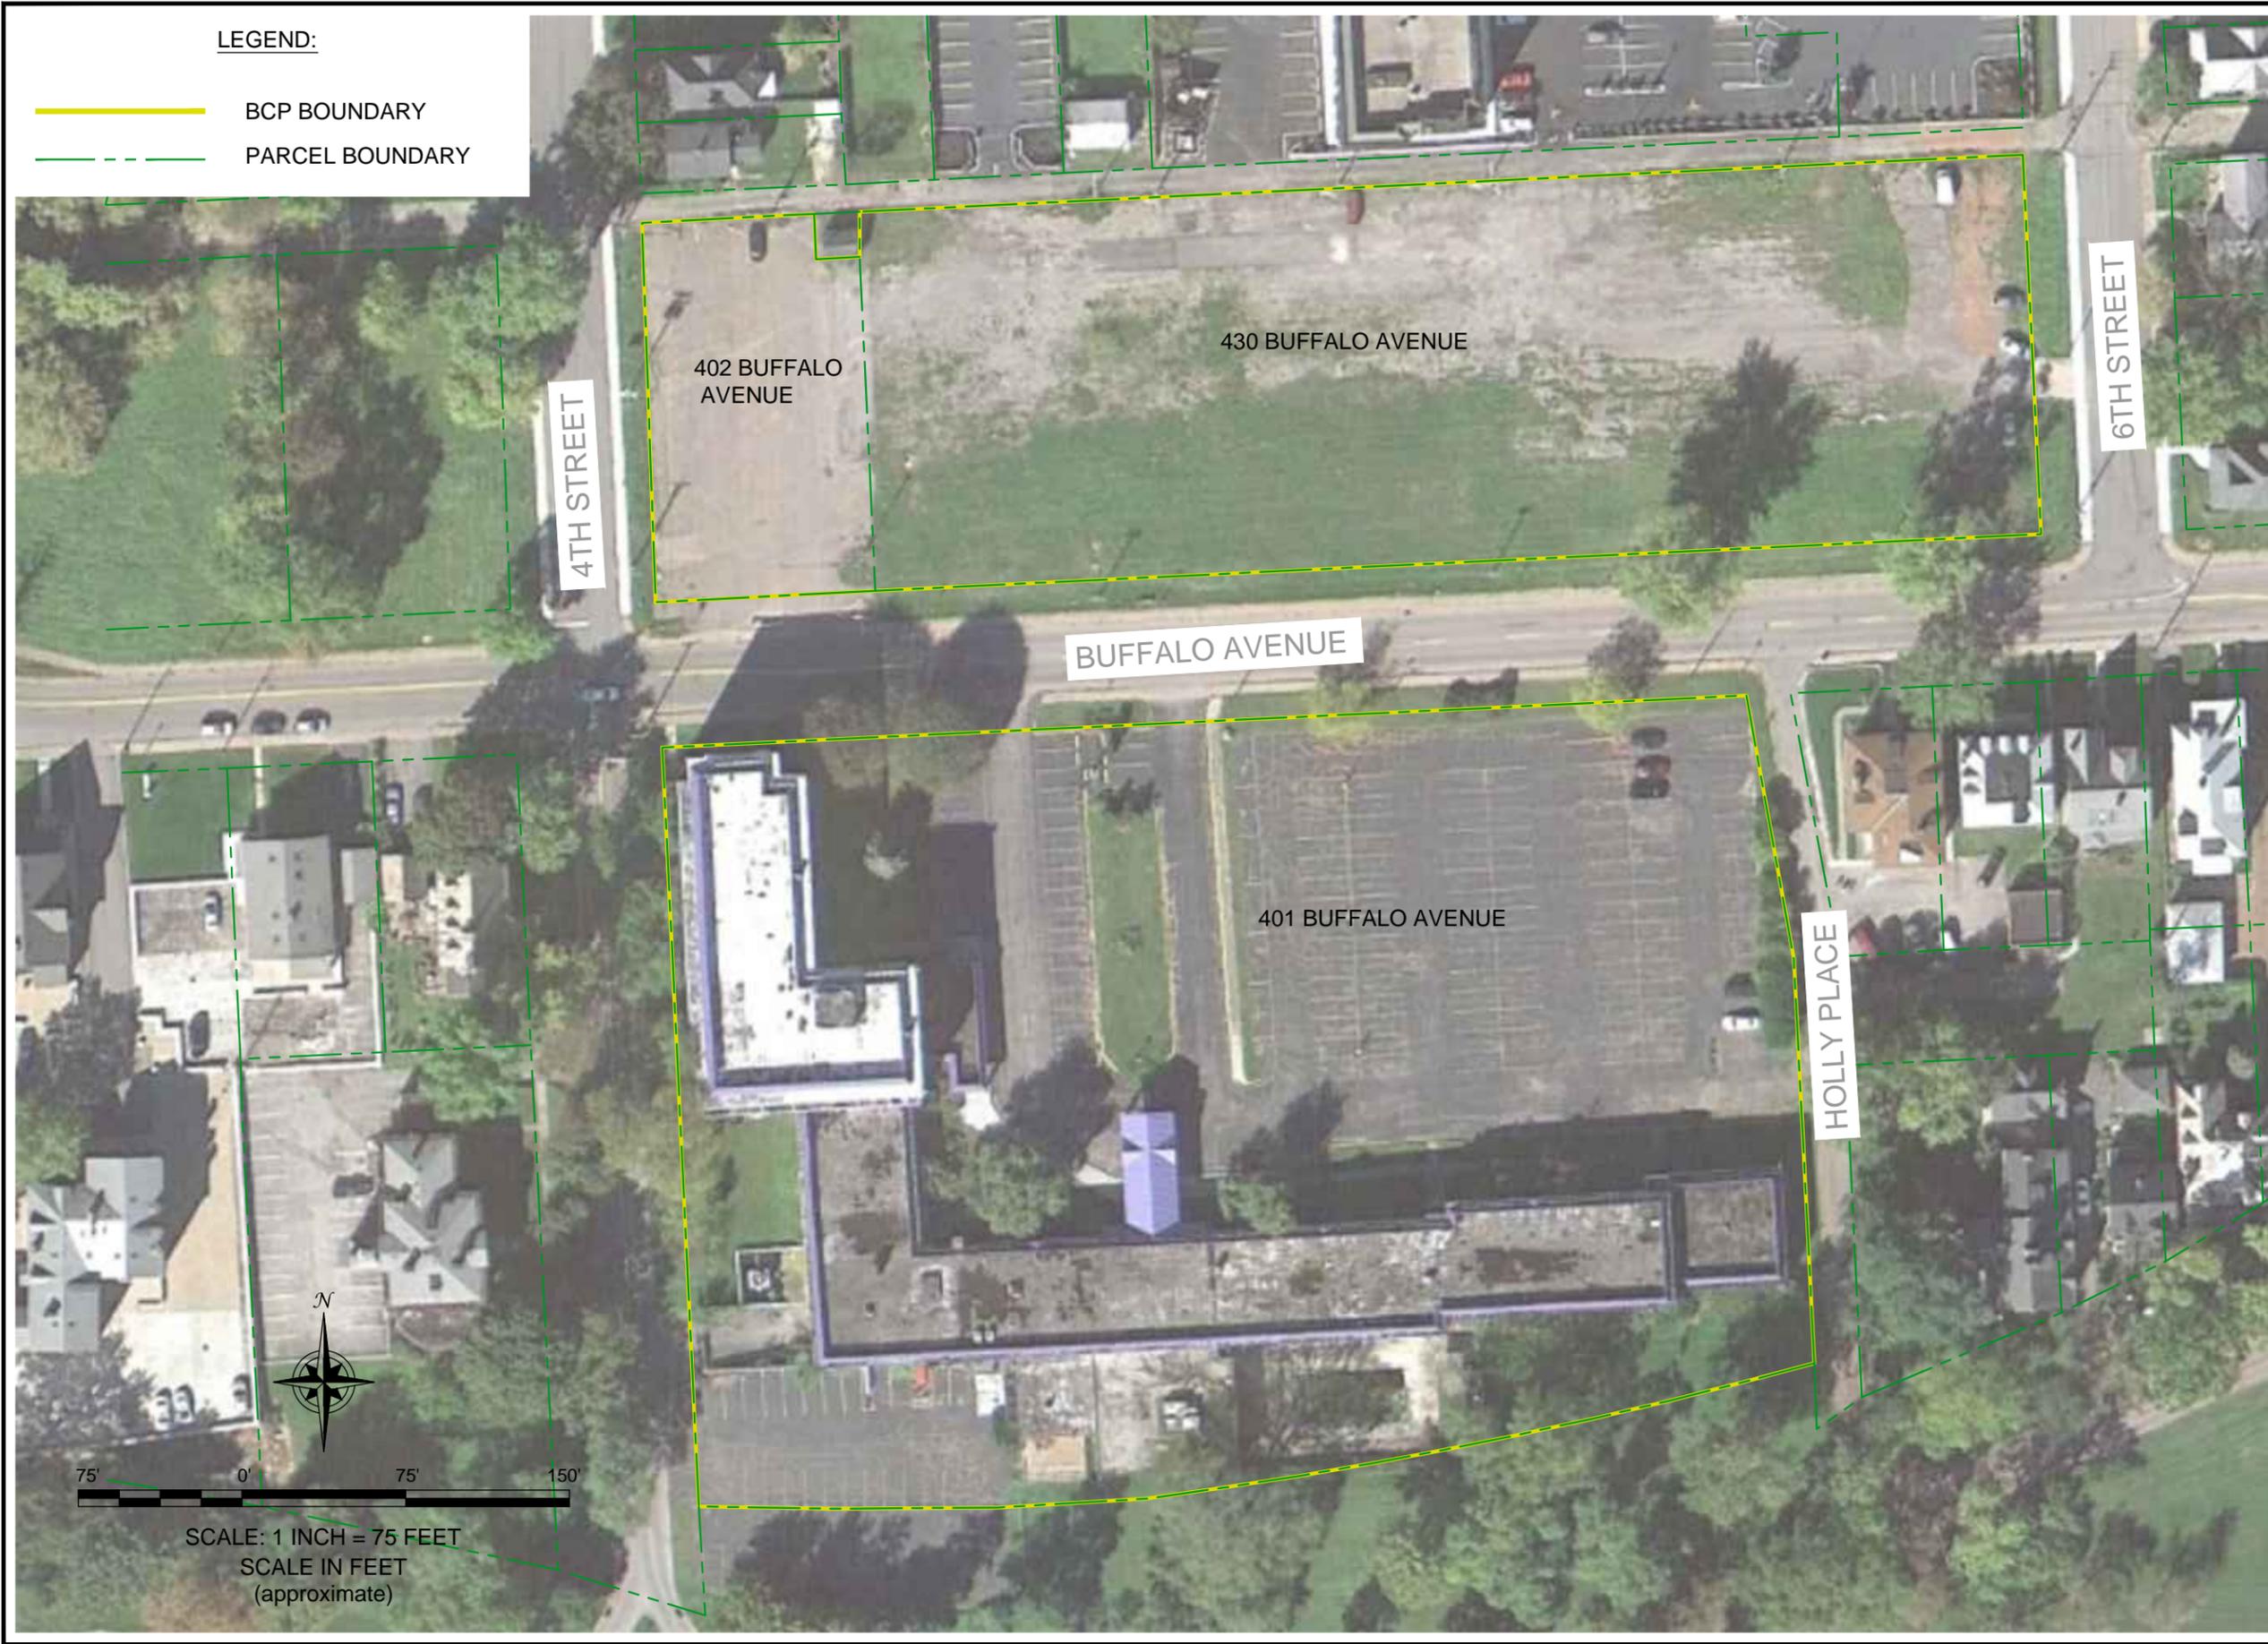
FIGURE 2

SITE PLAN (AERIAL)

On behalf of Merani Hospitality, Inc., Benchmark Environmental Engineering and Science, PLLC (Benchmark) in association with TurnKey Environmental Restoration, LLC (TurnKey), has prepared this Addendum to the NYSDEC-approved Interim Remedial Measures Work Plan (November 2014) to present the proposed scope of work and implementation procedures for completion of additional Interim Remedial Measures (IRMs) at the Brownfield Cleanup Program (BCP) 402 and 430 Buffalo Avenue Site (Site; C932164), located at 401, 402, and 430 Buffalo Avenue, Niagara Falls, New York (see Figures 1 and 2).

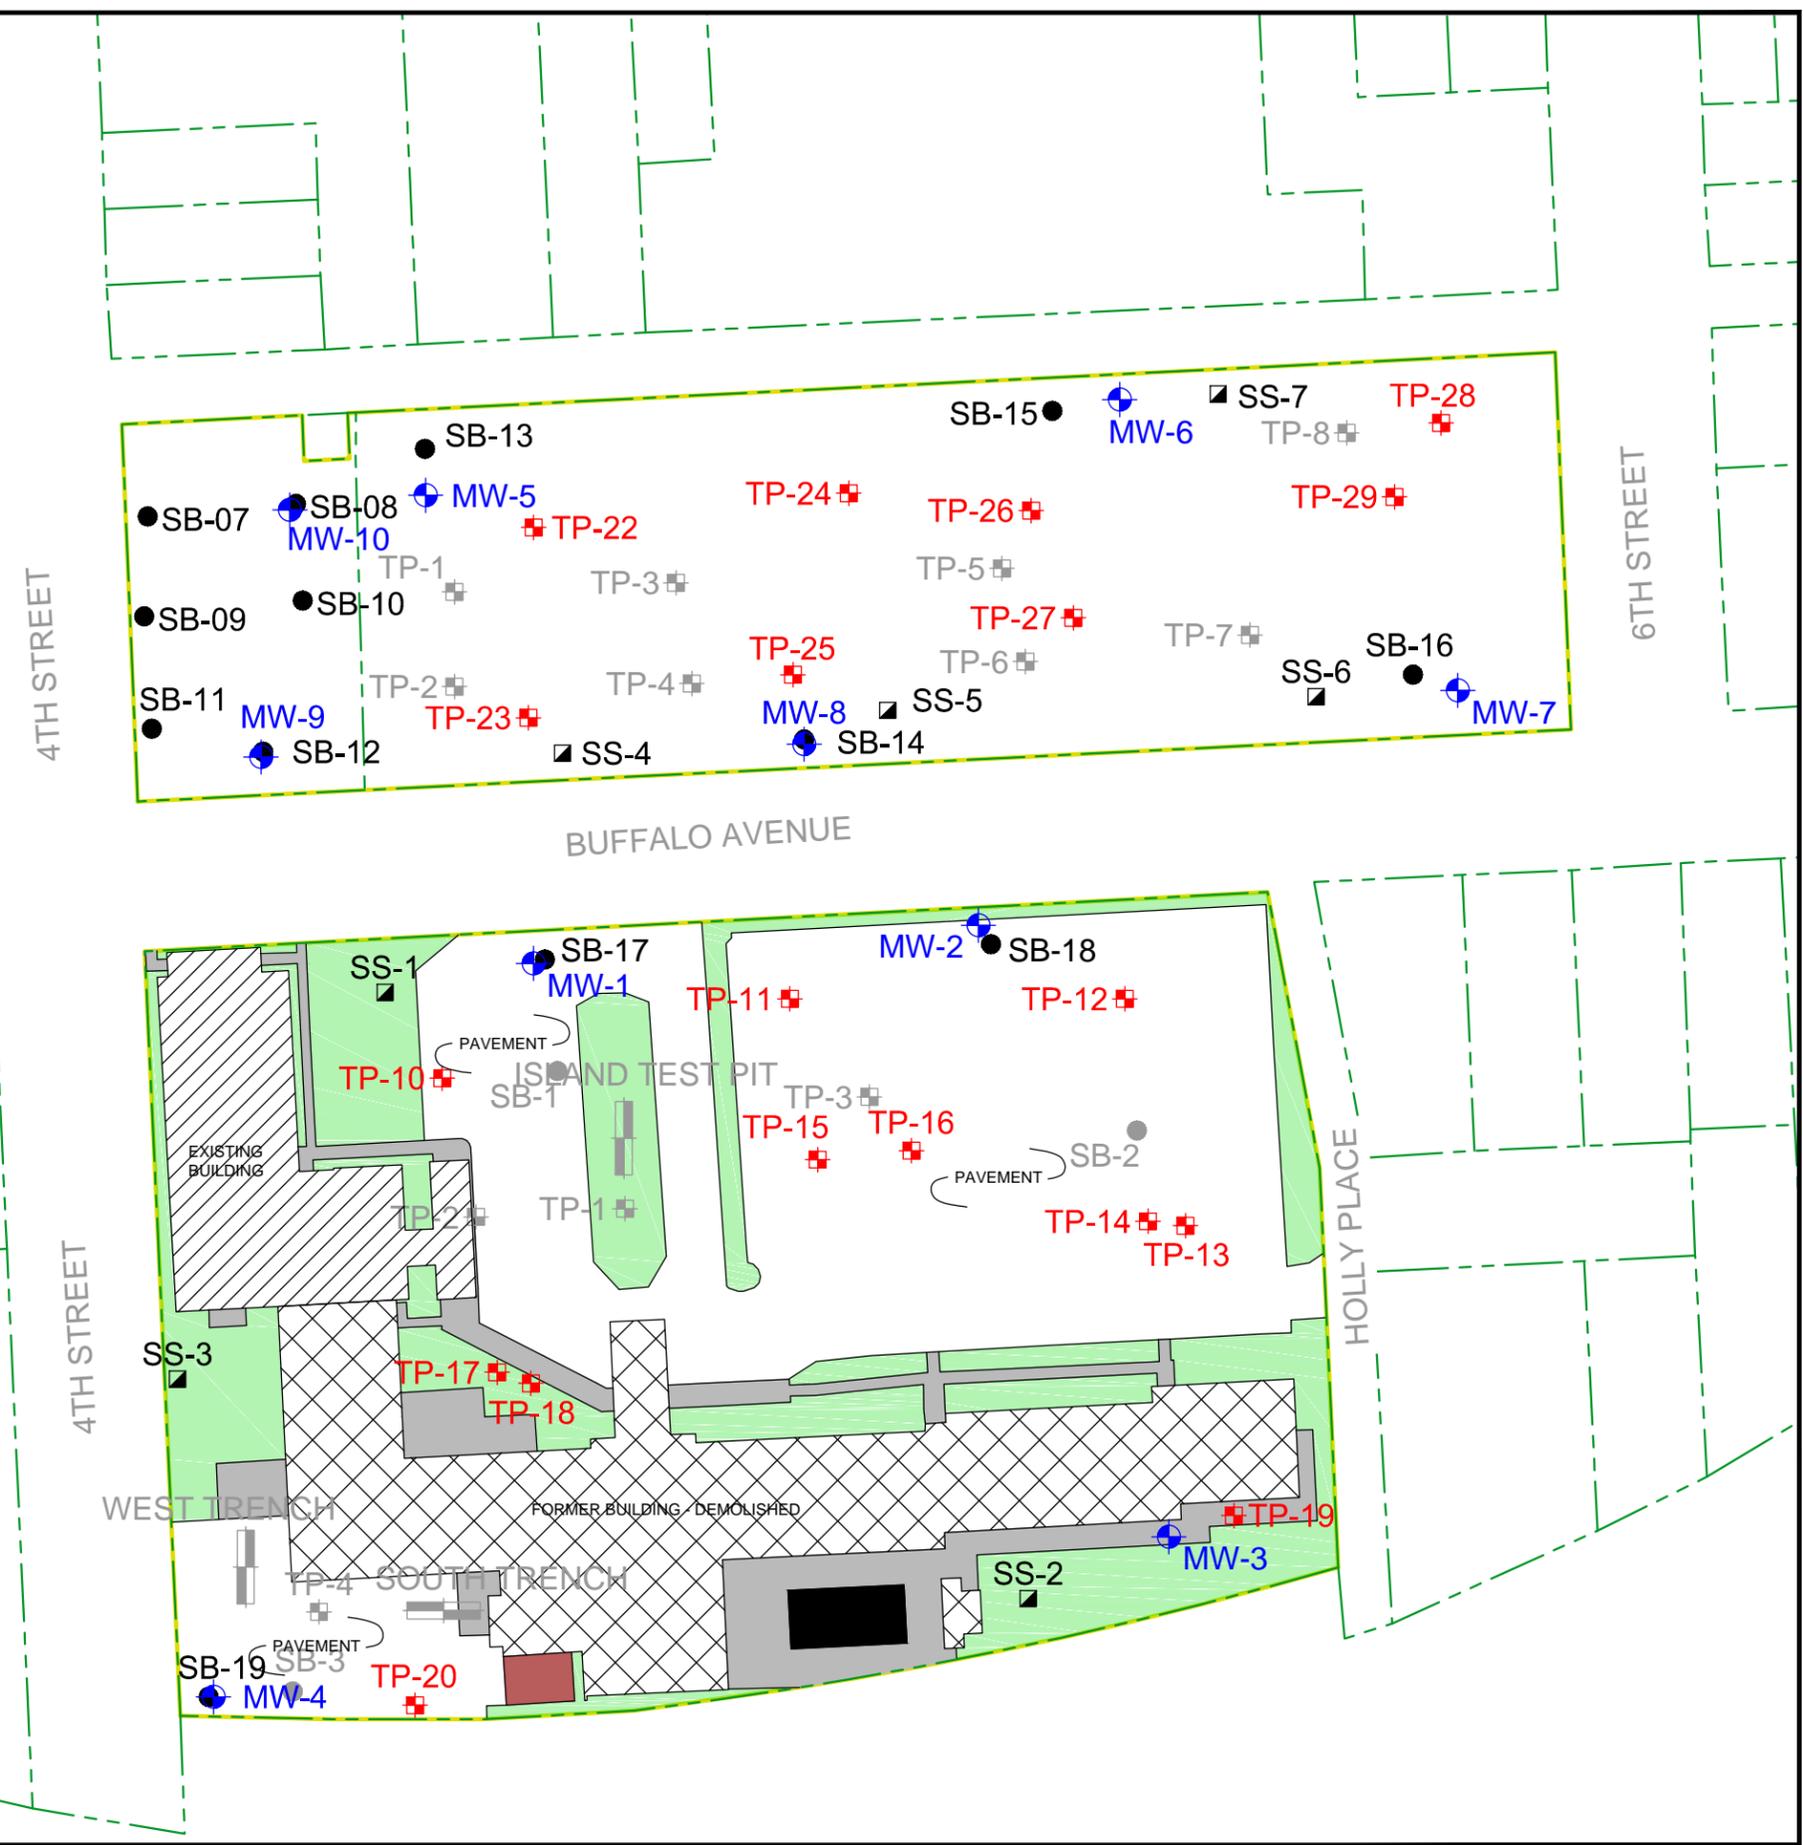
FIGURE 3

**HISTORIC AND REMEDIAL INVESTIGATION
SAMPLE LOCATIONS**

Merani Hospitality, Inc. completed RI activities at the Site between November 2014 and June 2015, and completed approved Interim Remedial Measures (IRMs) between April and July 2015. Based on the findings of the RI, an area of elevated radiologic slag-material was identified on the 402 Buffalo Avenue parcel and an area of lead-impacted soil/fill exceeding Industrial Use SCOs (ISCOs) was identified in the vicinity of TP-3 on the 430 Buffalo Avenue parcel (see Figure 3 and Table 3 from the RI-IRM-AA Report - draft July 2015, attached).

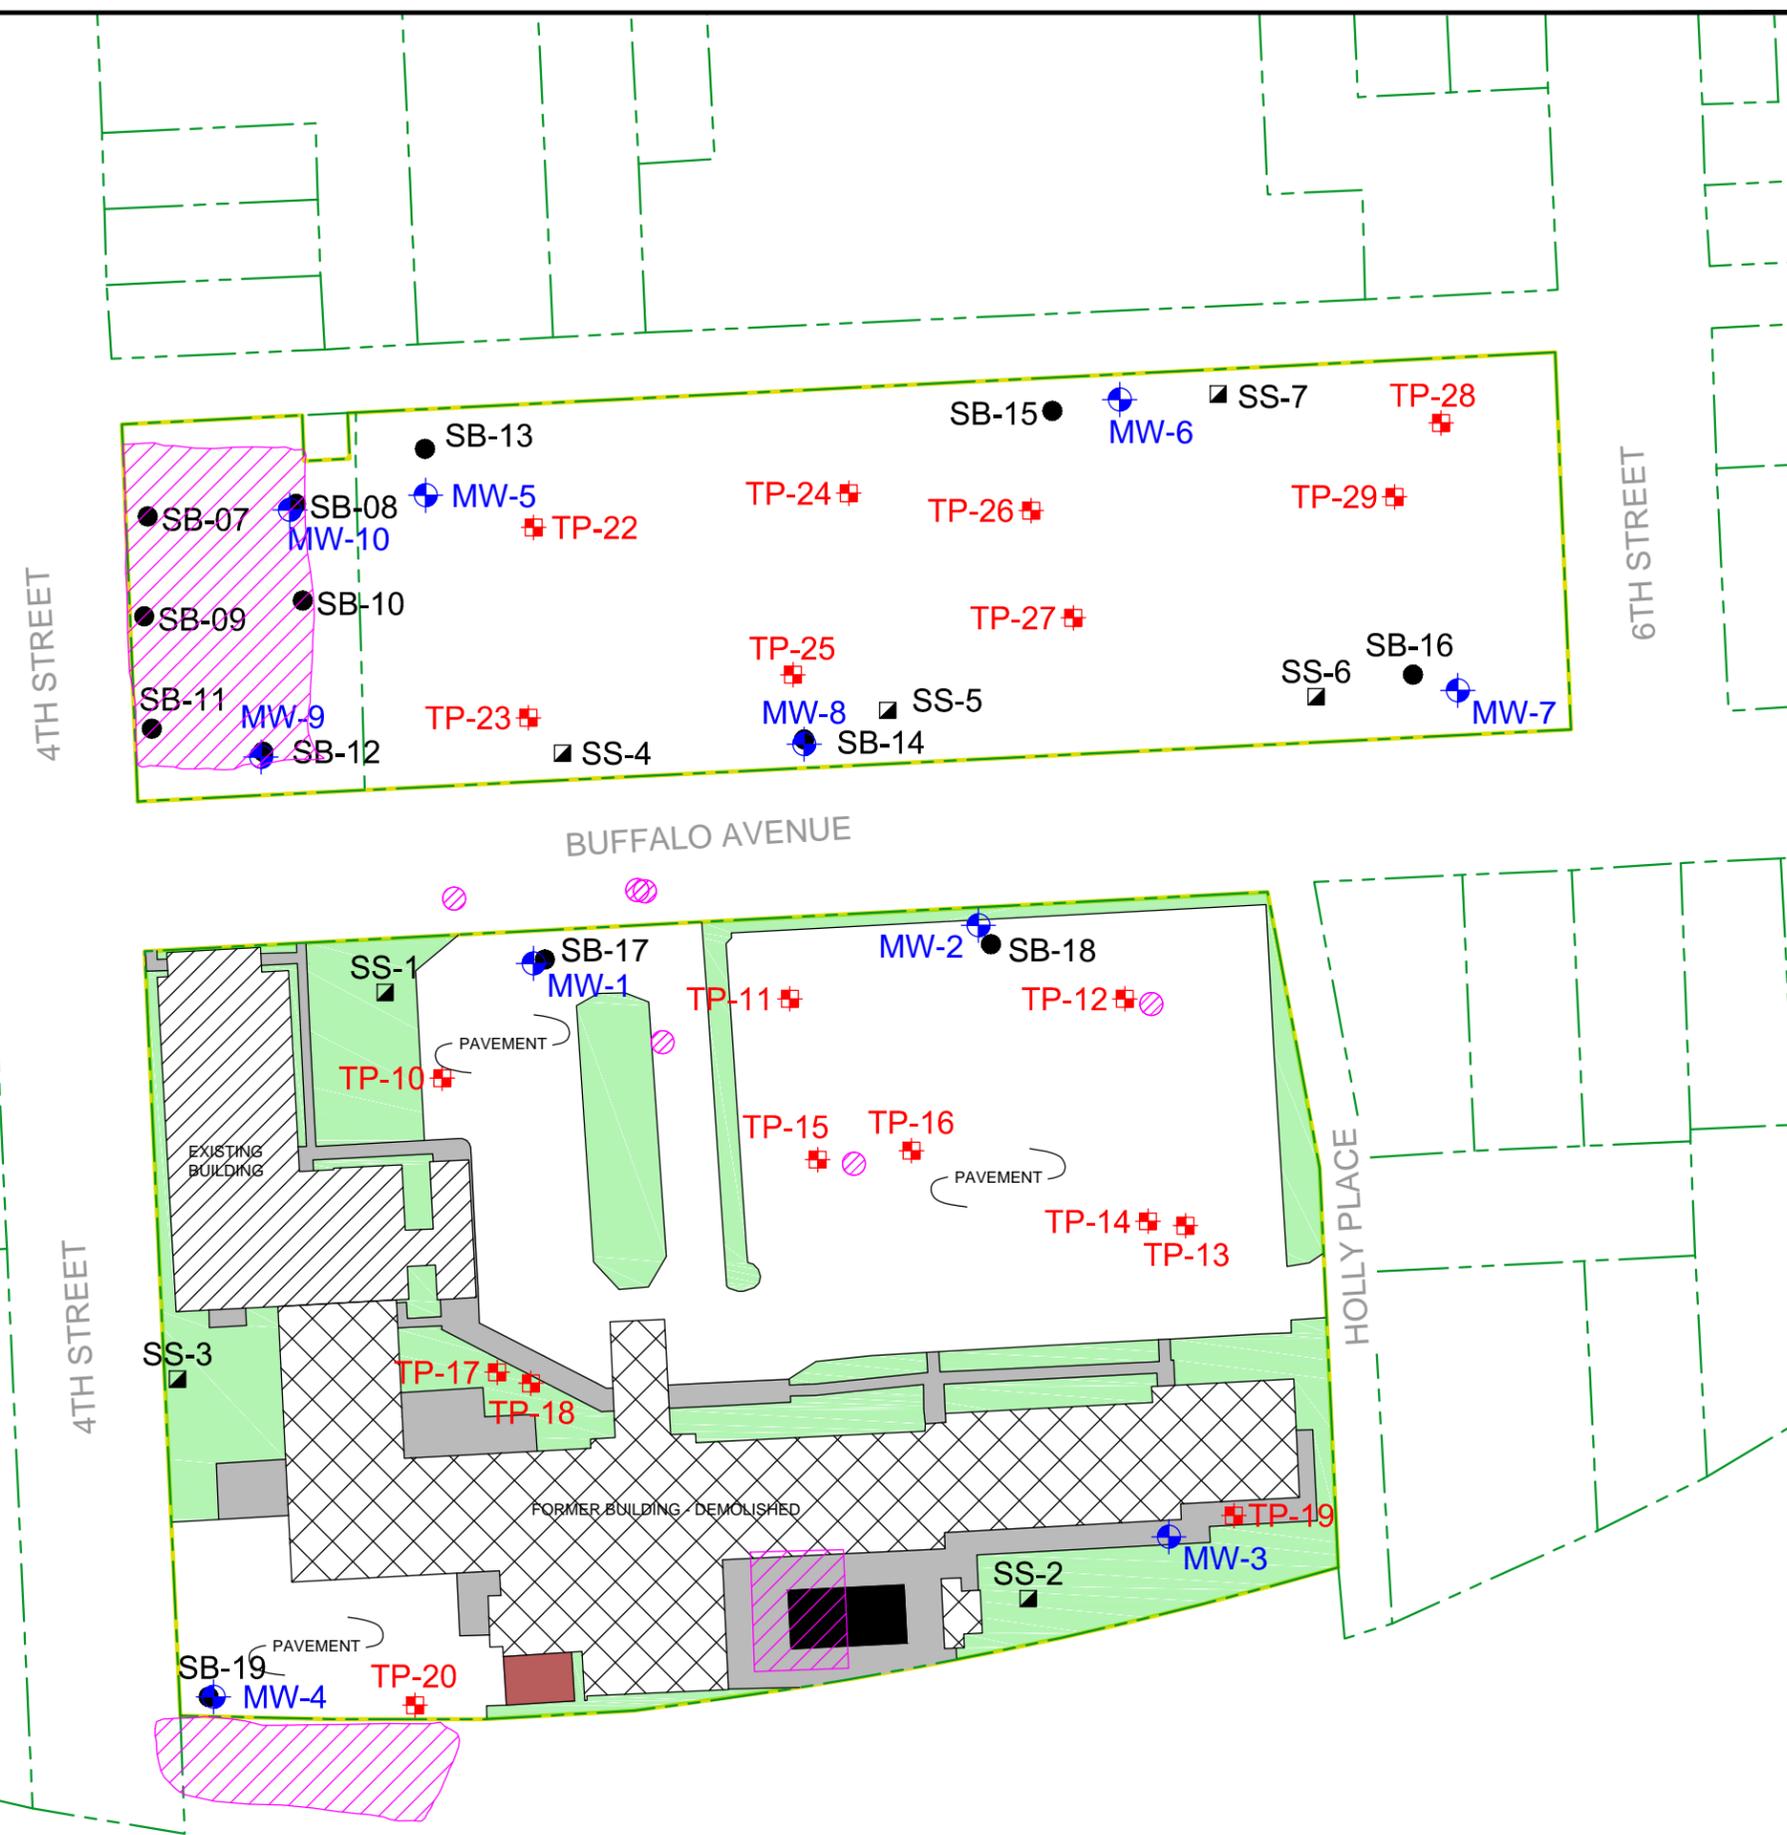
FIGURE 5

RADIATION HOTSPOT SURVEY LOCATIONS

RADIOLOGICAL SURVEY RESULTS

During the RI, the entire BCP site was screened for radiologic material by a NYSDOH licensed radiologic subcontractor, Greater Radiologic Dimensions (GRD). An approximate 10,000 sq. ft. area of the 402 Buffalo Avenue asphalt covered parking lot was observed to have elevated field screen readings of up to 40,000 counts per minute (cpm). Elevated radiologic readings are apparently associated with the underlying slag-material to an approximate depth of one-foot below surface in the subbase of the asphalt cover. Approximately 750 tons of slag material will be excavated, temporarily stockpiled, loaded and transported off-site for disposal at licensed disposal facility.

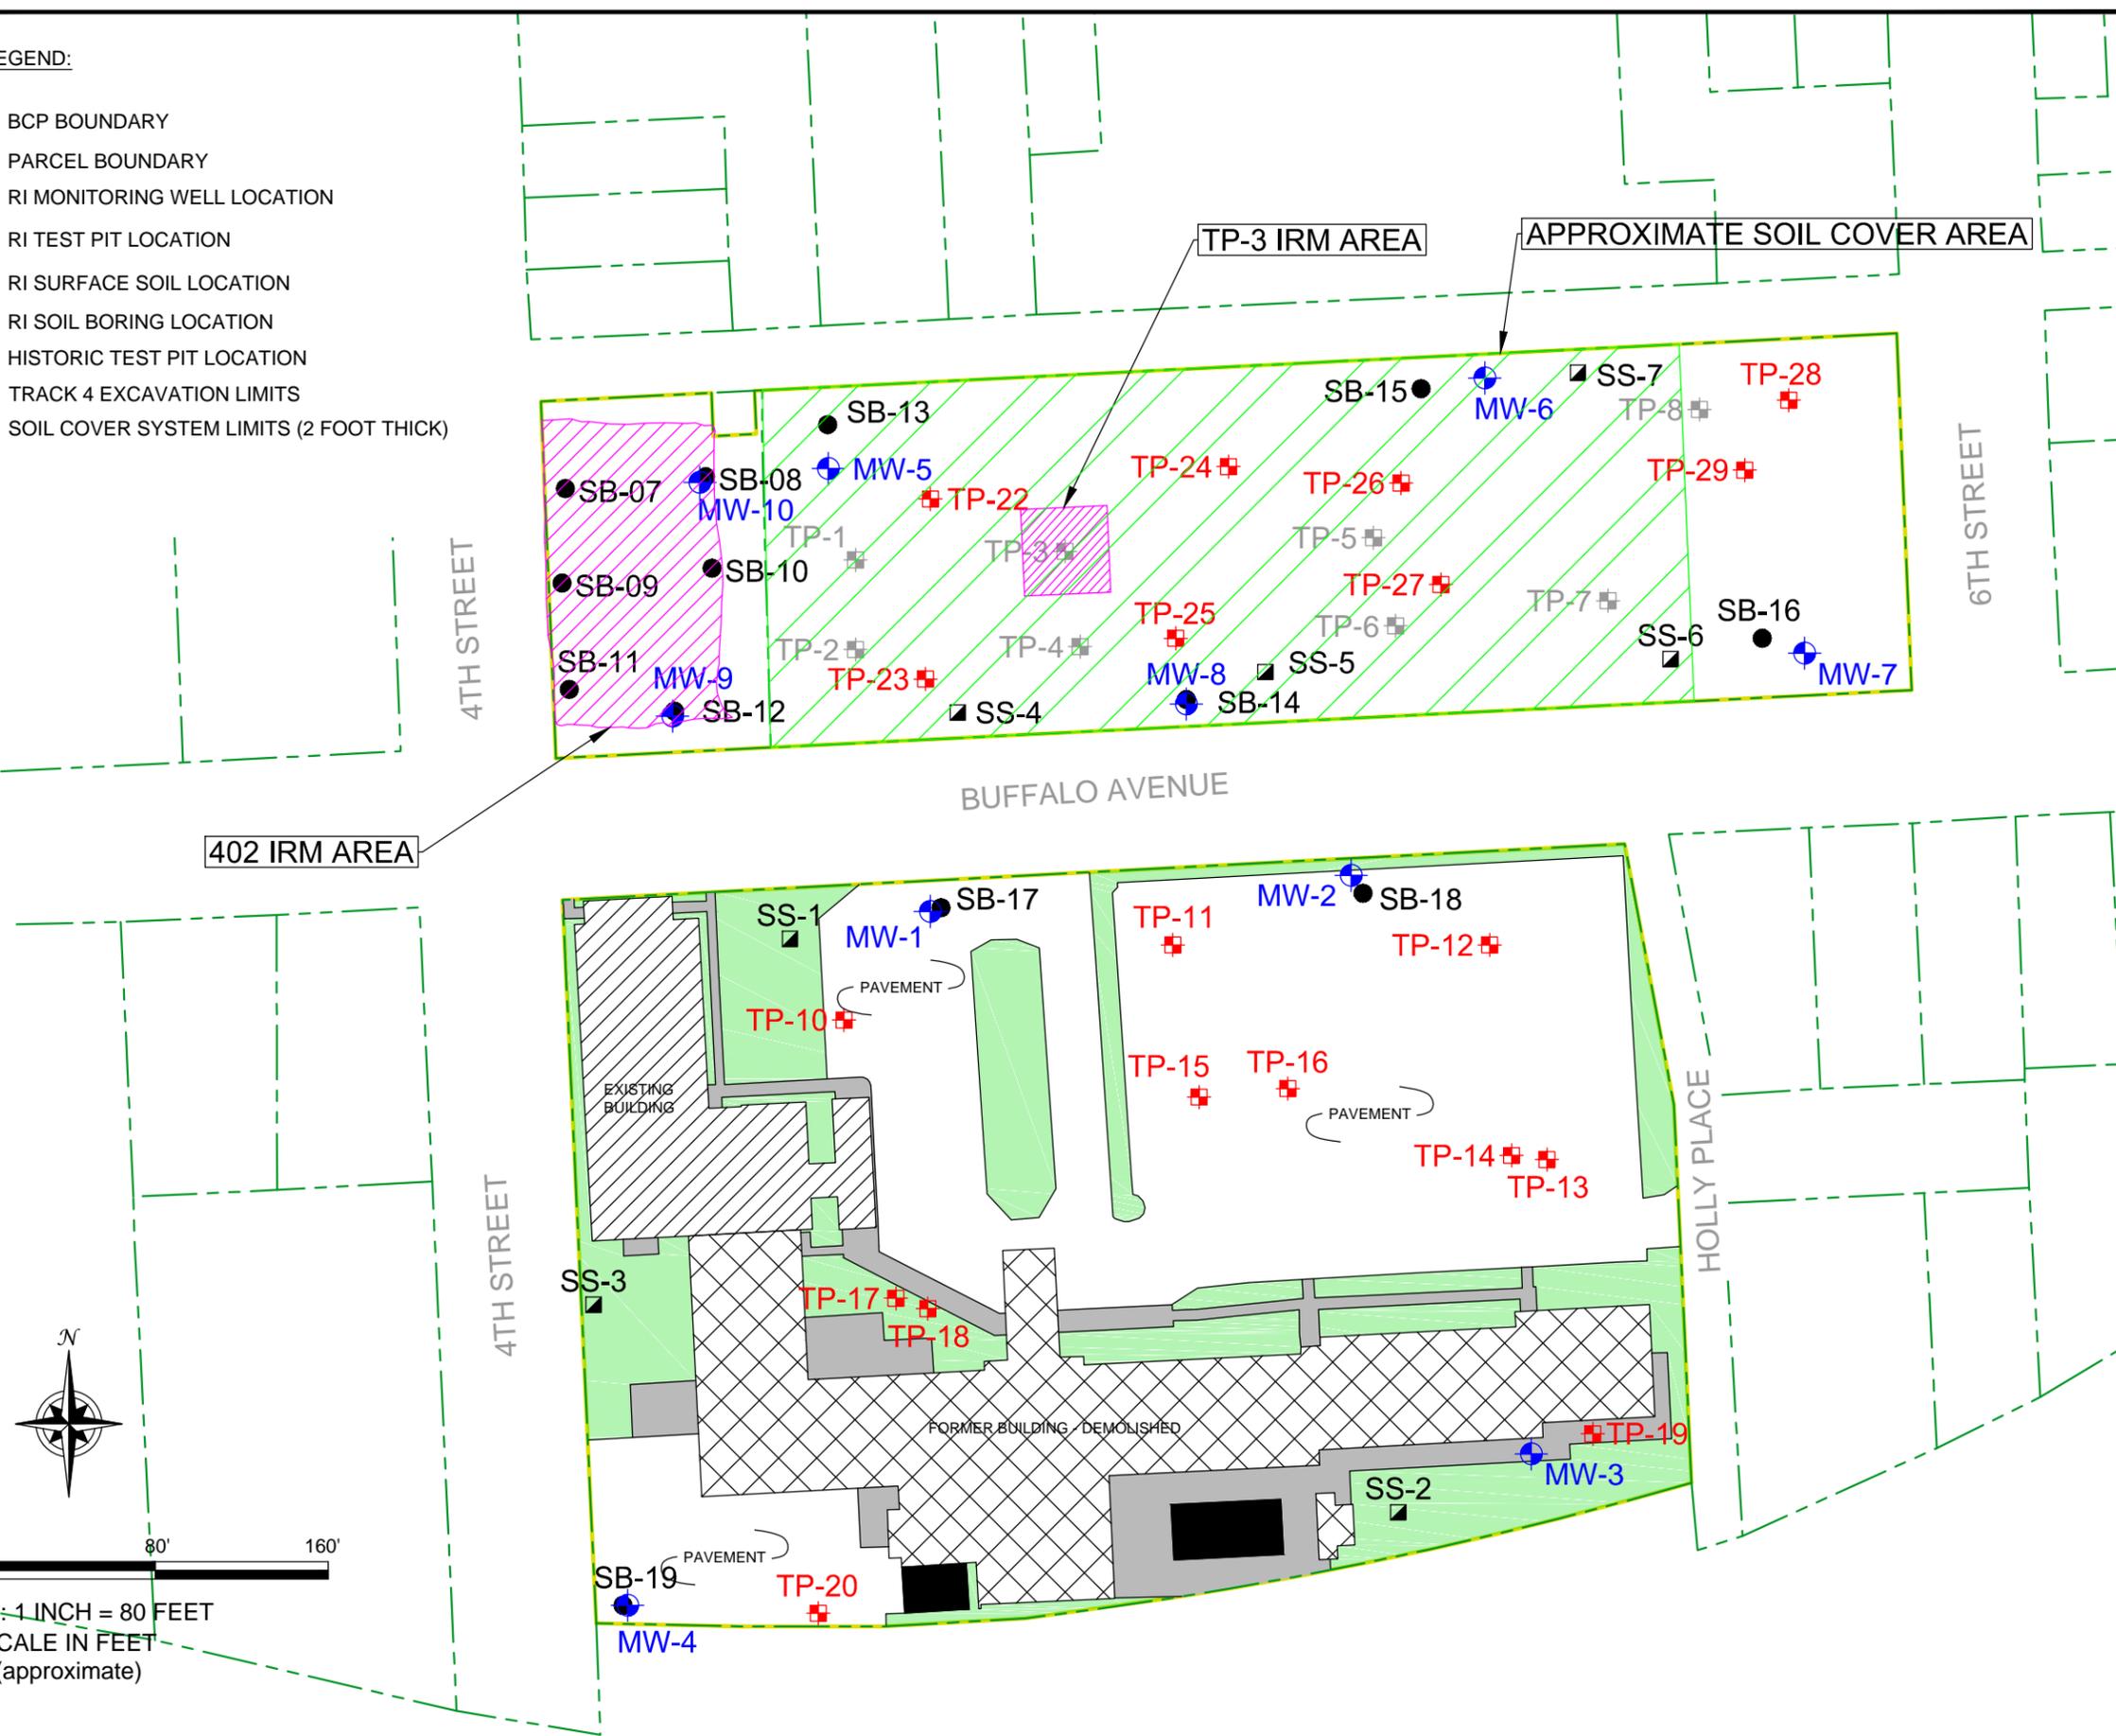
TRACK 4 EXCAVATION LIMITS
-

SOIL COVER SYSTEM LIMITS (2 FOOT THICK)

ALTERNATIVE 1: TRACK 4 RESTRICTED RESIDENTIAL CLEANUP OBJECTIVES
