# REMEDIAL INVESTIGATION WORK PLAN

The NEST Site  
333 1<sup>st</sup> Street  
City of Niagara Falls, New York

Tax Map ID No.: 159.09-1-2.11  
Property County: Niagara  
Site No.: C932183

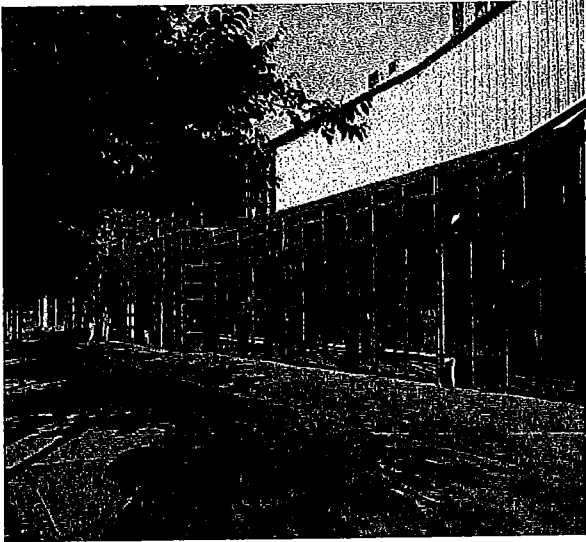
Lead Based Paint Photo:

Structural Steel – Red / Brown

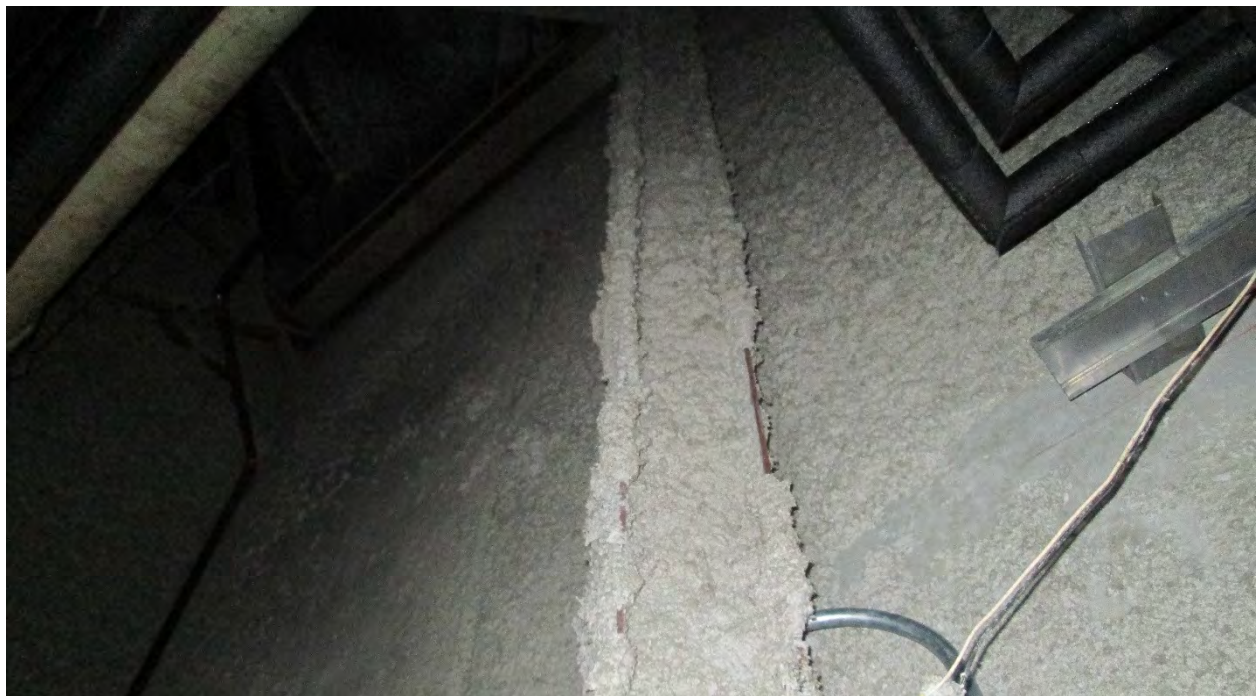
Photo 4 – View of spray-on fireproofing on beams and columns. No asbestos or vermiculite was detected in samples of the spray-on fireproofing.

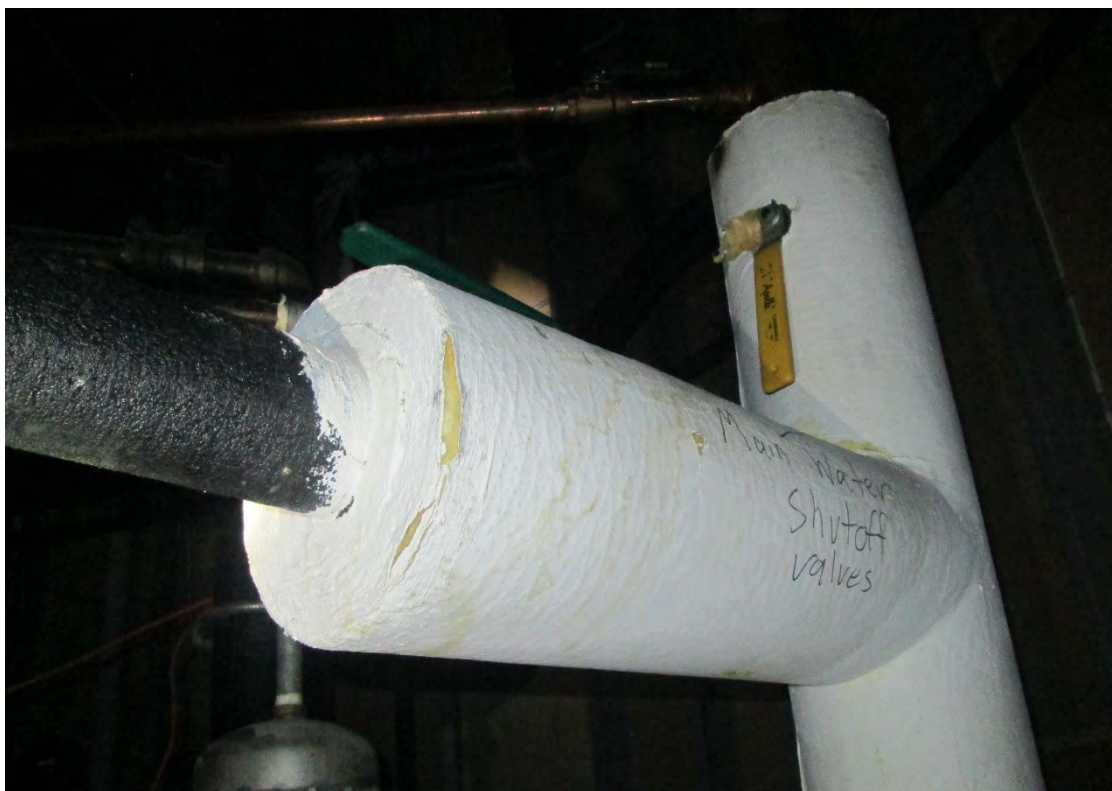
Photo 7 – View of insulation on piping. No asbestos was detected in gaskets, pipe insulation or end sealant.

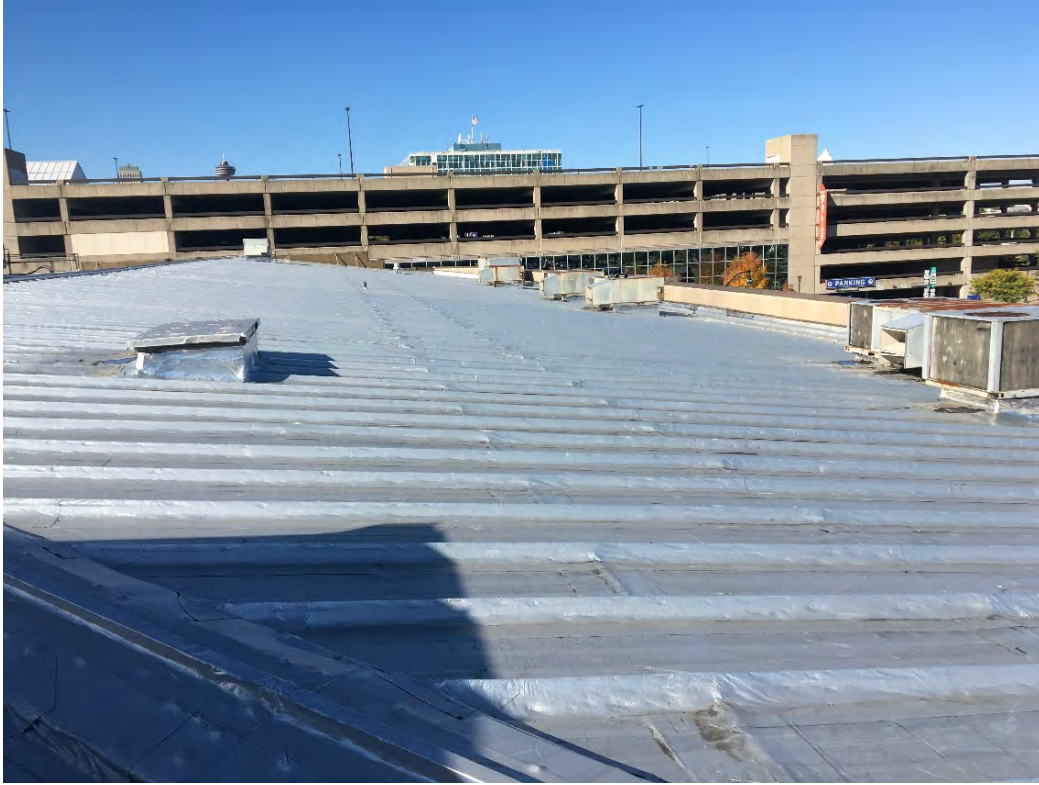
Photo 13 – View of the metal foil and tar surface covering the majority of the metal deck to the roof. ACM black tar was observed at the base of roof mounted components, vents and pipes.

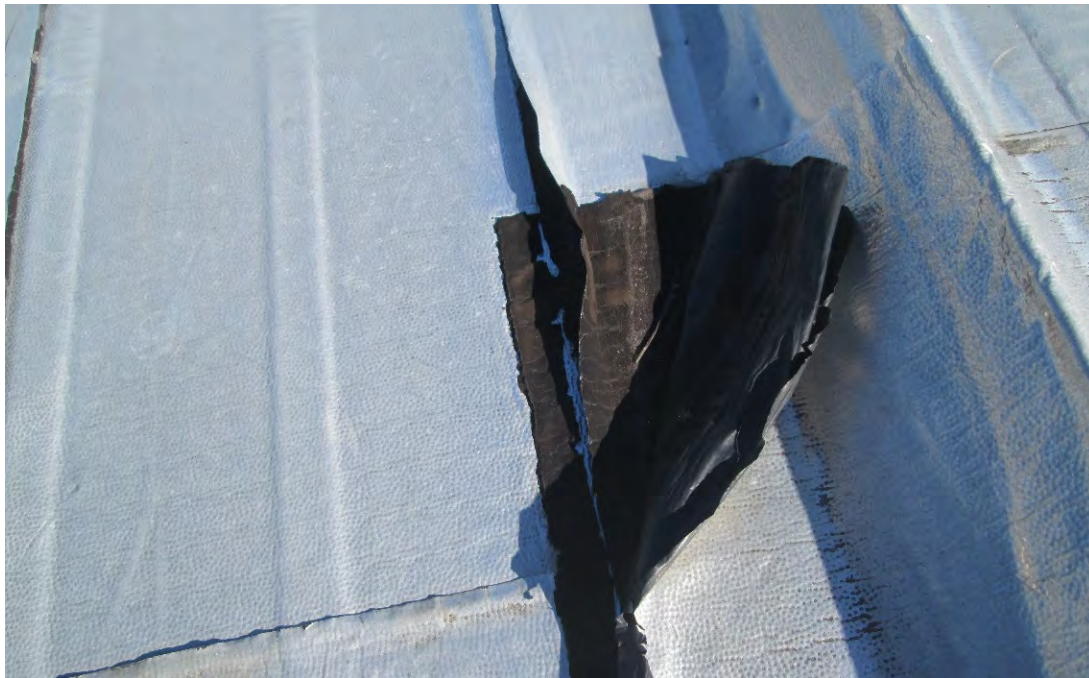
Photo 14 – Close-up view of a section of the metal foil and underlying non-ACM tar across the majority of the roof metal deck. The foil was not observed on the southern portion of the north-south roof or the southwest wing roof.

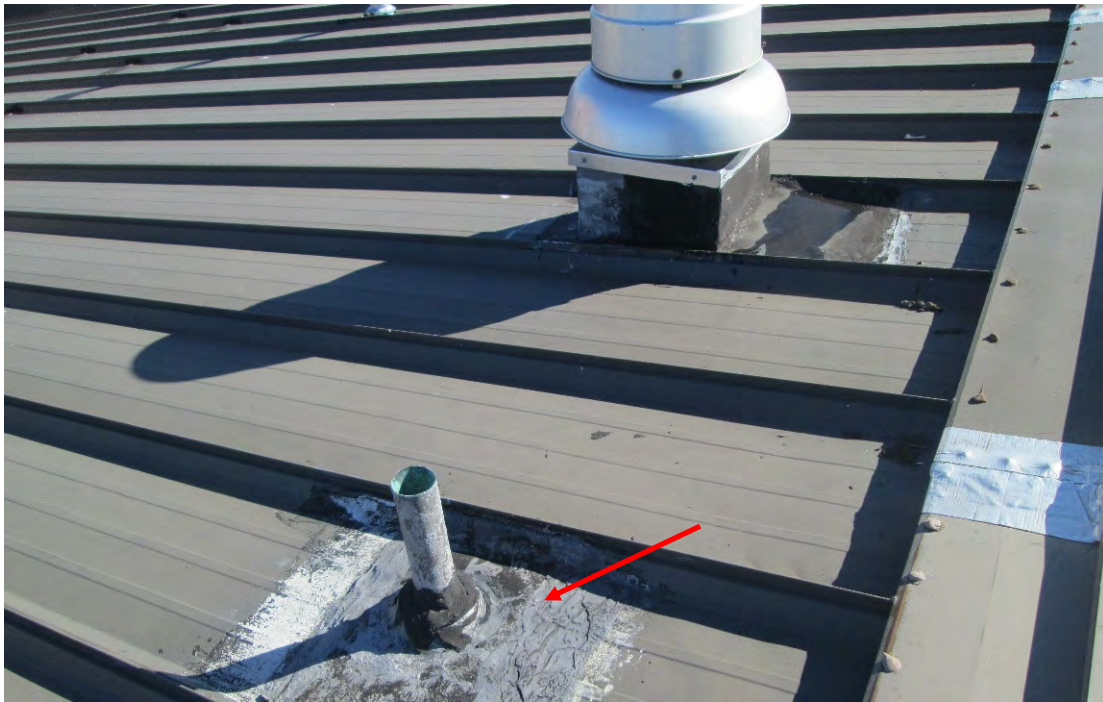
Photo 15 – View of ACM black tar at the base of a vent pipe and on the metal deck at the southern portion of the north-south roof (arrow).

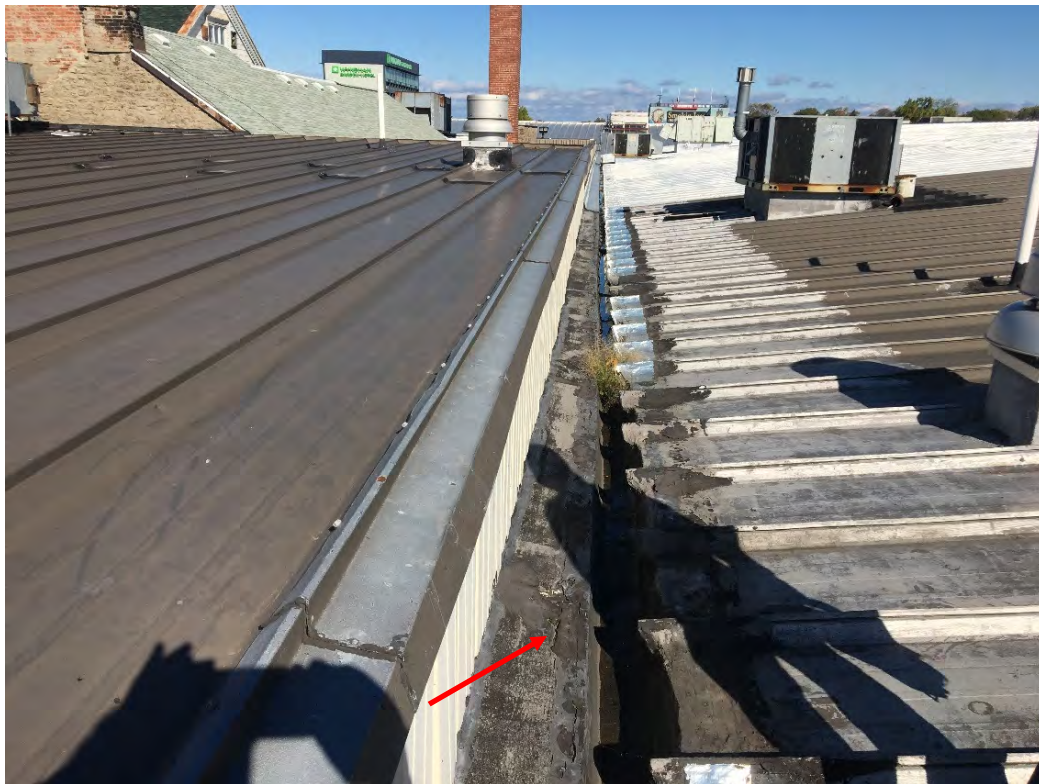
Photo 16 – View of ACM gray-black tar along the eastern edge of the southwest roof (arrow). The same tar was observed as patches along the southwest edge of the adjacent north-south wing roof.

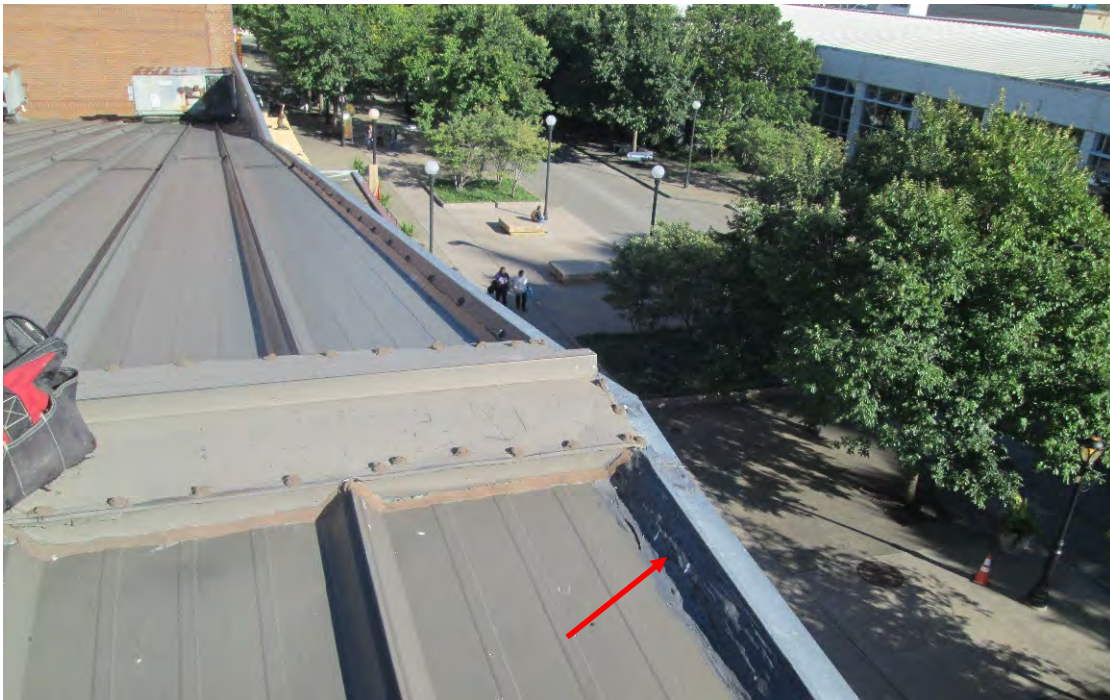
Photo 17 – View of ACM tar along the south parapet of the north-south wing roof (arrow). The tar was observed along the western half of the south parapet only.

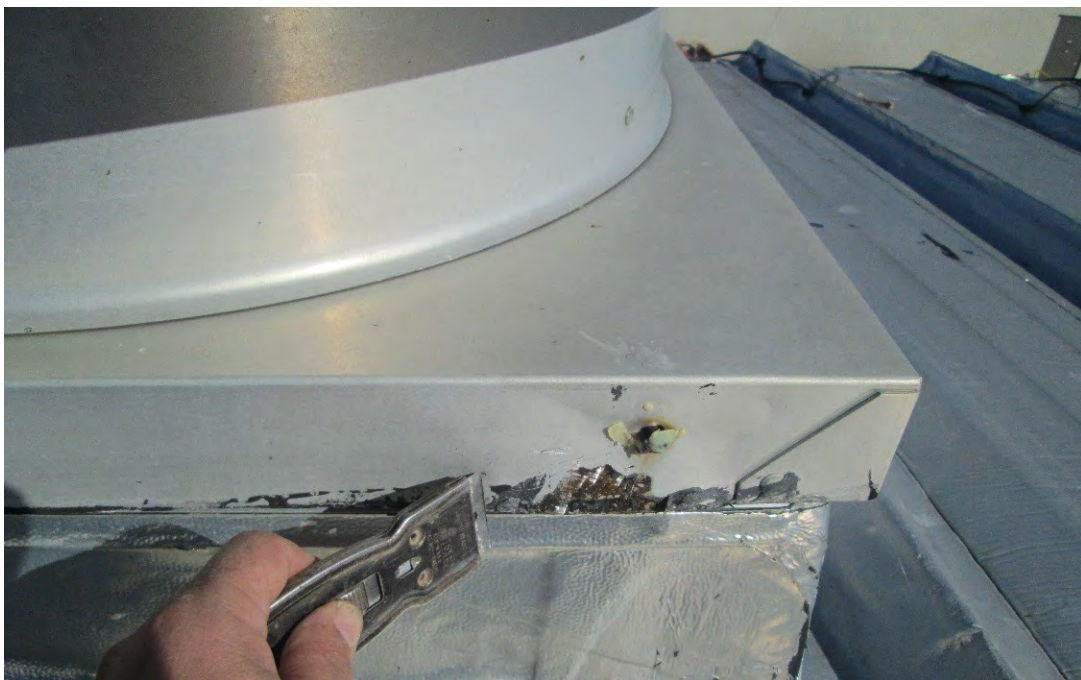
Photo 18 – View of ACM tar at the base to a roof mounted vent. The tar extended beneath the metal foil on the vent base.

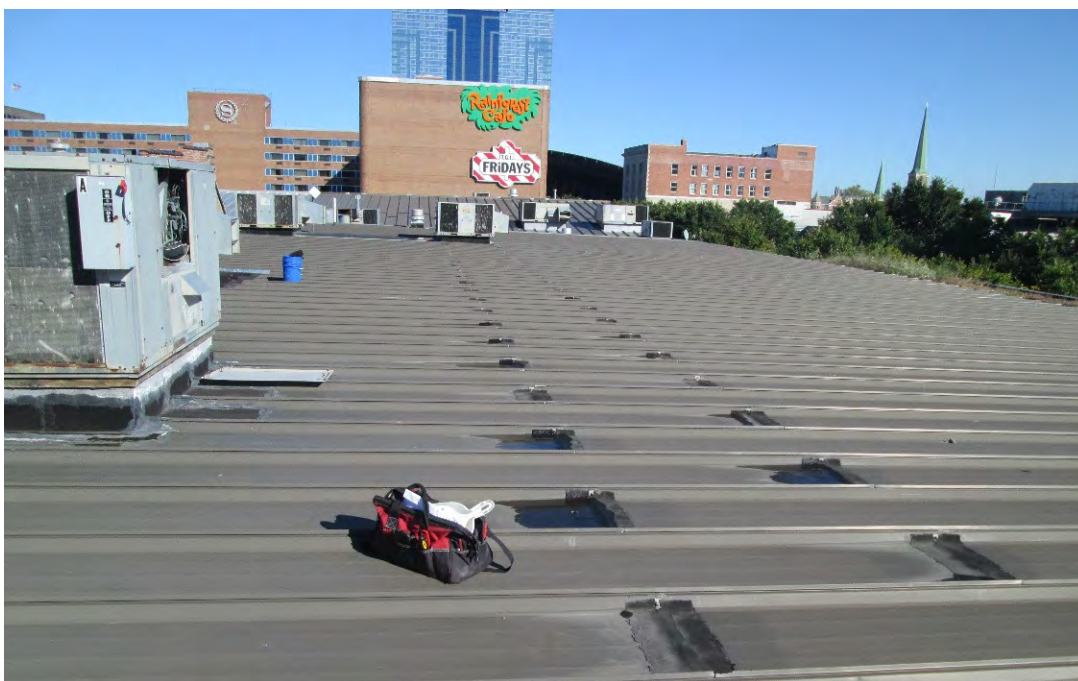
Photo 19 – View of rubber and tar patches observed in an orderly pattern on the southern portion of the north-south roof and the southwest roof. The tar and patches were determined to be non-ACM.

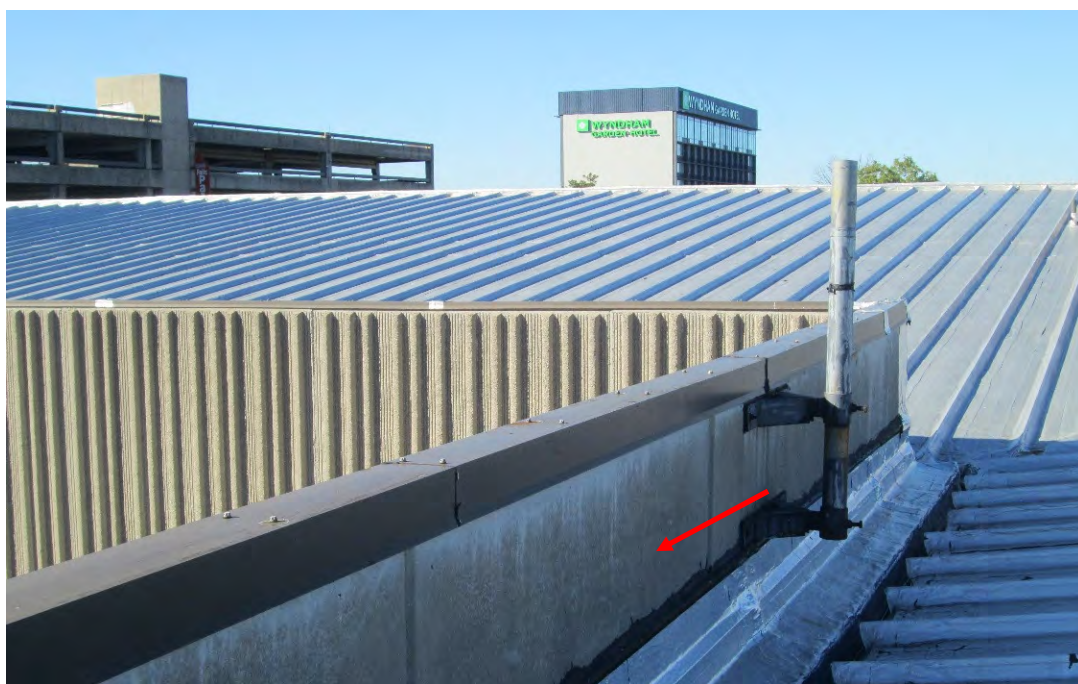
Photo 20 – View of black tar on the north-south roof west concrete parapet (arrow). The tar was determined to be non-ACM.

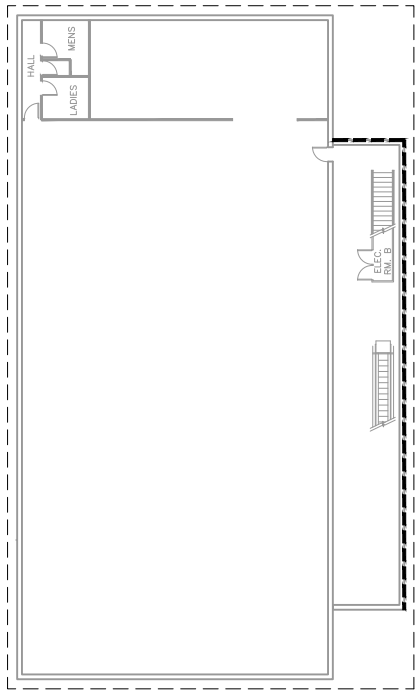
SECOND FLOOR PLAN

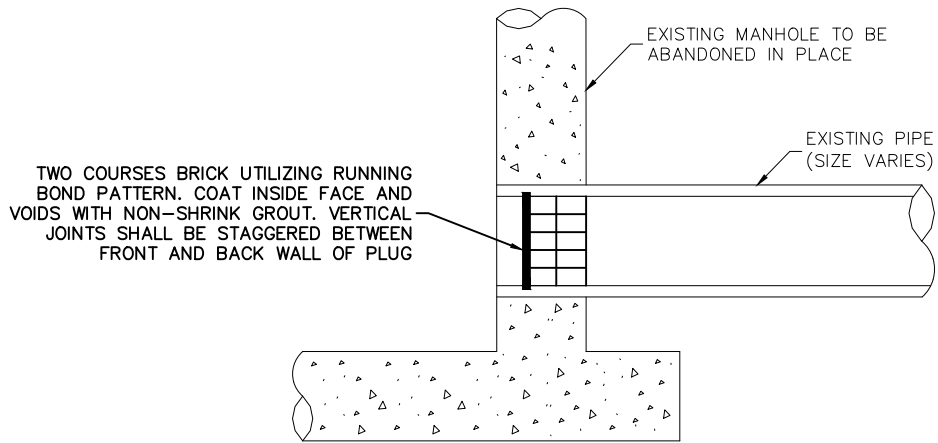
1  
UT-501

PIPELINE BULKHEAD IN EXISTING MANHOLE DETAIL  
NTS

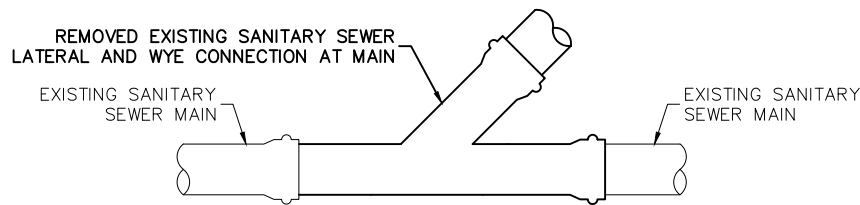
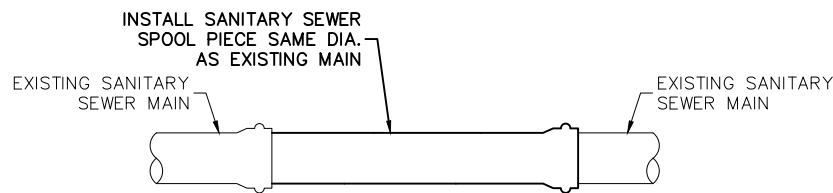
2  
UT-501

REMOVAL/INSTALLATION OF EXISTING SANITARY SEWER DETAIL  
NTS

1. THE CONTRACTOR IS RESPONSIBLE FOR LOCATING ALL SANITARY LATERALS FROM SUBJECT PARCEL TO TRUNK SEWER.
2. THE CONTRACTOR SHALL REMOVE ALL LATERALS FROM SANITARY FIXTURE UNIT LOCATIONS ON PLAN (UNLESS NOTED OTHERWISE ON DRAWING) TO TRUNK SEWER AND PROVIDE SPOOL PIECE AT TRUNK PER DETAIL 2/UT-501.
3. THE CONTRACTOR SHALL PROTECT ALL LATERALS SERVICING ADJACENT PARCELS.

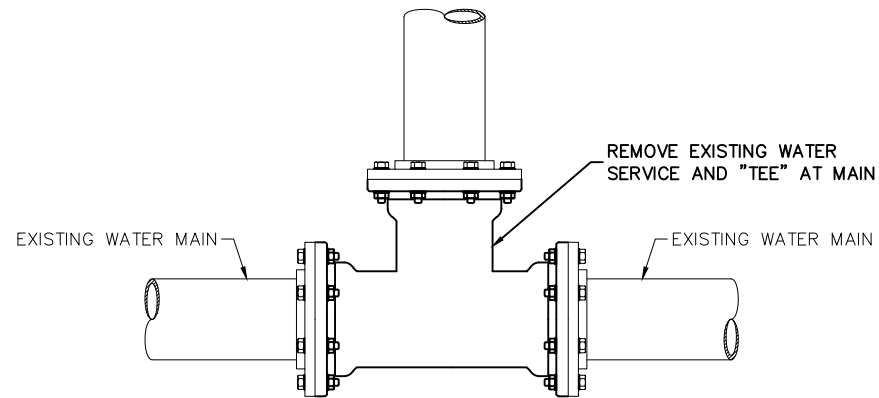
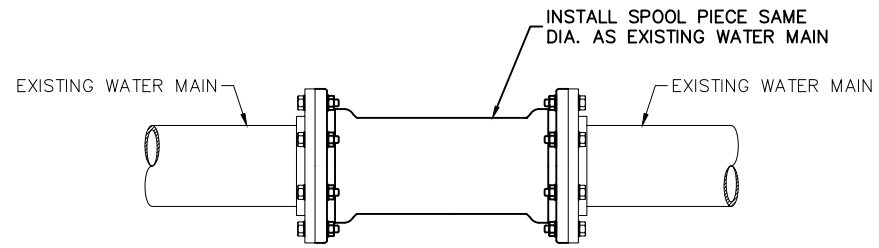
3  
UT-501

REMOVAL/INSTALLATION OF EXISTING WATER SERVICE DETAIL  
NTS

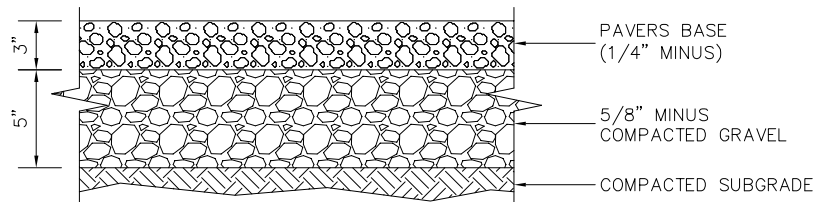
1  
C-101

**FINISHED GRADE SECTION**  
N.T.S.

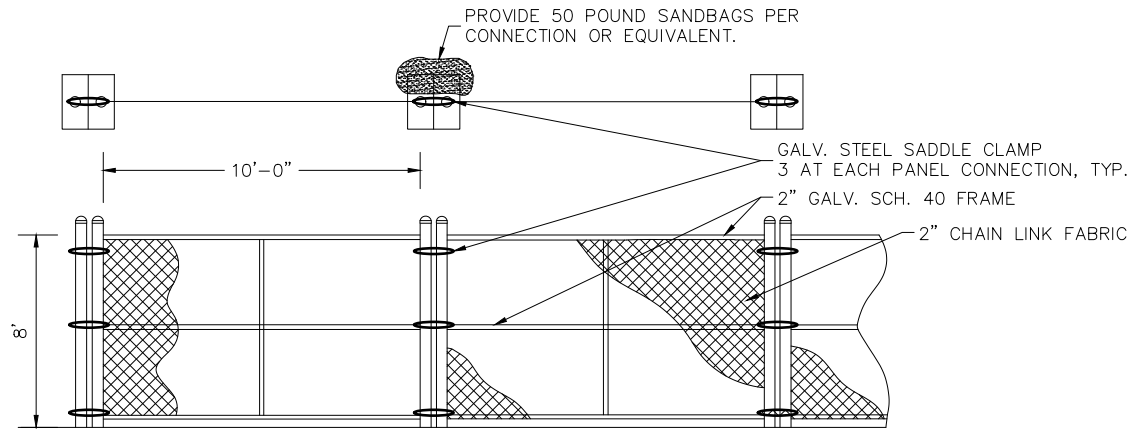
1  
C-503

TEMPORARY CONSTRUCTION FENCE, GATE AND POST DETAIL

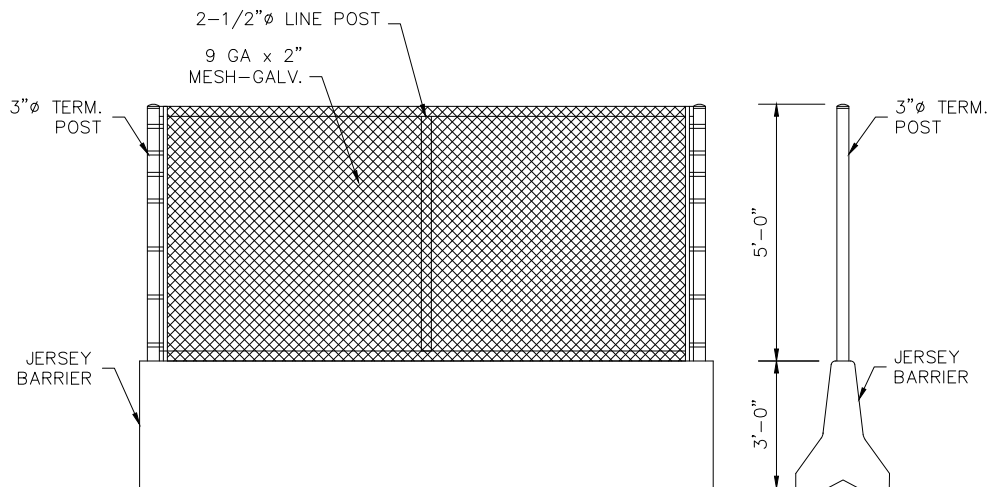
2  
C-503

JERSEY BARRIER TEMPORARY FENCE DETAIL

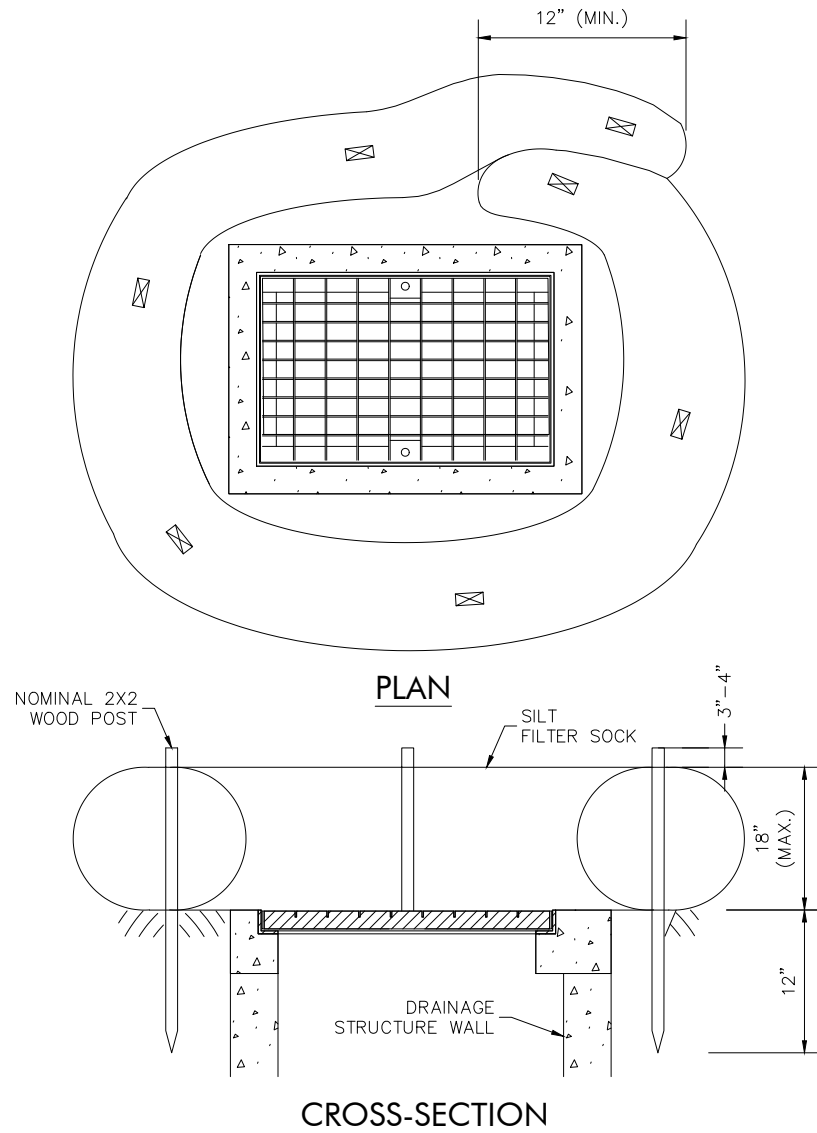
3  
C-503

DRAINAGE STRUCTURE INLET PROTECTION -  
TEMPORARY - NTS  
(SILT FILTER SOCK)
