**Adirondack Regional Business Incubator Site  
36 Elm Street  
City of Glens Falls, New York**

**Environmental Restoration Project**

## **Site Investigation Report**

**New York State Assistance Contract No. C303163  
ERP Project No. E557019**

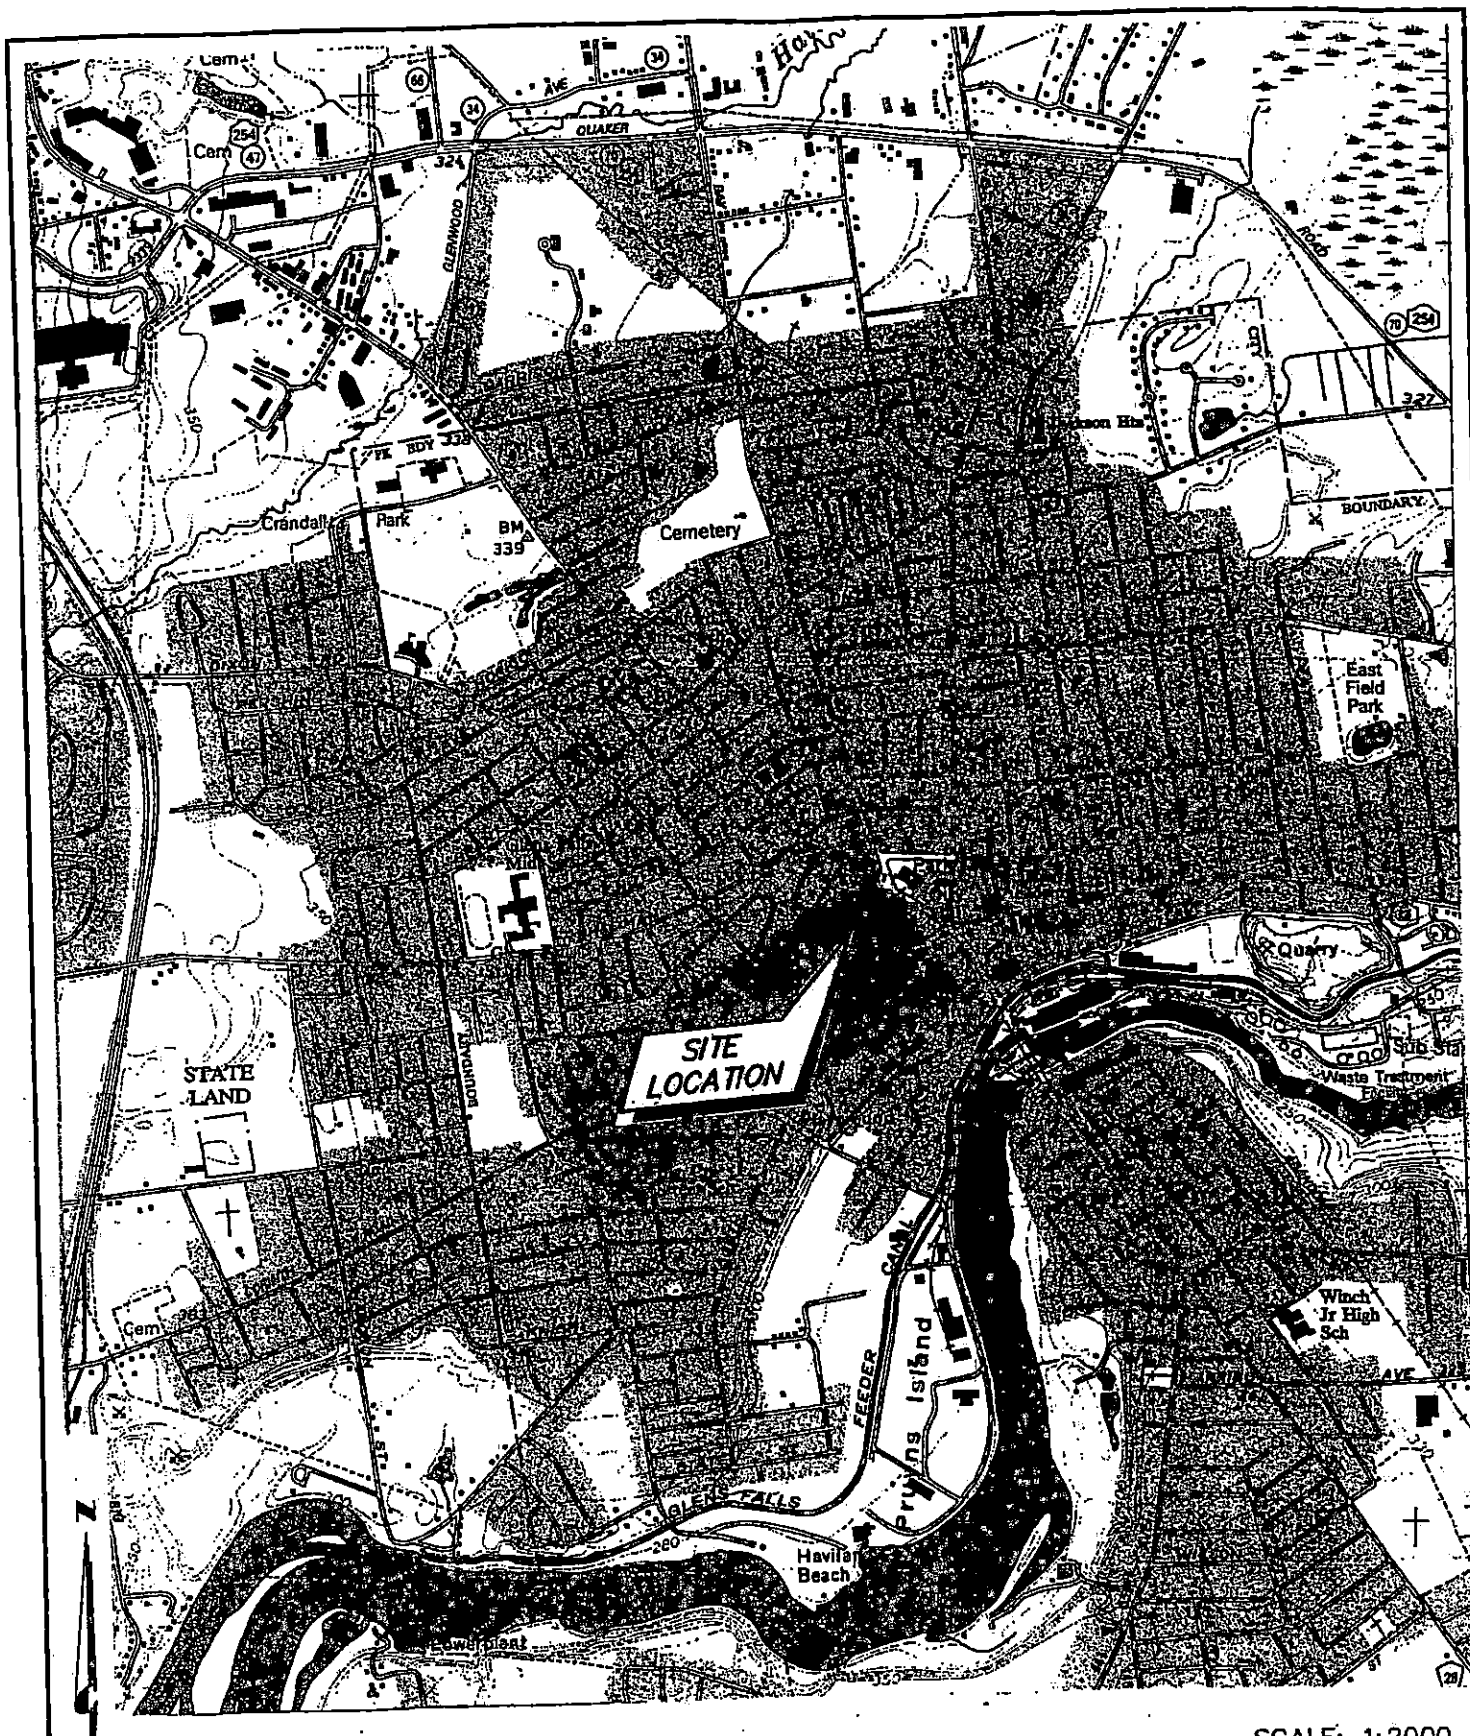
SCALE: 1:2000

SOURCE: NYSDOT 7.5' Topographic  
QUADRANGLE: GLENS FALLS, NY

The New York State Department of Transportation (NYSDOT), 7.5 Minute Series Topographic Map, Glens Falls Quadrangle, indicates that the approximate elevation of the subject site is 345 feet above mean sea level (AMSL). The topographic profile of the site is flat. There were no apparent areas of fill material noted on the subject site at the time of the site inspection.

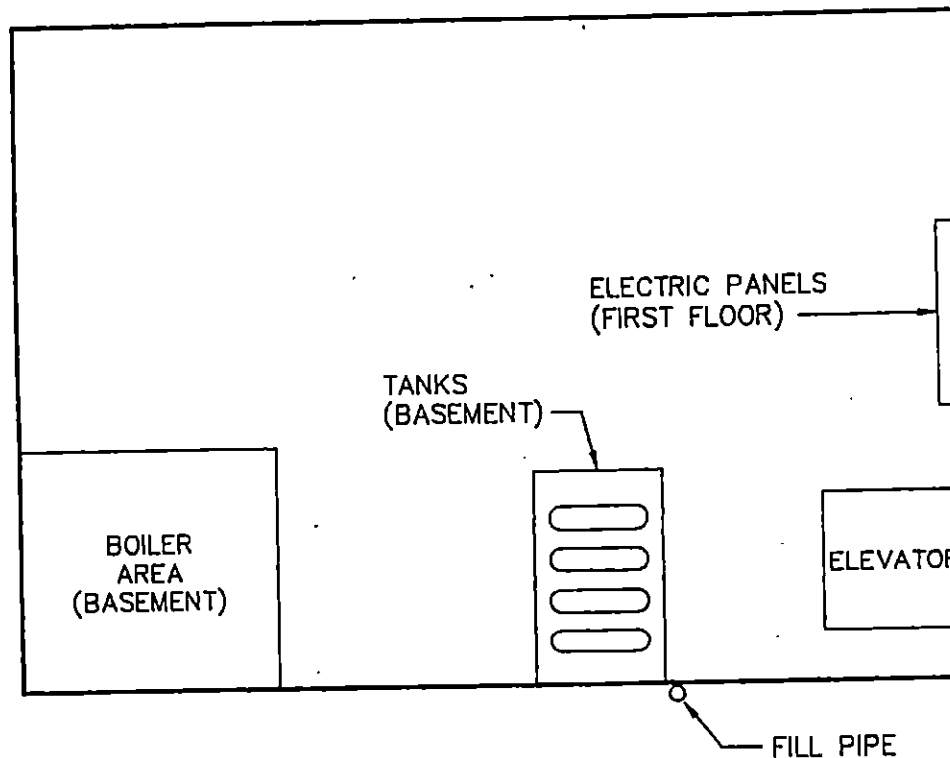
ELM STREET

The subject site is identified as tax parcel 309.28-1-13 and consists of approximately 0.13 acres. The site is occupied by a three story masonry building which encompasses the entire site (Photo 1). The first, second, and third floors are used for the storage of restaurant supplies and equipment (Photos 2 & 3) such as dishes, tables, chairs, stainless steel sinks, and appliances. A basement underlies the entire building and is also used for storage purposes. Site utilities consist of public water and sewer, natural gas, and electricity. It should be noted that the only utility actively used is electricity. A Site Plan depicting site features has been included as Figure 2.

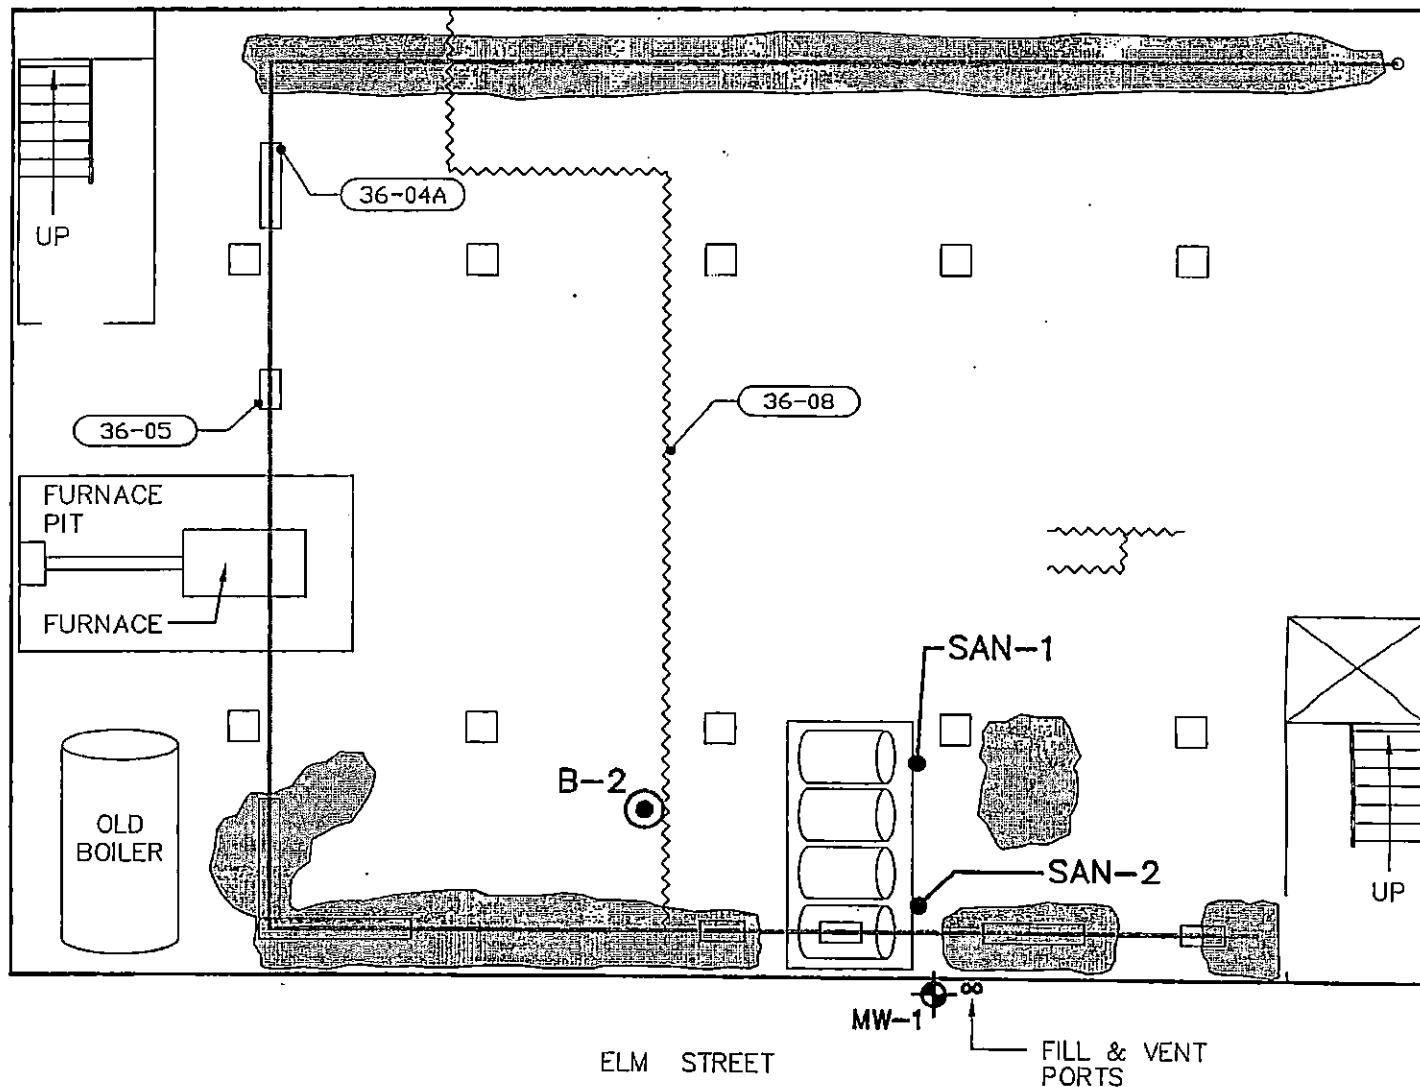
## LEGEND

- 36-01A • ASBESTOS SAMPLE LOCATION
- 36Pb-01A • PAINT CHIP SAMPLE LOCATION
- ~~~~~ BLACK PIPE WRAP
- [ ]— PIPE WITH AIRCELL
- [ ]— AREA OF INTACT AIRCELL
- [ ] AREA OF AIRCELL DEBRIS
- B-2 • BORING LOCATION
- SAN-1 • SAND SAMPLE LOCATION
- MW-1 • MONITORING WELL LOCATION

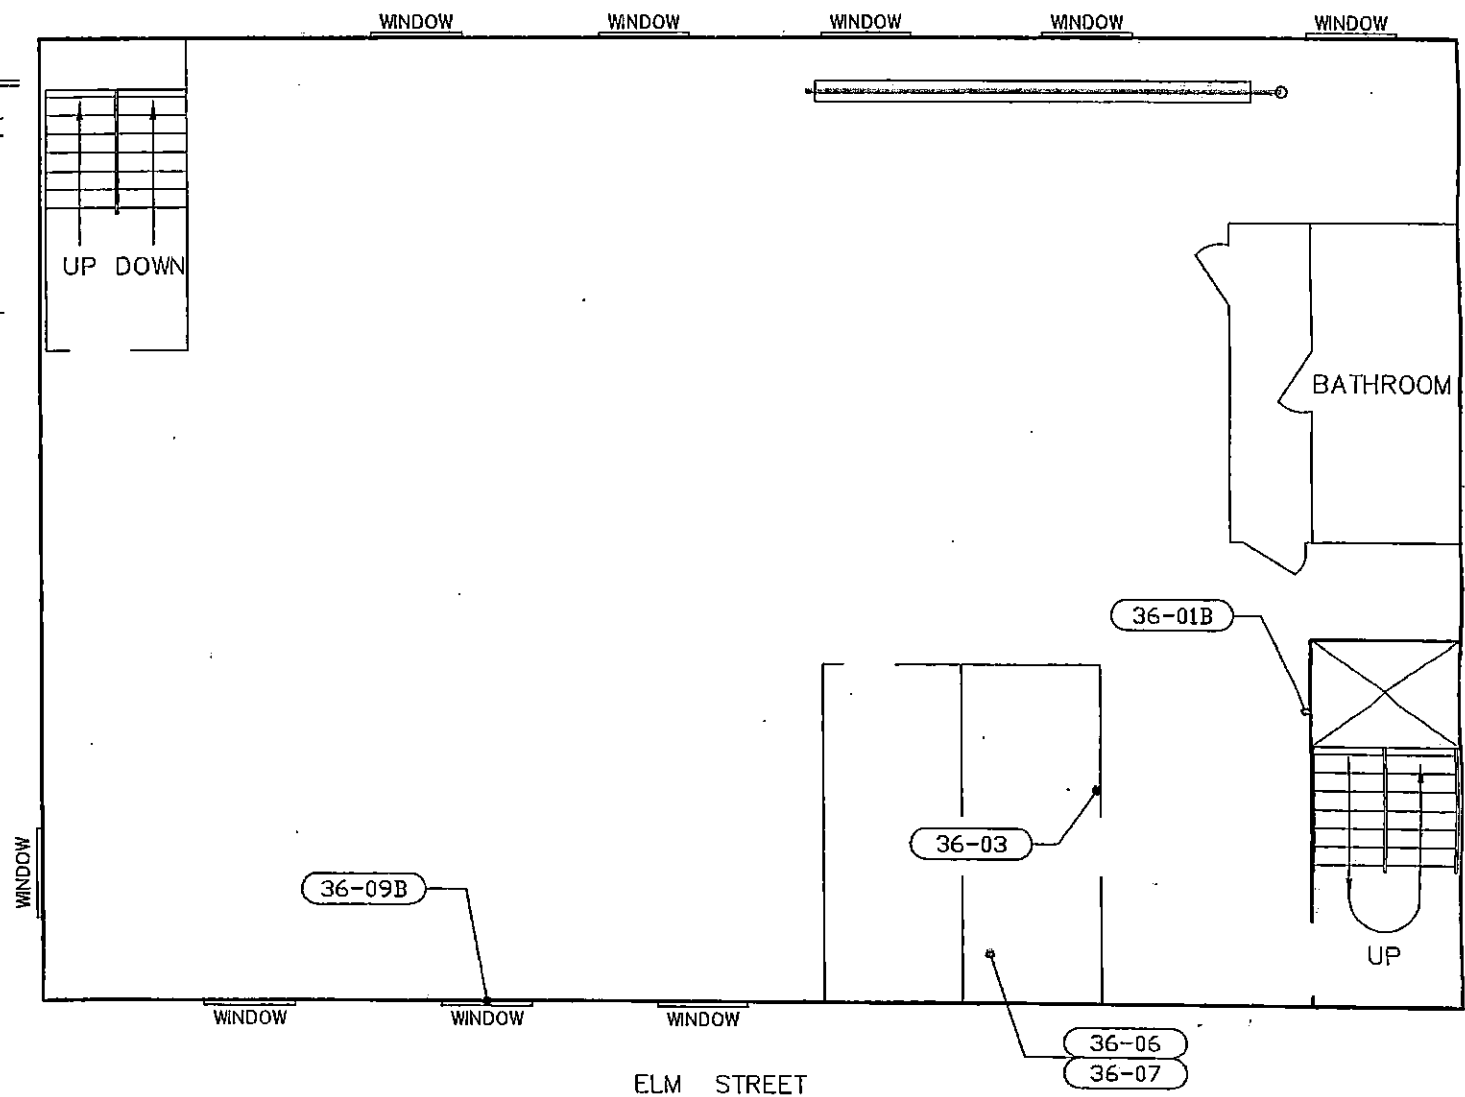
## LEGEND

- 36-01A • ASBESTOS SAMPLE LOCATION
- 36Pb-01A • PAINT CHIP SAMPLE LOCATION
- PIPE WITH AIRCELL
- AREA OF INTACT AIRCELL

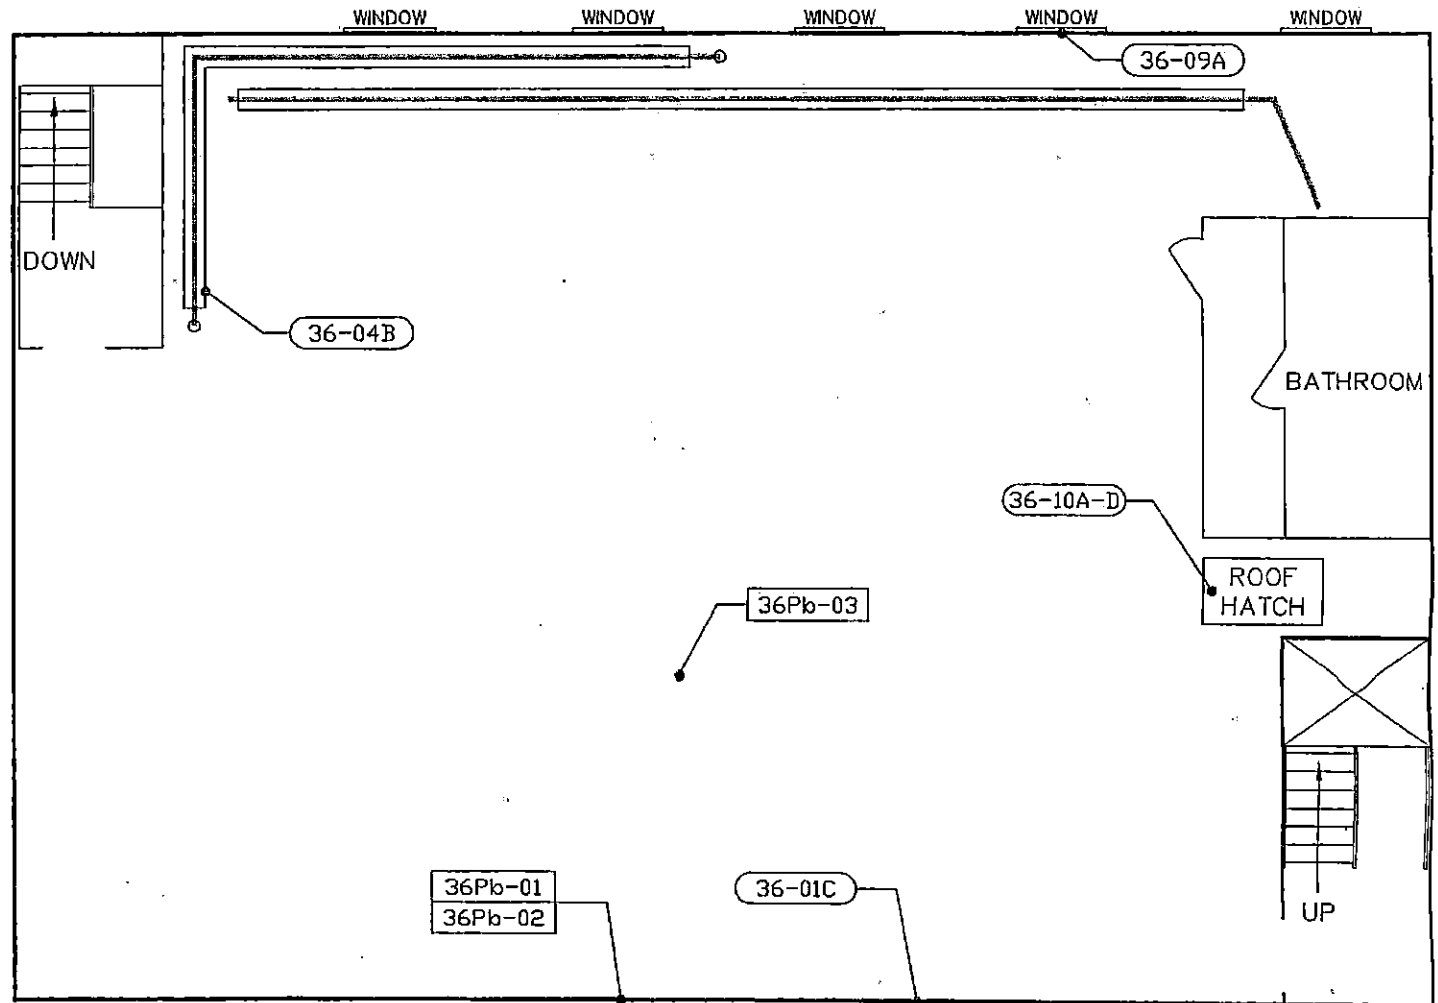
## LEGEND

- 36-01A • ASBESTOS SAMPLE LOCATION
- 36Pb-01A • PAINT CHIP SAMPLE LOCATION
- PIPE WITH AIRCELL
- AREA OF INTACT AIRCELL
