EXPLANATION OF SIGNIFICANT DIFFERENCE

1318 NIAGARA STREET SITE

City of Buffalo / Erie County / Site No. E915213 / September 2025

Prepared by the New York State Department of Environmental Conservation
Division of Environmental Remediation

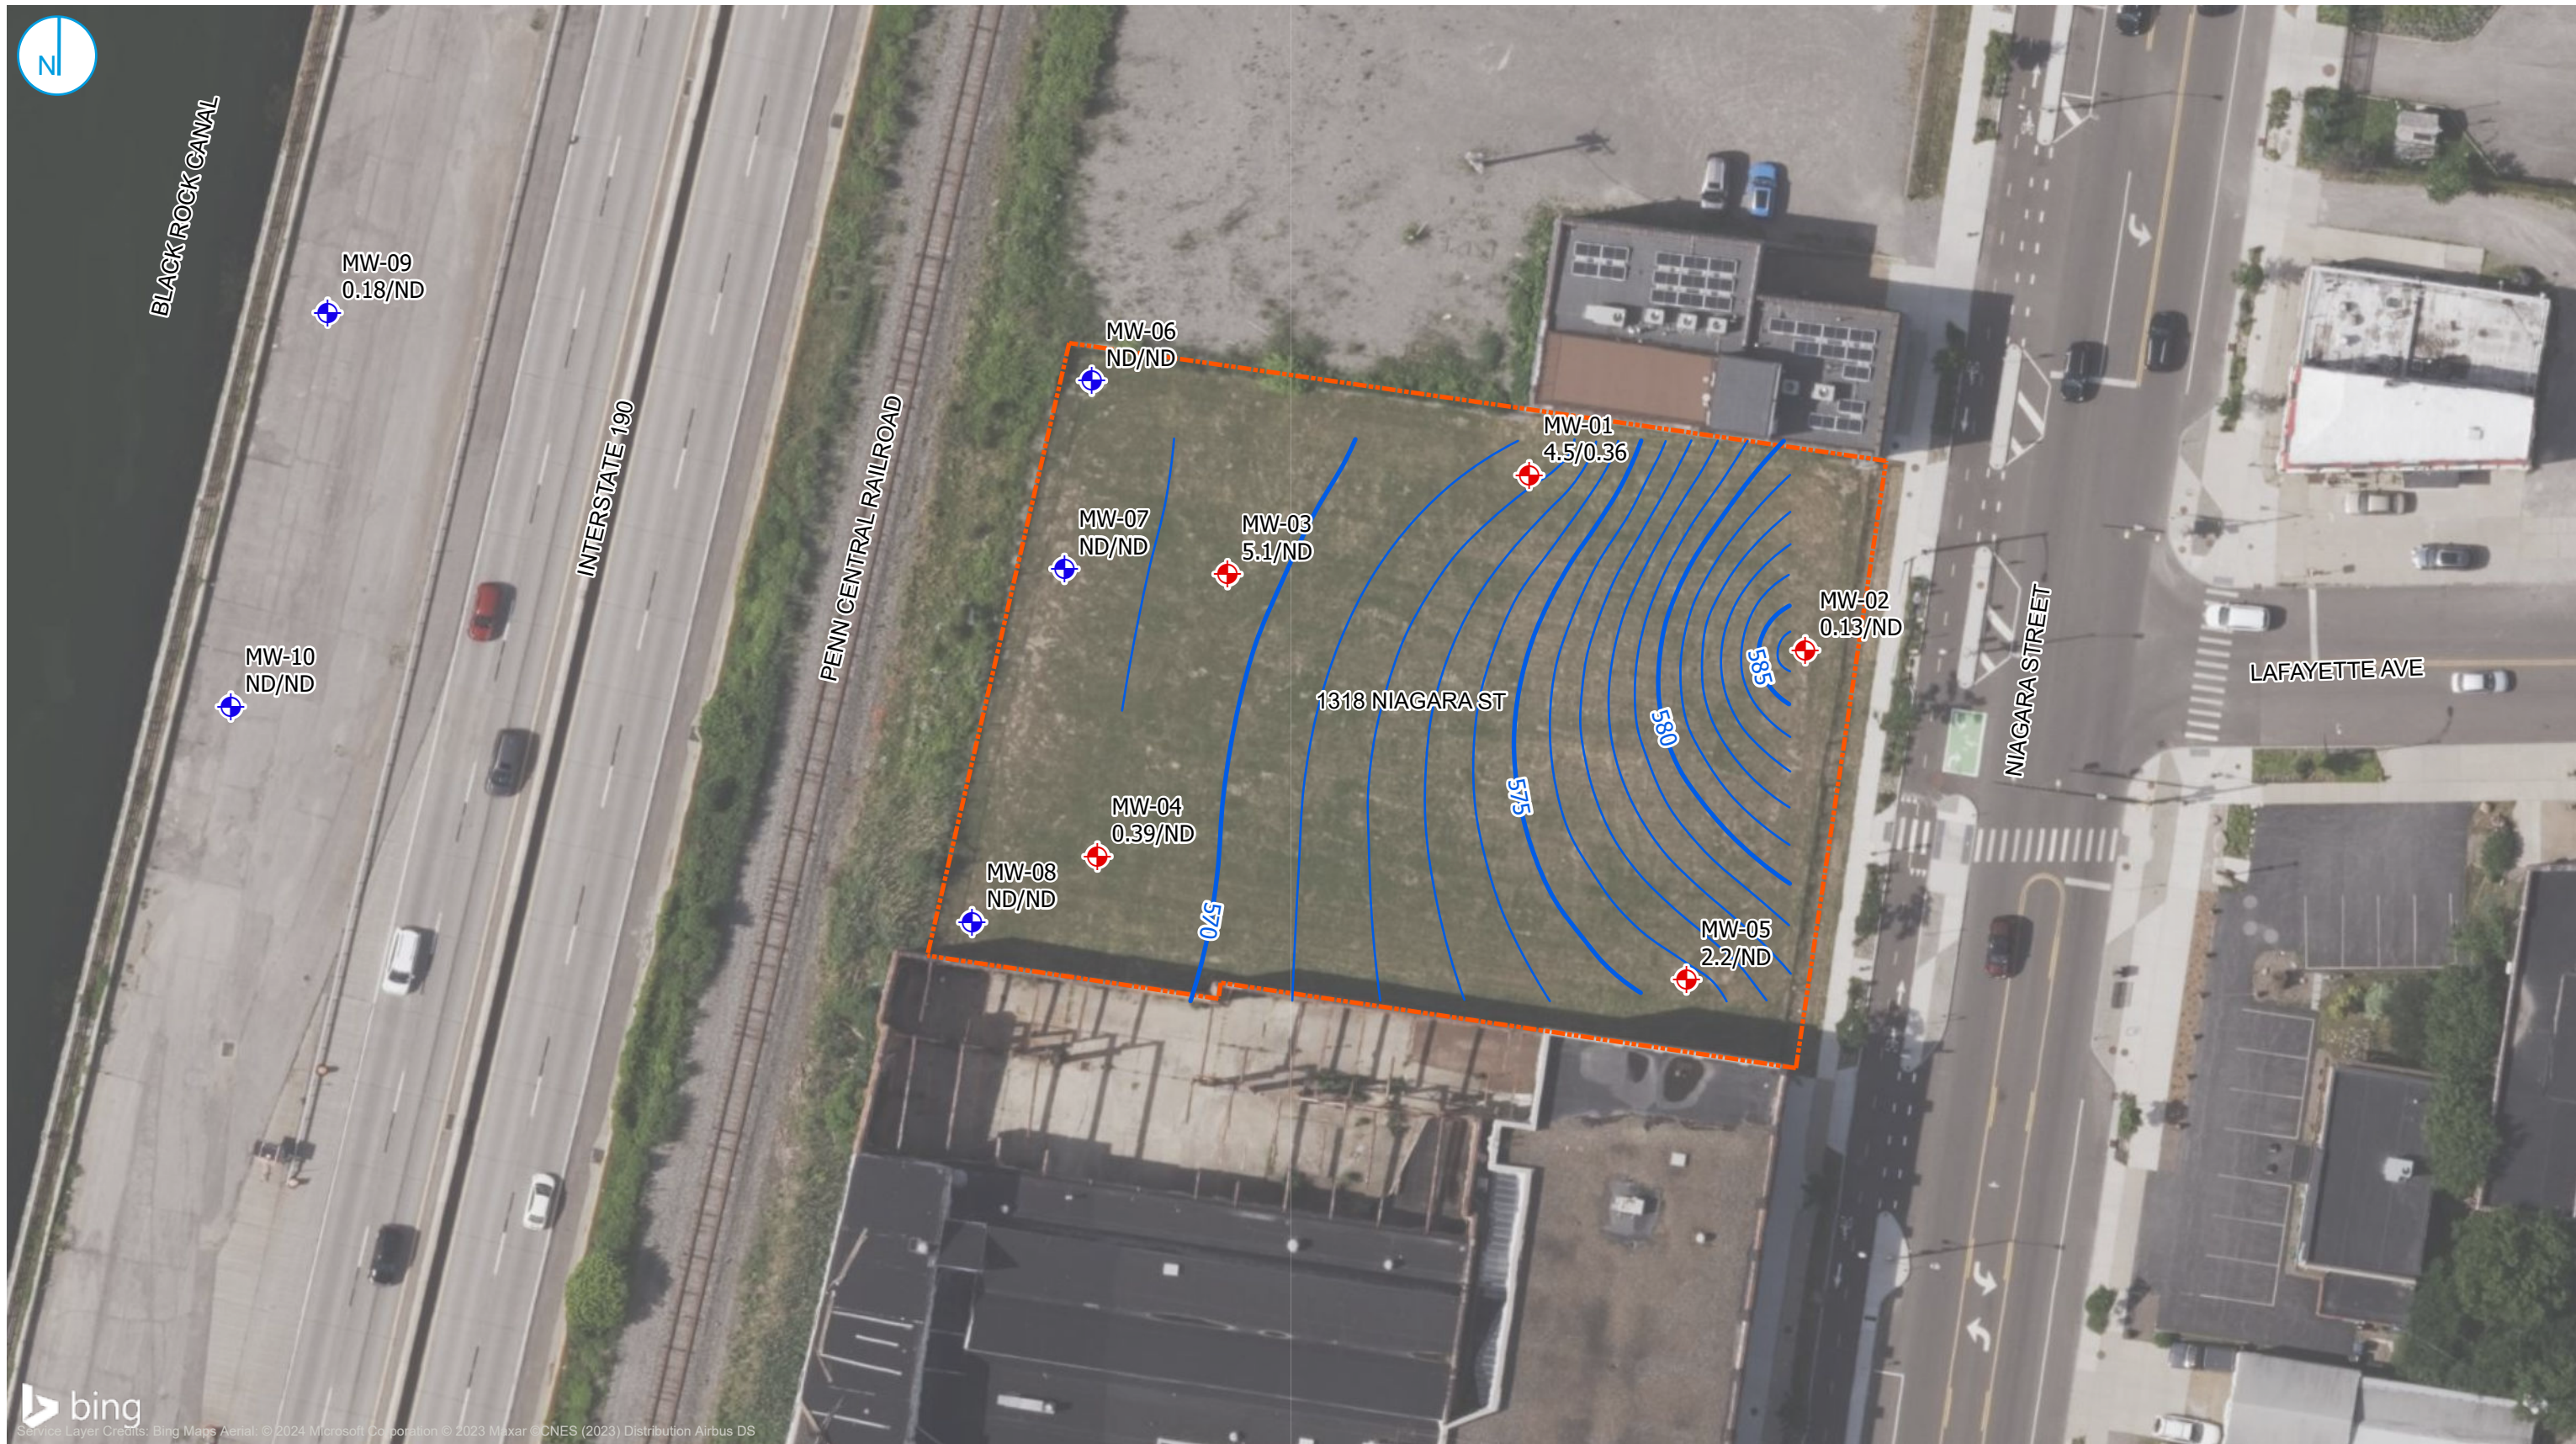
FIGURE 2

MW-XX
UNFILTERED/FILTERED RESULTS IN PPB
TOTAL PCBs IN PPB BASED ON NOVEMBER/DECEMBER 2023 EVENT

- WELL LOCATIONS ARE APPROXIMATE.
- CONTOUR INTERVAL IS 1 FOOT.
- ALL PCBs HAD DETECTIONS OF AROCLOR 1260. MW-10 HAD A SECOND SAMPLE WITH DETECTIONS OF BOTH 1260 AND 1254.

GROUNDWATER CONTOURS AND QUALITY

Groundwater - Groundwater contamination exceeding groundwater standards was noted in monitoring wells MW-03, MW-04, and MW-05 and consisted of several VOCs and associated degradation products (e.g., trichloroethylene at 350 ppb). PCB impacts to groundwater were found in wells MW-01, MW-02, MW-03, MW-04, and MW-05 with total PCBs of 4.5 ug/l, 0.13 ug/l, 5.1 ug/l, 0.39 ug/l, and 2.2 ug/l respectively in unfiltered samples. Only MW-01 had PCB detections after filtering. The sample retrieved from this location returned a PCB detection of 0.36 ug/l, exceeding the aquifer water quality standard guidance values (AWQSGVs) standard of 0.09 ug/l. Past results of MW-03 found high levels of PCBs in the groundwater. Subsequent investigations found a DNAPL layer in this area. Three (3) more wells were installed down gradient on the western fence line in 2022 to monitor migration of contaminants. The DNAPL layer has not been observed in MW-07, immediately down gradient of MW-03.

Two additional wells were installed in 2022 (MW-09 and MW-10) adjacent to the Black Rock Canal to monitor for migration farther off site. Testing of these wells found no detects in MW-10 and minor detections, 0.18 ug/l in MW-09. Similar results were not noted in the borings completed on the downgradient side of the site suggesting that the identified impacts observed in the offsite wells did not migrate from the Site and are unrelated to 1318 Niagara St. and this ESD.
