VOLUNTARY CLEANUP PROGRAM FINAL REPORT

SITE NO. V-00150-7

VOLUNTARY CLEANUP AGREEMENT NO. A7-0466-0702

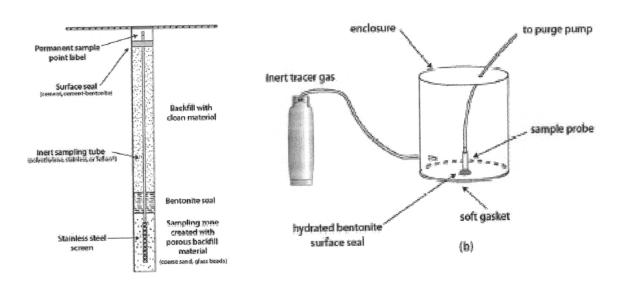
Two soil vapor sampling points were installed on March 7, 2006 in the Dunn Tire building to depths of 14 to 16 inches below the concrete slab. The construction of the soil vapor sampling points consisted of the installation of GeoProbe[™] sampling points in accordance with DOH guidance. Two sub-slab sampling points were installed in the Dunn Tire facility at depths between 14 and 16 inches below the concrete slab. The construction included a stainless steel well point, glass beads and a bentonite seal. These points are inside the building and finished with flush mount steel protective casing with screw covers. A round of sub-slab soil vapor and indoor air quality monitoring was conducted from March 18 to 19, 2006. Two indoor air samples were collected from inside the Dunn Tire facility and one outdoor air sample. was collected.

Each of the sub-slab sampling points was purged for 30 seconds with a peristaltic sampling pump to remove "stagnant" air from the sampling location. This pump was set at a flow rate of approximately 1 liter per minute, purging an estimated 0.5 liters from each sampling point. Each sampling location was checked for gross short-circuiting by injecting 1 liter of helium gas into a 4-liter stainless enclosure obtained from the laboratory. A Restec Catalogue No. 22451 helium leak detector was utilized to check for leaks in accordance with the procedures outlined in the Draft DOH Soil Vapor Guidance Policy mentioned above. No soil vapor sampling location exceeded 10% helium during the field testing, indicating the construction of the soil vapor sampling points was

adequately limiting short-circuiting to the atmosphere. A schematic of the soil vapor sampling point construction and the field-constructed leak test appear below:

A leak test was performed by inverting a stainless steel dome over the vapor point and sealing its perimeter with modeling clay. The soil vapor point was then purged of stagnant gases using a peristaltic pump for 30 seconds. The dome is fitted with two connector valves: one is used to release helium under the dome and the second is connected to a helium analyzer outside the dome and inside the dome to the tubing for the soil gas vapor point. A pressurized one-liter summa canister of helium gas is used to release helium under the dome while simultaneously the helium detector is collecting and analyzing gas pulled from the vapor point for helium. A successful leak test results in

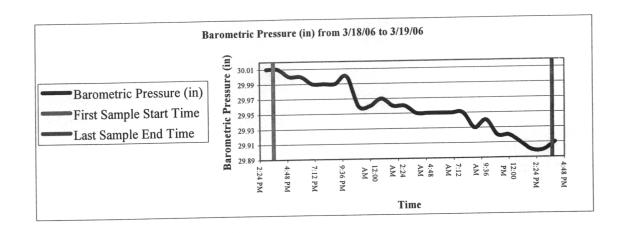
Barometric pressure for the sampling period was tracked and appears on the chart below. Collection of the first sample began at 3:35 p.m. on March 18, 2006 and collection of the last sample ceased at approximately 3:55 p.m. on March 19, 2006. As can be seen on the chart, the majority of this sampling interval coincides with a period of falling barometric pressure.

As previously stated, this sampling period was selected to optimize the soil vapor sampling, as the soil vapor mobility would be toward the atmosphere. and there is less likelihood of short-circuiting directly to atmosphere during sample collection.
