ADVANCED SITE RESTORATION

Re: Nassau Metals, OU-2
Voluntary Cleanup Program Site No. V00159
Corrective Actions Work Plan
ASR Project #A22-115

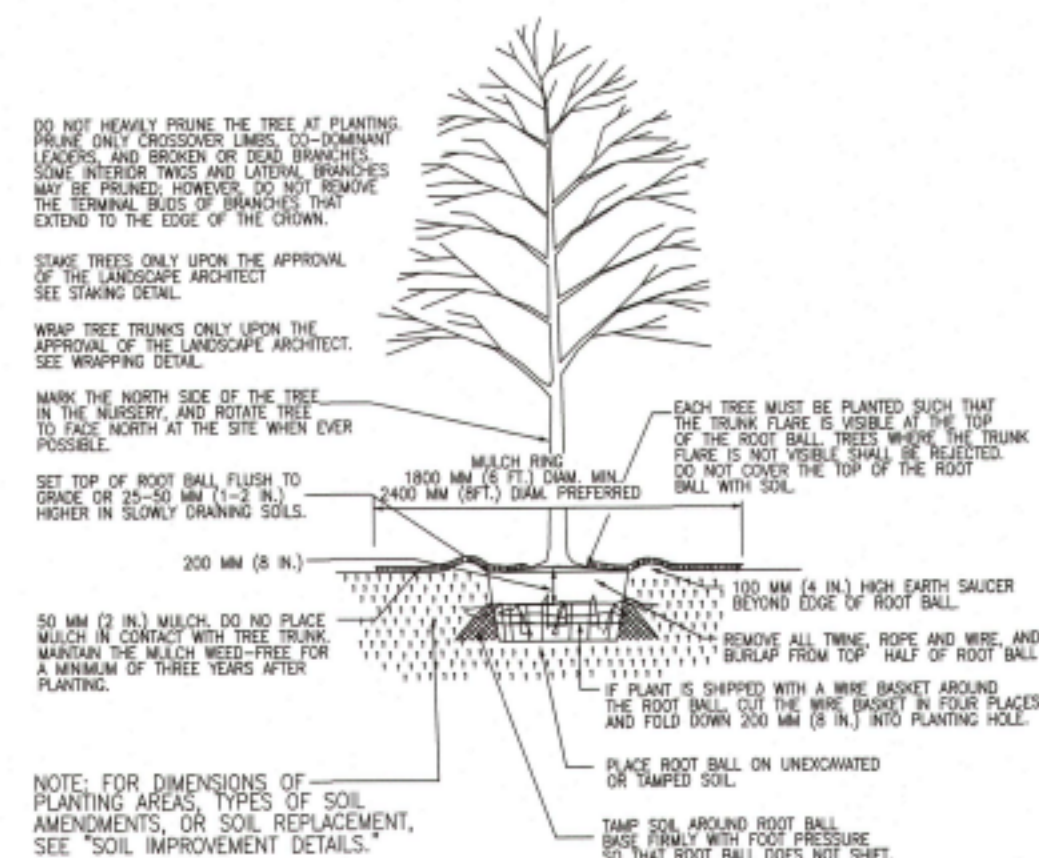
3 TREE PLANTING DETAIL - B&B TREES IN ALL SOIL TYPES
C-107/CPQ-09 NOTE: THE PLANTING SPACE IS LARGER THAN 2400 MM (8 FT.) CPE-09 SQUARE, OPEN TO THE SKY, AND NOT COVERED BY ANY PAVING OR GRATING.

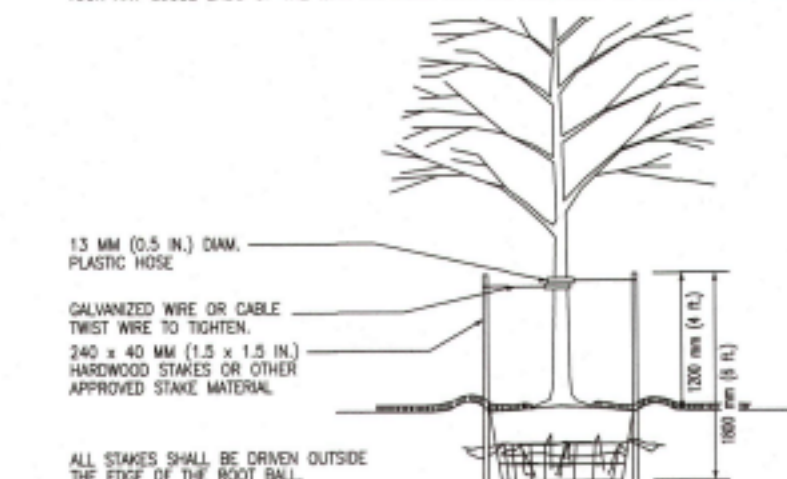
ASSURE THAT THE BEARING SURFACE OF THE PROTECTIVE COVERING OF THE WIRE OR CABLE AGAINST THE TREE TRUNK IS A MINIMUM OF 12 MM (0.5 IN.).

REMOVE ALL STAKING AS SOON AS THE TREE HAS GROWN SUFFICIENT ROOTS TO OVERCOME THE PROBLEM THAT REQUIRED THE TREE TO BE STAKED. STAKES SHALL BE REMOVED NO LATER THE END OF THE FIRST GROWING SEASON AFTER PLANTING.

4 TREE STAKING DETAIL - TREES 75MM (3 IN.) CALIPER OR LESS
C-107/CPQ-09

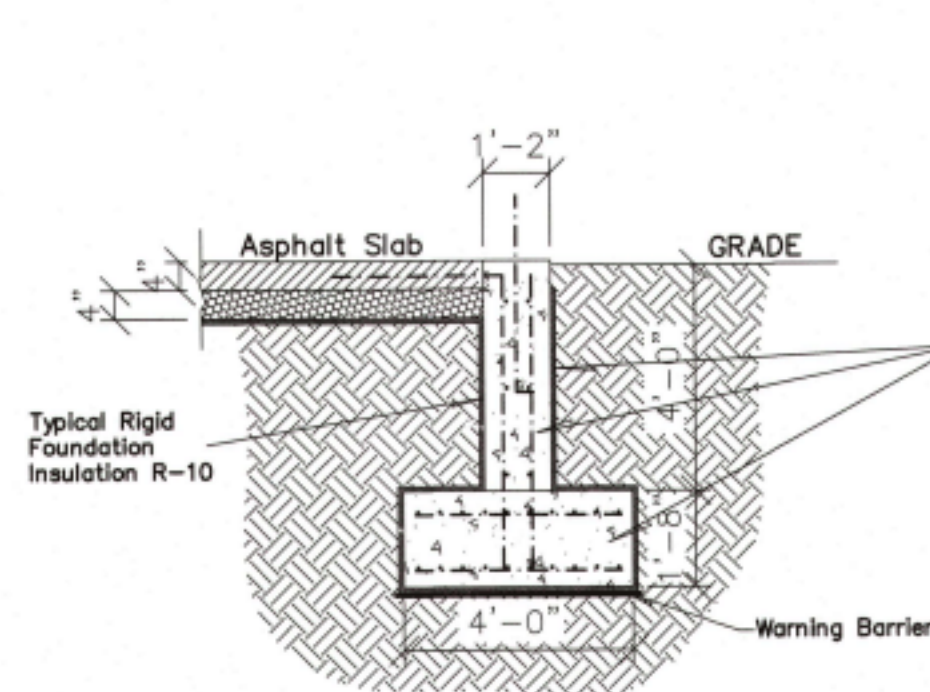
6 Typical Foundation Detail @ 168 Page Ave
C-107/CPQ-09 3/8" = 1'-0"

3500 psi Concrete 1'-2" Thick Foundation Wall and 4' x 1'-8" High Footings. at Footings provide at Bottom 7 Rows #7 Bars Min 4" cover at Top 7 Rows #5 Bars Min 4" cover, Run #5 Bars Vertically 24" every 48" O.C. to tie into Foundation Wall. Foundation Wall provide Two Rows #5 Bars Vertically every 24" O.C., Provide Three Rows Horizontal #5 Bars every 18" O.C.. Typical Top of Footing Set 4' Below Grade. Provide Foundation Insulating Encapsulating Membrane, Warning Barrier and Trenching Methods as per DEC VCP V-00159-2 Regulations, see DOB Note # 6/C-101.

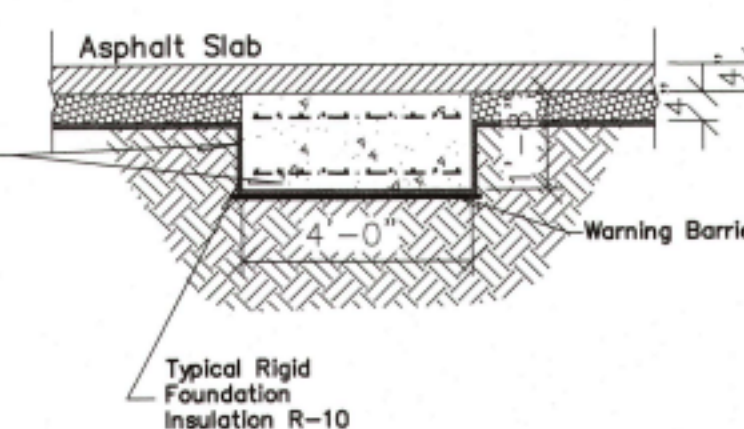
7 Typical Foundation Haunch Detail @ 168 Page Ave
C-107/CPQ-09 3/8" = 1'-0"

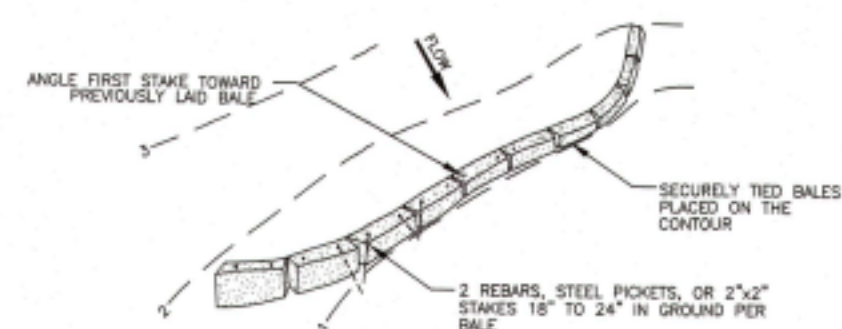
2 HAY BALE SEDIMENT BARRIER PLACEMENT
AND ANCHORING DETAIL
SCALE: NOT TO SCALE

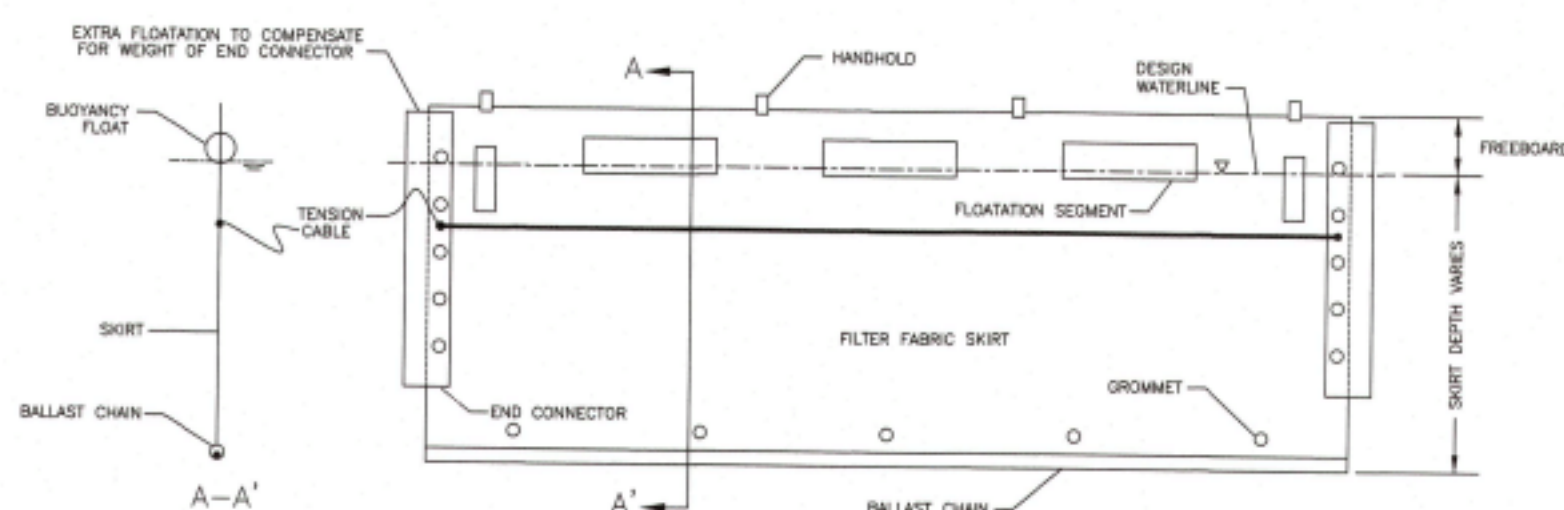
3 TYPICAL SILT CURTAIN DETAIL
SCALE: NOT TO SCALE

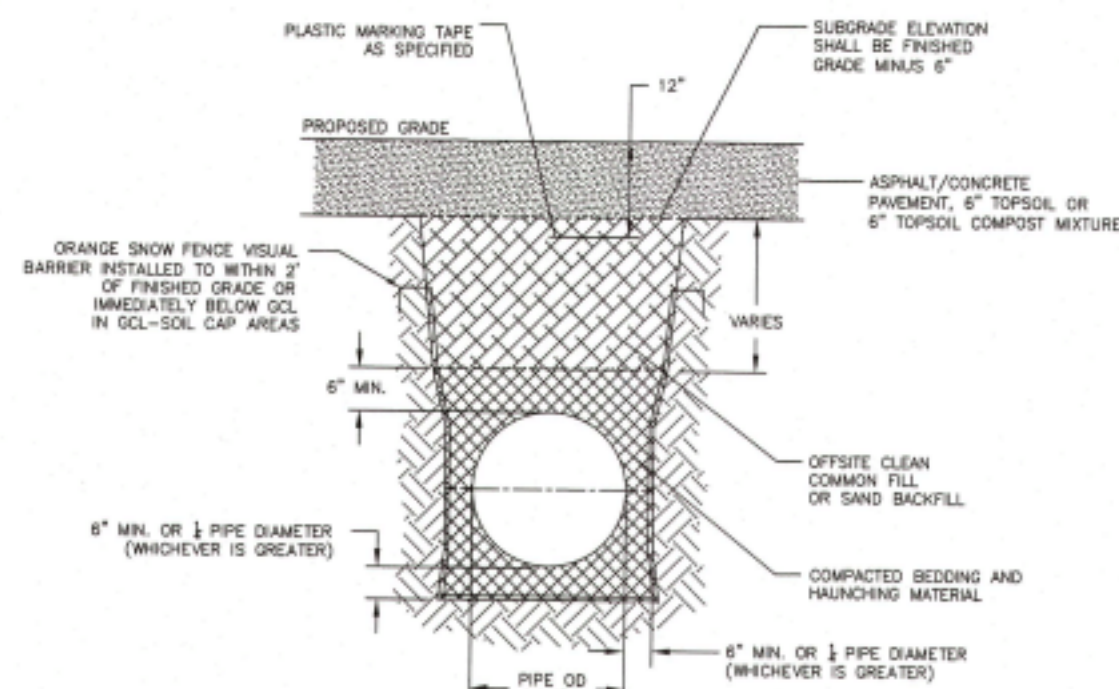
7 PROPOSED SEWER PIPE CROSS SECTION
SCALE: NOT TO SCALE

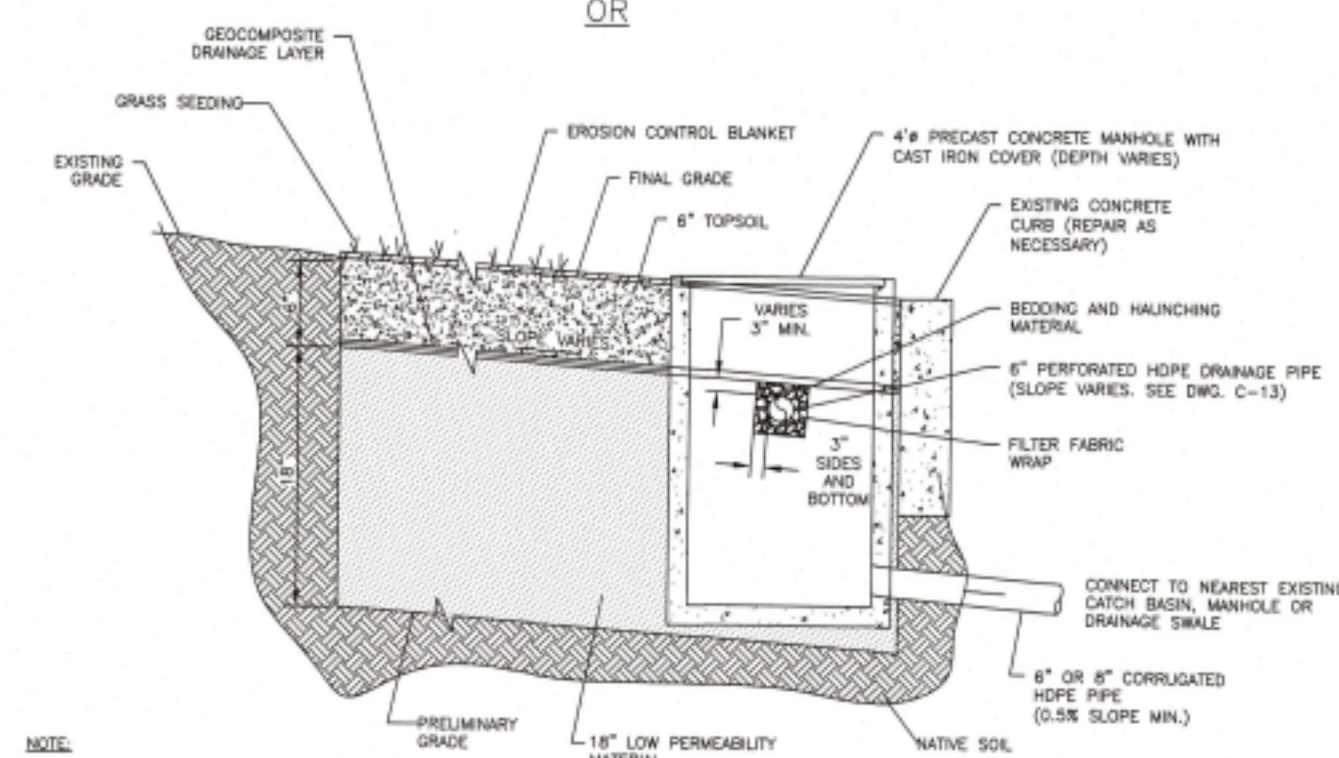
- NOTE:**
1. CONTRACTOR SHALL INSTALL PRECAST CONCRETE MANHOLES WHERE SHOWN ON DRAWING C-13.
 2. SEE DETAIL 2 ON DRAWING C-23 FOR A LONGITUDINAL DETAIL OF PERFORATED PIPING AND MANHOLE.
 3. FILTER FABRIC WRAP SHALL BE 10oz NON WOVEN FILTER FABRIC.
 4. 6-INCH PERFORATED DRAINAGE PIPING SHALL BE ADVANCED DRAINAGE SYSTEMS (ADS) CORRUGATED PERFORATED HOPE PIPE OR APPROVED EQUAL.

8 LOW PERMEABILITY MATERIAL CAP DETAILS
SCALE: NOT TO SCALE

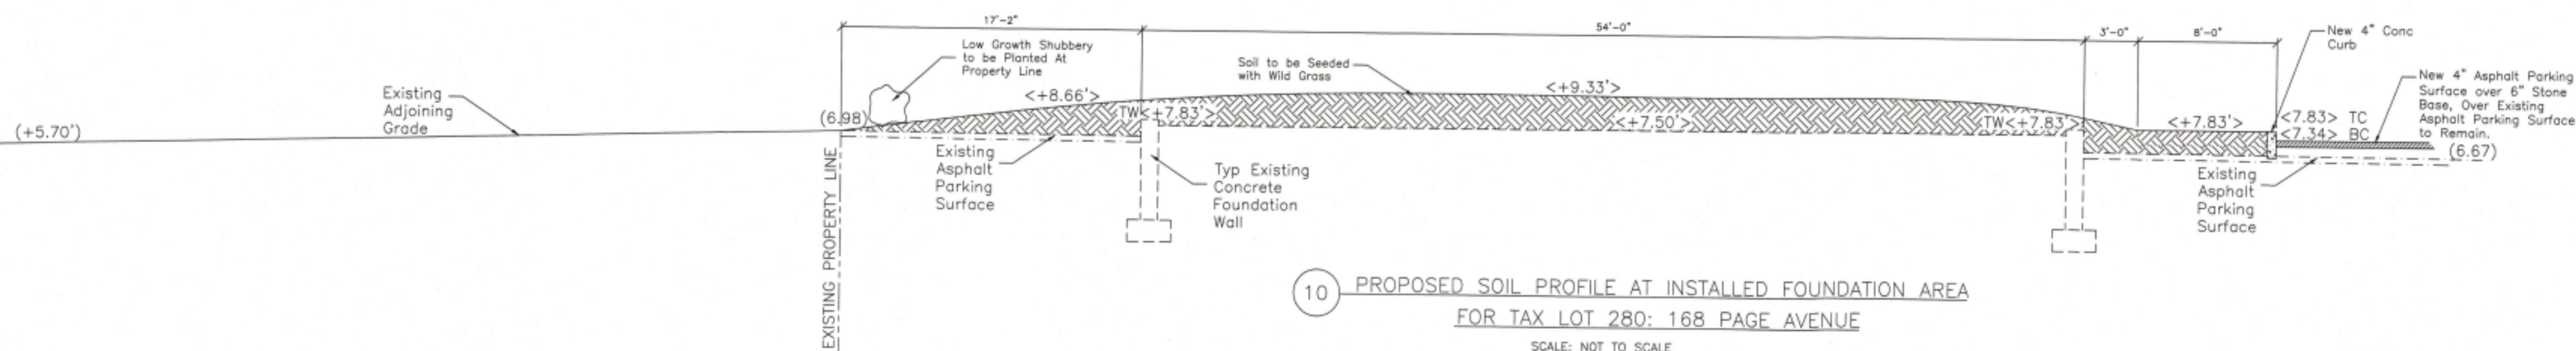
10 PROPOSED SOIL PROFILE AT INSTALLED FOUNDATION AREA
FOR TAX LOT 280: 168 PAGE AVENUE
SCALE: NOT TO SCALE
