# Remedial Action Selection Report

## Site No. V00178-8

Stuart Park Complex – Ultralife Battery  
2000 Technology Parkway  
Newark, New York

LaBella Project No. 209025

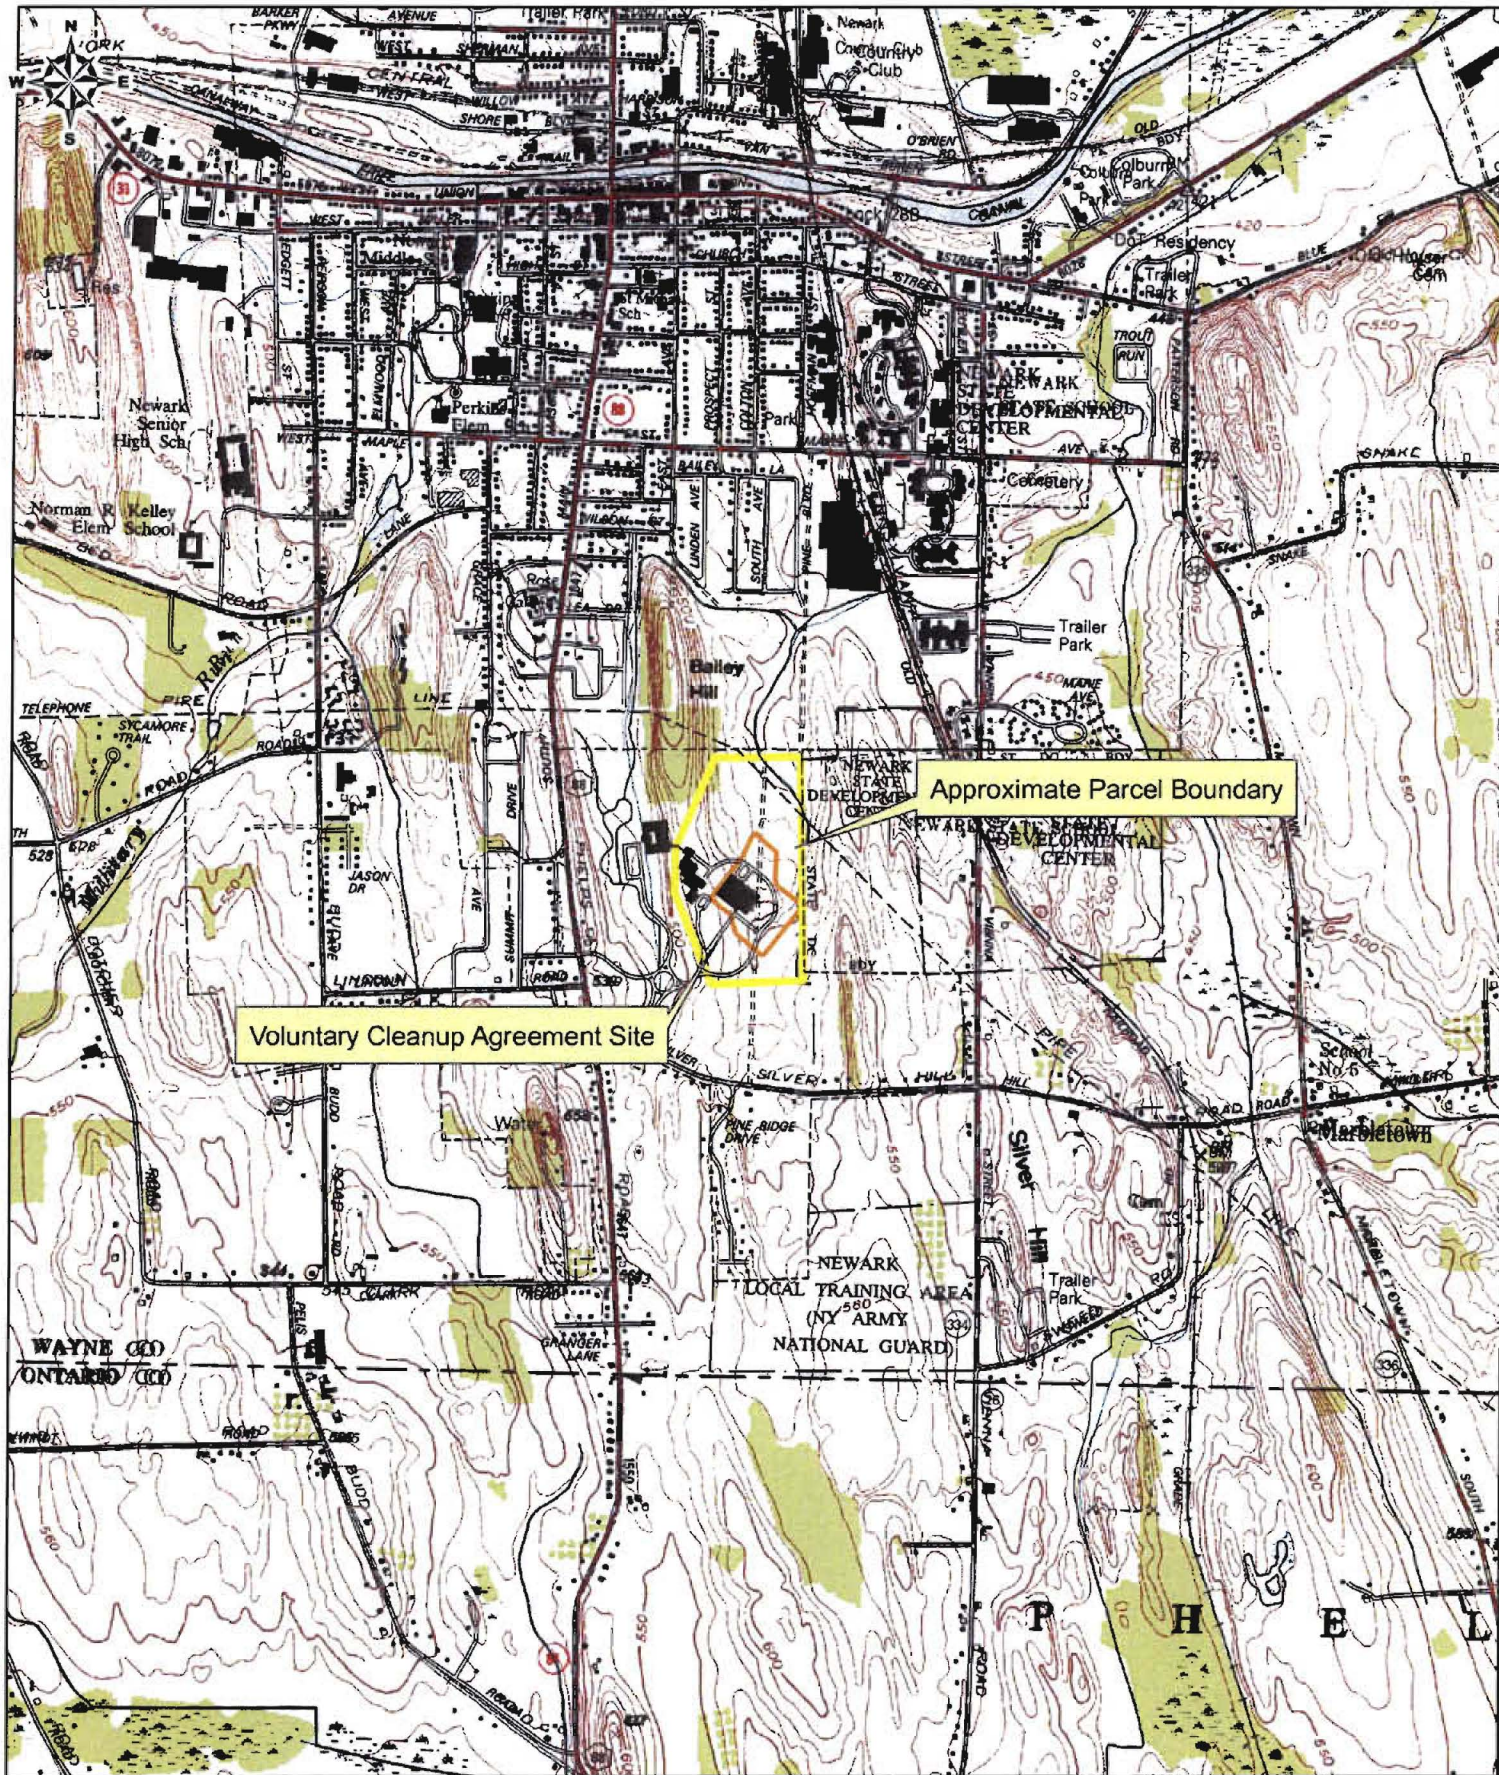
PROJECT DRAWING NUMBER  
**[ 209025 ]**  
**[ FIGURE 1 ]**

Figure 1 – Site Location

This Remedial Action Selection (RAS) Report provides an evaluation of several potential remedies and selects a remedy for New York State Department of Environmental Conservation (NYSDEC) Voluntary Cleanup Program (VCP) Site #V00178-8, which is located within 2000 Technology Parkway, located in the Village of Newark, Wayne County, New York, hereinafter referred to as "the Site." This RAS/RAWP were prepared in accordance with NYSDEC DER-10 and Section 7.0 of the Voluntary Cleanup Program Guide. A Project Locus Map is included as Figure 1.

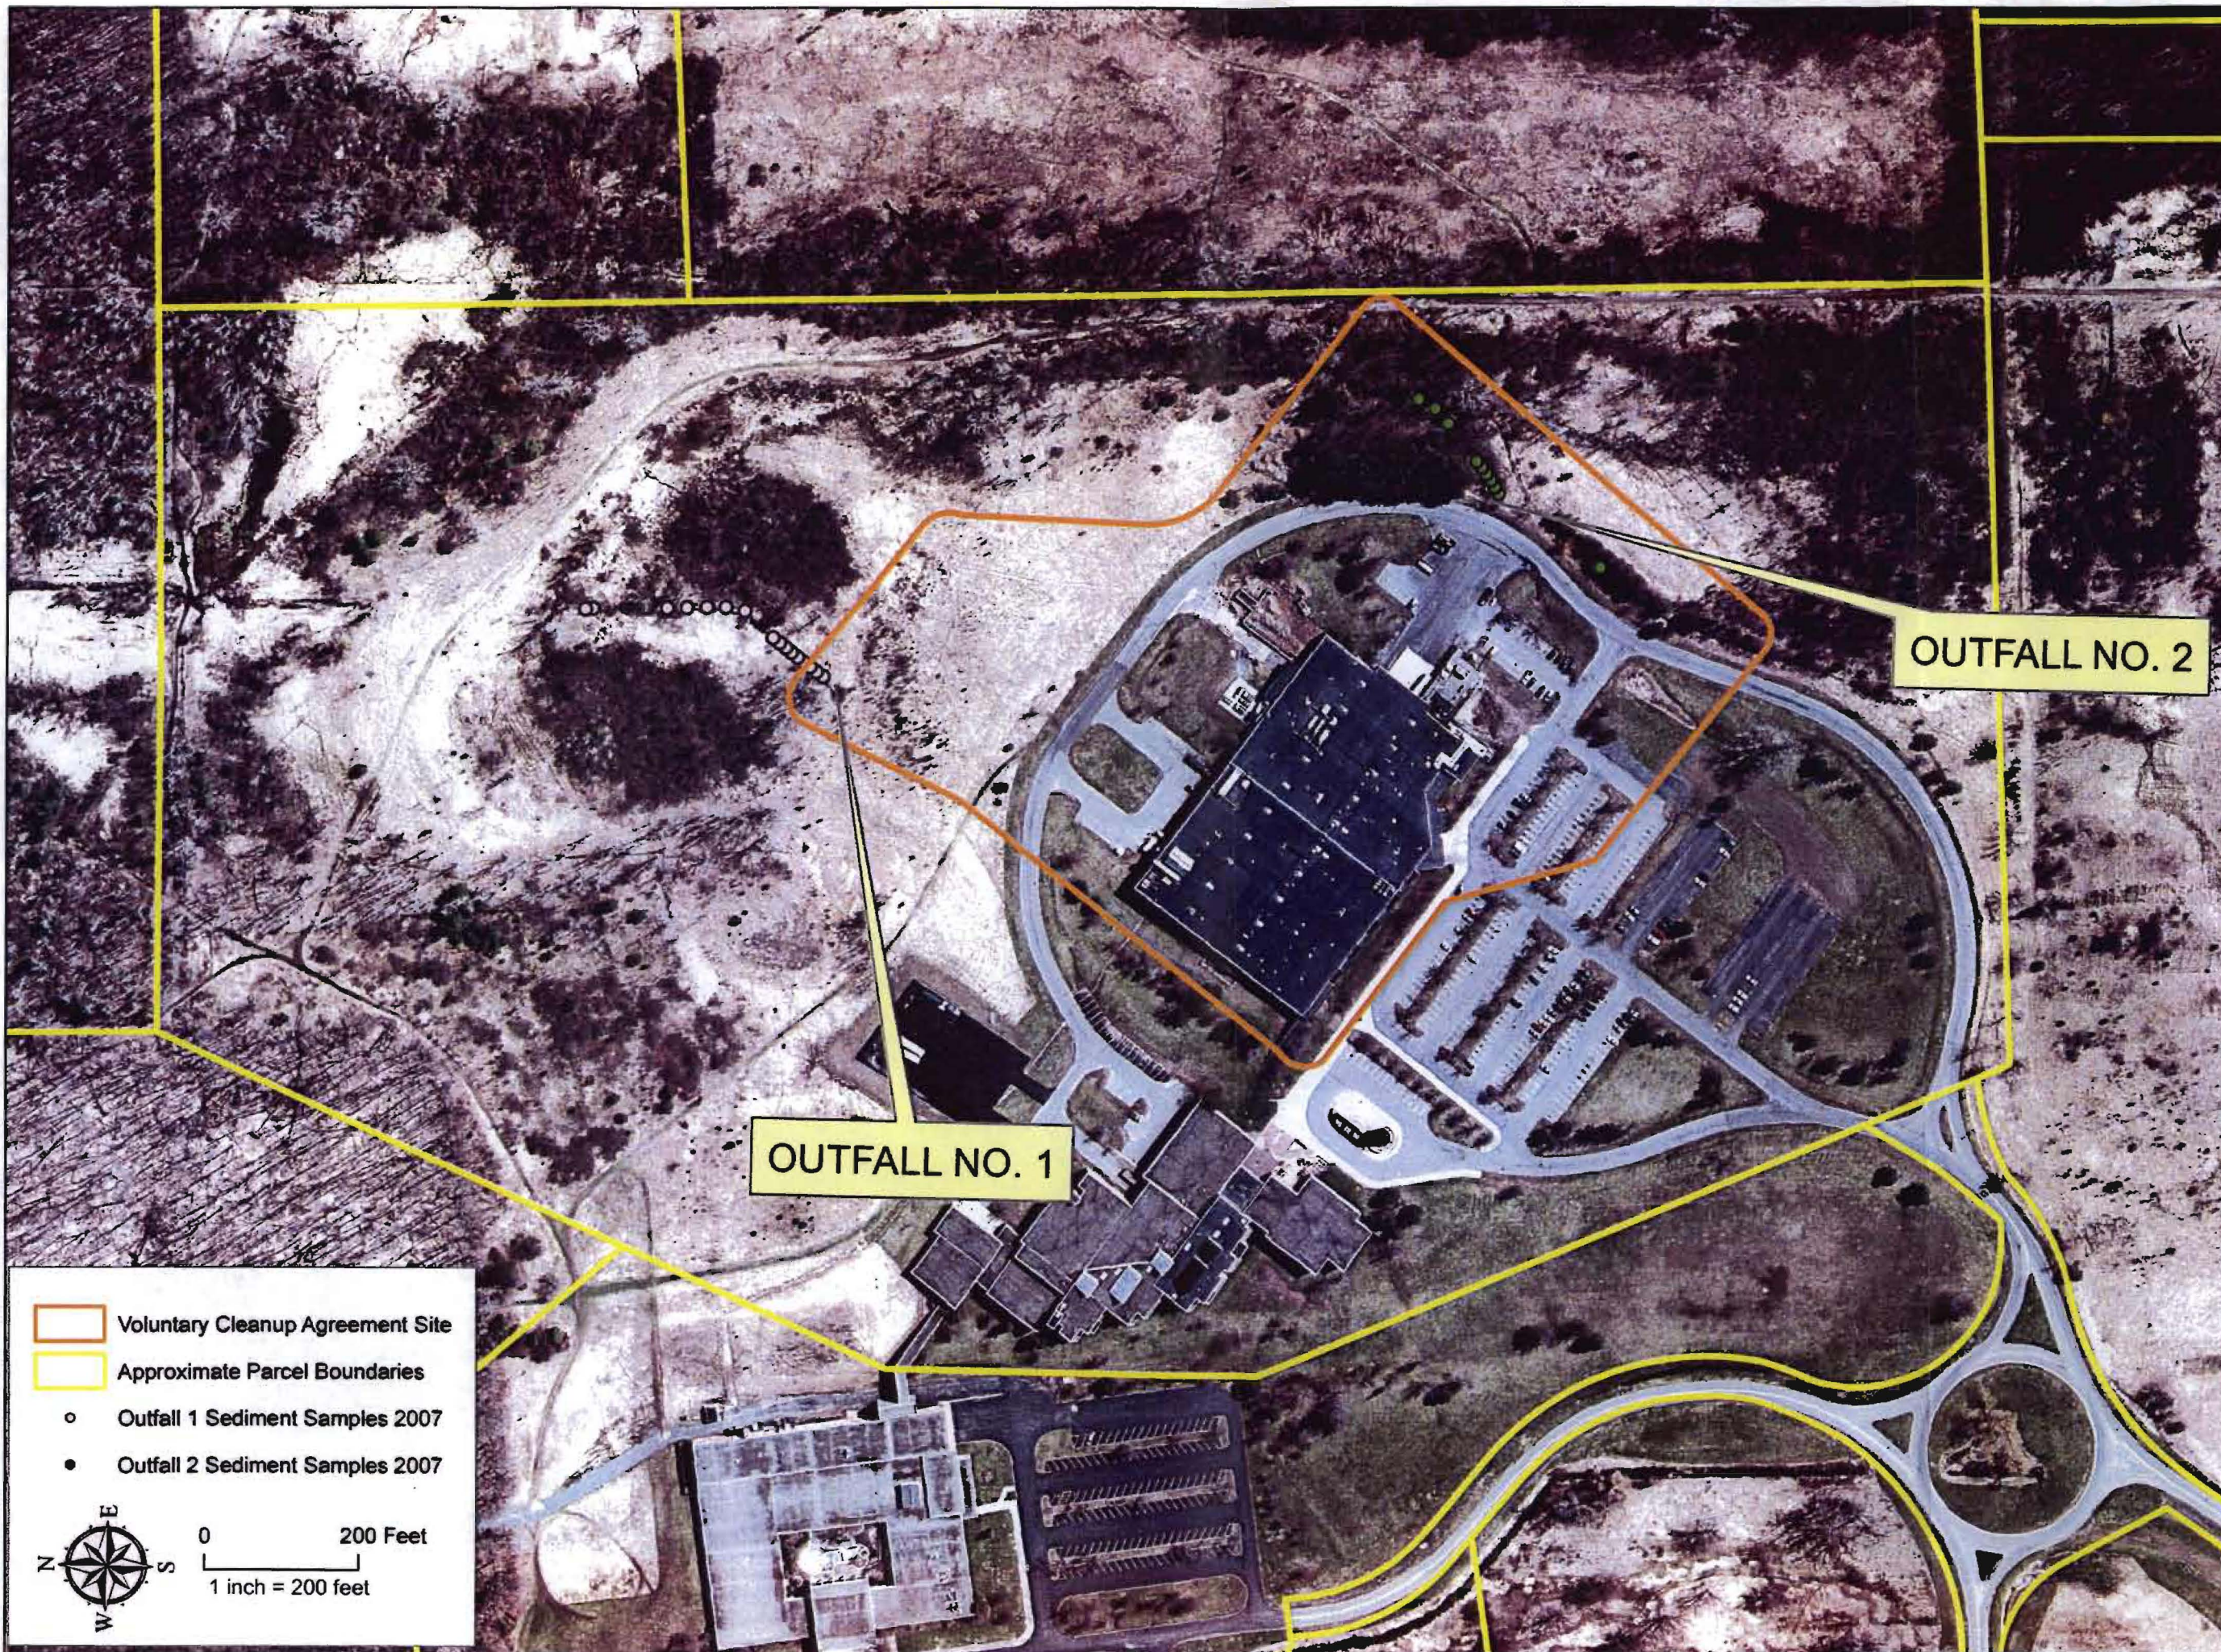
Figure 2 – Site Plan with Outfall Location

Storm water runoff from the property (including some roof drains) discharges to two (2) outfalls. Outfall #1 is located on the northern portion of the property and Outfall #2 is located on the eastern portion of the property as shown on Figure 2. Outfall #1 previously received non-contact cooling water; however, the non-contact cooling water consisted only of potable water and was redirected to the sanitary sewer in September 2008. Runoff is directed to the outfalls via a series of on-site catch basins with associated underground conduits, and/or surface channels. Flow from the two (2) outfalls is directed to a wetland area, which eventually joins Marbletown Creek.

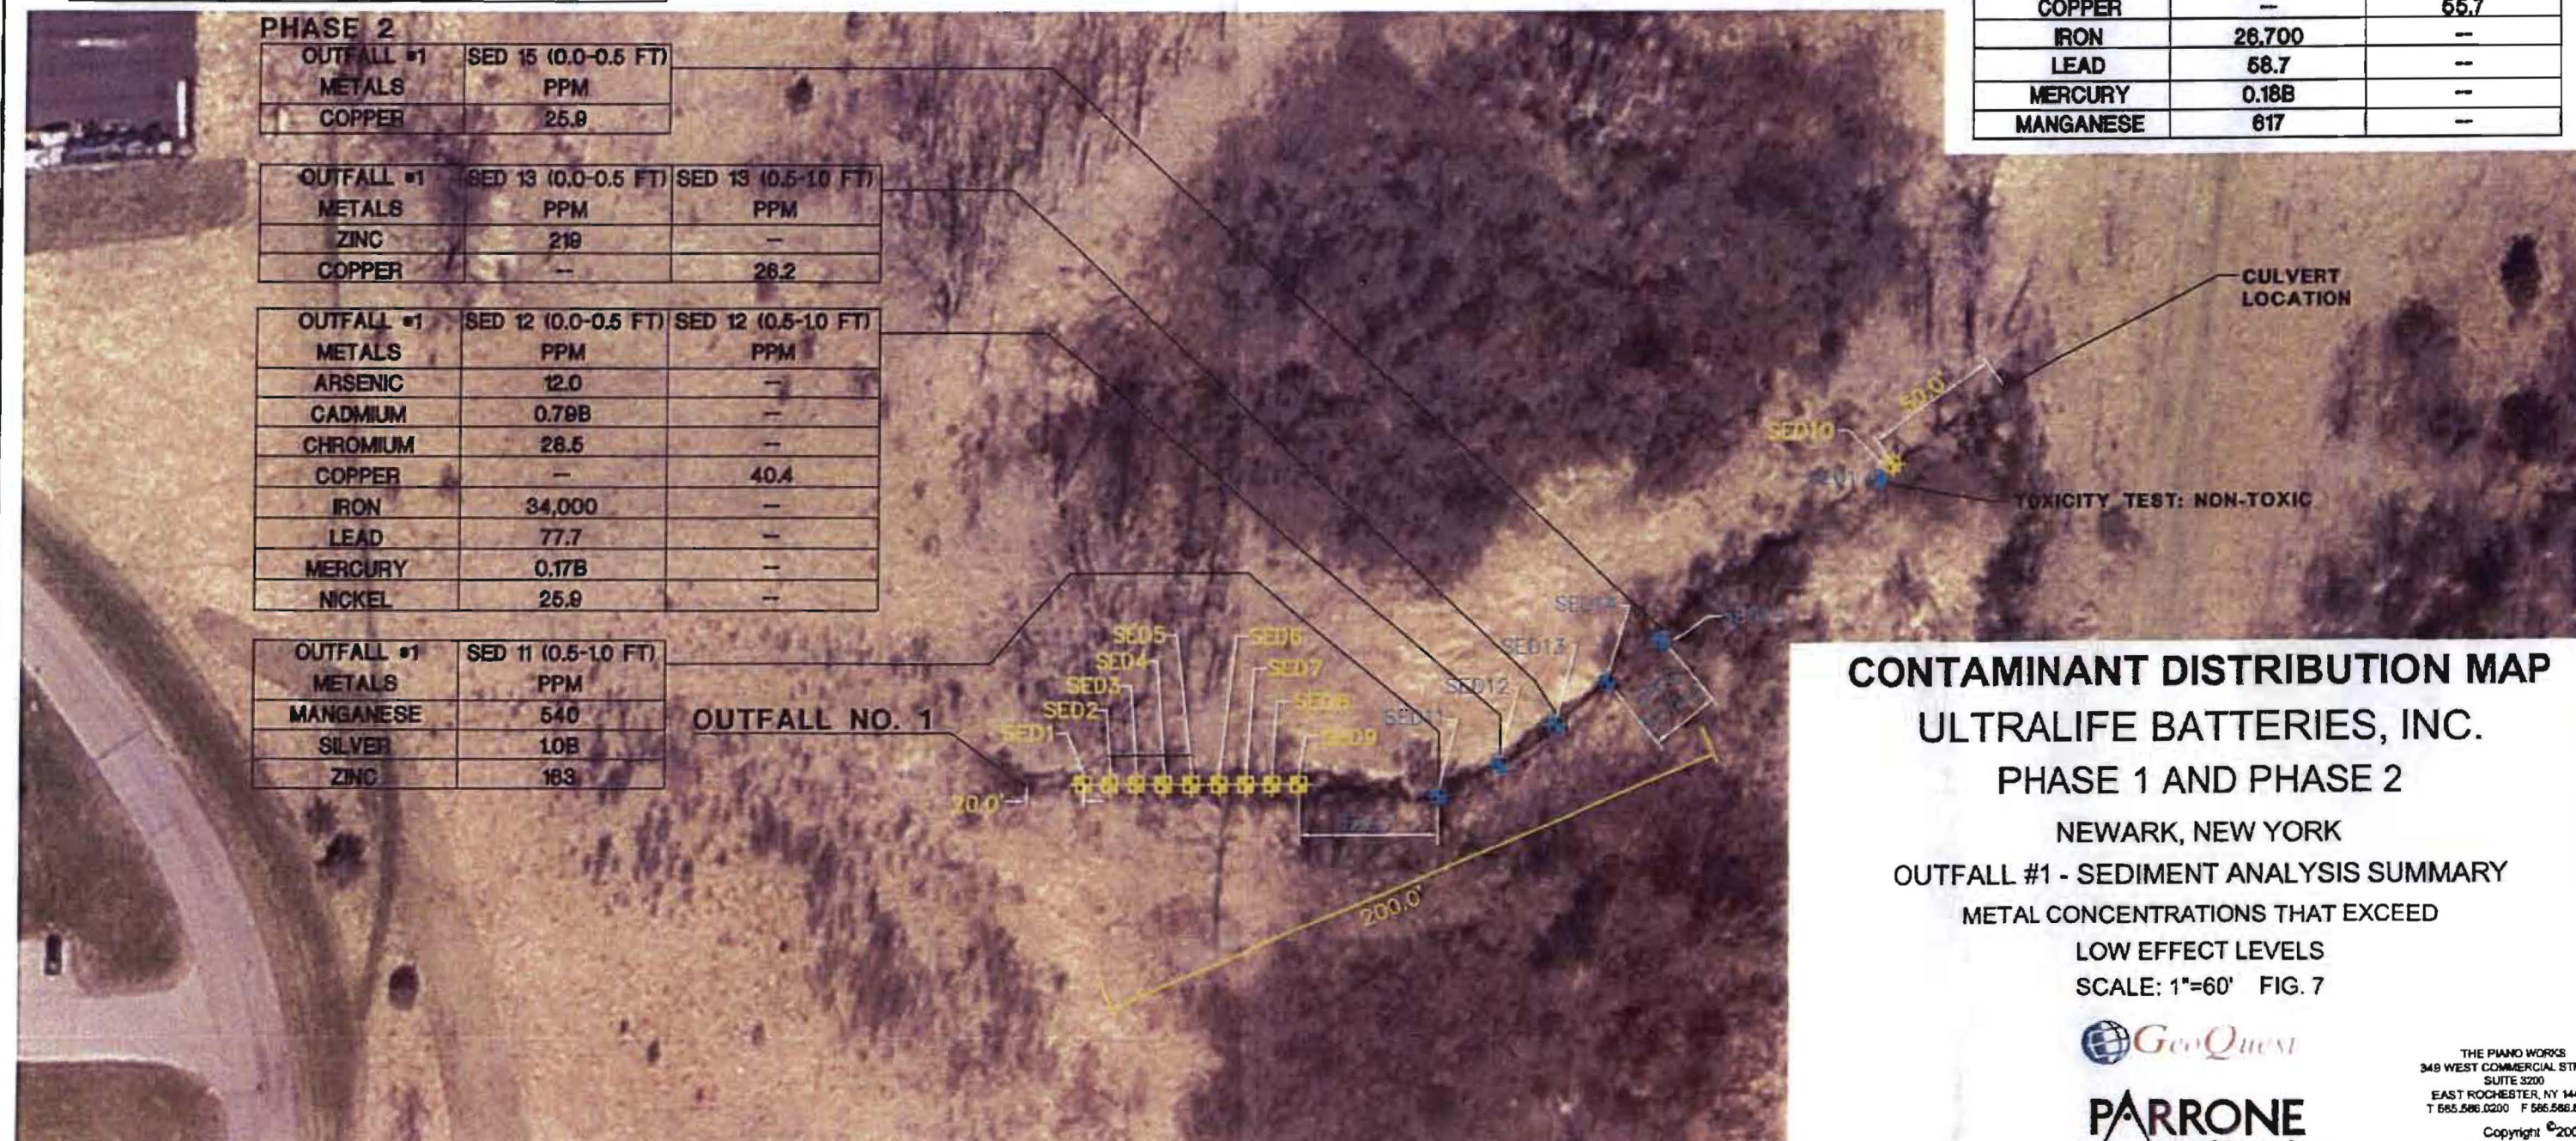
## CONTAMINANT DISTRIBUTION MAP ULTRALIFE BATTERIES, INC. PHASE 1 AND PHASE 2

NEWARK, NEW YORK  
OUTFALL #1 - SEDIMENT ANALYSIS SUMMARY  
METAL CONCENTRATIONS THAT EXCEED  
LOW EFFECT LEVELS  
SCALE: 1"=60' FIG. 7

For reference, figures 7 through 12 of the Final Investigation Report have been included in Appendix 1.

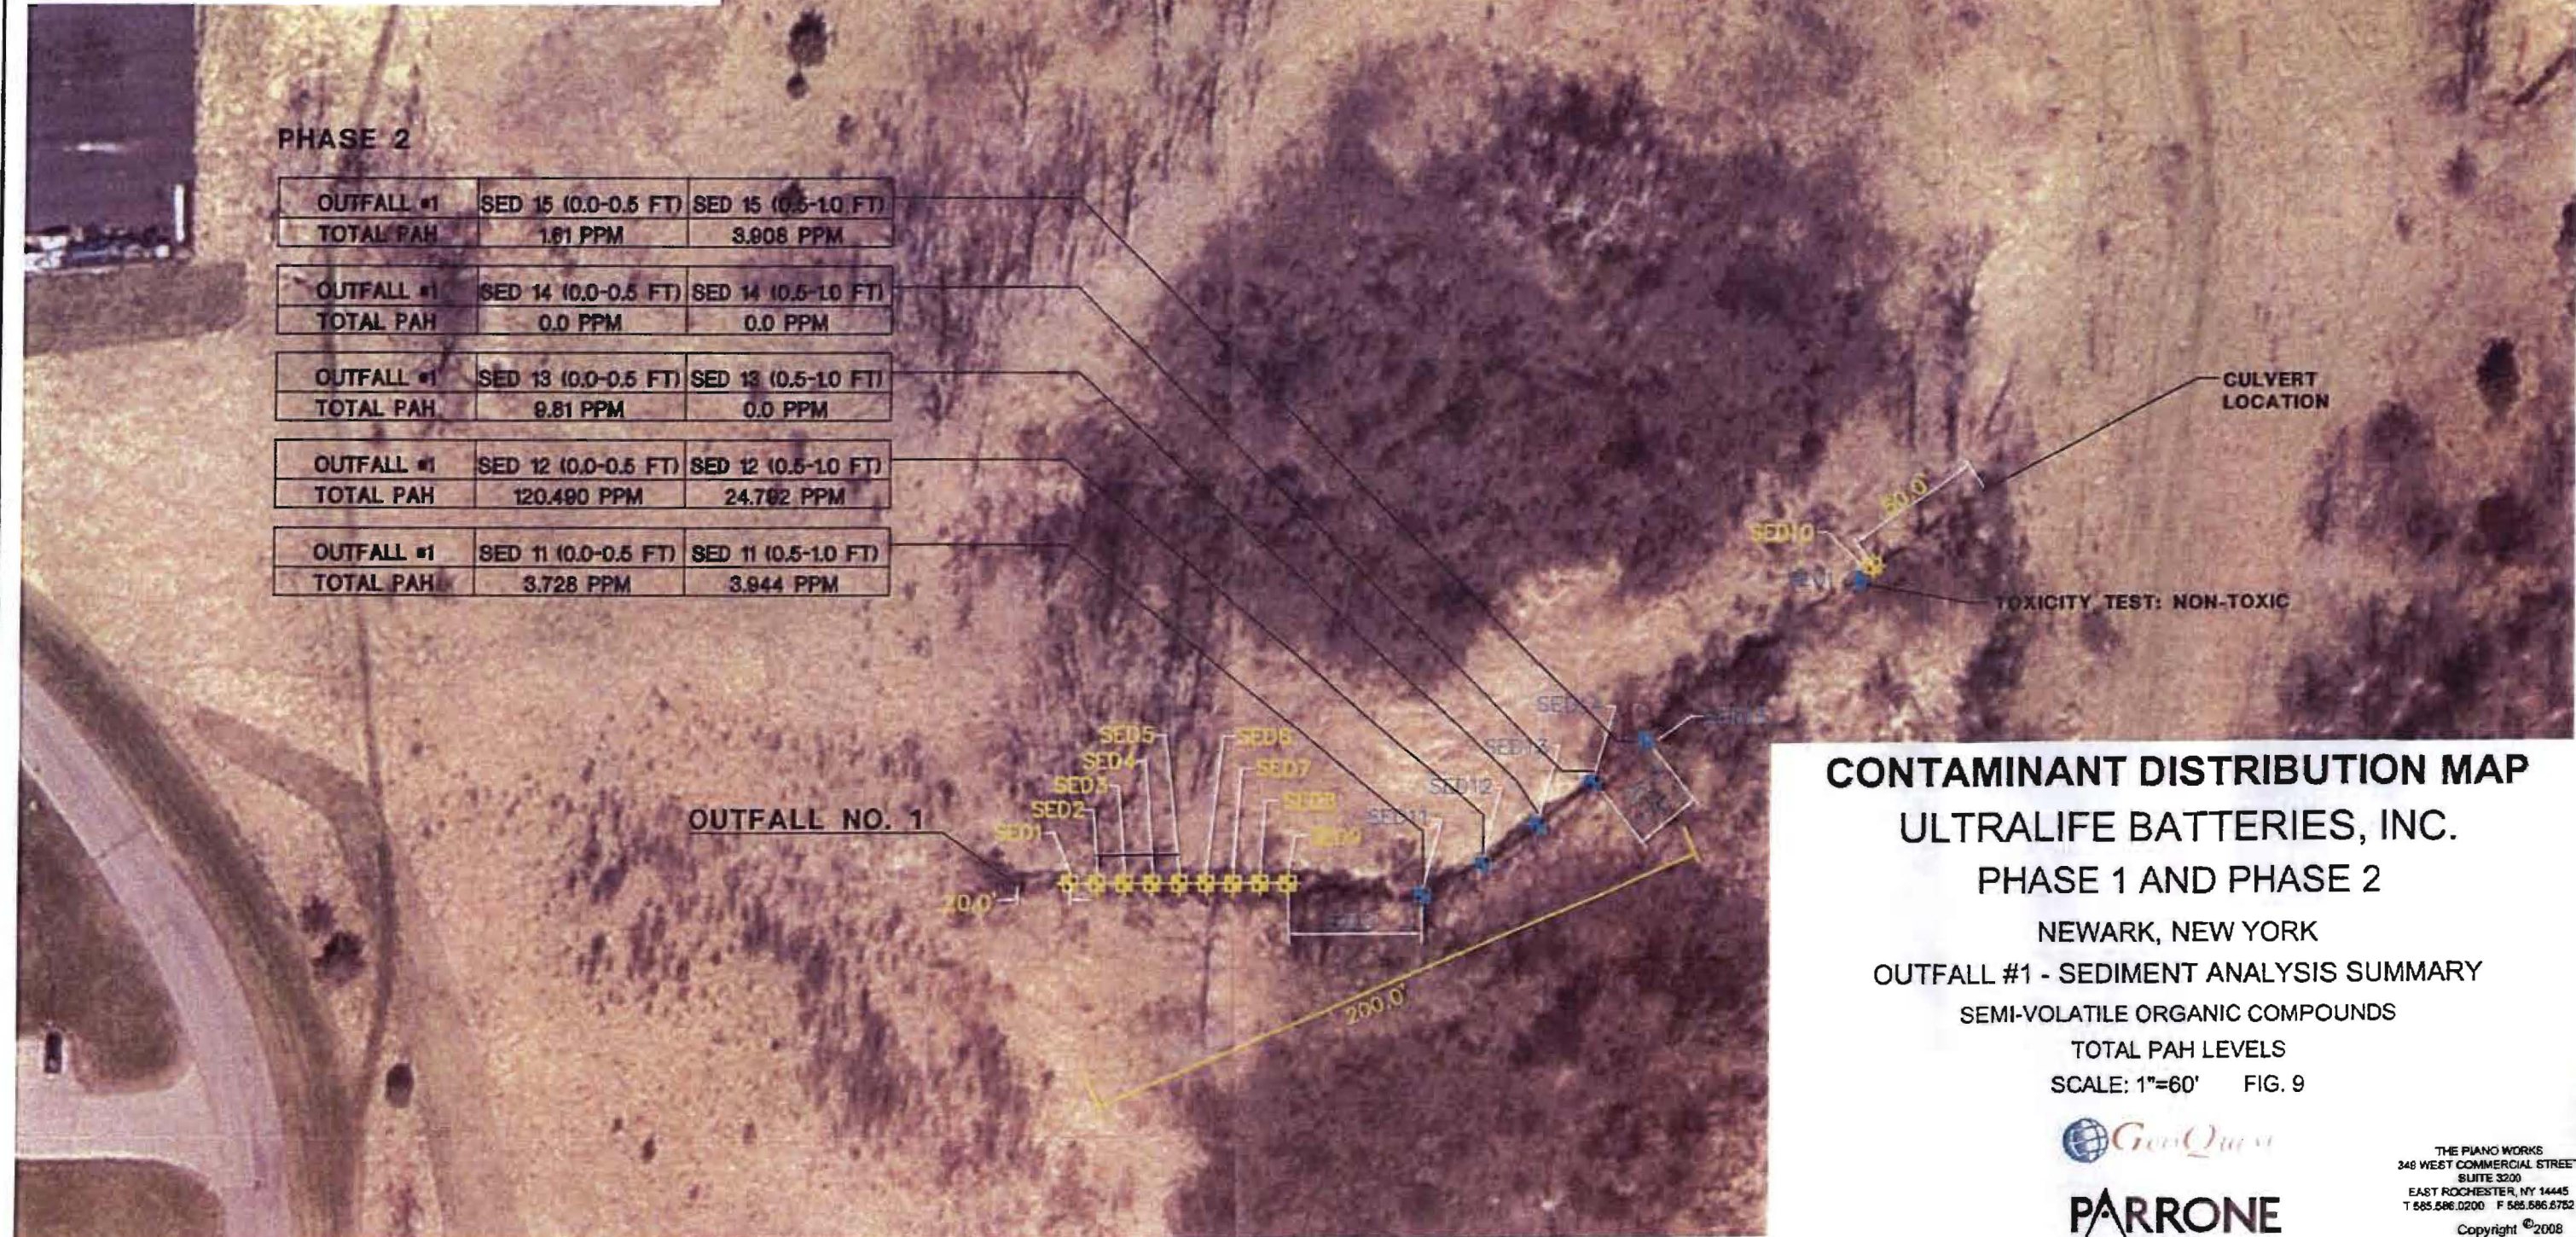
## CONTAMINANT DISTRIBUTION MAP ULTRALIFE BATTERIES, INC. PHASE 1 AND PHASE 2

NEWARK, NEW YORK  
OUTFALL #1 - SEDIMENT ANALYSIS SUMMARY  
SEMI-VOLATILE ORGANIC COMPOUNDS  
TOTAL PAH LEVELS  
SCALE: 1"=60' FIG. 9
