Re: Ekonol Polyester Resins Site #V00653-9
Sub-slab Depressurization System
Operations, Maintenance and Monitoring Plan

SUB-SLAB DEPRESSURIZATION SYSTEM OPERATION, MAINTENANCE, AND MANAGEMENT PLAN

**Ekonol Polyester Resins, NYSDEC # V00653-9
6600 Walmore Rd.
Town of Wheatfield, Niagara County, New York**

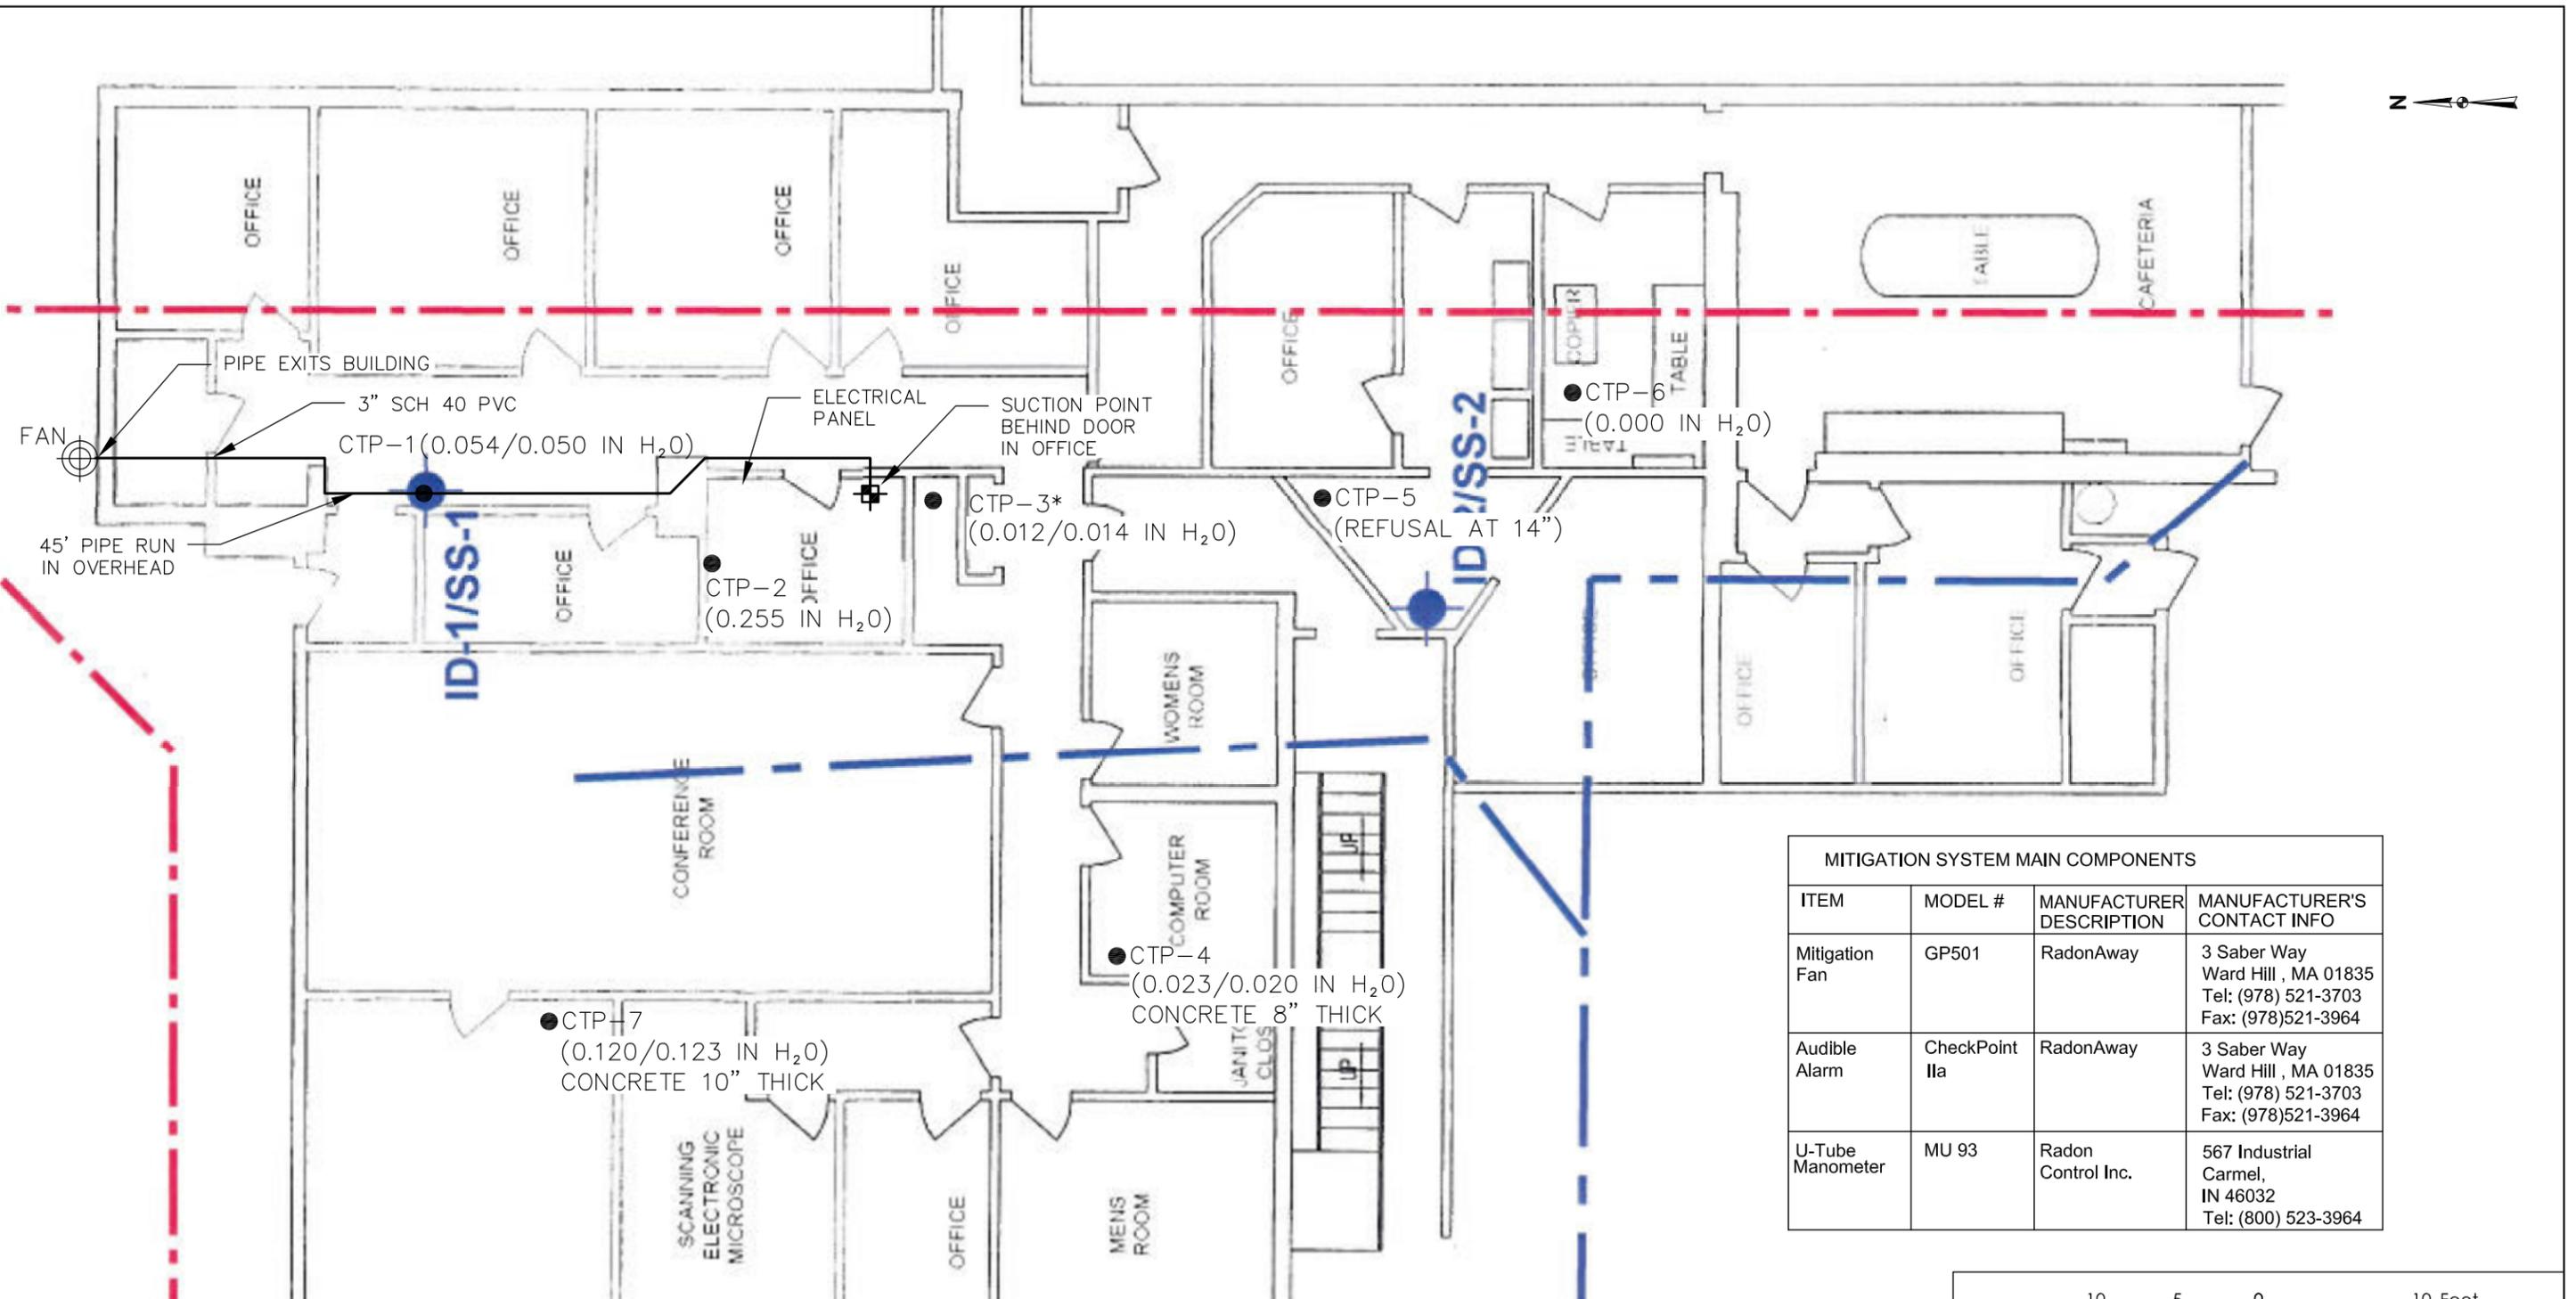
Guelph	07-Dec-2010	Figure: 1
--------	-------------	---------------------

The SSD system was installed and began operation on November 17, 2010. The system was installed by Mitigation Tech of Brockport, New York, under the direction and oversight of Geosyntec of Guelph, Ontario, Canada. An as-built drawing of the SSD system is provided as Figure 1.

The SSD system consists of one suction point, centrally located within the office area at the St. Gobain building, as shown in Figure 1. A 3-inch diameter hole was drilled through the concrete, and sub-grade materials were excavated to a depth of about six inches below the bottom of the existing concrete floor. A Schedule 40 polyvinyl chloride (PVC) vent-pipe, three inches in diameter, was installed vertically within the sump. The bottom of the suction pipe was installed so that it is flush with the bottom of the concrete slab, and was sealed using polyurethane sealant.

Items identified during the routine monitoring and maintenance visits pertaining to system design and/or performance will be addressed during the inspection visit if possible, or a follow-up visit will be scheduled. Any needed repairs or system modifications will be documented and the as-built diagram (Figure 1) will be updated as necessary. The attached inspection form will be used during the visit.

Upon being contacted by an owner/occupant of the site about a suspected problem with the system, a site visit will be scheduled. During on-site visits, the inspector will investigate reported problems, identify the potential causes, and implement the necessary repairs. To the extent practical, repairs will be made during the investigation visit. However, if repairs cannot be executed at that time, a follow-up visit will be scheduled for a later date that is convenient to the owner/occupant. Upon completion of the action, the investigation/repair activities will be documented and the as-built diagram (Figure 1) will be updated as needed.
