Ecology Engineering Evaluation Report Buffalo River, New York

Buffalo River Great Lakes Legacy Act Project Coordination Team

**ENVIRON International Corporation
MACTEC Engineering & Consulting, Inc.**

May 21, 2010

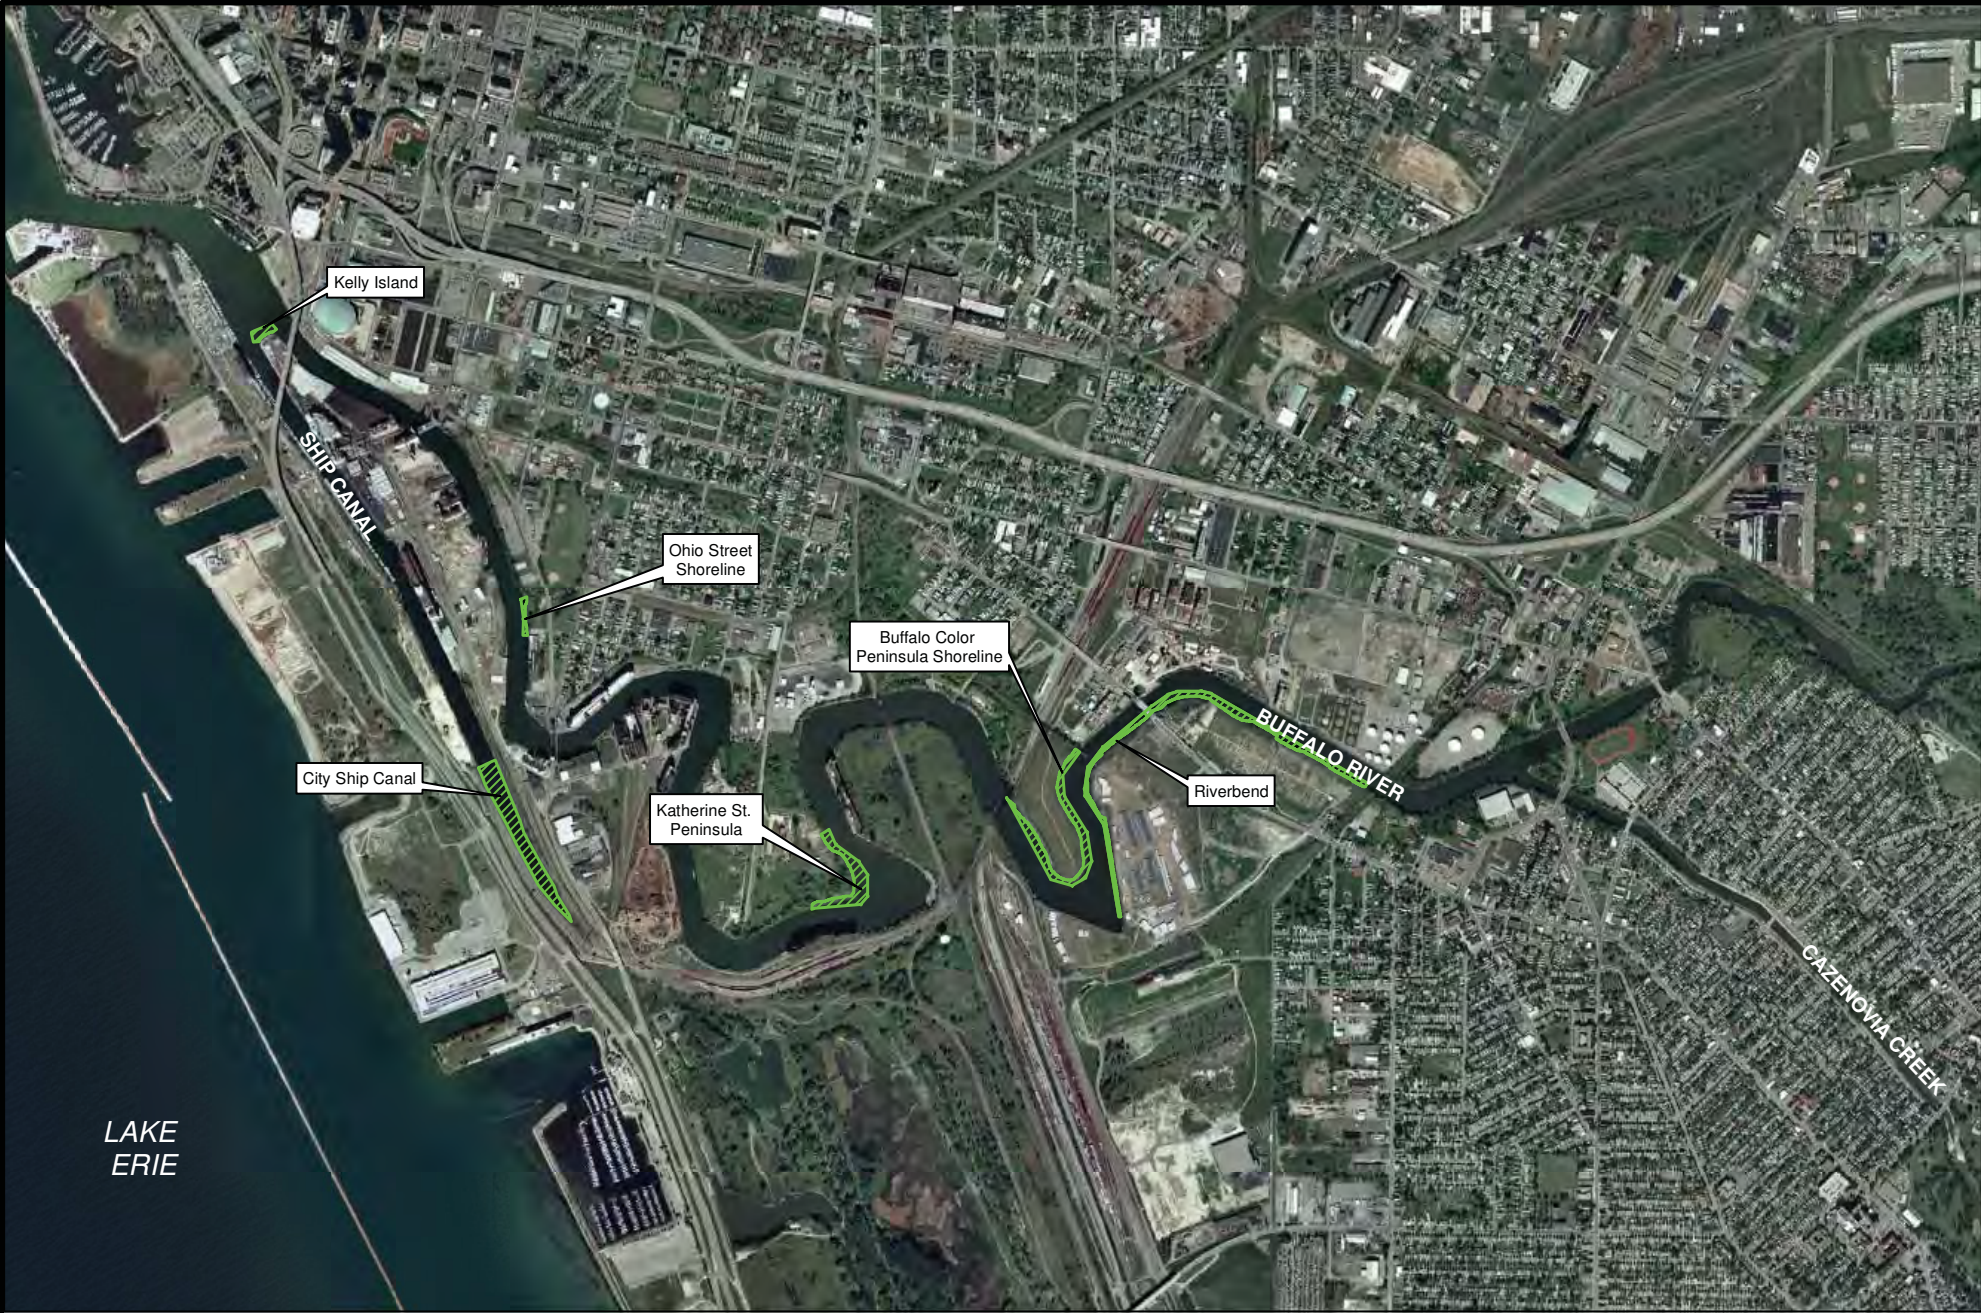
**Figure
1**

Areas summarized from Buffalo Niagara Riverkeeper draft list of potential habitat restoration projects.

**POTENTIAL RESTORATION PROJECT LOCATIONS
BUFFALO RIVER, NY**

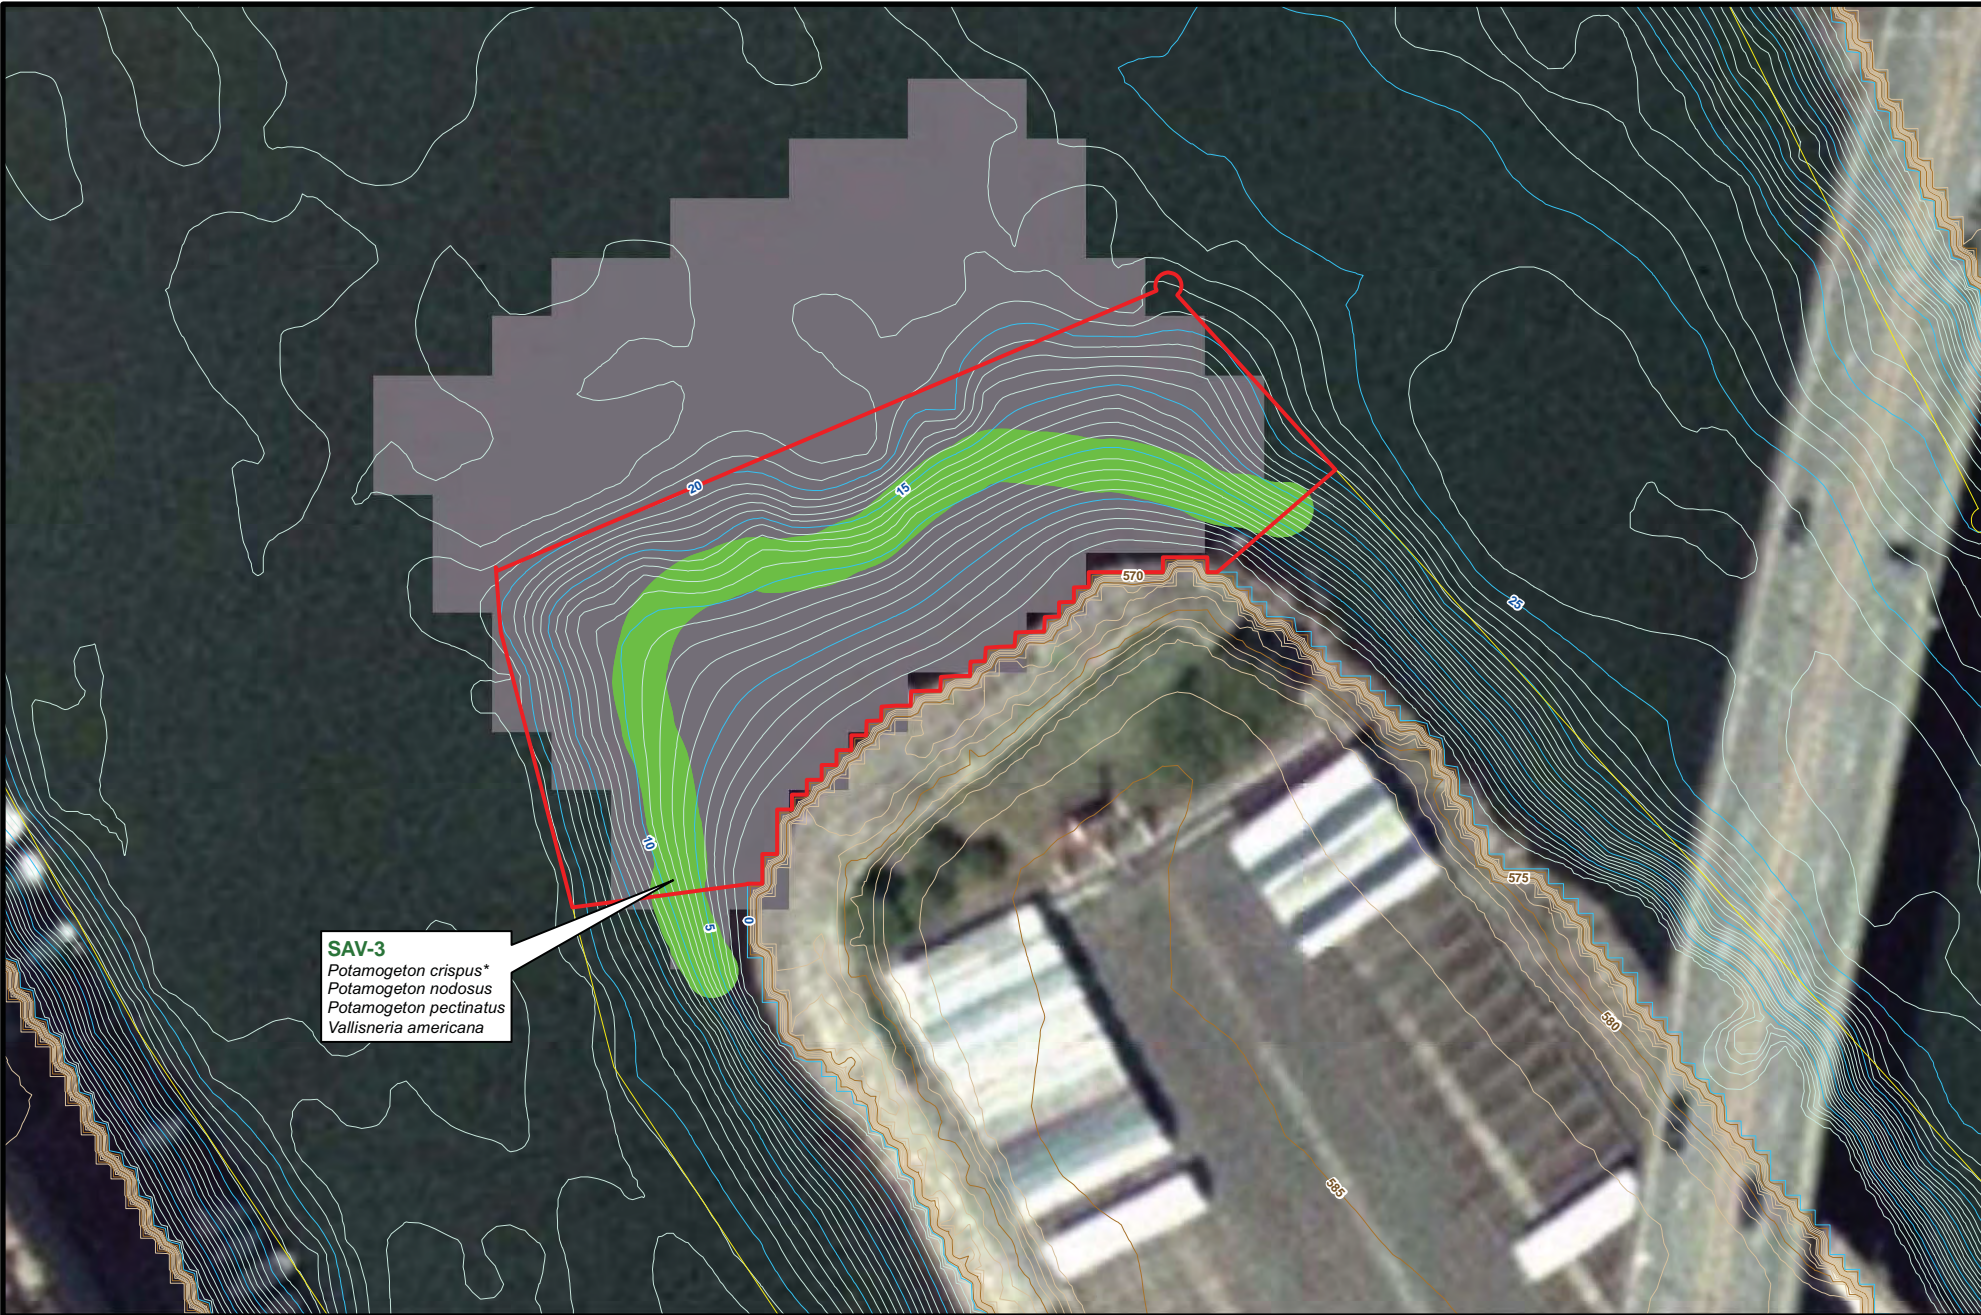
Figure
2

SAV-3
*Potamogeton crispus**
Potamogeton nodosus
Potamogeton pectinatus
Vallisneria americana

KELLY ISLAND RESTORATION AREA BUFFALO RIVER, NY

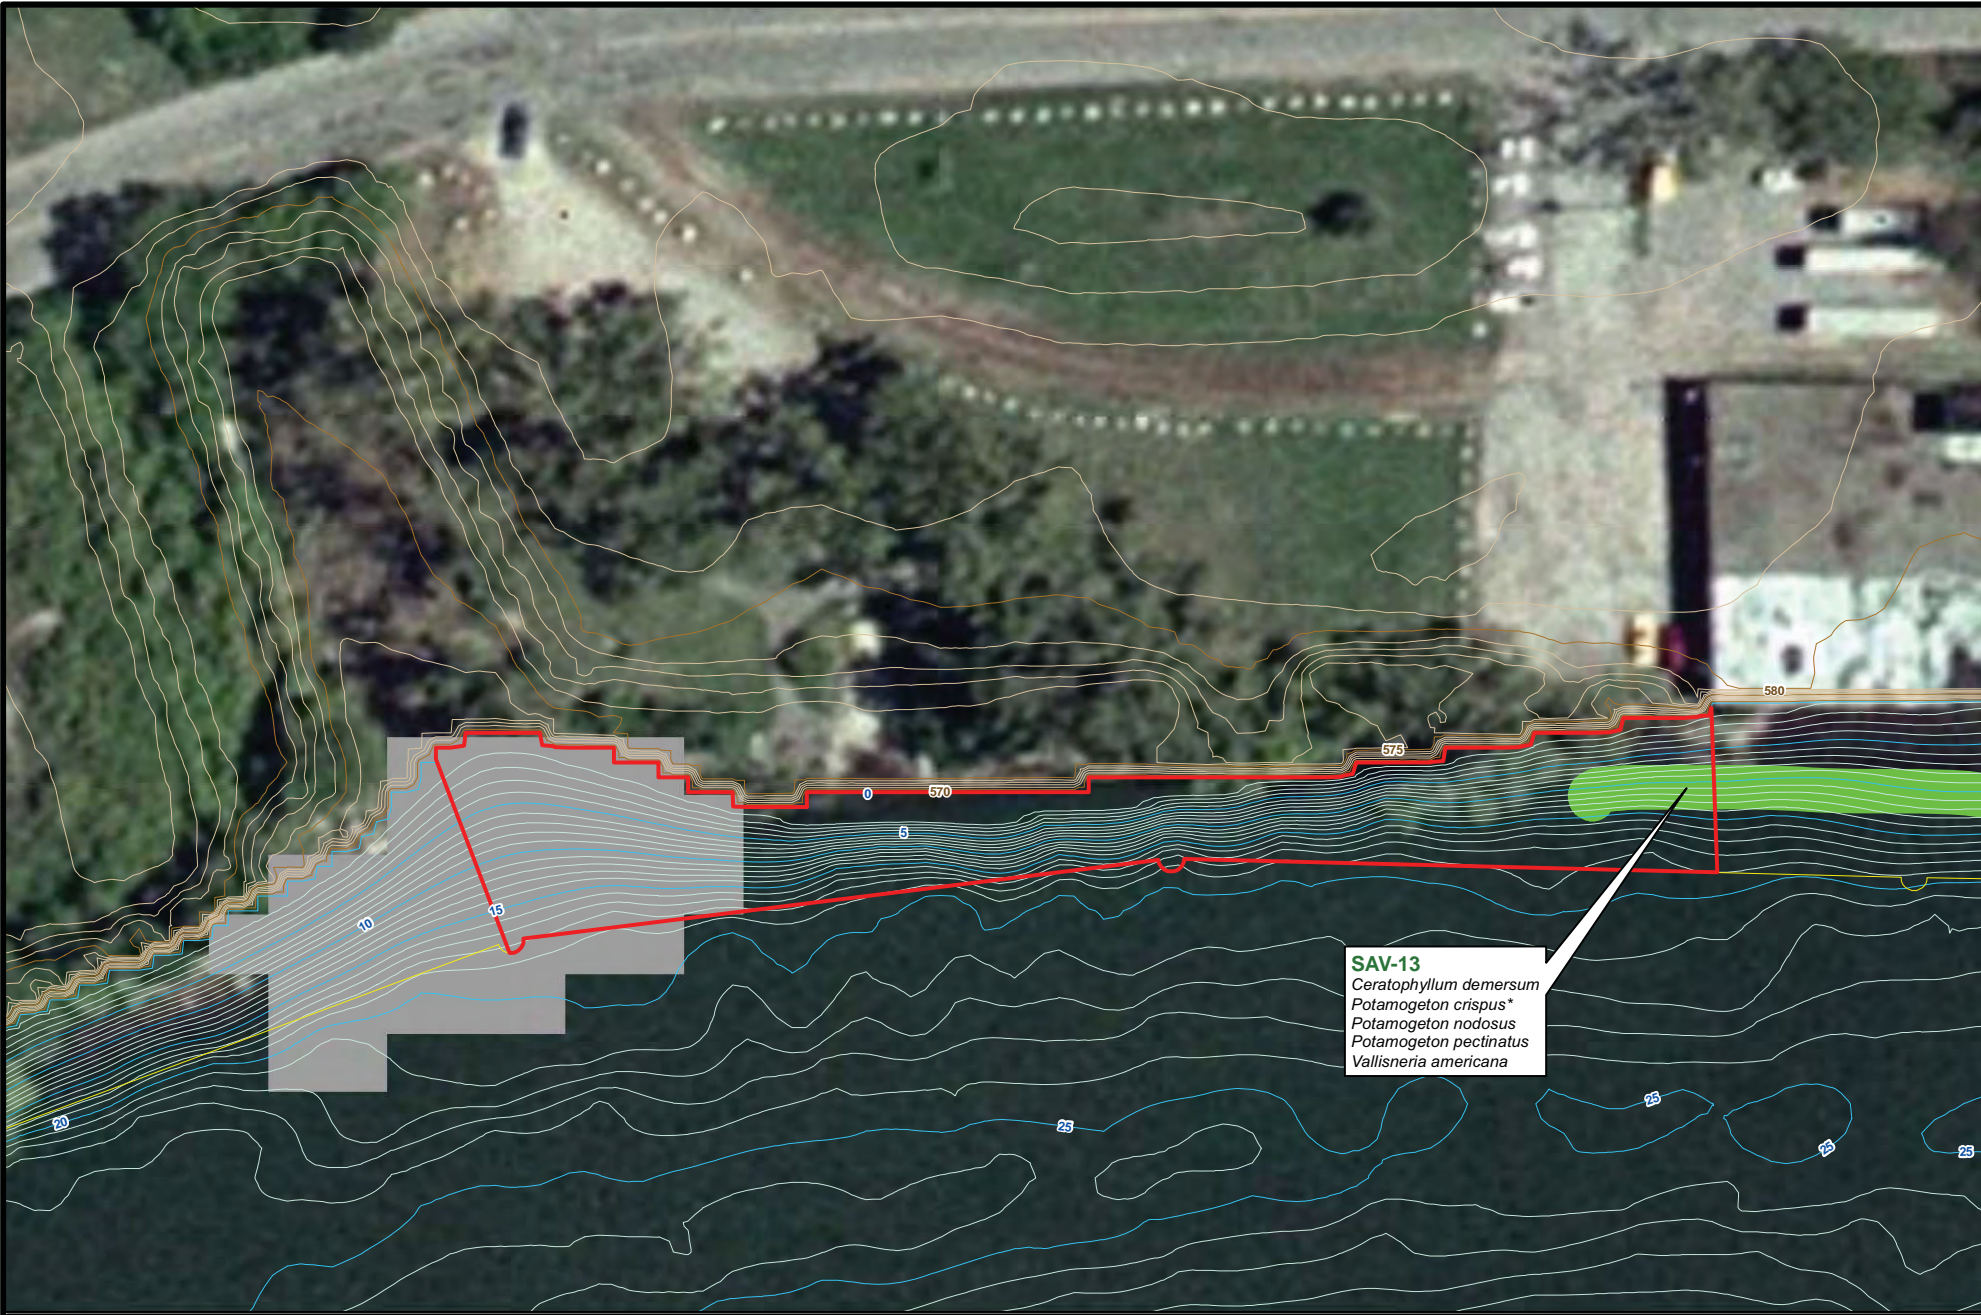
**Figure
4**

**OHIO STREET SHORELINE RESTORATION AREA
BUFFALO RIVER, NY**

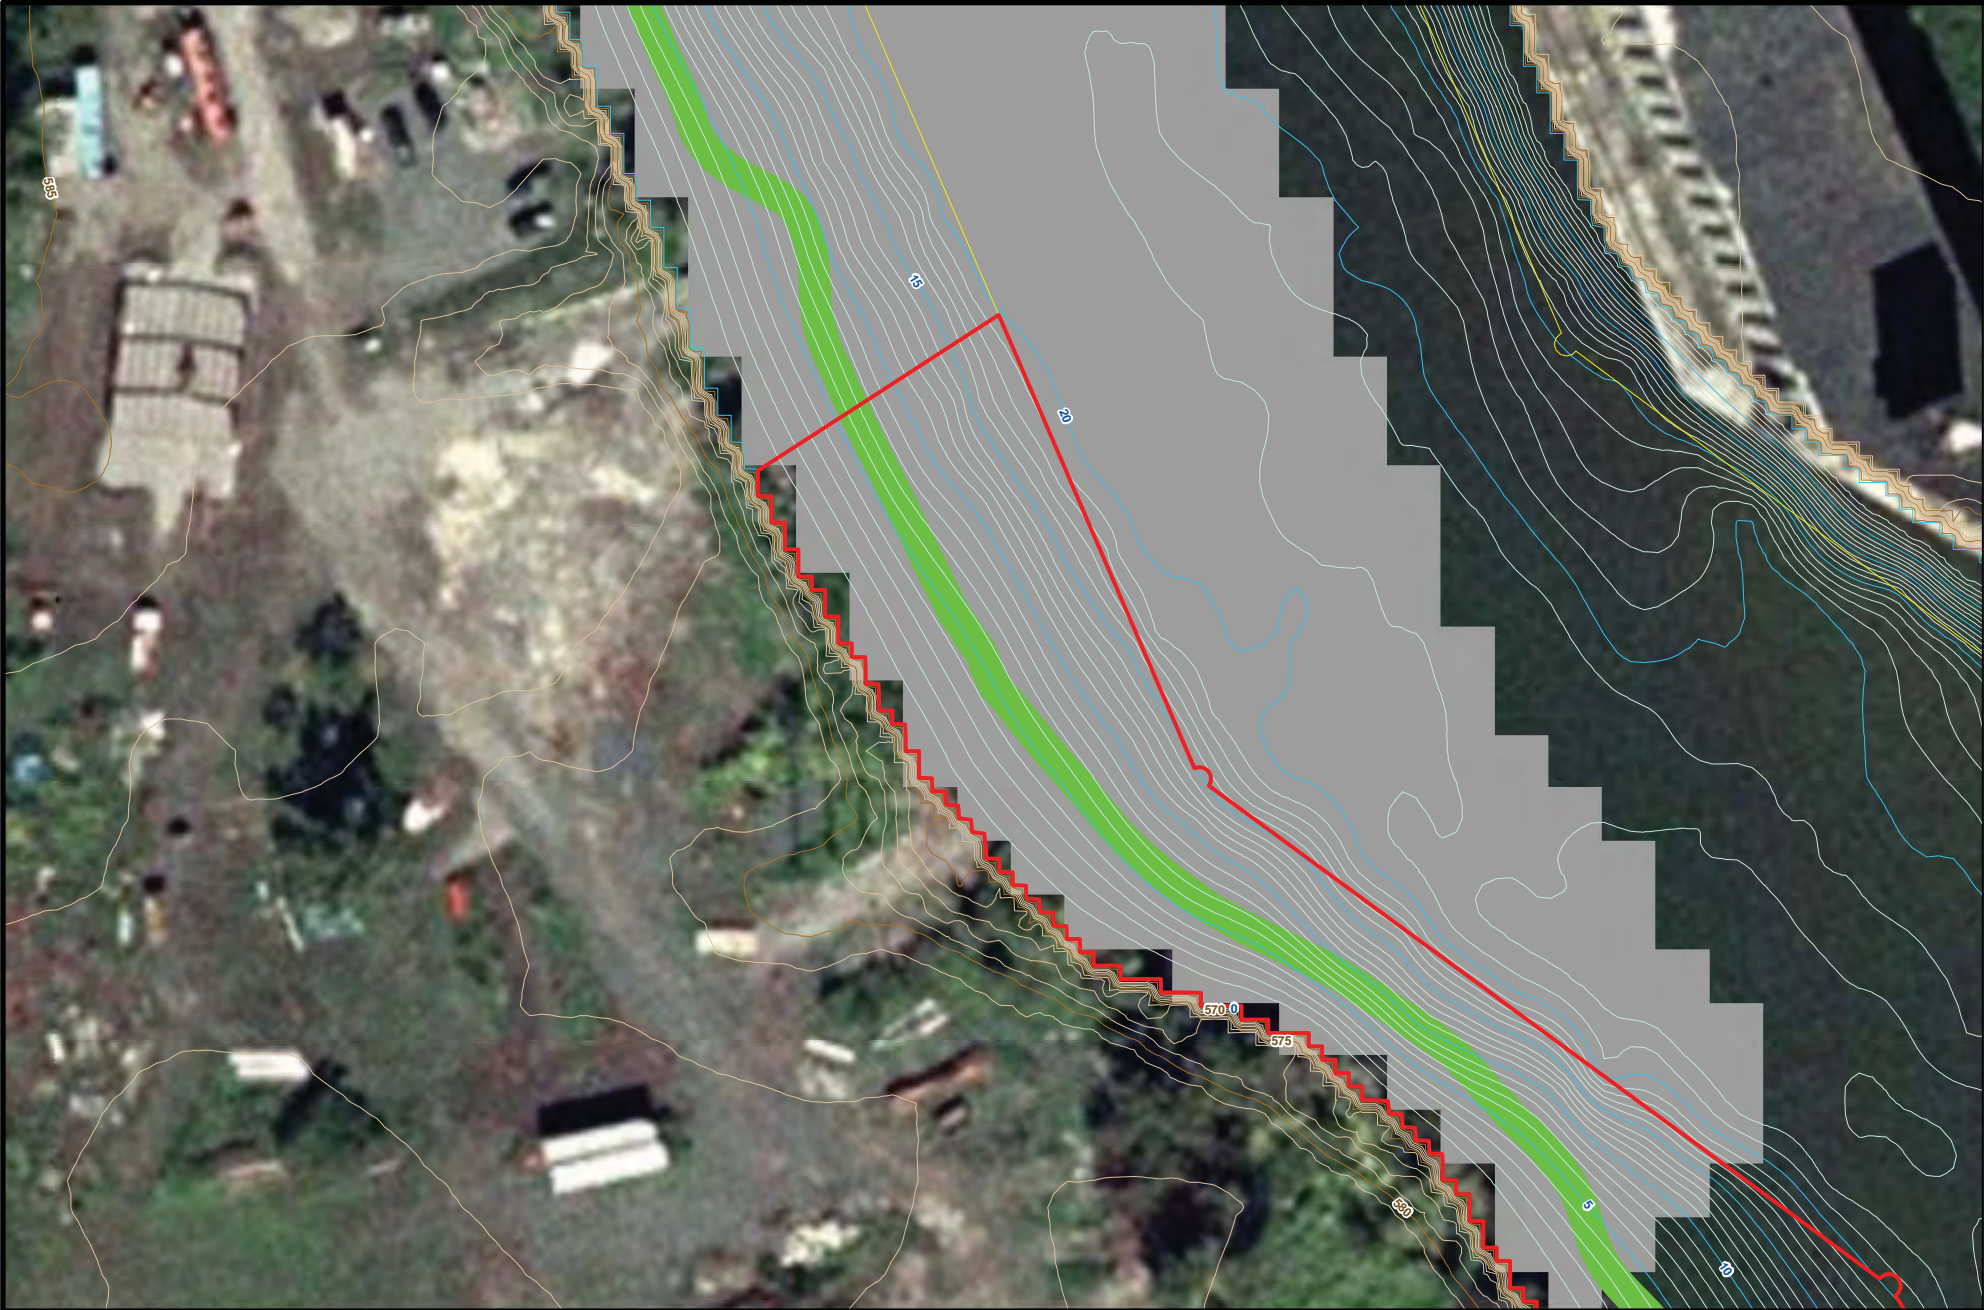
Figure 5a

KATHERINE STREET PENINSULA NORTHERN SHORELINE RESTORATION AREA
BUFFALO RIVER, NY

Due to the differences in shoreline stability between the northern and southern portions of the restoration area, conceptual restoration alternatives are considered separately (Figures 5a and 5b). Extensive riparian soil excavation and habitat modification may be limited by potential soil contamination; to our knowledge, soils have not been tested in the Katherine Street Peninsula and should be evaluated before proceeding with upland/riparian restoration. Additionally, the nearby transmission tower may limit potential bank and riparian restoration techniques due to limited access and right of ways. Restoration techniques for this restoration area are presented in Table 4.

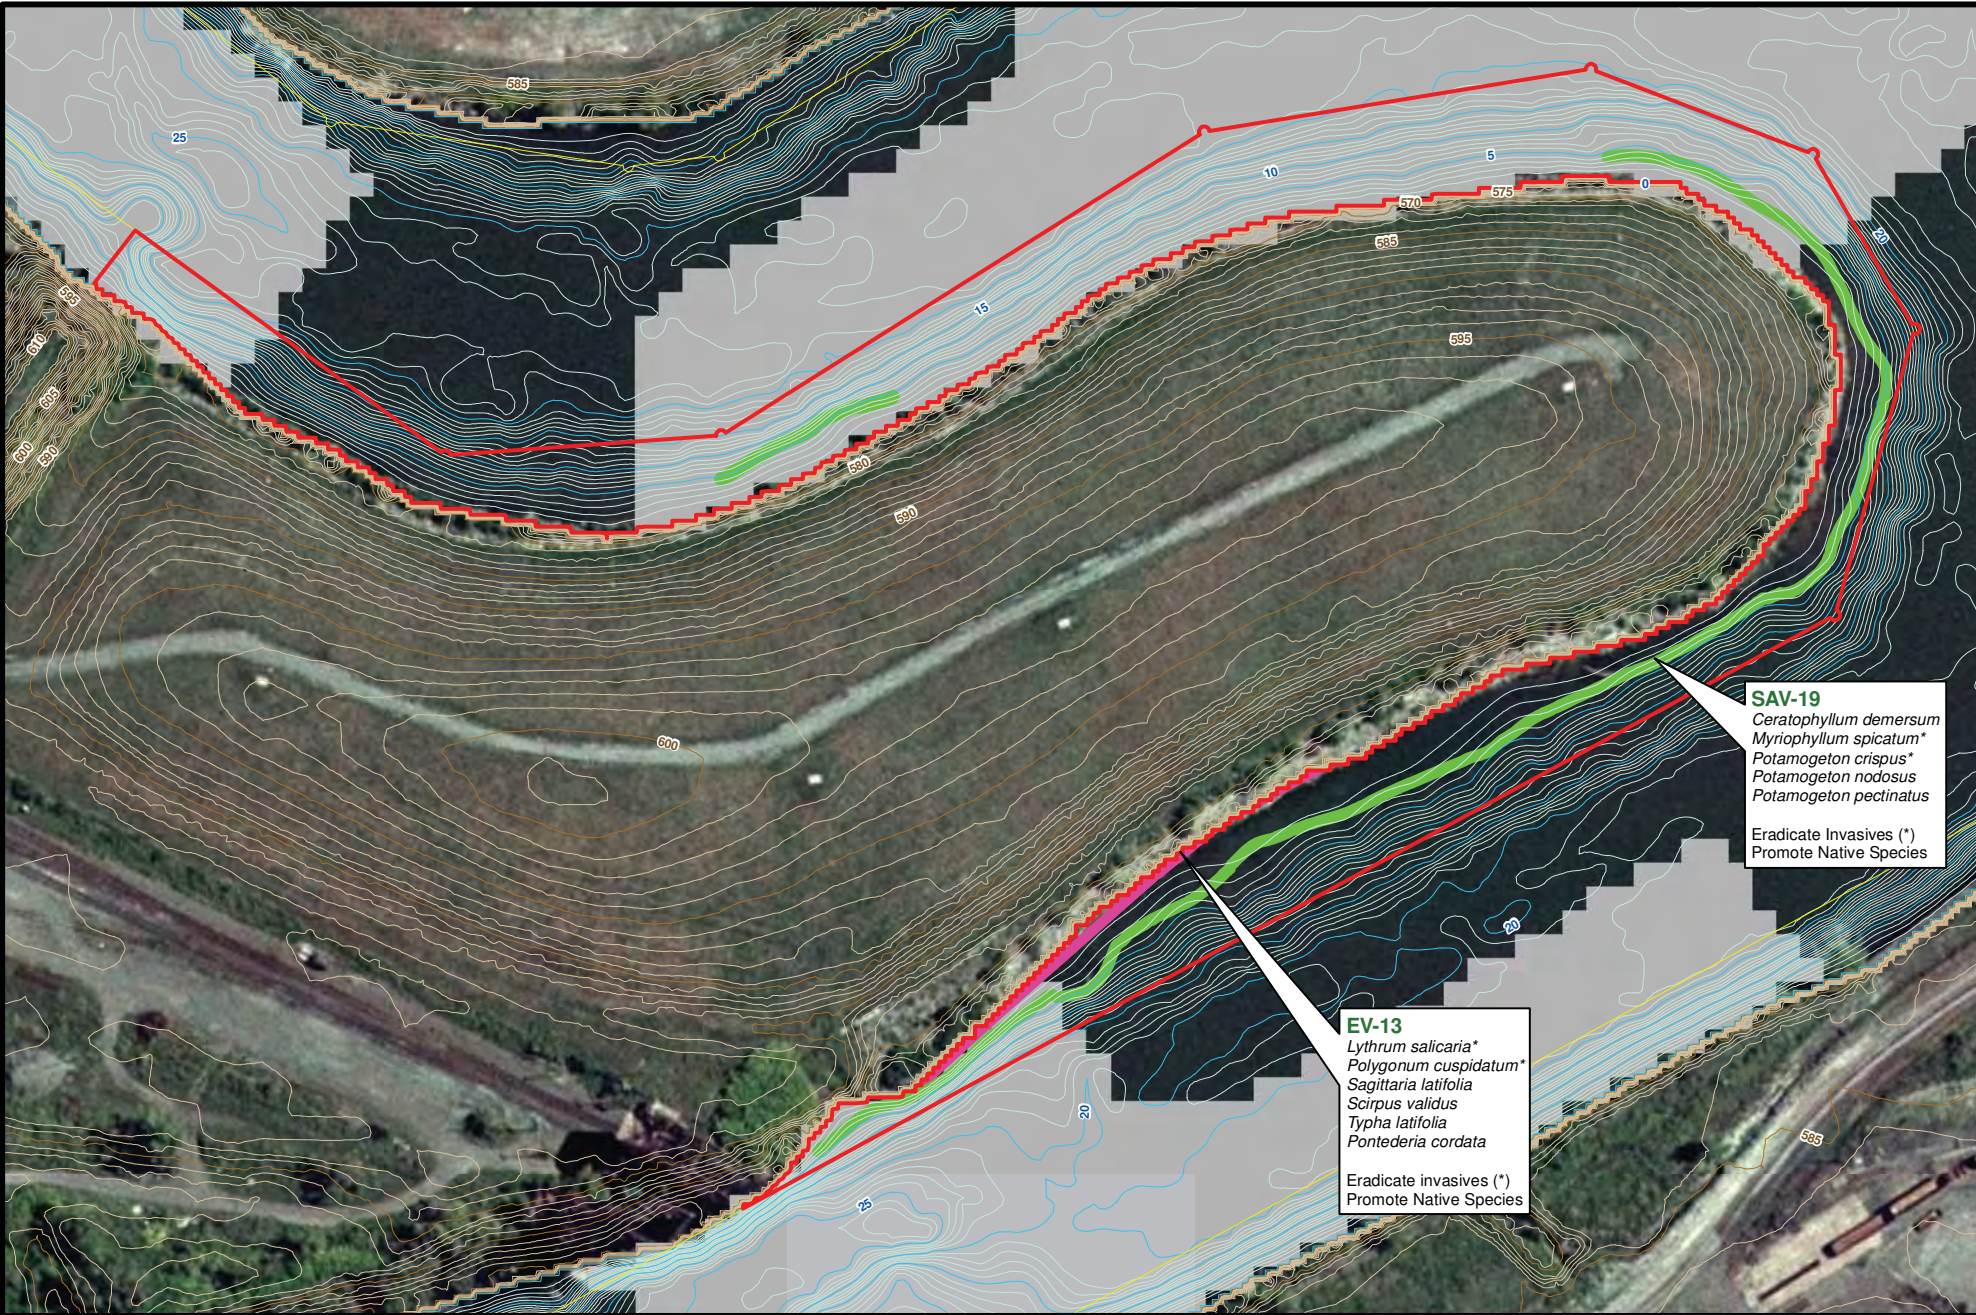
**Figure
6**

SAV-19
Ceratophyllum demersum
*Myriophyllum spicatum**
*Potamogeton crispus**
Potamogeton nodosus
Potamogeton pectinatus
Eradicate Invasives (*)
Promote Native Species

EV-13
*Lythrum salicaria**
*Polygonum cuspidatum**
Sagittaria latifolia
Scirpus validus
Typha latifolia
Pontederia cordata
Eradicate invasives (*)
Promote Native Species

**BUFFALO COLOR PENINSULA SHORELINE RESTORATION AREA
BUFFALO RIVER, NY**

The Buffalo Color Peninsula shoreline is a combination of riprap and naturalized shoreline types (Figure 6). The techniques proposed are constrained by the presence of the slurry wall along the perimeter of the entire site. This slurry wall limits the possible restoration measures in the riparian areas along the Buffalo Color Peninsula shoreline. However, the presence of both EV and SAV beds along the downstream portion of the site indicates that the habitat is suitable for aquatic vegetation. Therefore, proposed restoration at this site focuses on expansion and improvement of the existing EV and SAV beds (Section 2.1) with limited bank and riparian restoration (Sections 2.14) focused on planting native species along the shoreline.

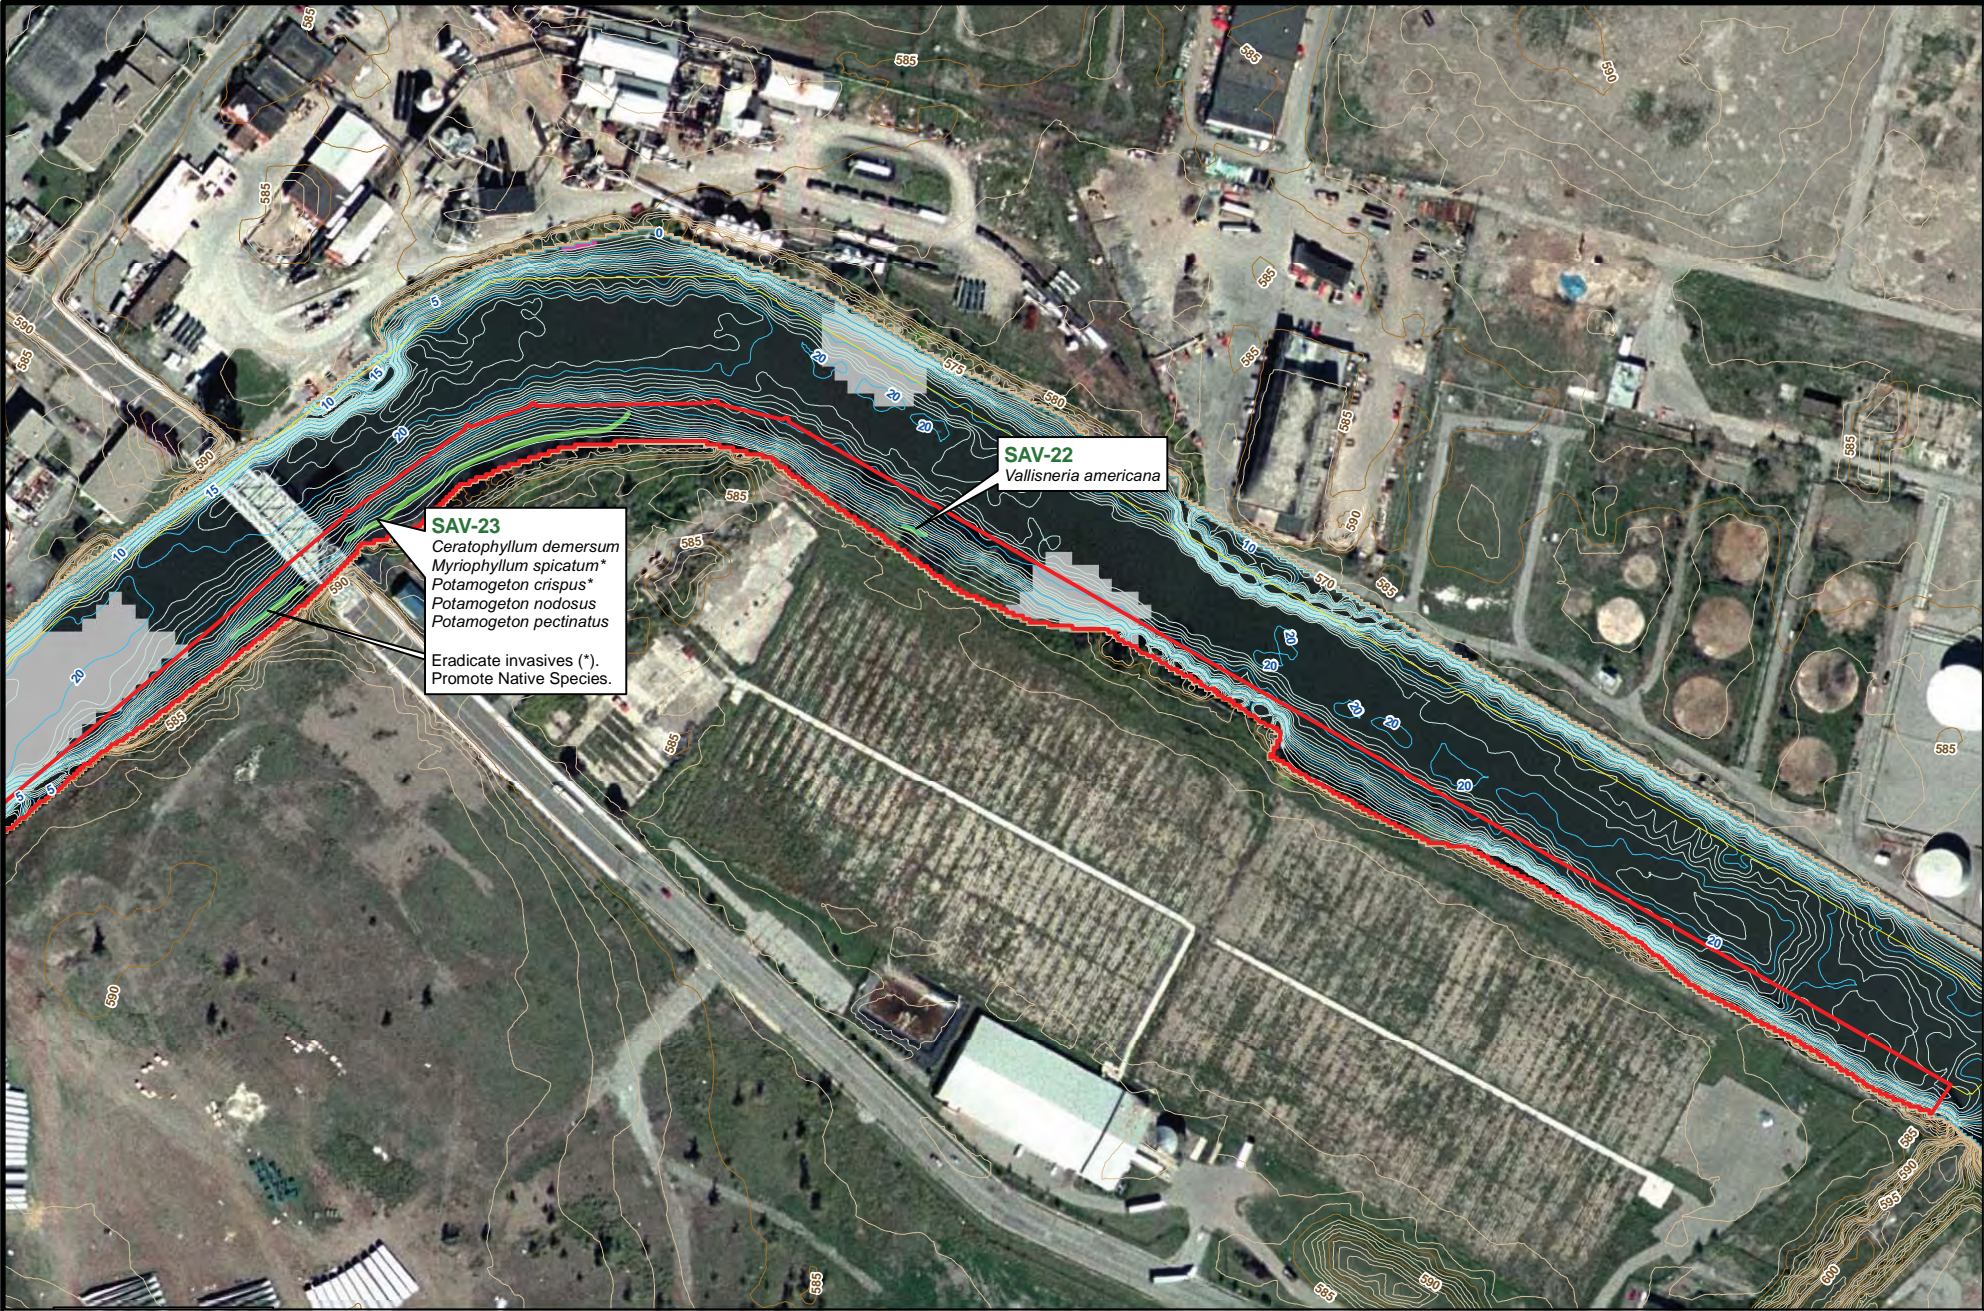
Figure
7a

UPSTREAM RIVERBEND RESTORATION AREA
BUFFALO RIVER, NY

Restoration alternatives for the Riverbend project include a combination of the natural/softened shoreline and bulkheaded shoreline restoration techniques (Figures 7a and 7b, Table 4). Relatively little of the Riverbend restoration area is expected to be impacted by implementation of the remedy. However, the lack of aquatic vegetation along most of the Riverbend shoreline indicates that some factor(s) limit the extent of aquatic vegetation within this reach of the Buffalo River.

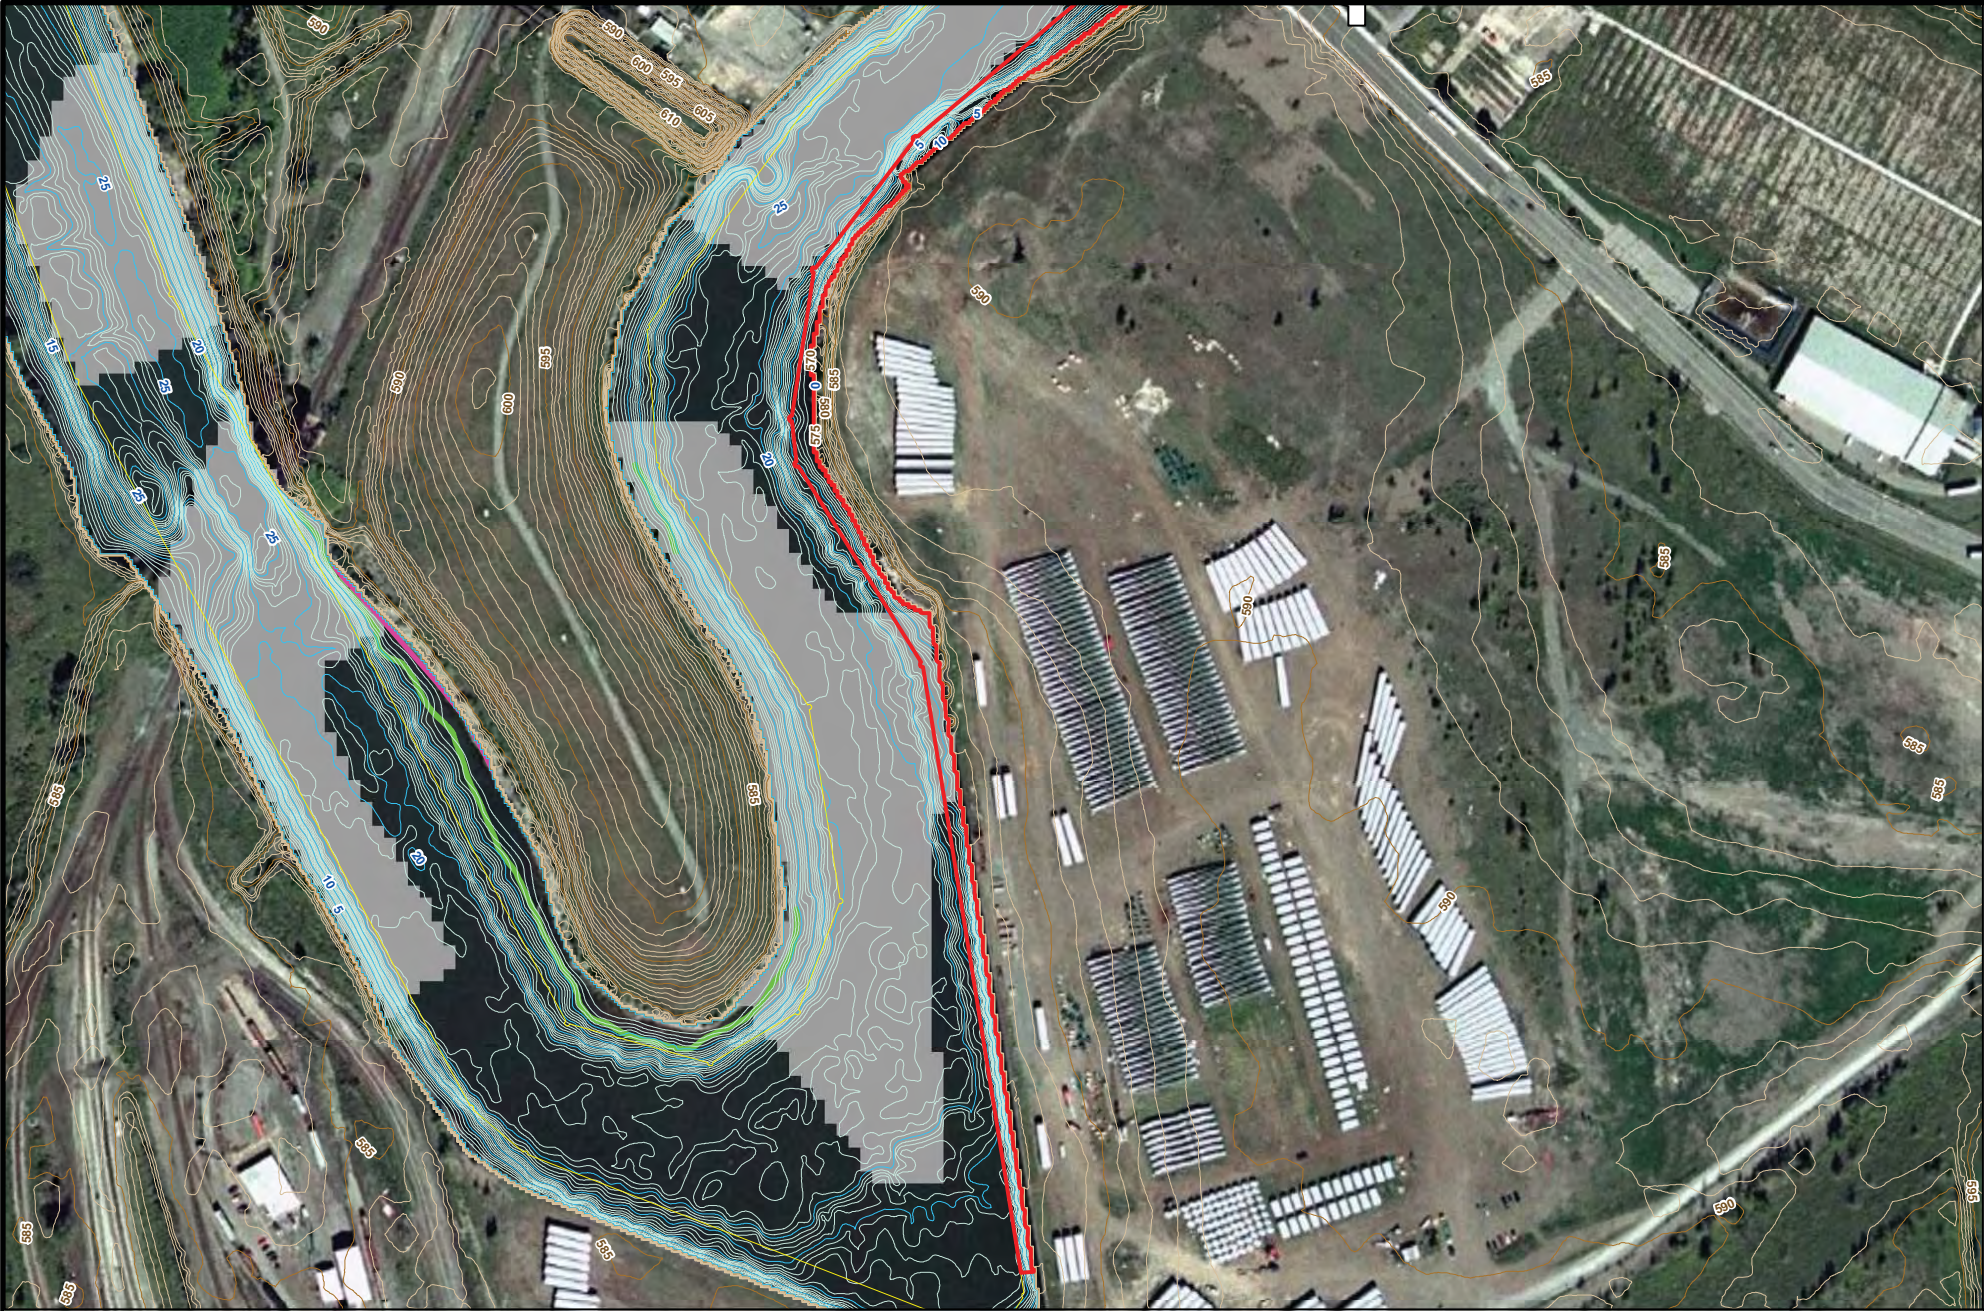
**Figure
7b**

**DOWNSTREAM RIVERBEND RESTORATION AREA
BUFFALO RIVER, NY**

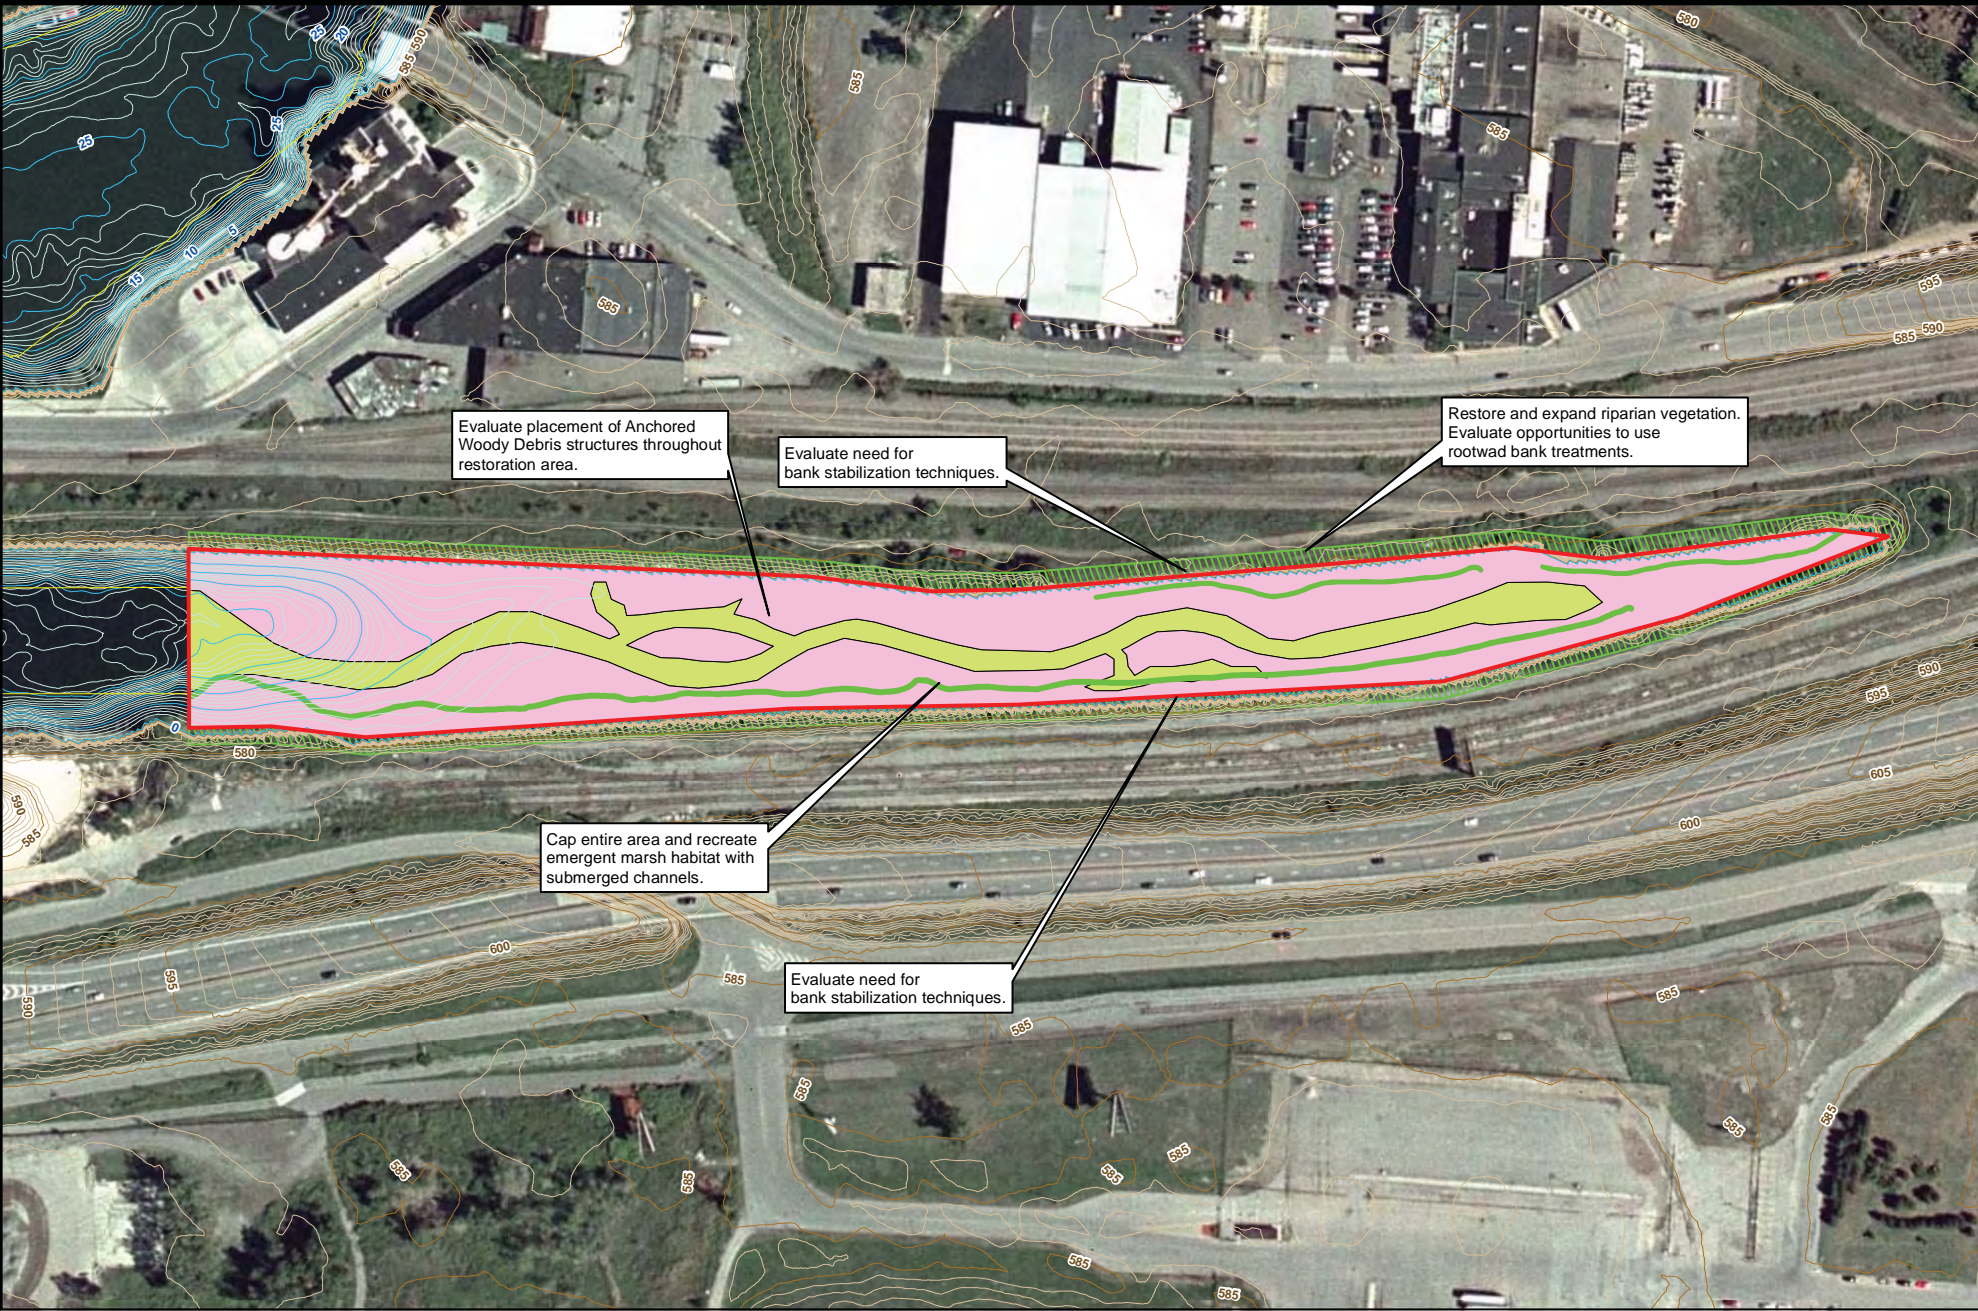
**Figure
9**

**CITY SHIP CANAL RECOMMENDED RESTORATION ALTERNATIVE
BUFFALO RIVER, NY**

CSC-A4 is chosen as the preferred restoration alternative for the City Ship Canal because it scored the highest among the four restoration alternatives proposed for the location (Figure 9). As mentioned in Section 4.2, restoration alternative CSC-A4 incorporates all restoration techniques proposed in CSC-A1,
