Ecology Engineering Evaluation Report Buffalo River, New York

Buffalo River Great Lakes Legacy Act Project Coordination Team

**ENVIRON International Corporation
MACTEC Engineering & Consulting, Inc.**

May 21, 2010

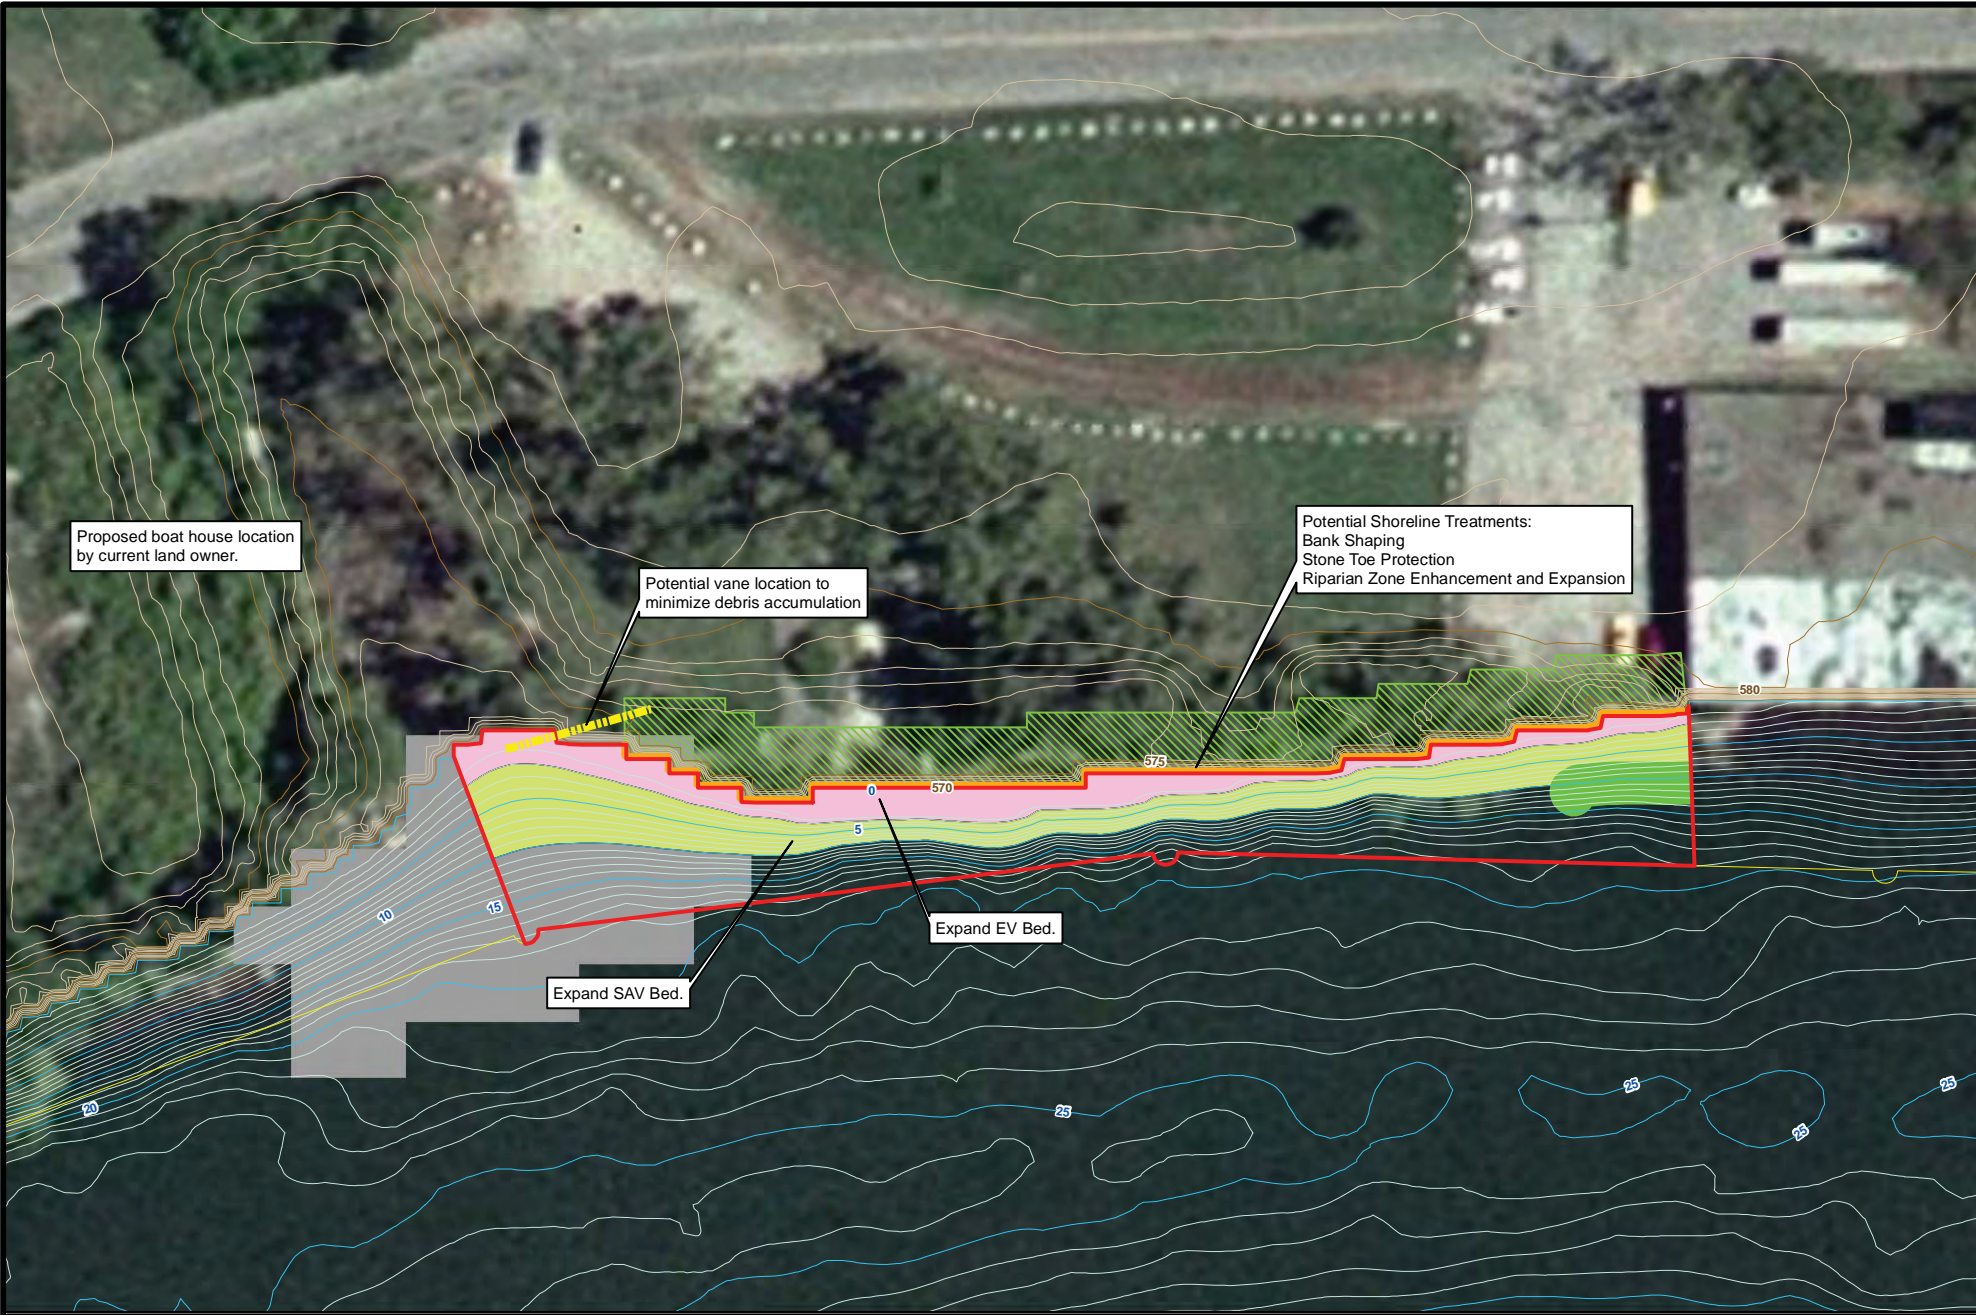
**Figure
10**

**OHIO STREET SHORELINE RECOMMENDED RESTORATION ALTERNATIVE
BUFFALO RIVER, NY**

Of the two restoration alternatives proposed for the Ohio Street Shoreline, OSS-A2 is chosen as the preferred alternative (Figure 10). OSS-A2 differs from OSS-A1 in its use of a vane to redirect flow and increase oxygenation along the shoreline; all other proposed restoration techniques are the same for each alternative (in-stream vegetation and substrate enhancement, bank shaping, stone toe protection, bank and riparian zone vegetation enhancement, and riparian zone expansion). Both OSS-A1 and OSS-A2 passed the screening criteria presented in Table 5. However, OSS-A2 received a higher score based on the scoring criteria presented above and in Table 6. Specifically, OSS-A2 scored highest due to:

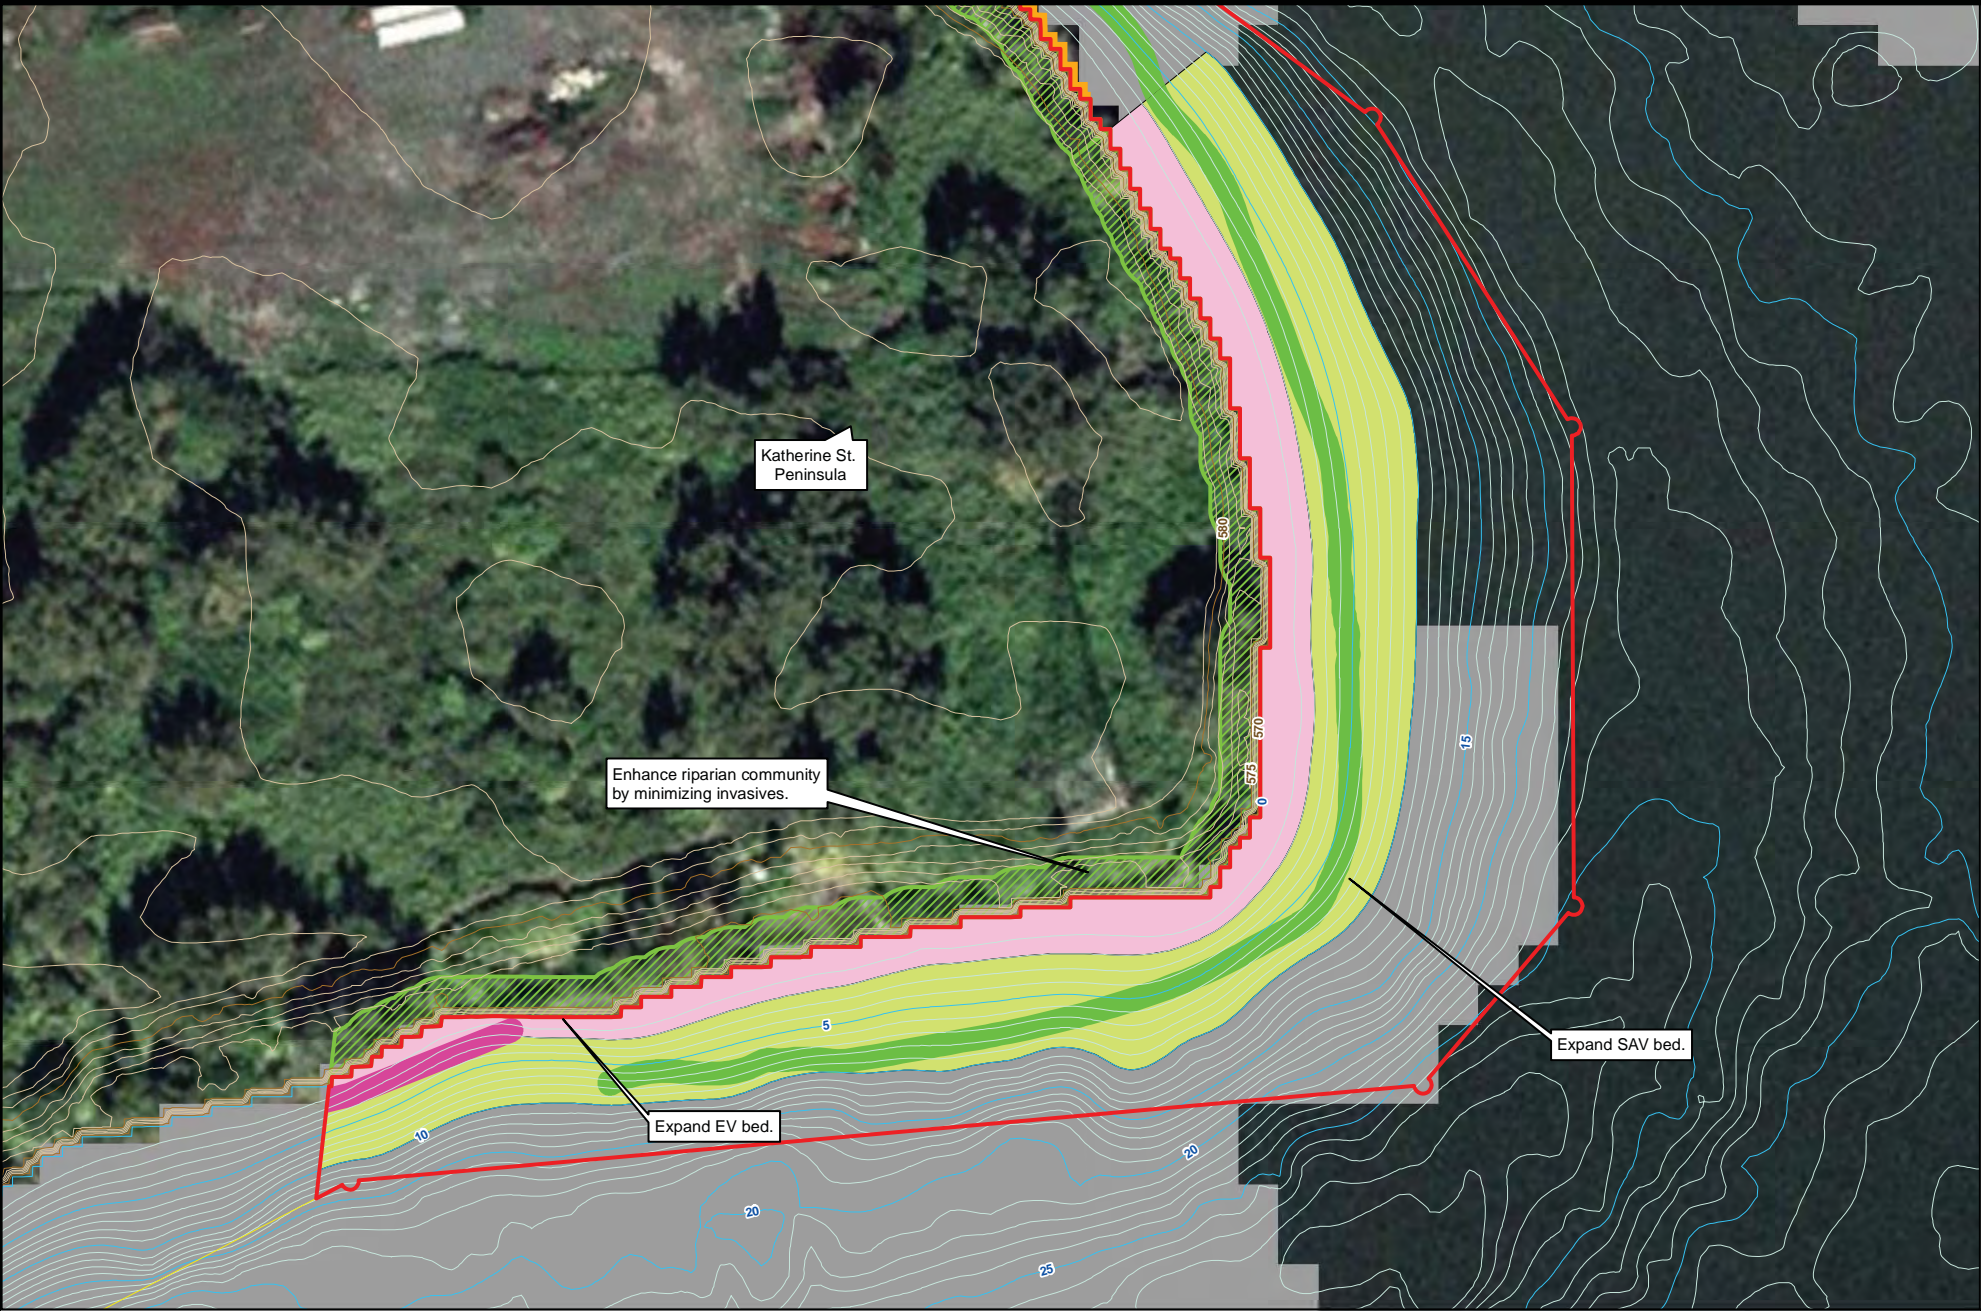
**Figure
11b**

**KATHERINE STREET PENINSULA SOUTHERN SHORELINE
RECOMMENDED RESTORATION ALTERNATIVE
BUFFALO RIVER, NY**

Of the two restoration alternatives proposed for the southern shoreline of the Katherine Street Peninsula, KSP(SS)-A2 is chosen as the preferred alternative (Figure 11b). The alternatives differ because KSP(SS)-A2 incorporates bank and riparian zone vegetation enhancement whereas KSP(SS)-A1 does not. Both restoration alternatives passed the screening criteria presented in Table 5. KSP(SS)-A2 is chosen as the preferred alternative because it scored highest among the two proposed alternatives. Specifically, KSP(SS)-A2 scored highest due to:

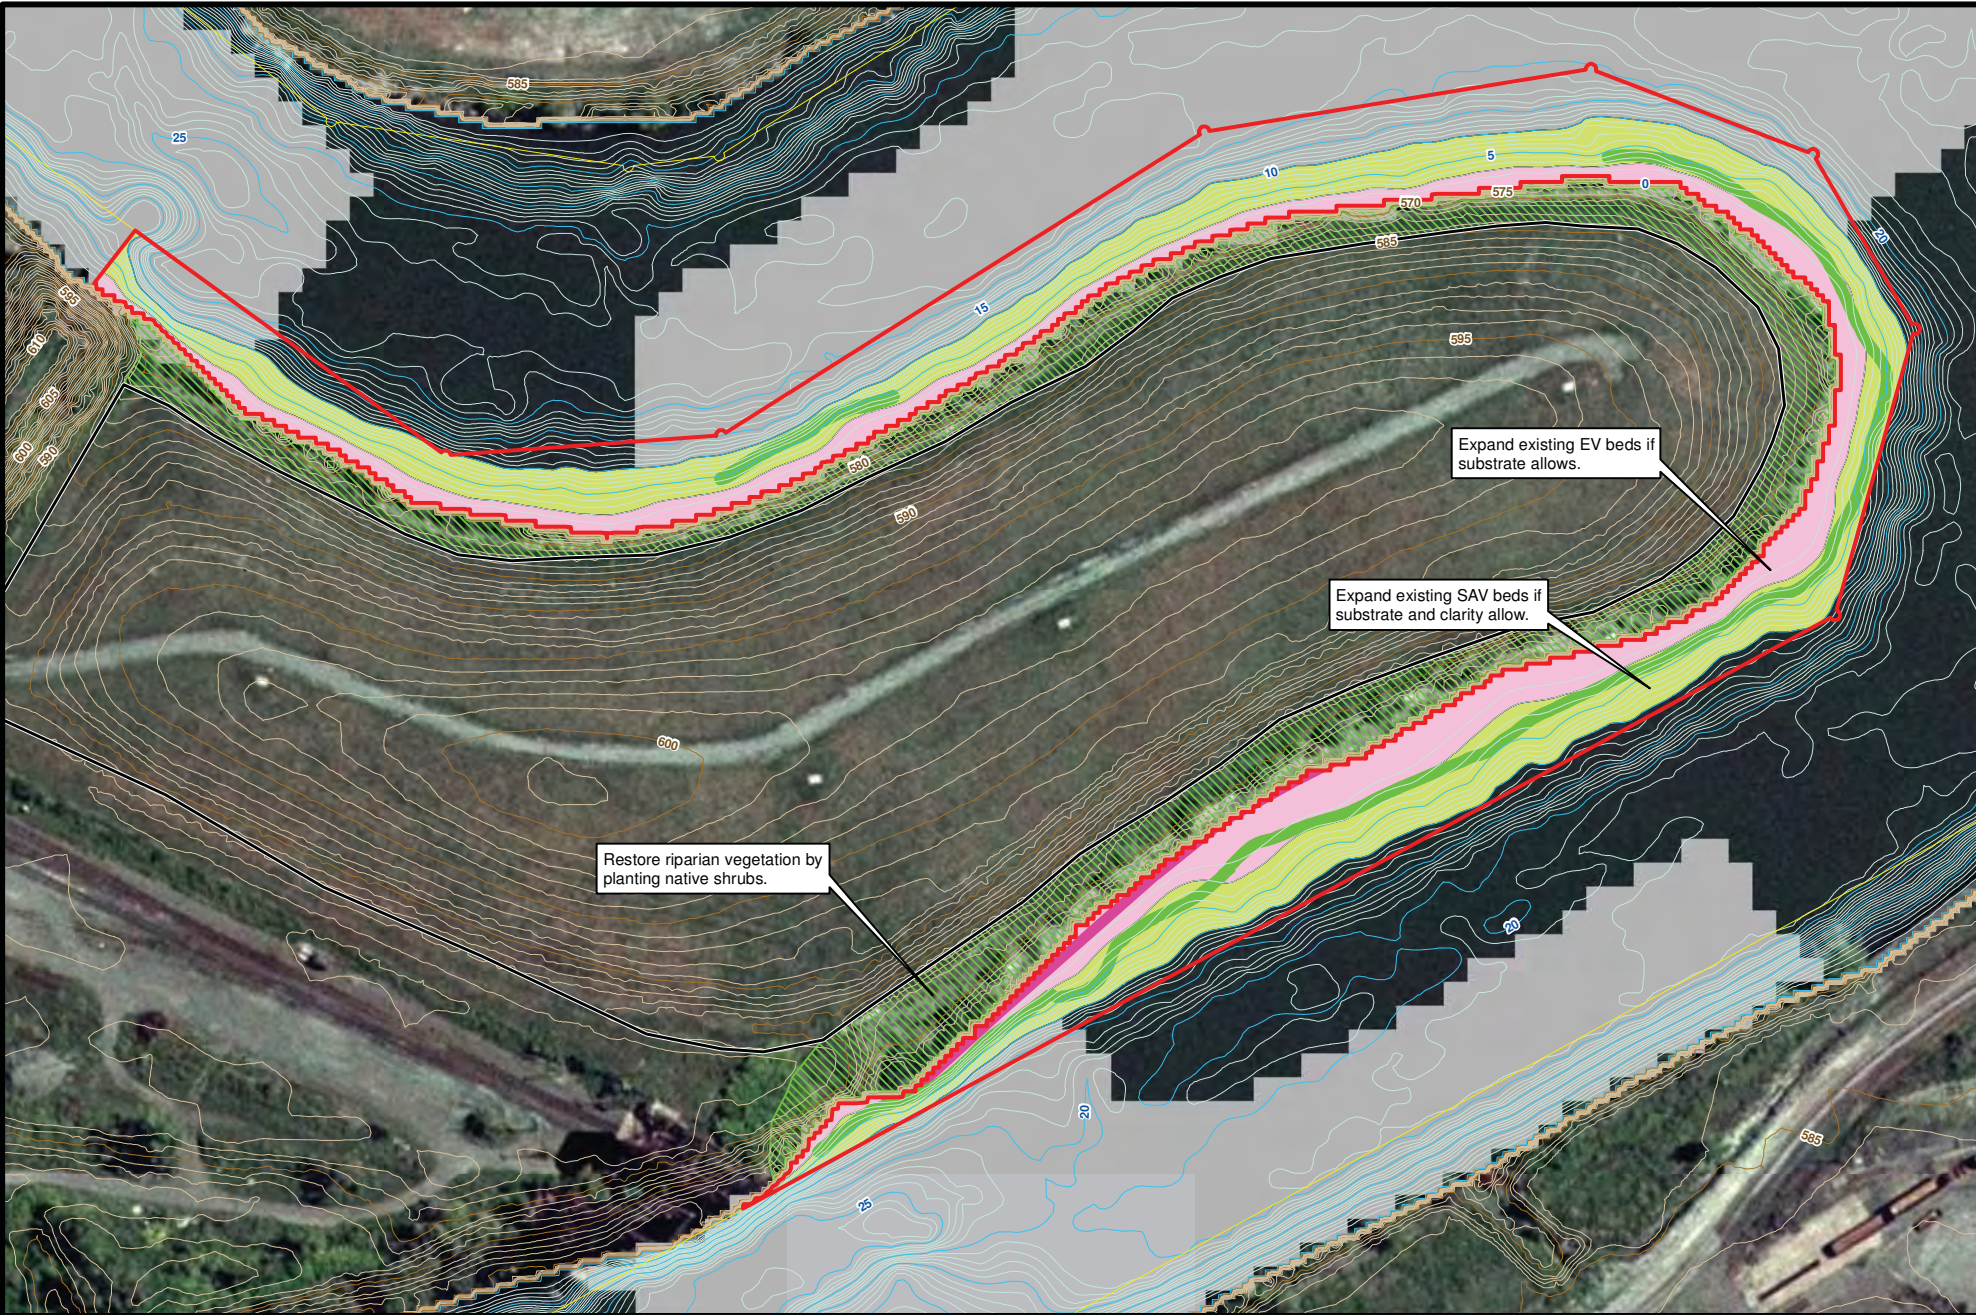
**Figure
12**

**BUFFALO COLOR PENINSULA SHORELINE
RECOMMENDED RESTORATION ALTERNATIVE
BUFFALO RIVER, NY**

Of the two restoration alternatives proposed for the Buffalo Color Peninsula shoreline, BCAD-A2 is chosen as the preferred alternative (Figure 12). BCAD-A2 differs from BCAD-A1 by the proposed enhancement of bank and riparian zone vegetation. Both alternatives passed the screening criteria presented in Table 5. However, BCAD-A2 received a higher score based on the scoring criteria presented above and in Table 6. Specifically, BCAD-A2 scored highest due to:

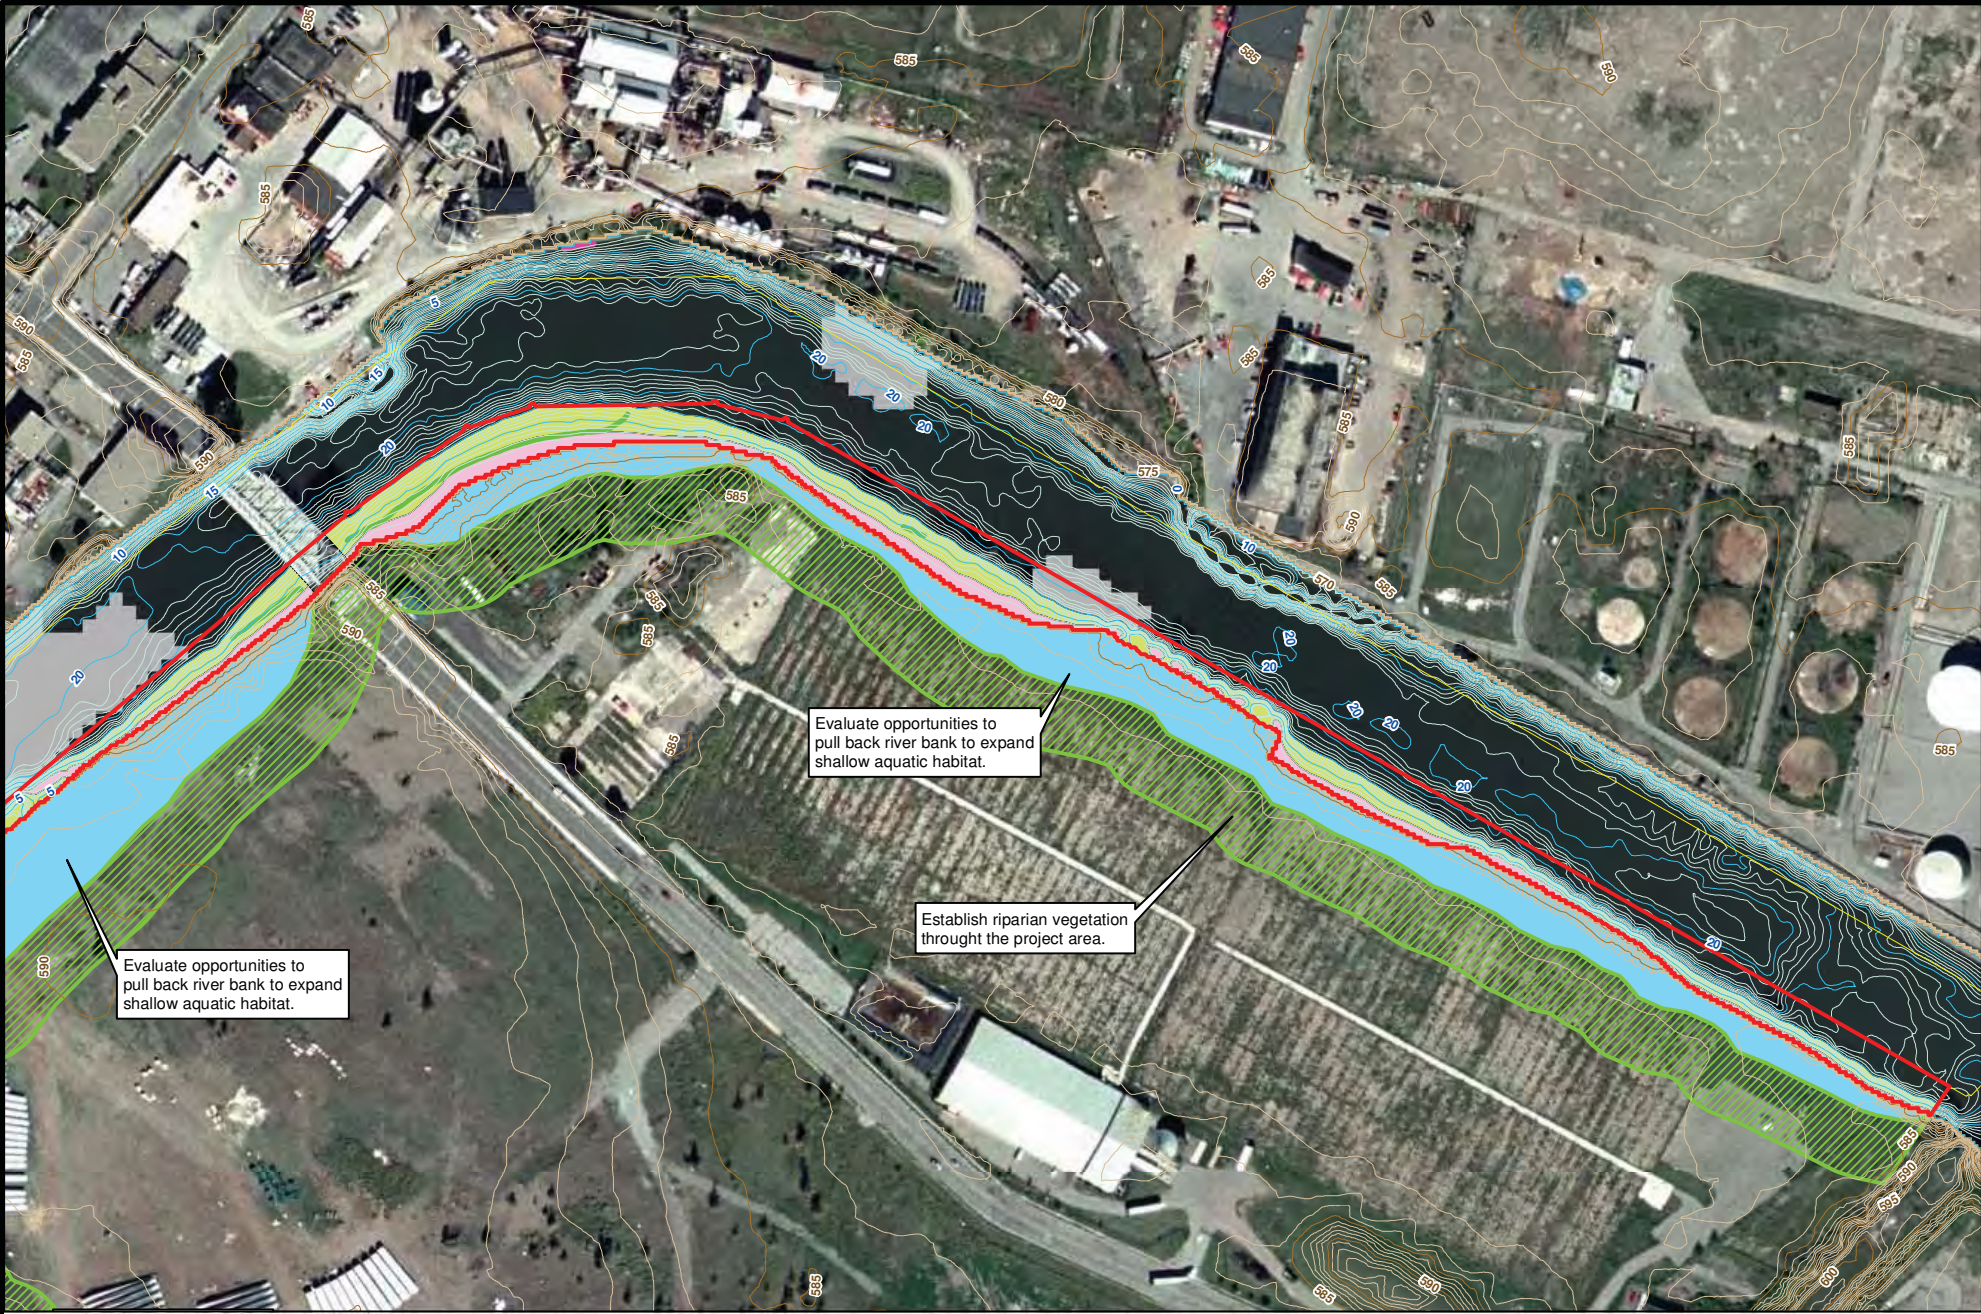
Figure 13a

UPSTREAM RIVERBEND RECOMMENDED RESTORATION ALTERNATIVE
BUFFALO RIVER, NY

RU-A2 is chosen as the preferred restoration Alternative for the upstream/natural shoreline of the Riverbend Area (Figure 13a). All alternatives for the Riverbend Area (downstream and upstream) passed the screening criteria presented in Section 5.1.1 and Table 5. All three restoration alternatives for the upstream/natural shoreline of the Riverbend Area incorporate in-stream vegetation and substrate enhancement, bank shaping, bank and riparian zone vegetation enhancement, and riparian zone expansion. RU-A2 differs from the other alternatives by its use of rootwads (RU-A1 does not include any additional bank stabilization techniques, where as RU-A3 incorporates tree revetments instead of rootwads). RU-A2 is chosen because it scored highest among the three restoration alternative proposed for the location (Table 6). Specifically, RU-A2 scored highest due to:

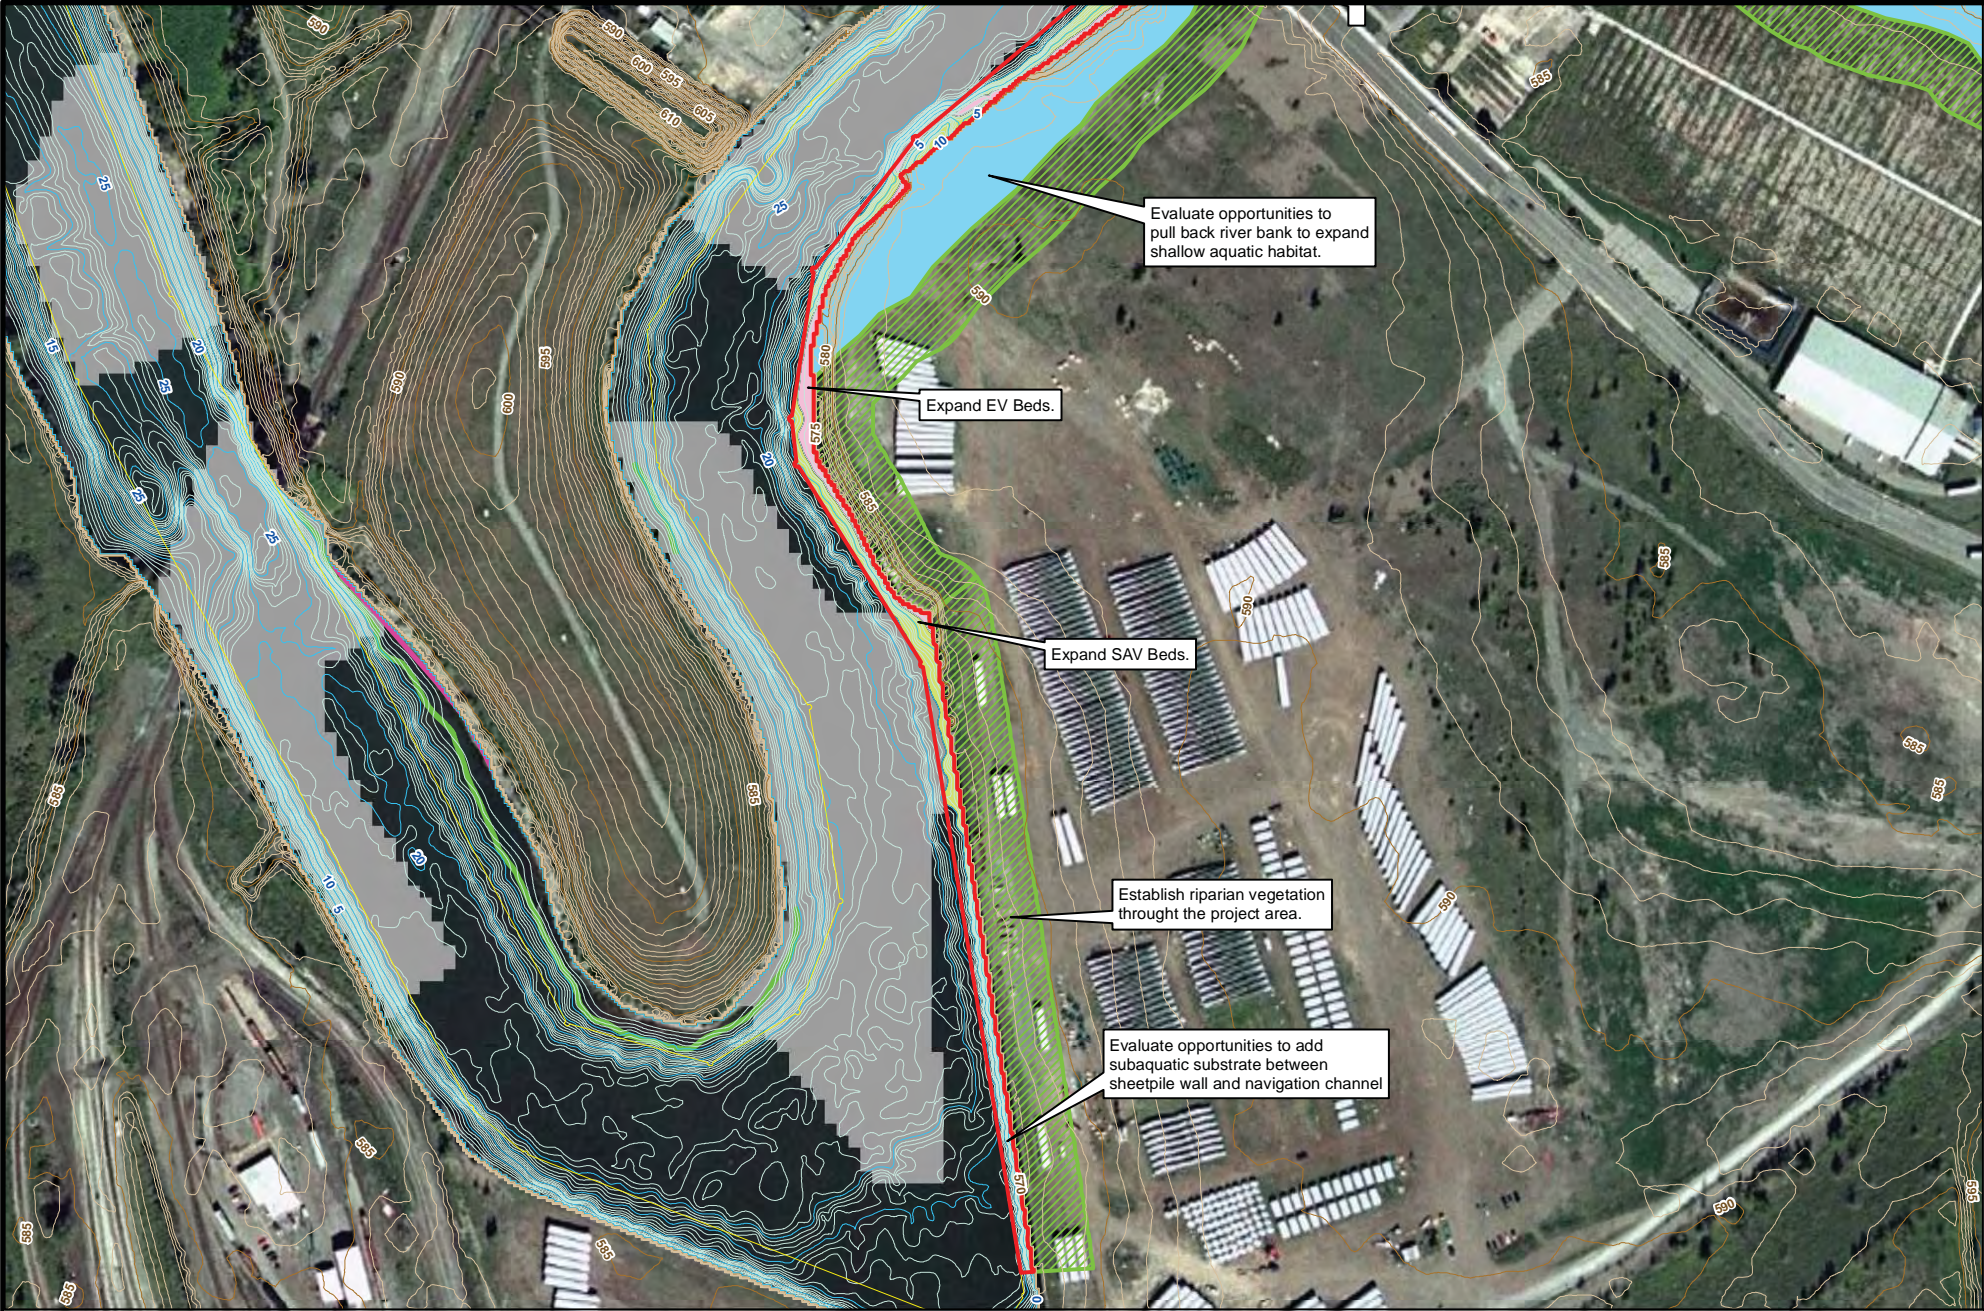
**Figure
13b**

**DOWNSTREAM RIVERBEND RECOMMENDED RESTORATION ALTERNATIVE
BUFFALO RIVER, NY**

RD-A1 is chosen as the preferred restoration alternative for the downstream/bulkheaded shoreline of the Riverbend Area (Figure 13b). As mentioned above, all alternatives for the Riverbend Area (downstream and upstream) passed the screening criteria presented in Section 5.1.1 and Table 5. All three restoration alternatives for the downstream/bulkheaded shoreline of the Riverbend Area incorporate riparian zone expansion. RD-A1 uses in-stream substrate enhancement rather than floating log shelters (RD-A2) or modified lunger boxes (RD-A3). RD-A1 is chosen because it scored highest among the three restoration alternatives proposed for the location (Table 6). Specifically, RD-A1 scored highest due to:

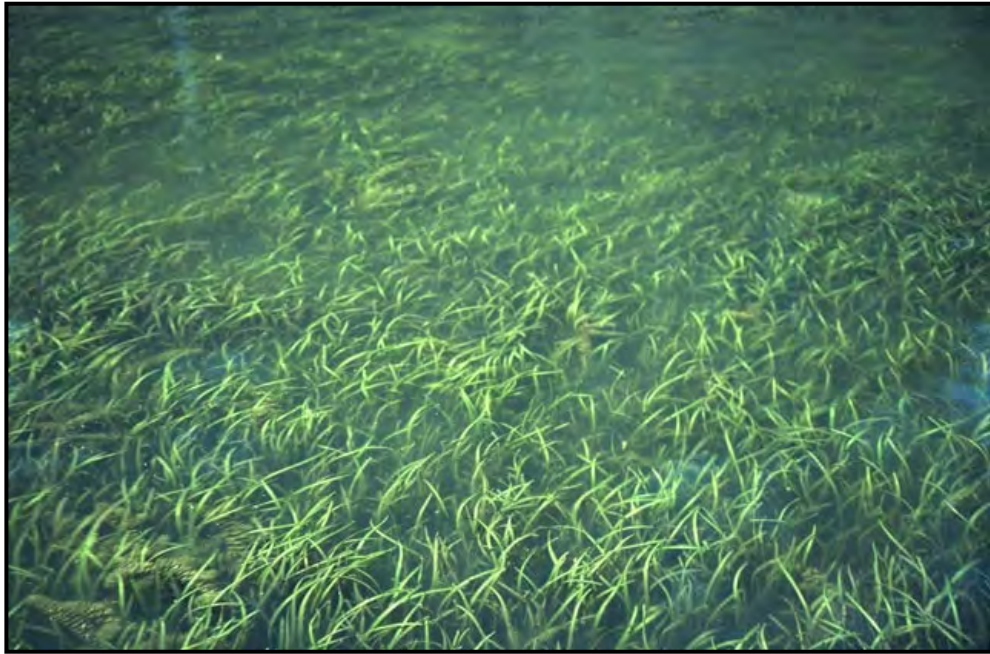
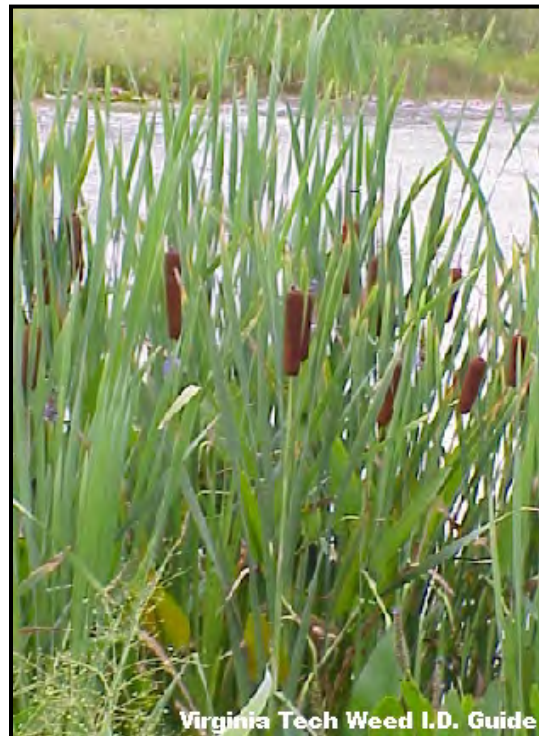
Aquatic Vegetation Enhancement

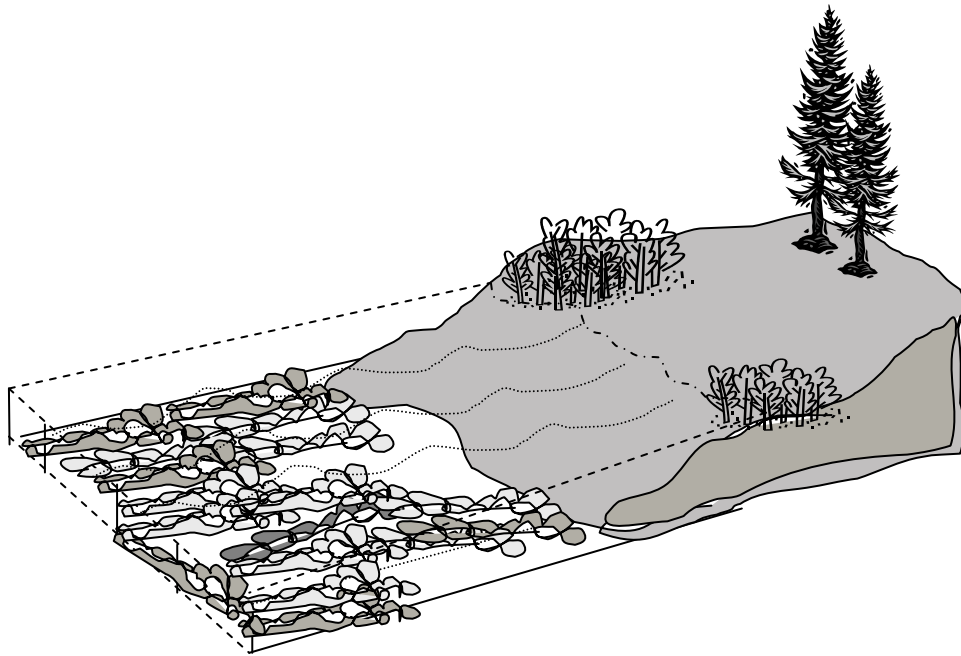
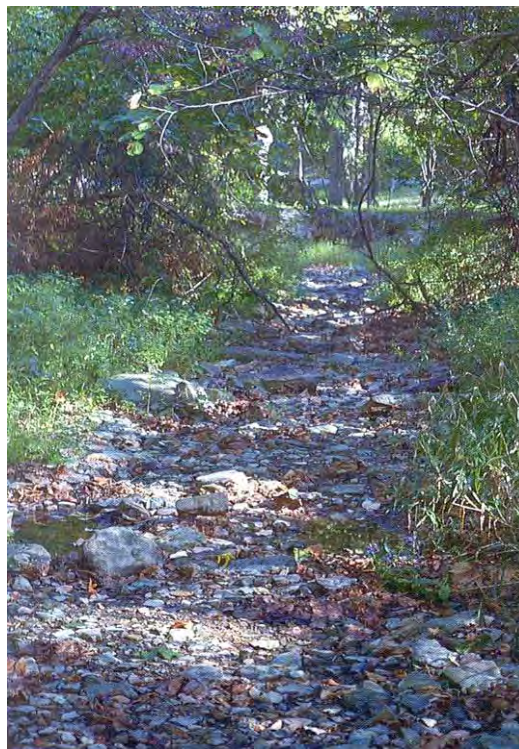
In-Stream Shallows Substrate Enhancement

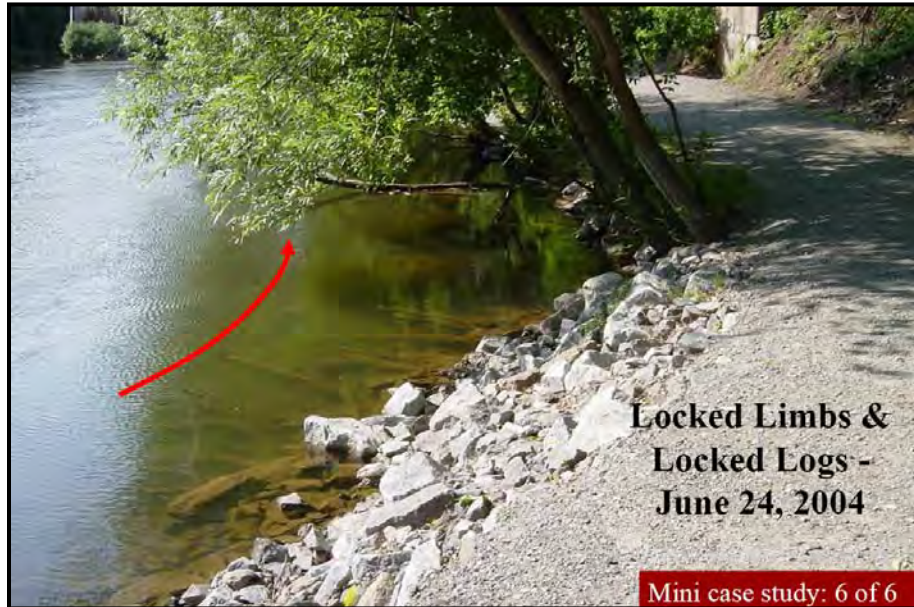
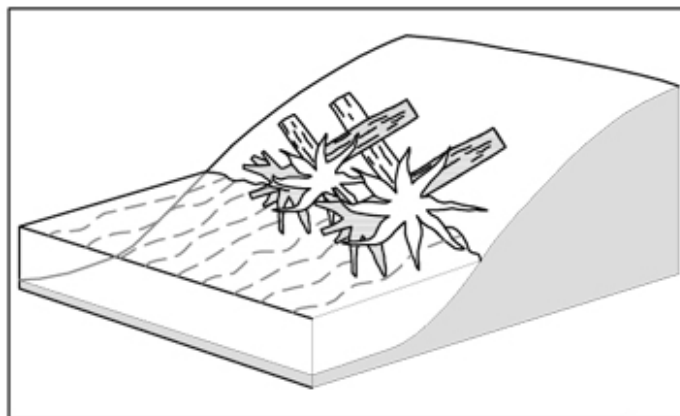
Anchored Woody Debris

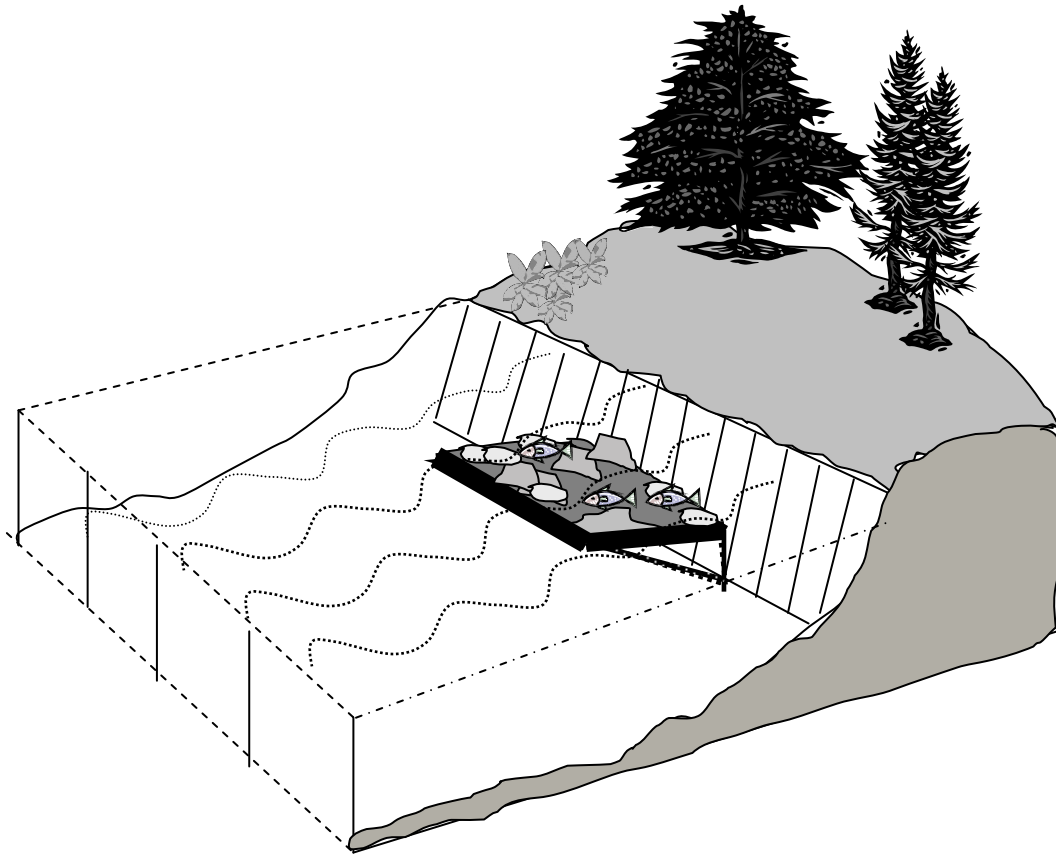
Modified Lunker Boxes

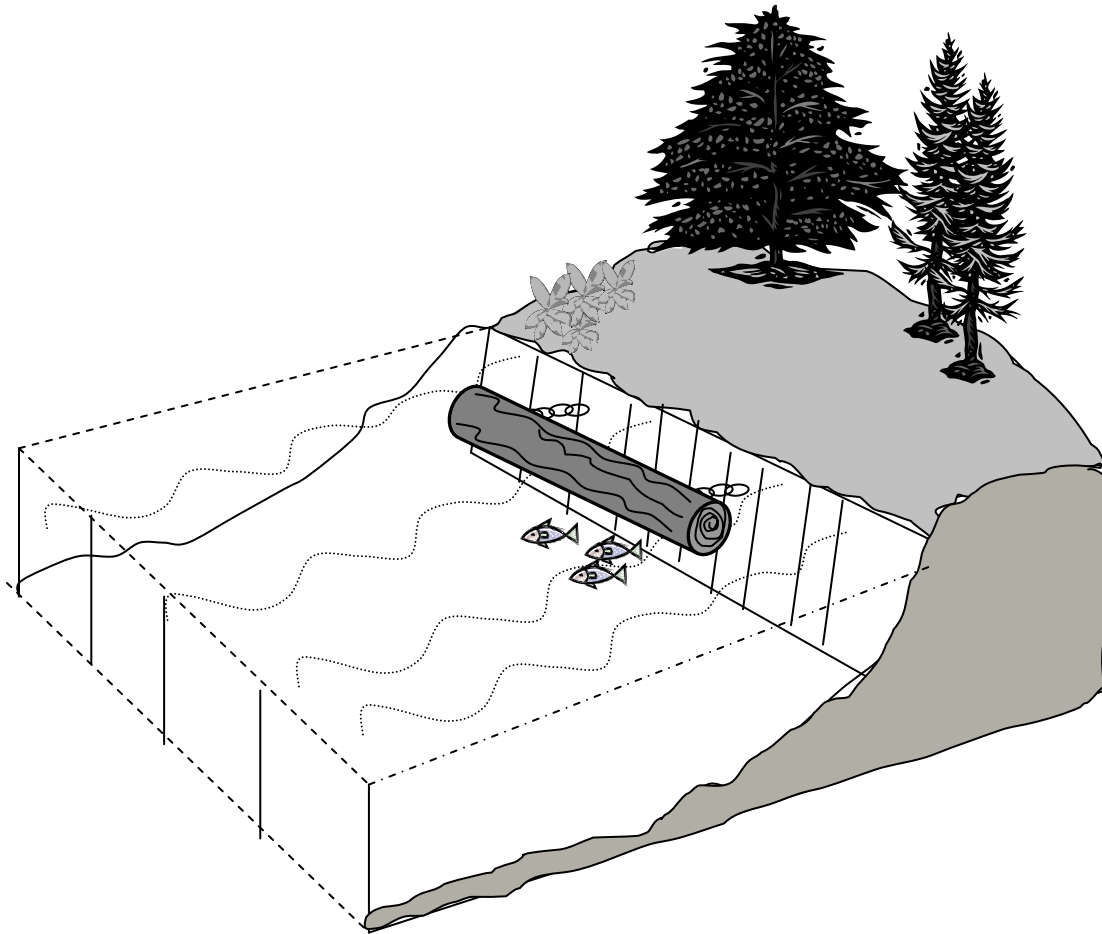
Floating Log Shelters

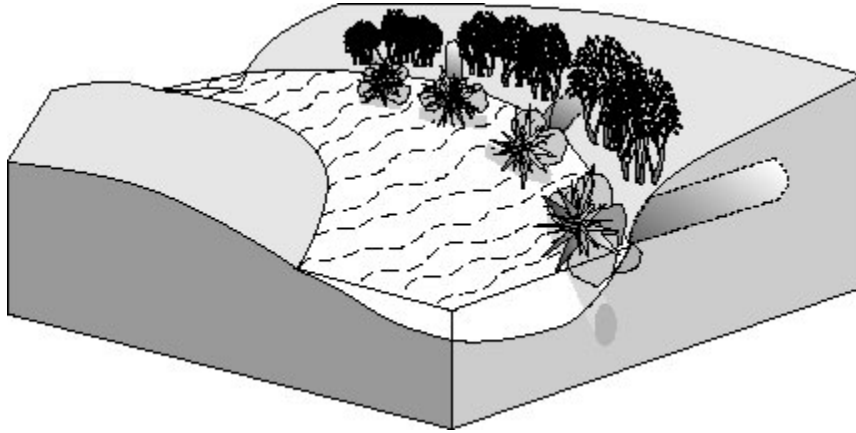
Rootwads

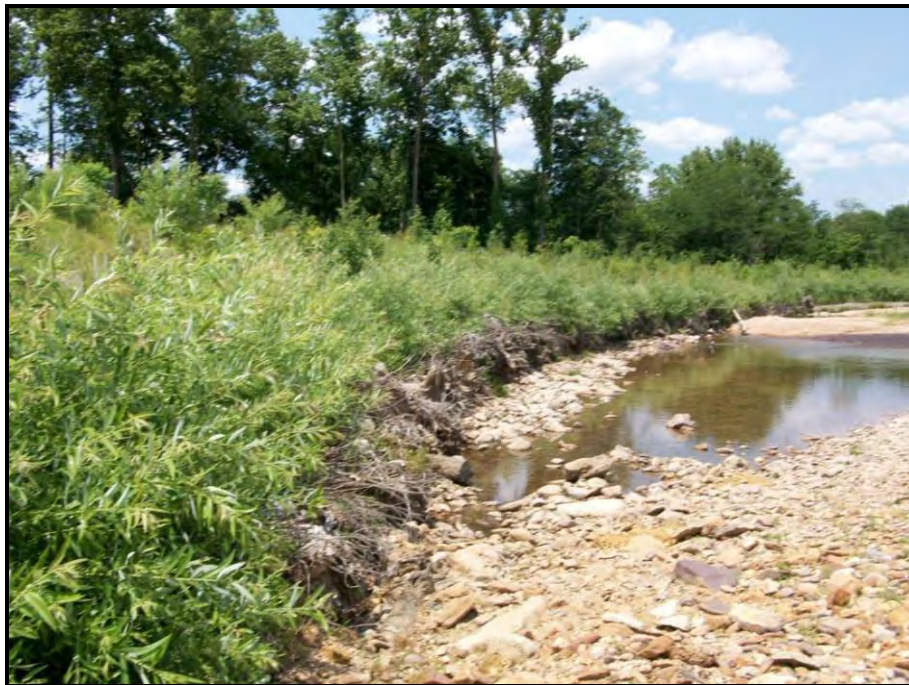
Rootwads with branch packing and live stakes after one year.

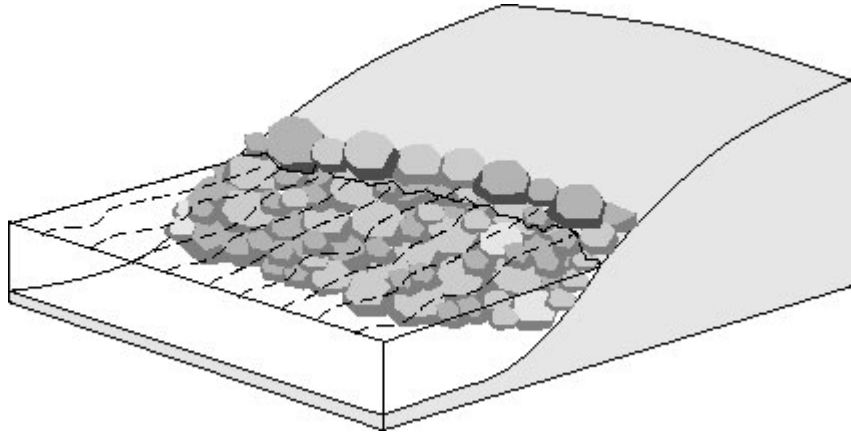
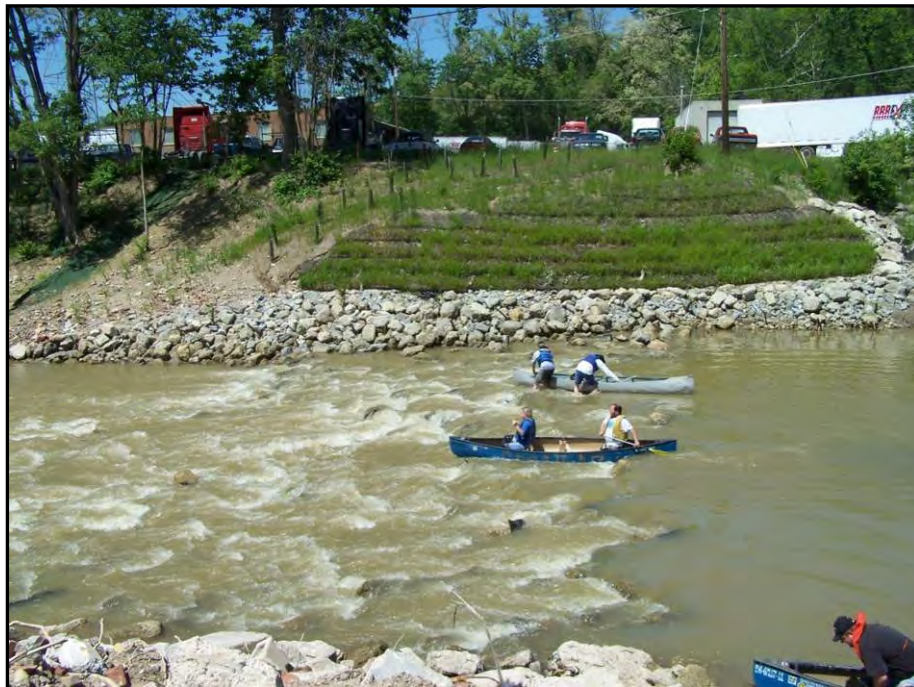
Stone Toe Protection

Rock toe with live posts, wrapped geogrid with branch packing, and riparian planting on far bank behind constructed riffle.

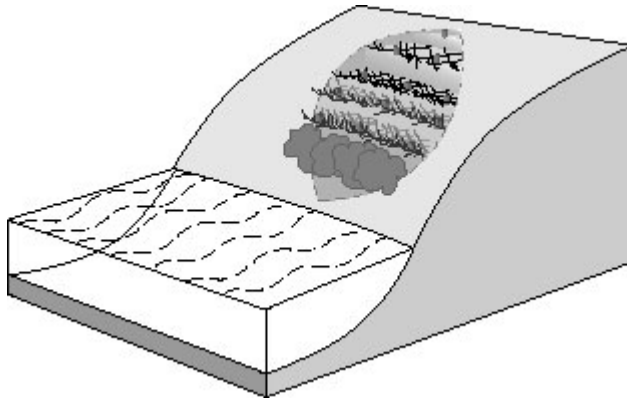
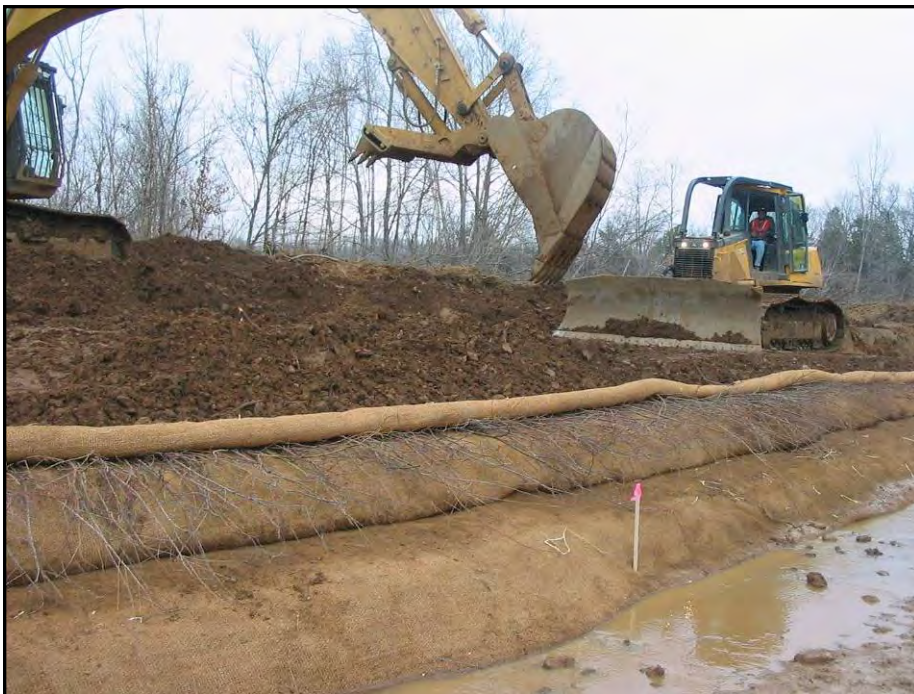
Wrapped Earth and Branch Packing

Wrapped earth with branch packing during installation.

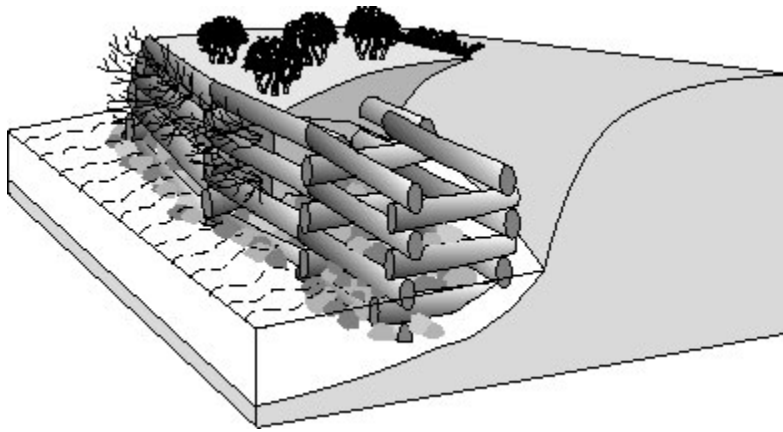
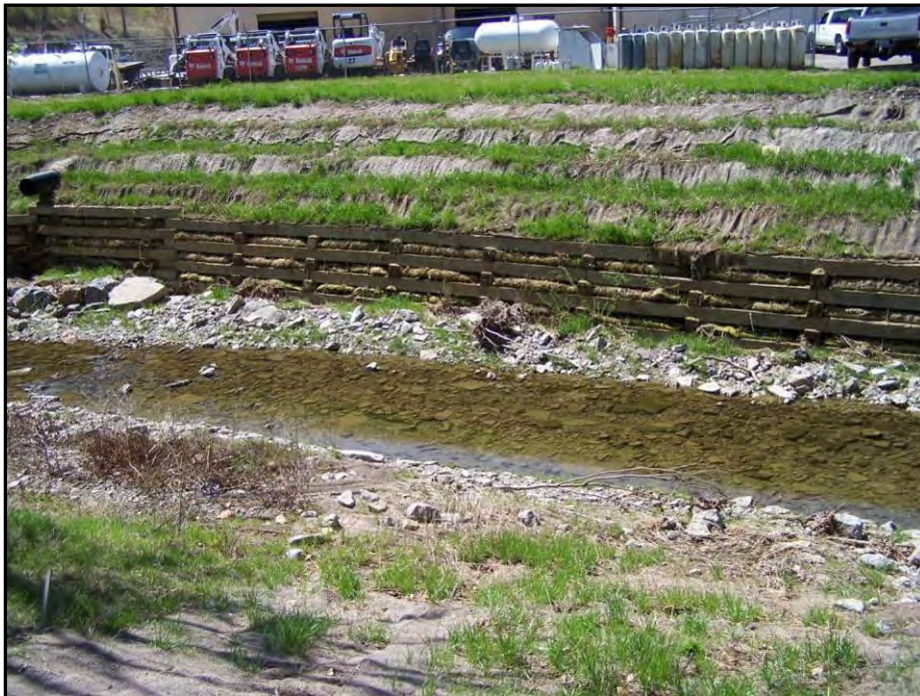
Living Crib Wall

Crib wall with wrapped earth.
