Ecology Engineering Evaluation Report Buffalo River, New York

Buffalo River Great Lakes Legacy Act Project Coordination Team

**ENVIRON International Corporation
MACTEC Engineering & Consulting, Inc.**

May 21, 2010

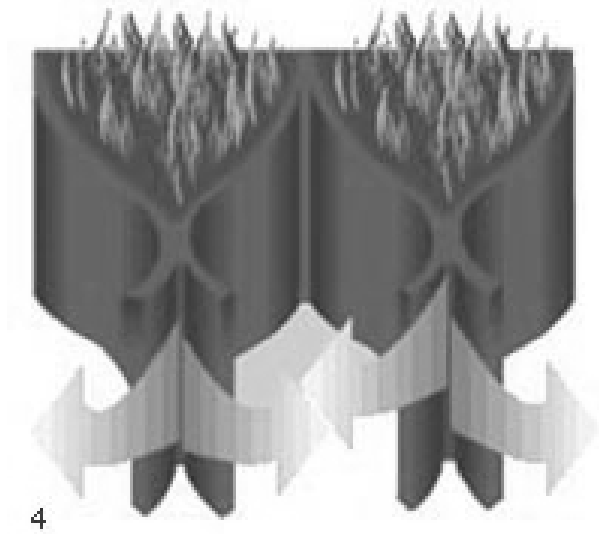
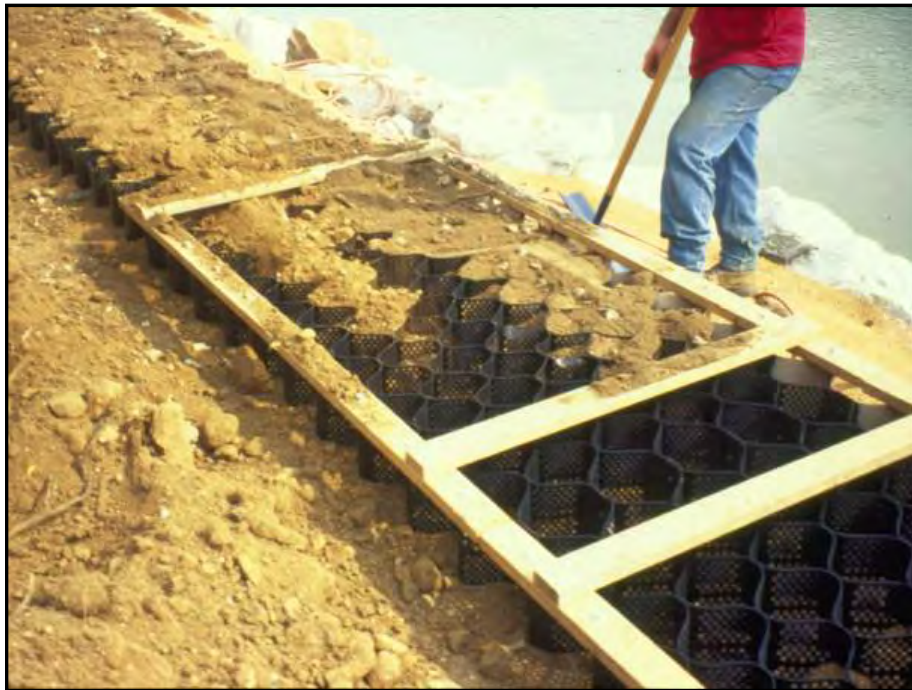
Geocells during installation.

- Kelly Island. Existing conditions include a concrete slab shoreline that extends below the water line. Wildlife were observed perching on the few pilings that were present. Proposed restoration includes: enhancing submerged aquatic vegetation (SAV), enhancing emergent vegetation (EV), placing gravel or in-stream substrate to improve available fish spawning habitat, and replacing any pilings that may be removed during remedy implementation. In the long term, local groups may work with the property owner to determine if the owners would be willing to consider riparian zone restoration (e.g., replacing the landscaping trees with a vegetated buffer) and alternatives to the apron and concrete shoreline (e.g., Geocells).
