**REMEDIAL INVESTIGATION (RI) REPORT**  
**VOLUME I: Report Text and Appendices**

**15-ACRE PRAXAIR SITE**  
**137 47<sup>TH</sup> STREET**  
**NIAGARA FALLS, NEW YORK**

**REMEDIAL INVESTIGATION OF 15-ACRE PRAXAIR SITE  
137 47th STREET  
NIAGARA FALLS, NEW YORK**

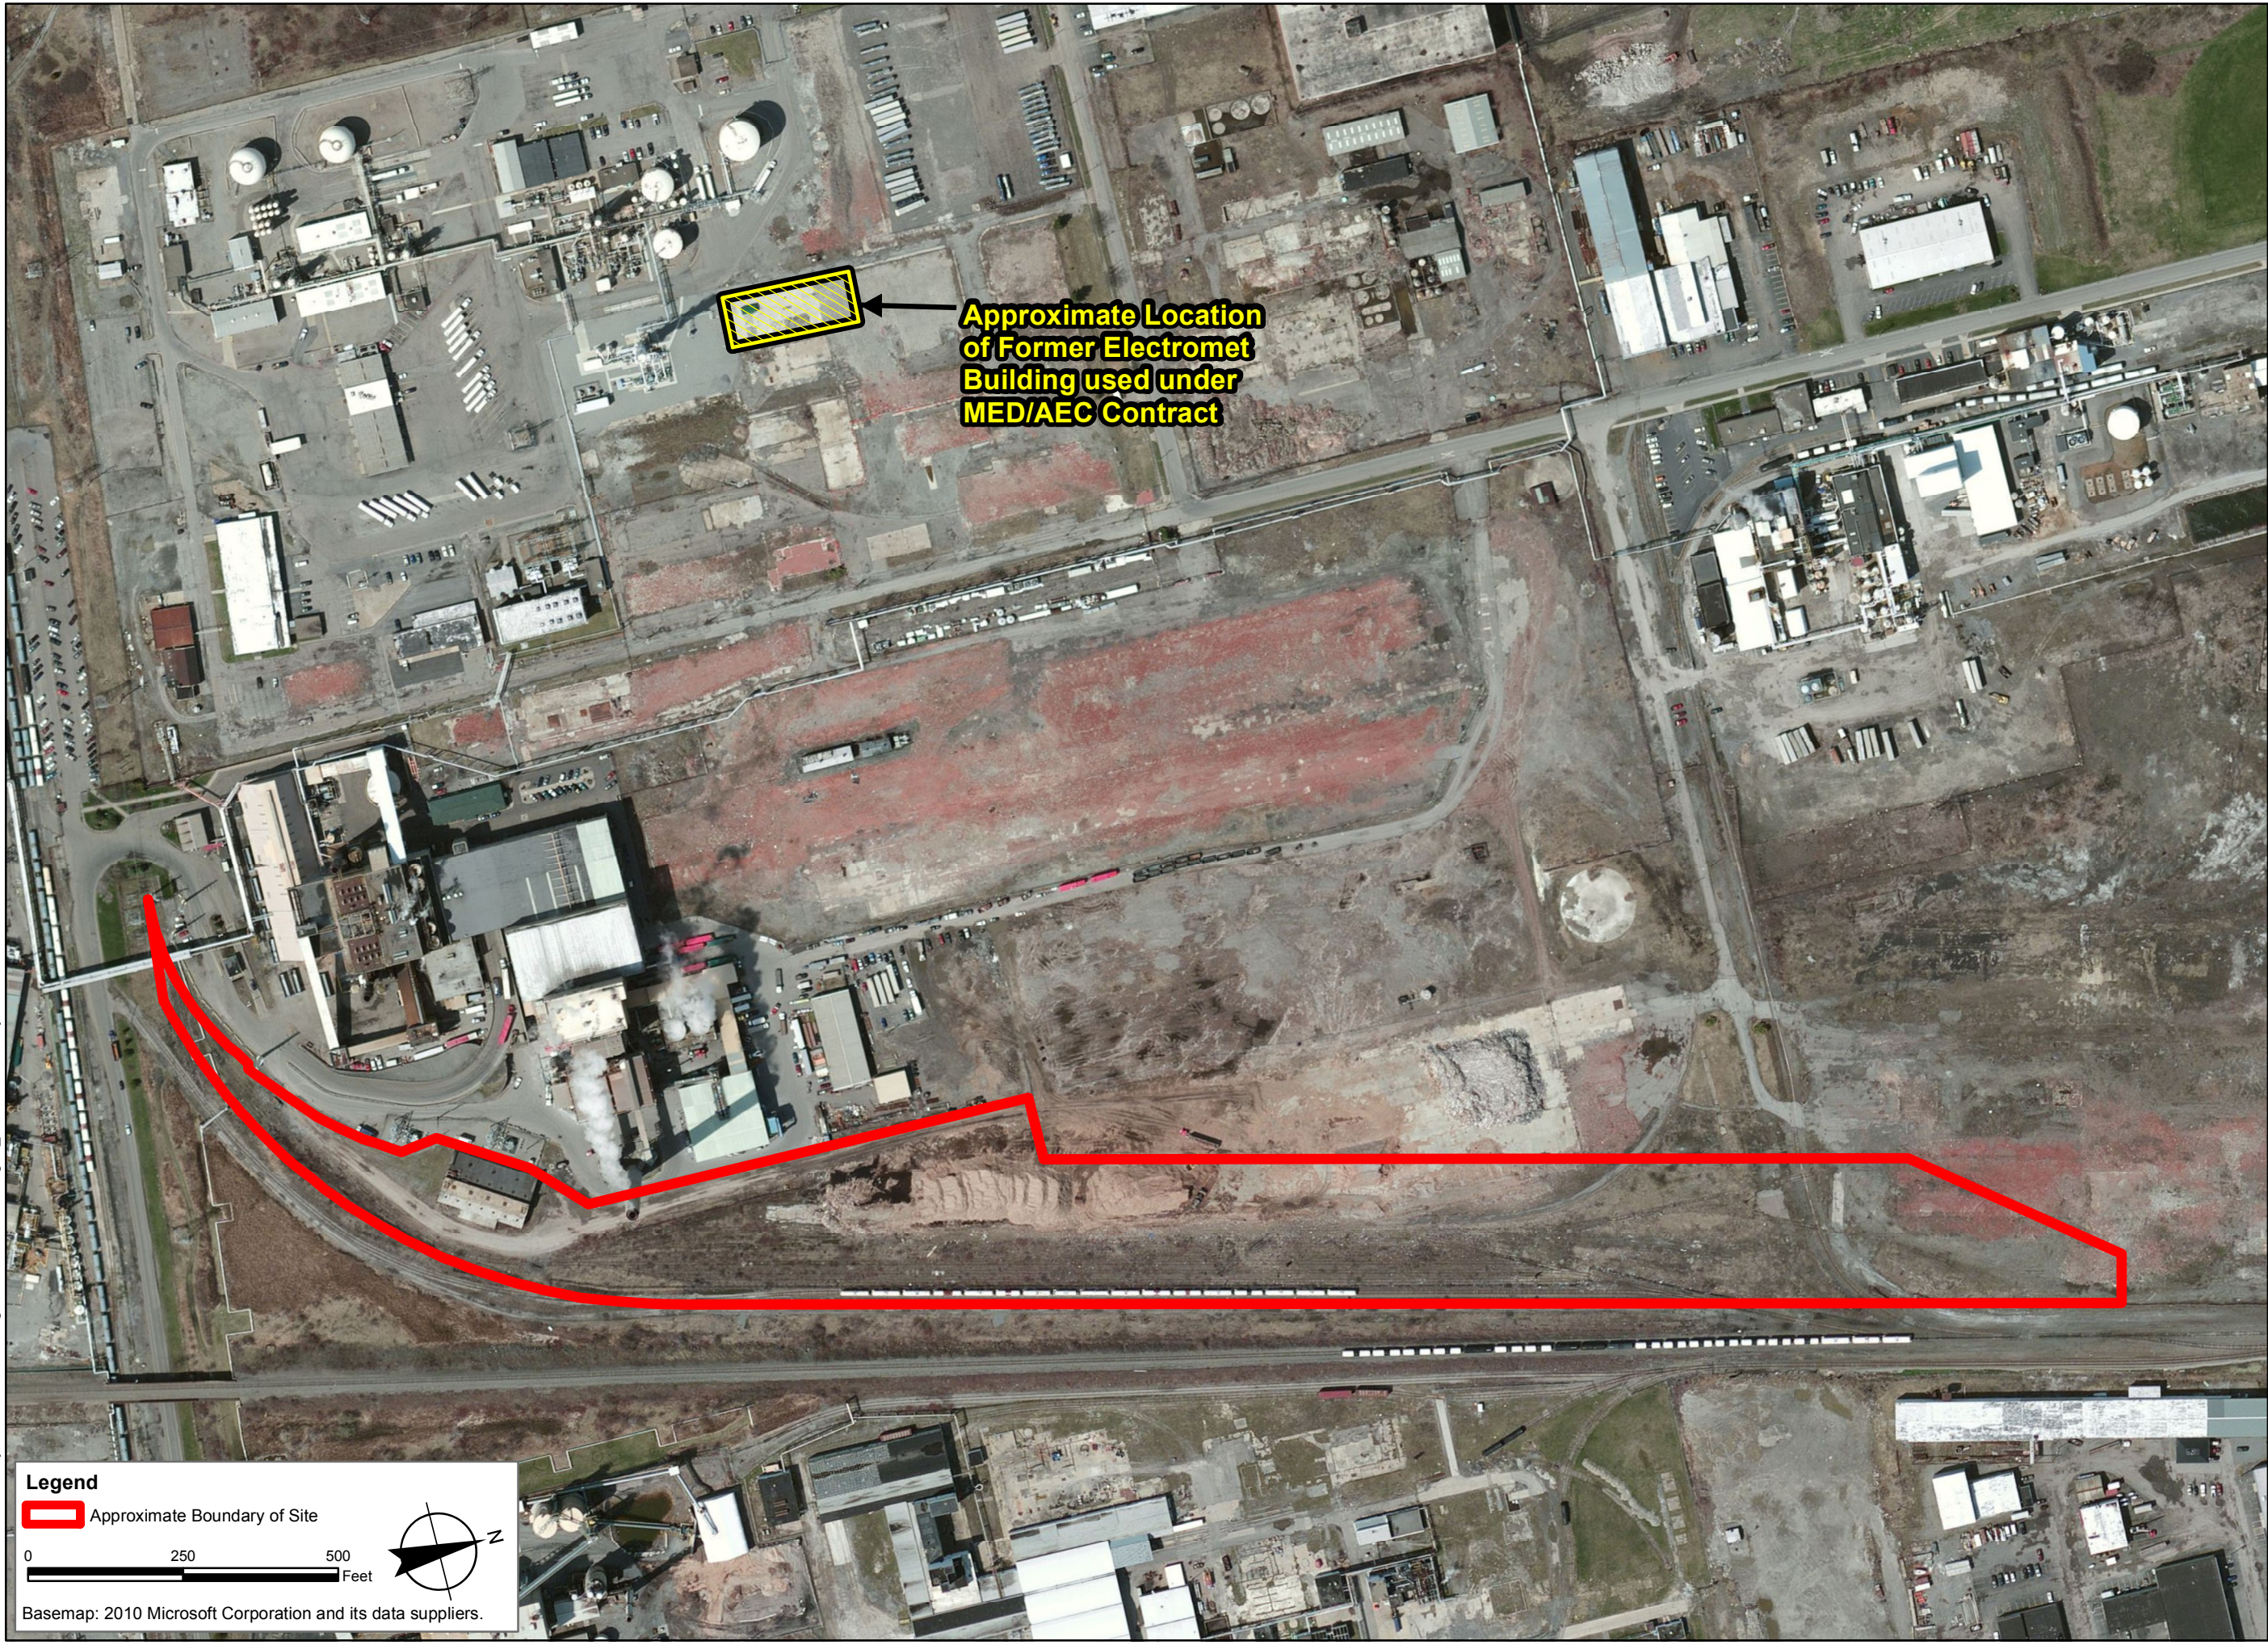
**FIGURE 2A**

**Approximate Location  
of Former Electromet  
Building used under  
MED/AEC Contract**

In 1942, the Atomic Energy Commission (AEC) and Manhattan Engineer District (MED) contracted for the construction and operation of a facility on the Union Carbide plant property that came to be known as Electromet. The Electromet facility produced uranium metal from uranium tetrafluoride by reacting it with magnesium in induction furnaces. The uranium metal was recast into ingots that were shipped off-site for testing or rolling. Process residue, including dolomite slag, uranium chips and crucible dross, was shipped to other sites for uranium recovery, storage or disposal. Electromet also recast scrap metal, supplied calcium metal to other facilities and conducted research and development activities. In 1948, Electromet became a subsidiary of the Union Carbide Metals Division called the Electro Metallurgical Company, and the last casting of uranium was conducted in 1949. The facility was reactivated in 1950 for casting zirconium metal sponge into ingots. During the early 1950s, portions of the facility were used under contract to the AEC for research and development activities that may have involved uranium, as well as titanium processing. The MED/AEC operations took place in one building that was demolished in 1957. This building was formerly located approximately 1,250 feet to the west of the project site as shown by Figure 2A. Additional information concerning historical radiological surveys of the Electromet facility is presented in Section 1.2.5 of this report.

A March 1980 Oak Ridge National Laboratory report summarizing a preliminary survey of the Union Carbide Corporation – Metals Division Plant (formerly the Electromet Corporation Plant) indicates that a portion of the plant site was utilized under the Manhattan Engineer District (MED) contract during the period of 1943 through 1946. According to the report, drums of green salt (uranium tetrafluoride) were received from the Linde Air plant in Tonawanda, New York, reacted in furnaces, converted into metal and then recasted into ingots. This process was reportedly performed in a portion of the plant that is situated to the west of 47<sup>th</sup> Street, west of the project site (see Figure 2A). The report also indicates that waste from the operation was disposed at the Lake Ontario Ordinance Works depot, and that residues of dolomite slag liners, uranium chips and crucible dross were shipped to other sites for uranium recovery. The preliminary survey detected slightly elevated radiation levels between two buildings on the Electromet Plant property to the west of 47<sup>th</sup> Street and recommended the collection of additional measurements to define the extent of the elevated readings in this area.

A follow up survey was conducted by the Oak Ridge National Laboratory in September 1980, the results of which were summarized in a report dated December 1980. This survey focused on the area of elevated measurements detected during the previous survey, which occurred in an area of the plant referred to as the "Technology Area" situated to the west of 47<sup>th</sup> Street (the former Electromet building shown in Figure 2A is located within the technology area). The survey detected wide-spread contamination over an extensive portion of the Technology Area, with relatively high concentrations of gamma-emitting radionuclides in localized areas, including areas occurring along two railroad spurs traversing the property. The radionuclides were associated with the thorium and uranium decay chains. The report indicates that thorium-bearing ores were used during operations at the plant, but that these operations were unrelated to MED/Atomic Energy Commission (AEC) activities. Therefore, the report concluded that the contamination was not likely related to MED/AEC activities, which were limited to reacting of uranium tetrafluoride to uranium metal. The report also recommended the completion of a detailed radiological survey of the Technology Area. No records of a subsequent radiological survey of this area were obtained during the course of this RI.
