# FREUDENTHAL & ELKOWITZ CONSULTING GROUP, INC.

Re: Phase II Environmental Site Assessment Report Industrial Property 71 Clinton Road Incorporated Village of Garden City, New York 368 Veterans Memorial Highway
Commack, New York 11725
Tel: (631) 499-2222
Fax: (631) 499-5928

# Figure 1 - Site Details

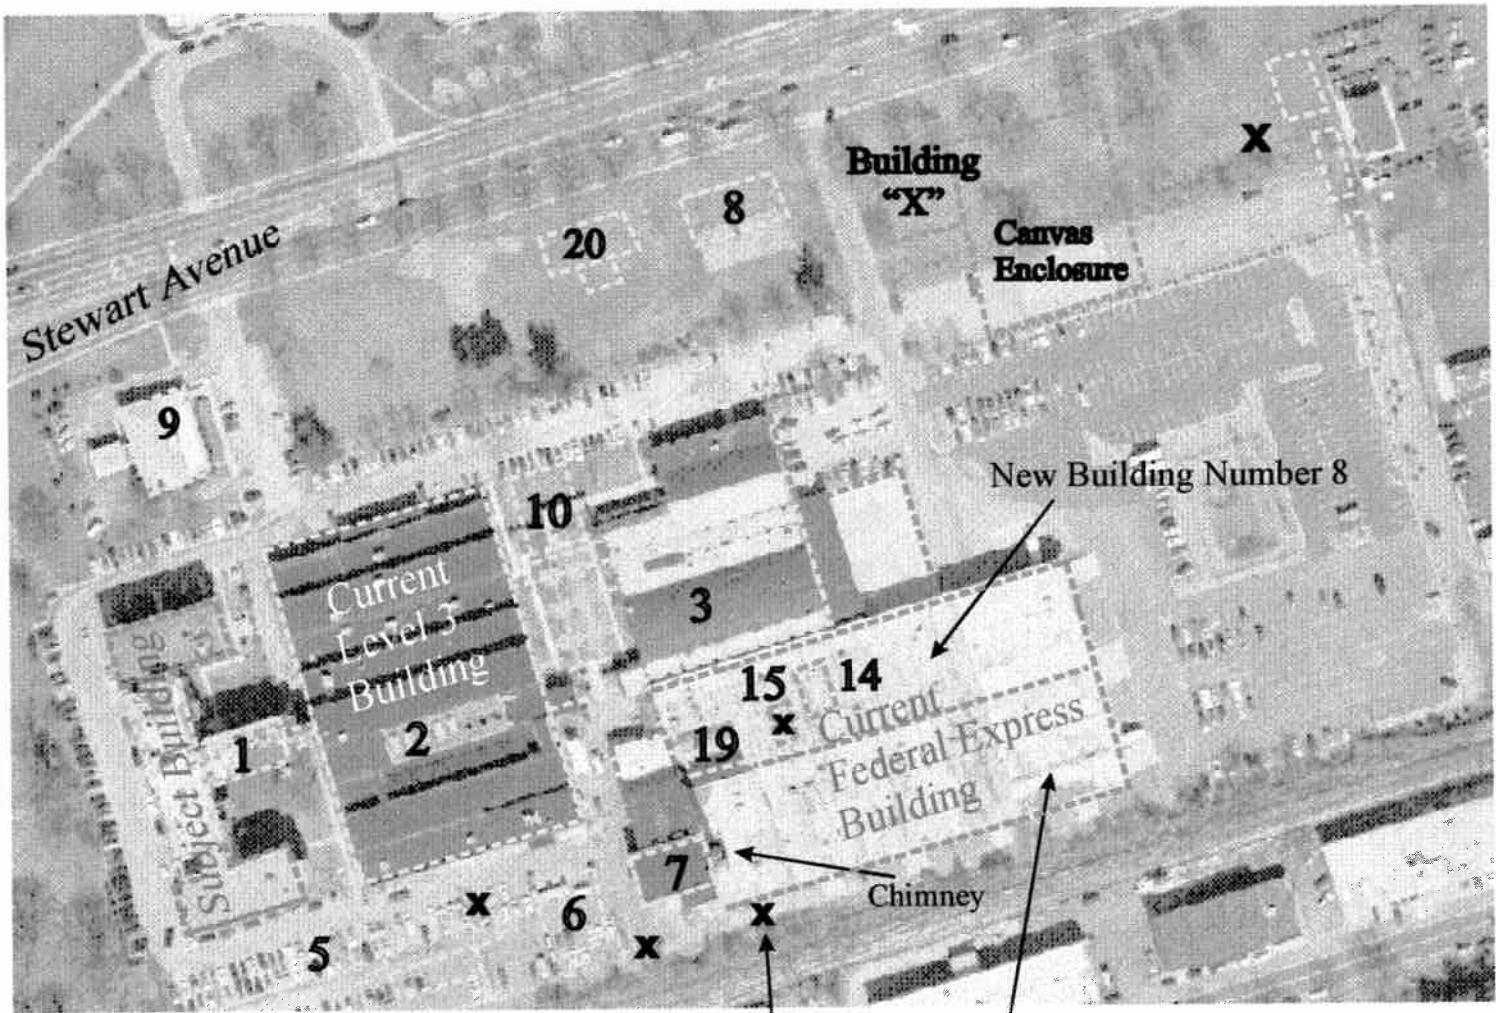
20,000 gallon No. 2 UST

Buildings present in 1925

New Building Number 10 erected by Oxford Filing Company

- Buildings erected by Sperry Gyroscope until 1944
- Buildings erected after 1948.
  - **x** Historical tank locations according to Plot plans and Sanborn maps.

2001 Aerial photograph provided by the New York State Geographical Information System orthoimagery database.

The geophysical survey was conducted utilizing ground penetrating radar (GPR), magnetometer and cable-avoidance tool techniques. As indicated on Figure 1 and Table 1, there were five locations where historic records indicated the presence of USTs. One location was within the existing Federal Express building while a second location was off of the site to the northeast. These two locations were not investigated during the geophysical survey. The reported locations of three USTs situated in the southern parking lot were evaluated as part of the geophysical survey.
