SUPPLEMENTAL REMEDIAL INVESTIGATION REPORT

FORMER NUHART PLASTIC MANUFACTURING SITE

280 FRANKLIN STREET, BROOKLYN, NEW YORK NYSDEC SITE #224136

OCTOBER 2015

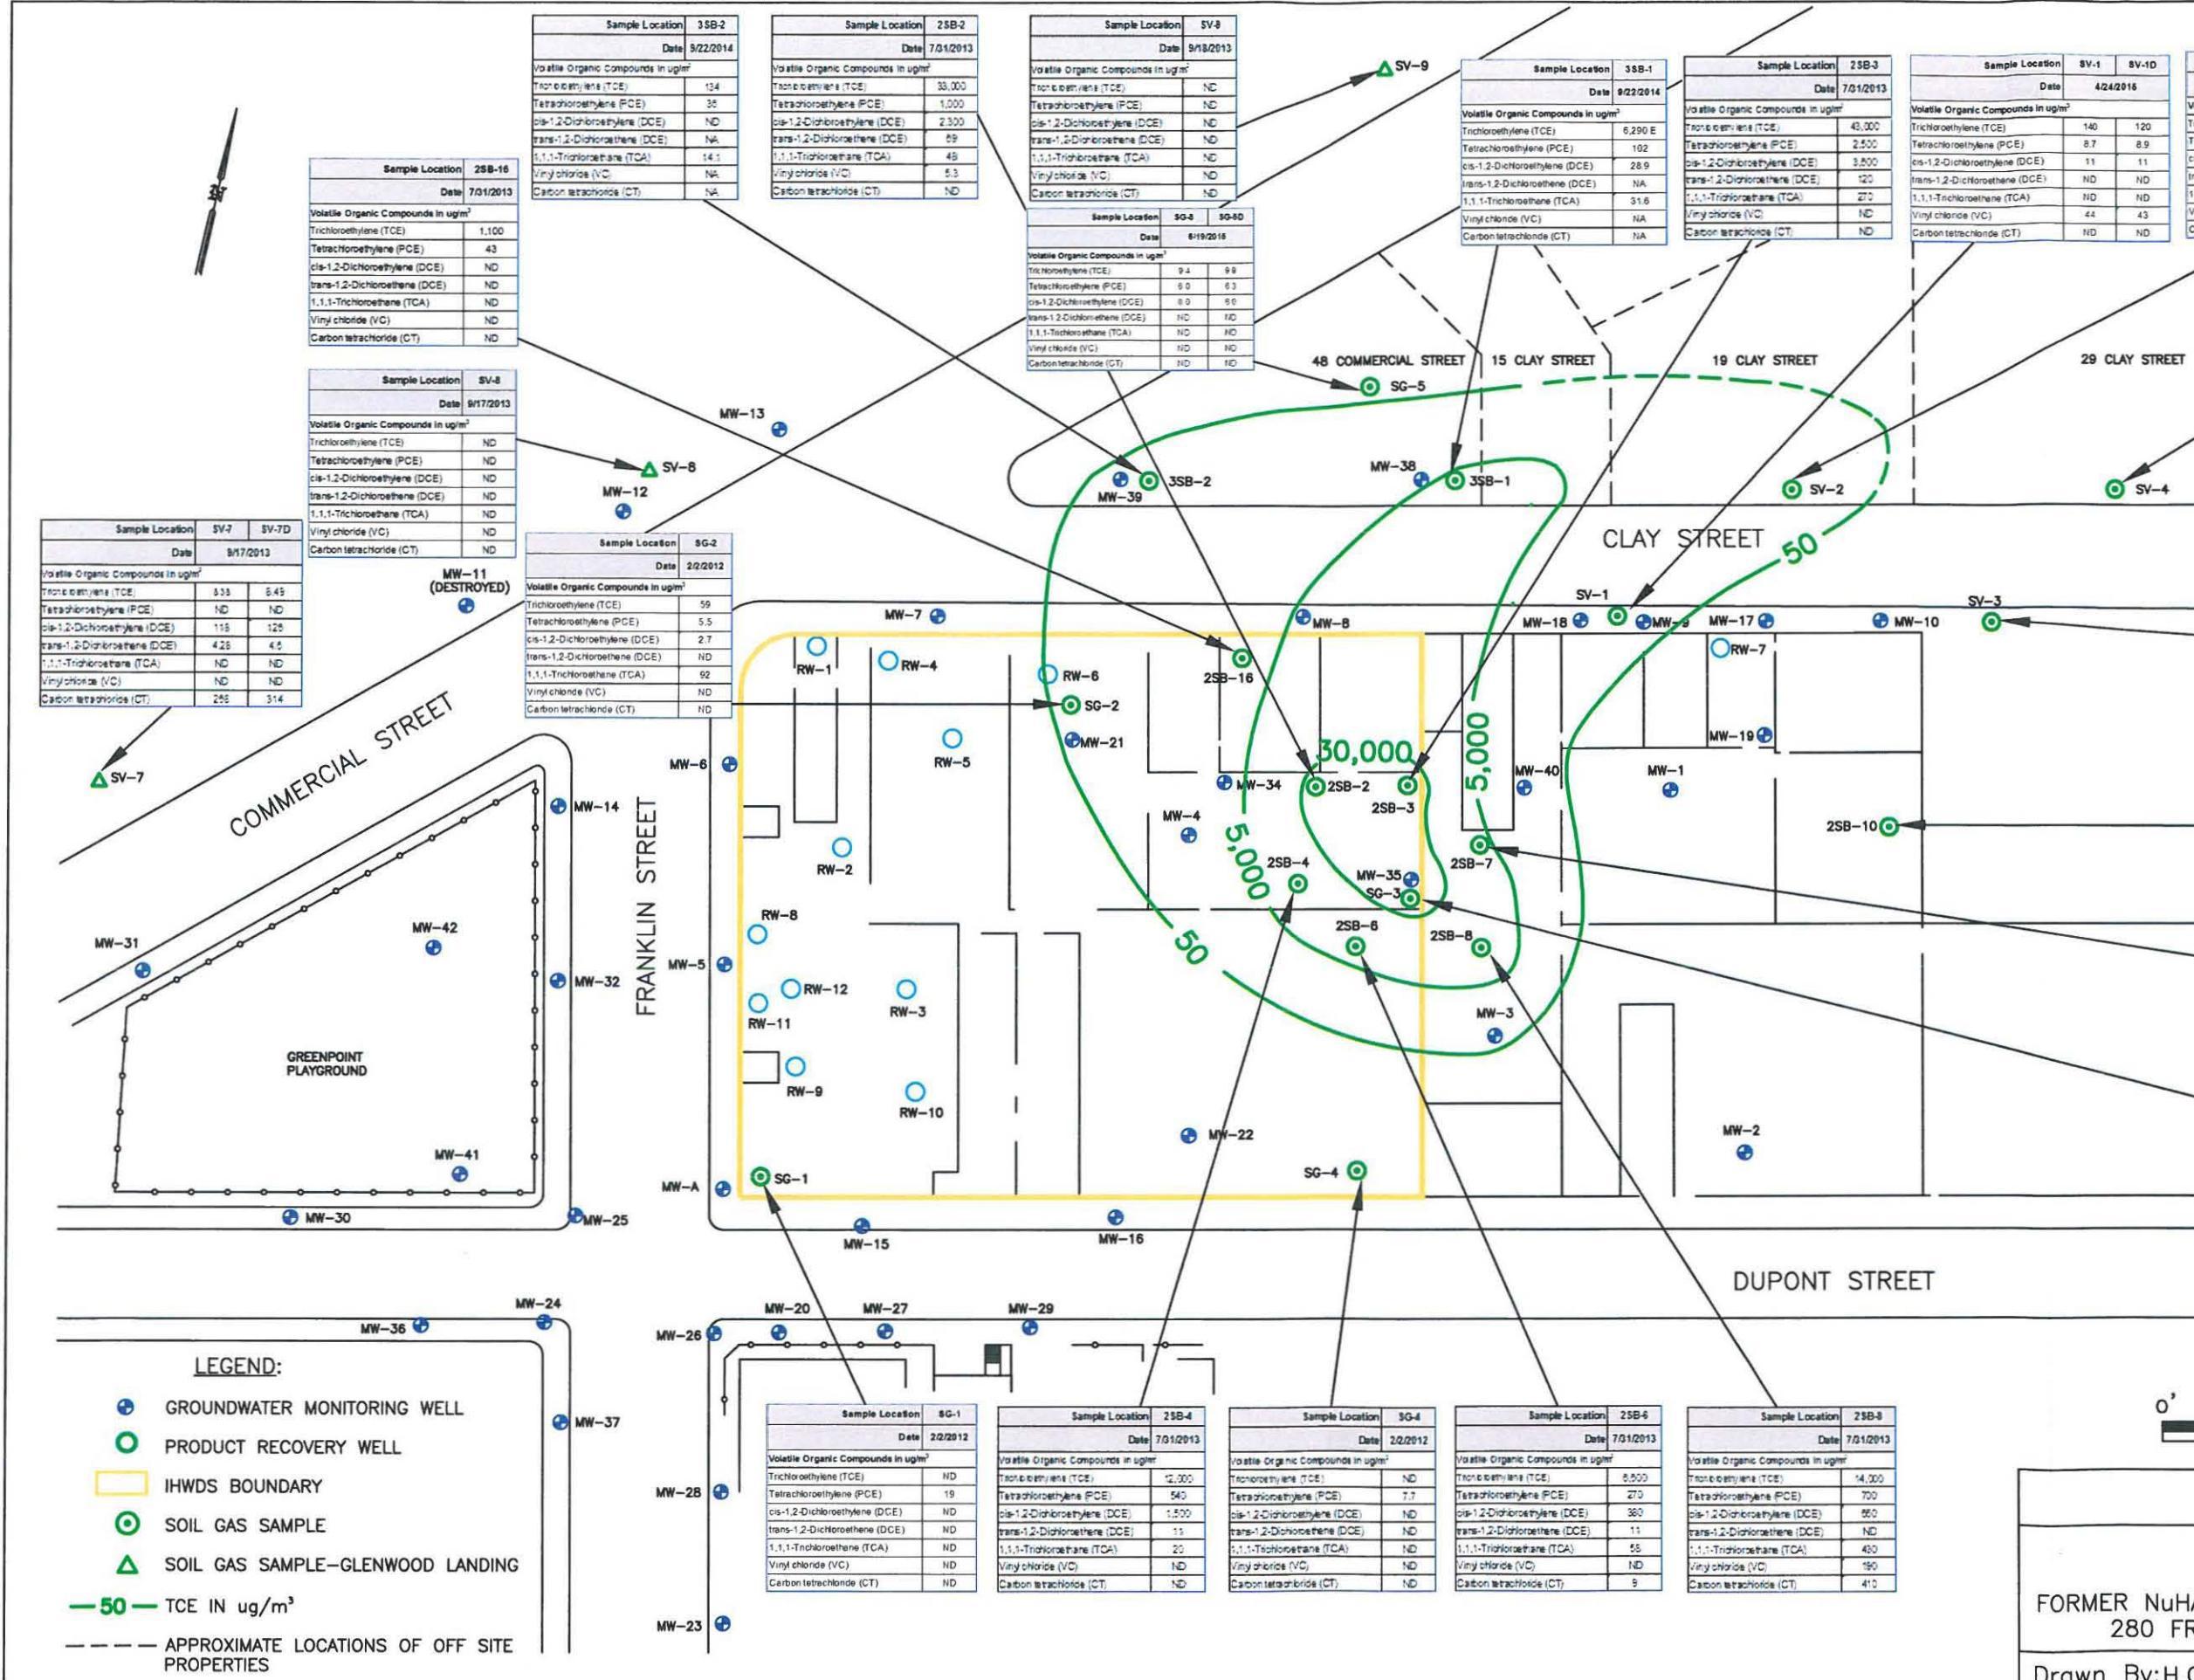
TCE and/or tetrachloroethylene (PCE) were detected at the SV-1 through SV-3 locations and at the SG-5 location at up to 1,100 µg/m³ and 8.9 µg/m³, respectively. Neither TCE nor PCE was detected at the SV-4 location. The TCE detections at SV-1, SV-2, and SG-5, when compared to the NYSDOH Matrix 1, were at levels where monitoring or mitigation could be indicated, depending on associated indoor air concentrations. None of the PCE detections were sufficiently elevated to present a potential SVI concern. The VOC cis-1,2dichloroethene (cis-DCE), a breakdown product of TCE, was found at the SV-1, SV-2, and SG-5 locations, but none of the detections was sufficiently elevated to present a potential SVI concern. Vinyl chloride (VC), a further breakdown product of TCE, was detected only at SV-1; the VC detections were at levels where monitoring or mitigation could be indicated, depending on associated indoor air concentrations. Carbon tetrachloride was found at a very low level in SV-4; this detection does not present an SVI concern.

Several other VOCs, including petroleum constituents, refrigerants, and non-chlorinated solvents, were detected at all sampling points. Most of these detections were not highly elevated and were noted to be within the typical ranges of indoor air background levels in commercial buildings, as shown on Table 3.2.4.1. Several petroleum constituent detections at SV-4, including ethylbenzene, xylenes, and toluene, were noted to be somewhat elevated. This location is on the north side of Clay Street to the east of the Site and the levels of these constituents at SV-3, closer to the Site, were lower. These detections at SV-4 are suggestive of a potential offsite petroleum source (unrelated to the Site) on the north side of Clay Street.

The benzene level at SV-1 was noted to be higher than at the other locations. SV-1 is located in proximity to petroleum Spill #0601852, which is on the former NuHart facility located just to the east of the Site. It is likely that the benzene at this location is associated with this spill.

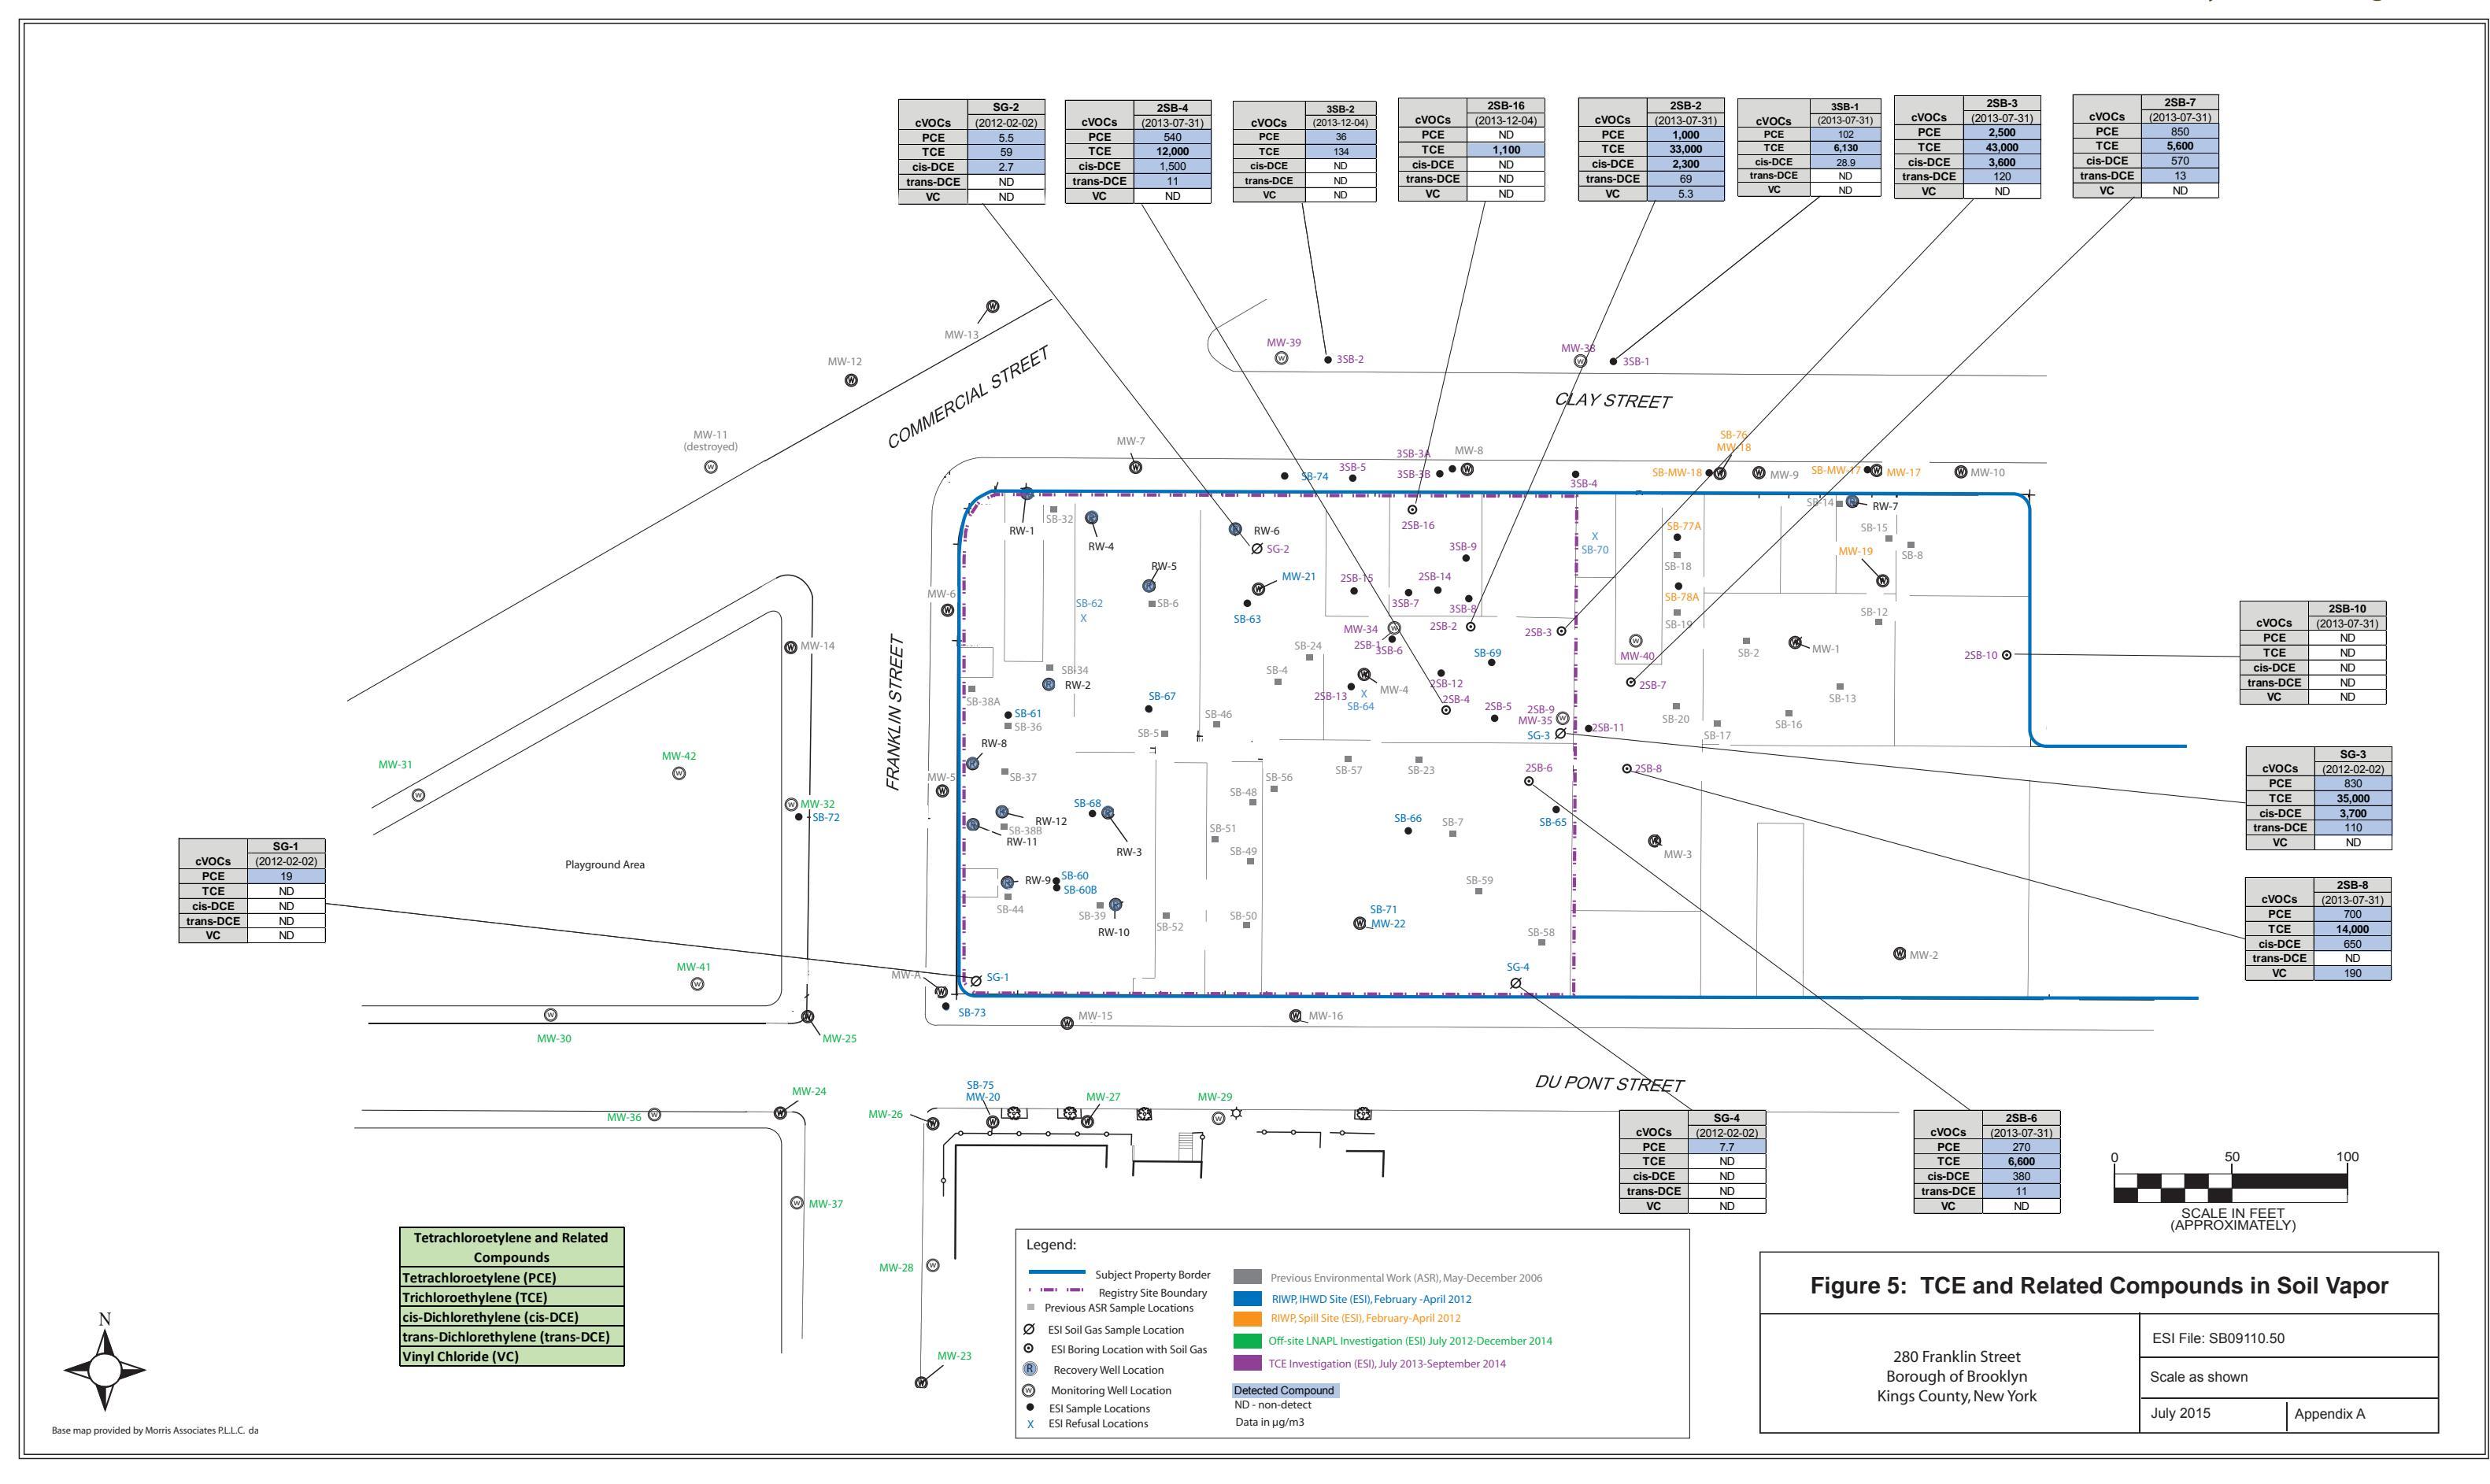
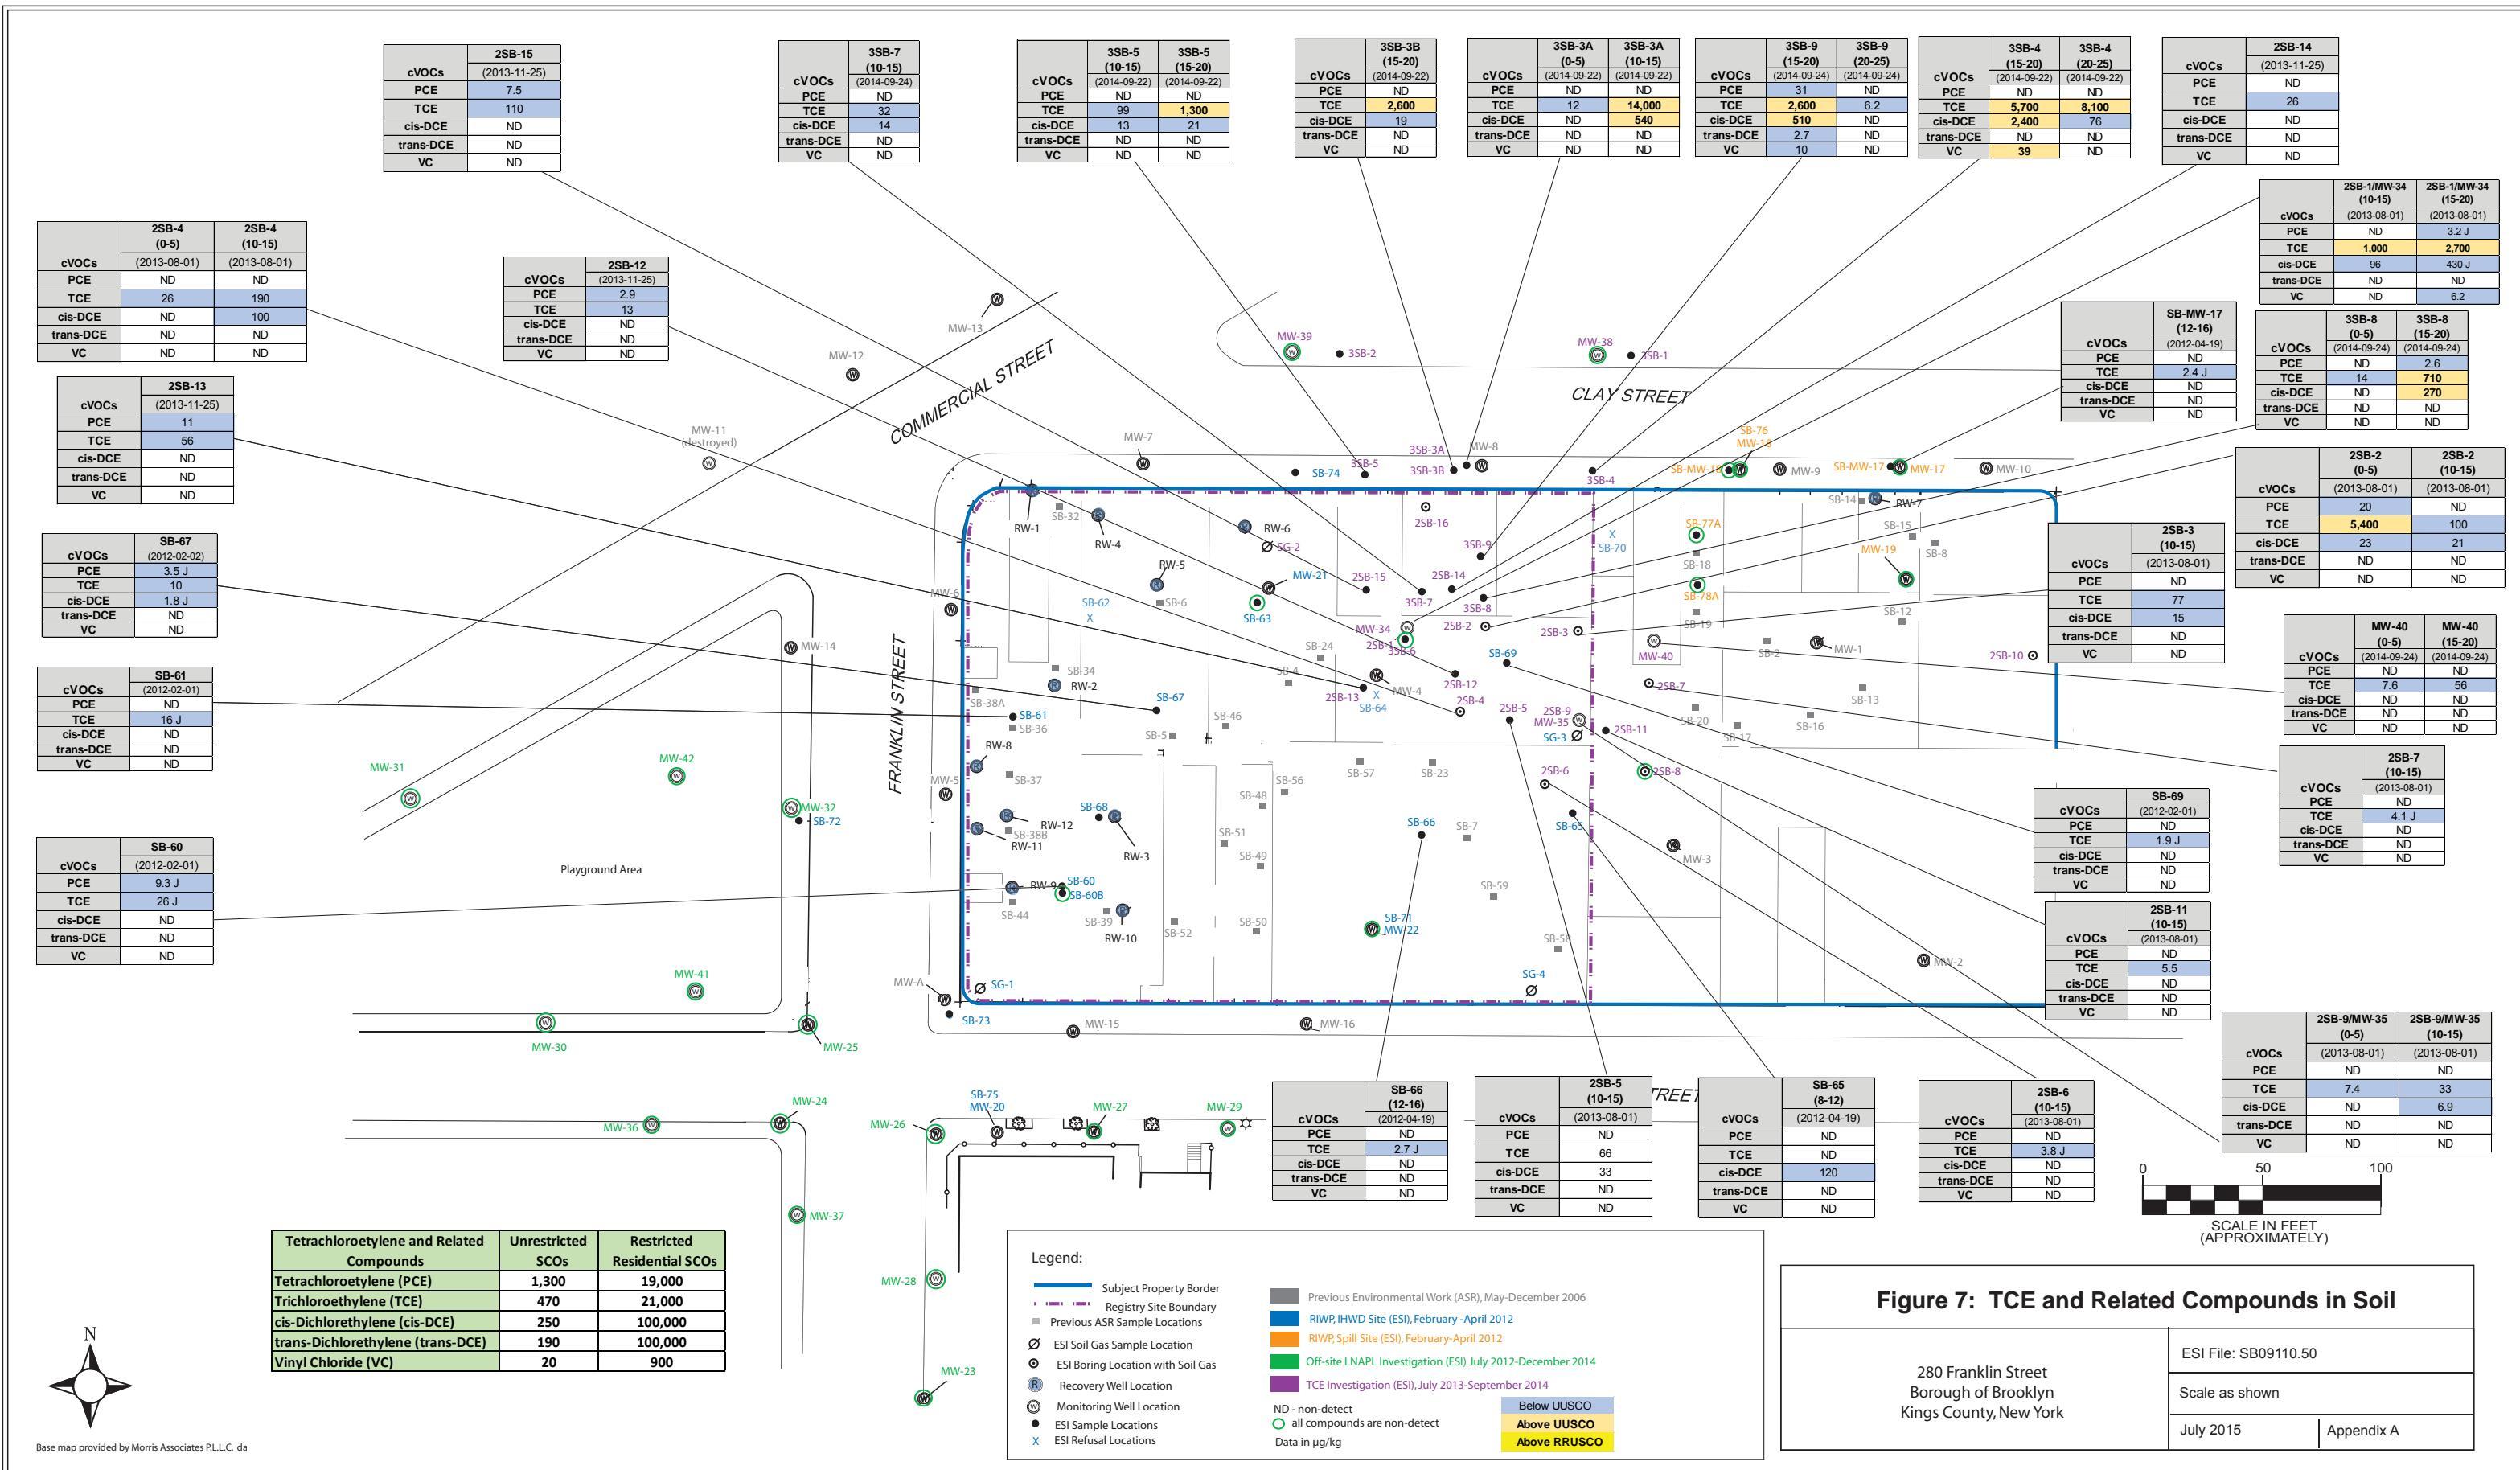
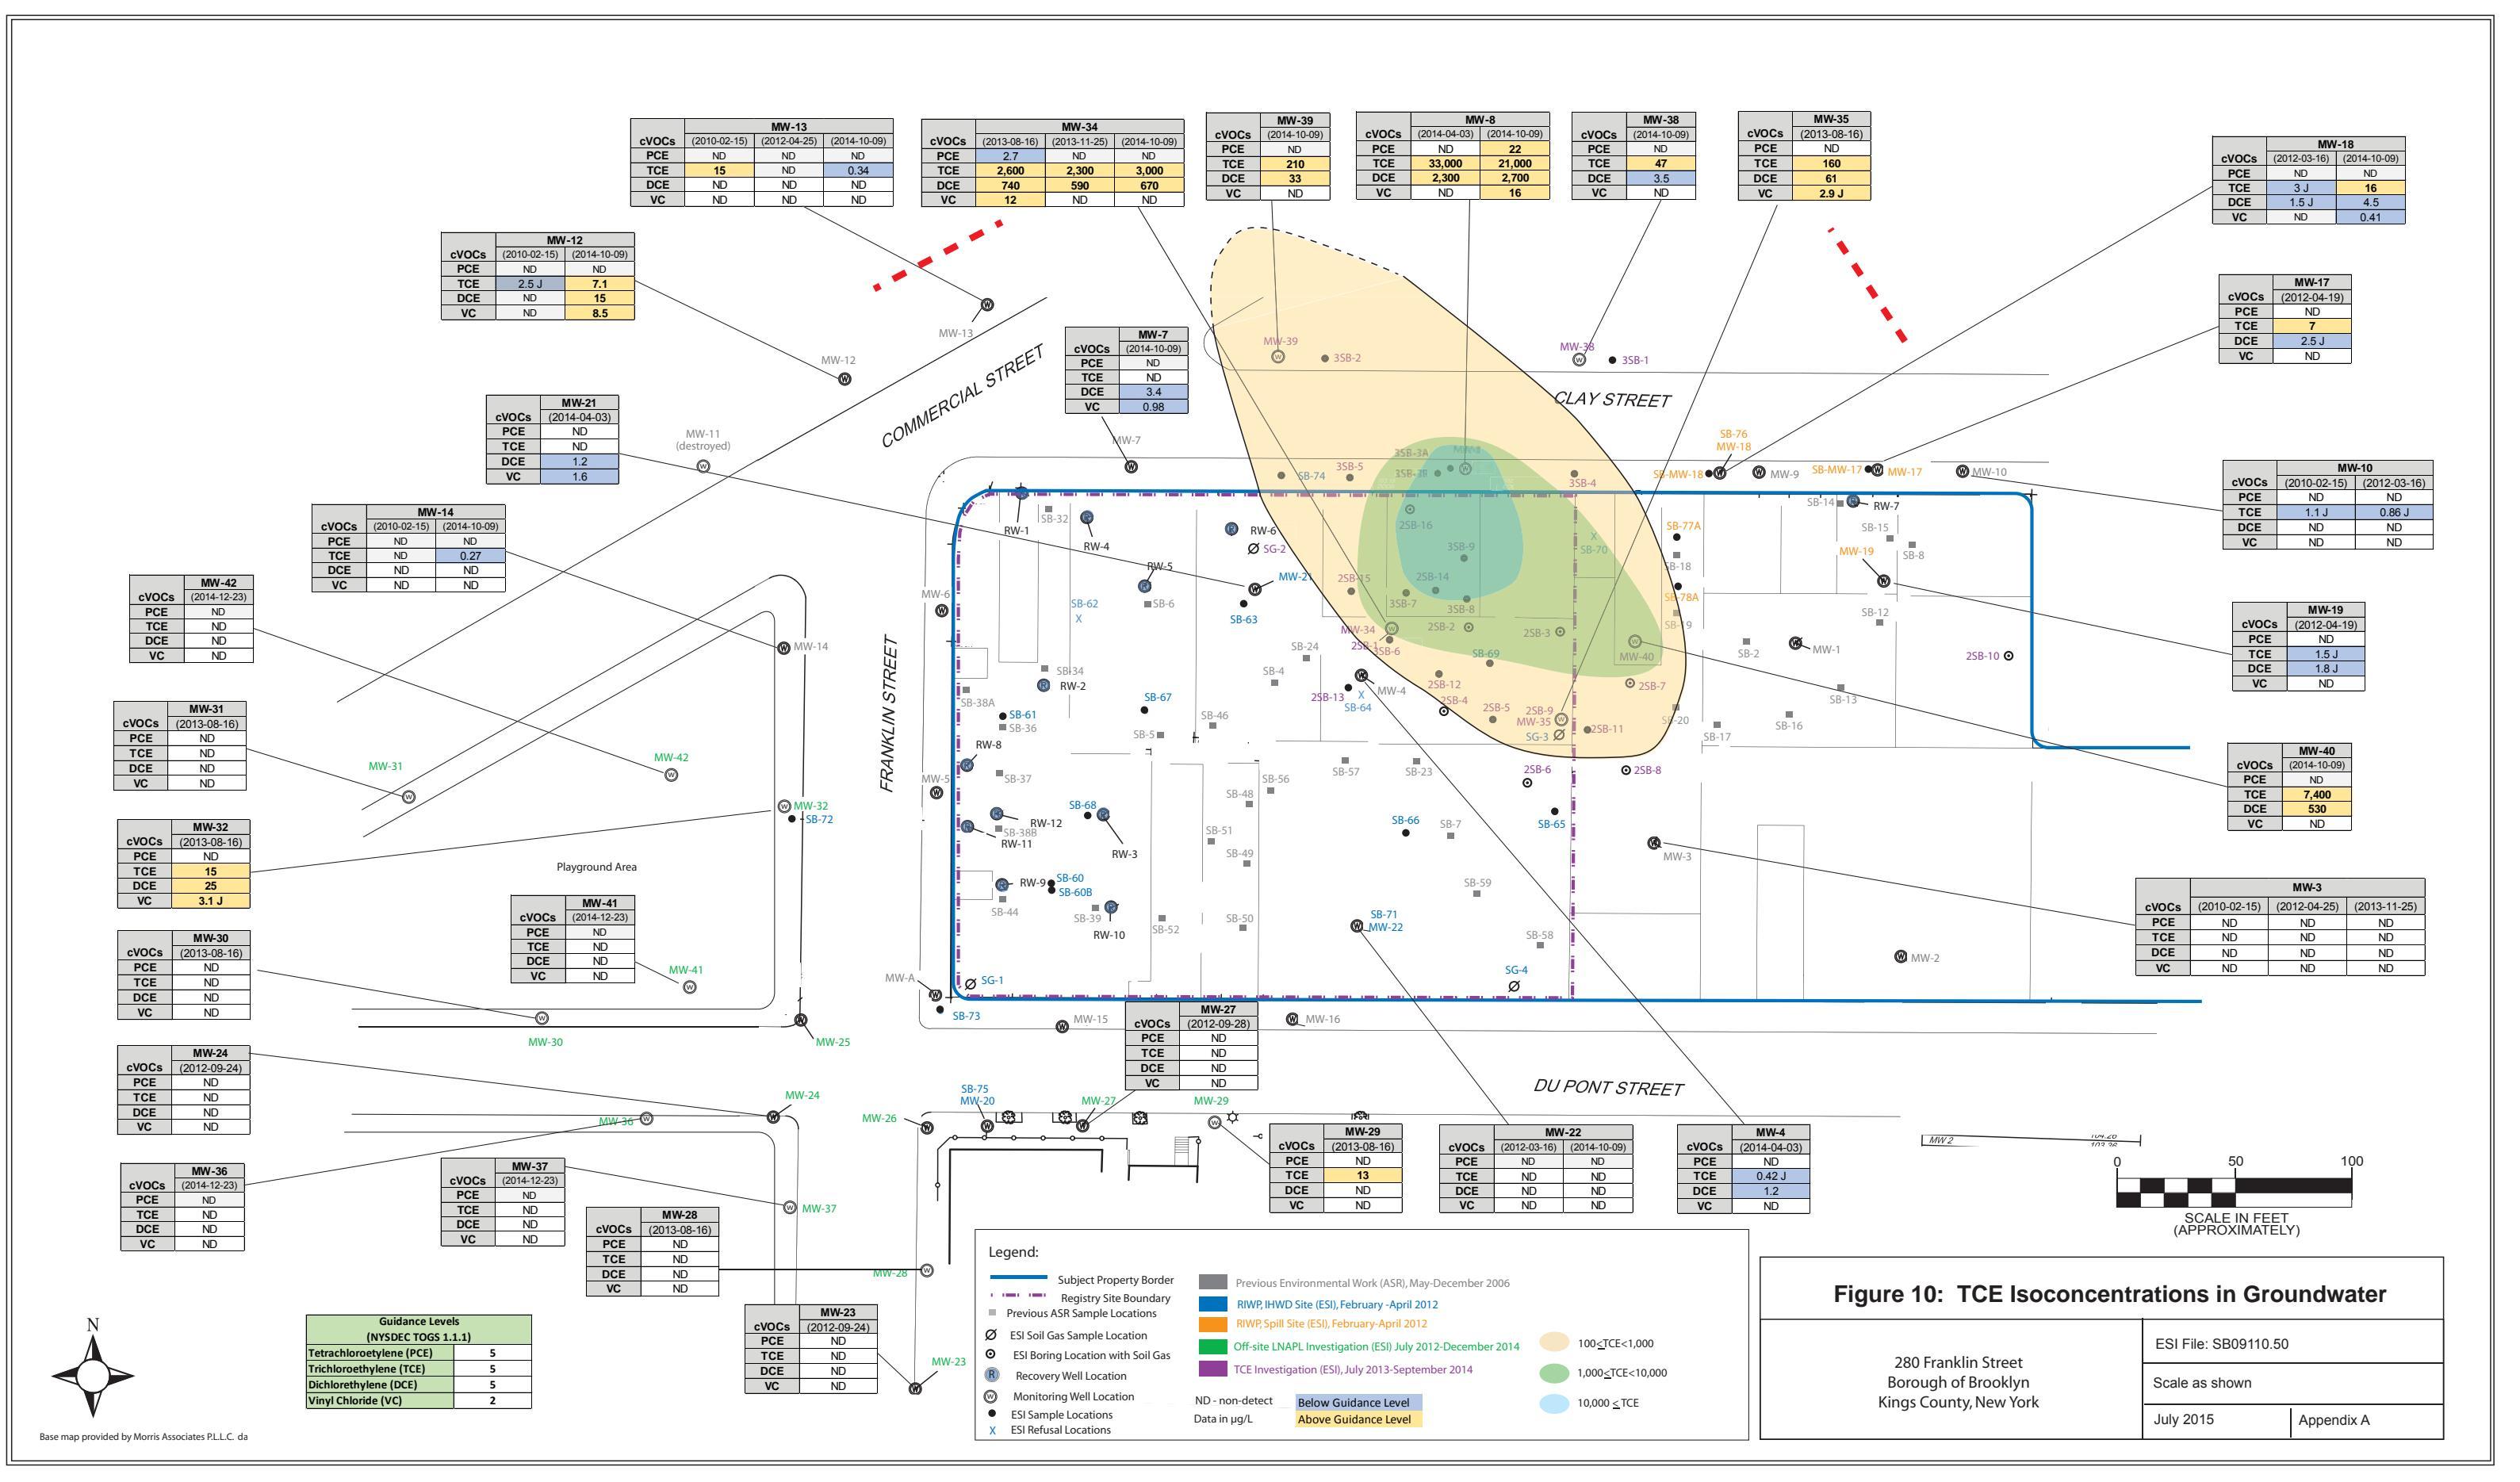
SUMMARIES OF CVOC IMPACTS

CVOC concentrations above SCOs for unrestricted use were detected in several borings performed in the northeastern portion of the Site and extending a short distance offsite to the north, beneath the sidewalk on the south side of Clay Street. The CVOCs noted to exceed the SCOs include TCE, cis-DCE, and one detection of vinyl chloride. These exceedances generally coincide with the area where the highest CVOC detections are noted in soil vapor, including locations beneath the northeastern portion of the Site and locations immediately offsite to the north, beneath the sidewalk adjoining the south side of Clay Street. No exceedances of the SCOs for unrestricted use were noted for any CVOCs elsewhere on the Site or offsite and CVOC impacts in soil have been delineated.

Concentrations of TCE, cis-DCE, and/or vinyl chloride in excess of their Standards have been detected at various times at onsite wells MW-34 and MW-35, and offsite wells MW-8, MW-12, MW-13, MW-17, MW-18, MW-29, MW-32, MW-38, MW-39 and MW-40. In general, the highest concentrations of CVOCs are detected at onsite well MW-34 and offsite wells MW-8 and MW-40, located immediately north and east, respectively, of the apparent source area on the northeastern portion of the Site. CVOC concentrations decrease significantly to the east, west, and south of these wells, with more moderate decreases noted to the northwest, in the apparent direction of local groundwater flow in this area.

Soil vapor impacted by TCE and related CVOCs is present beneath the northeastern portion of the Site building, with the greatest impacts coinciding with CVOC-impacted groundwater in this area. The impacts do not extend fully beneath the Site and are not found beneath the western or southern portions of the Site, as shown in Figure 5 in Appendix E.
