# 2021-2023 PERIODIC REVIEW REPORT

Rockland Psychiatric Center Former Laundry Facility Orangeburg, Rockland County, New York

NYSDEC Site Number: 344011 DASNY Project Number: 3043009999

March 2024

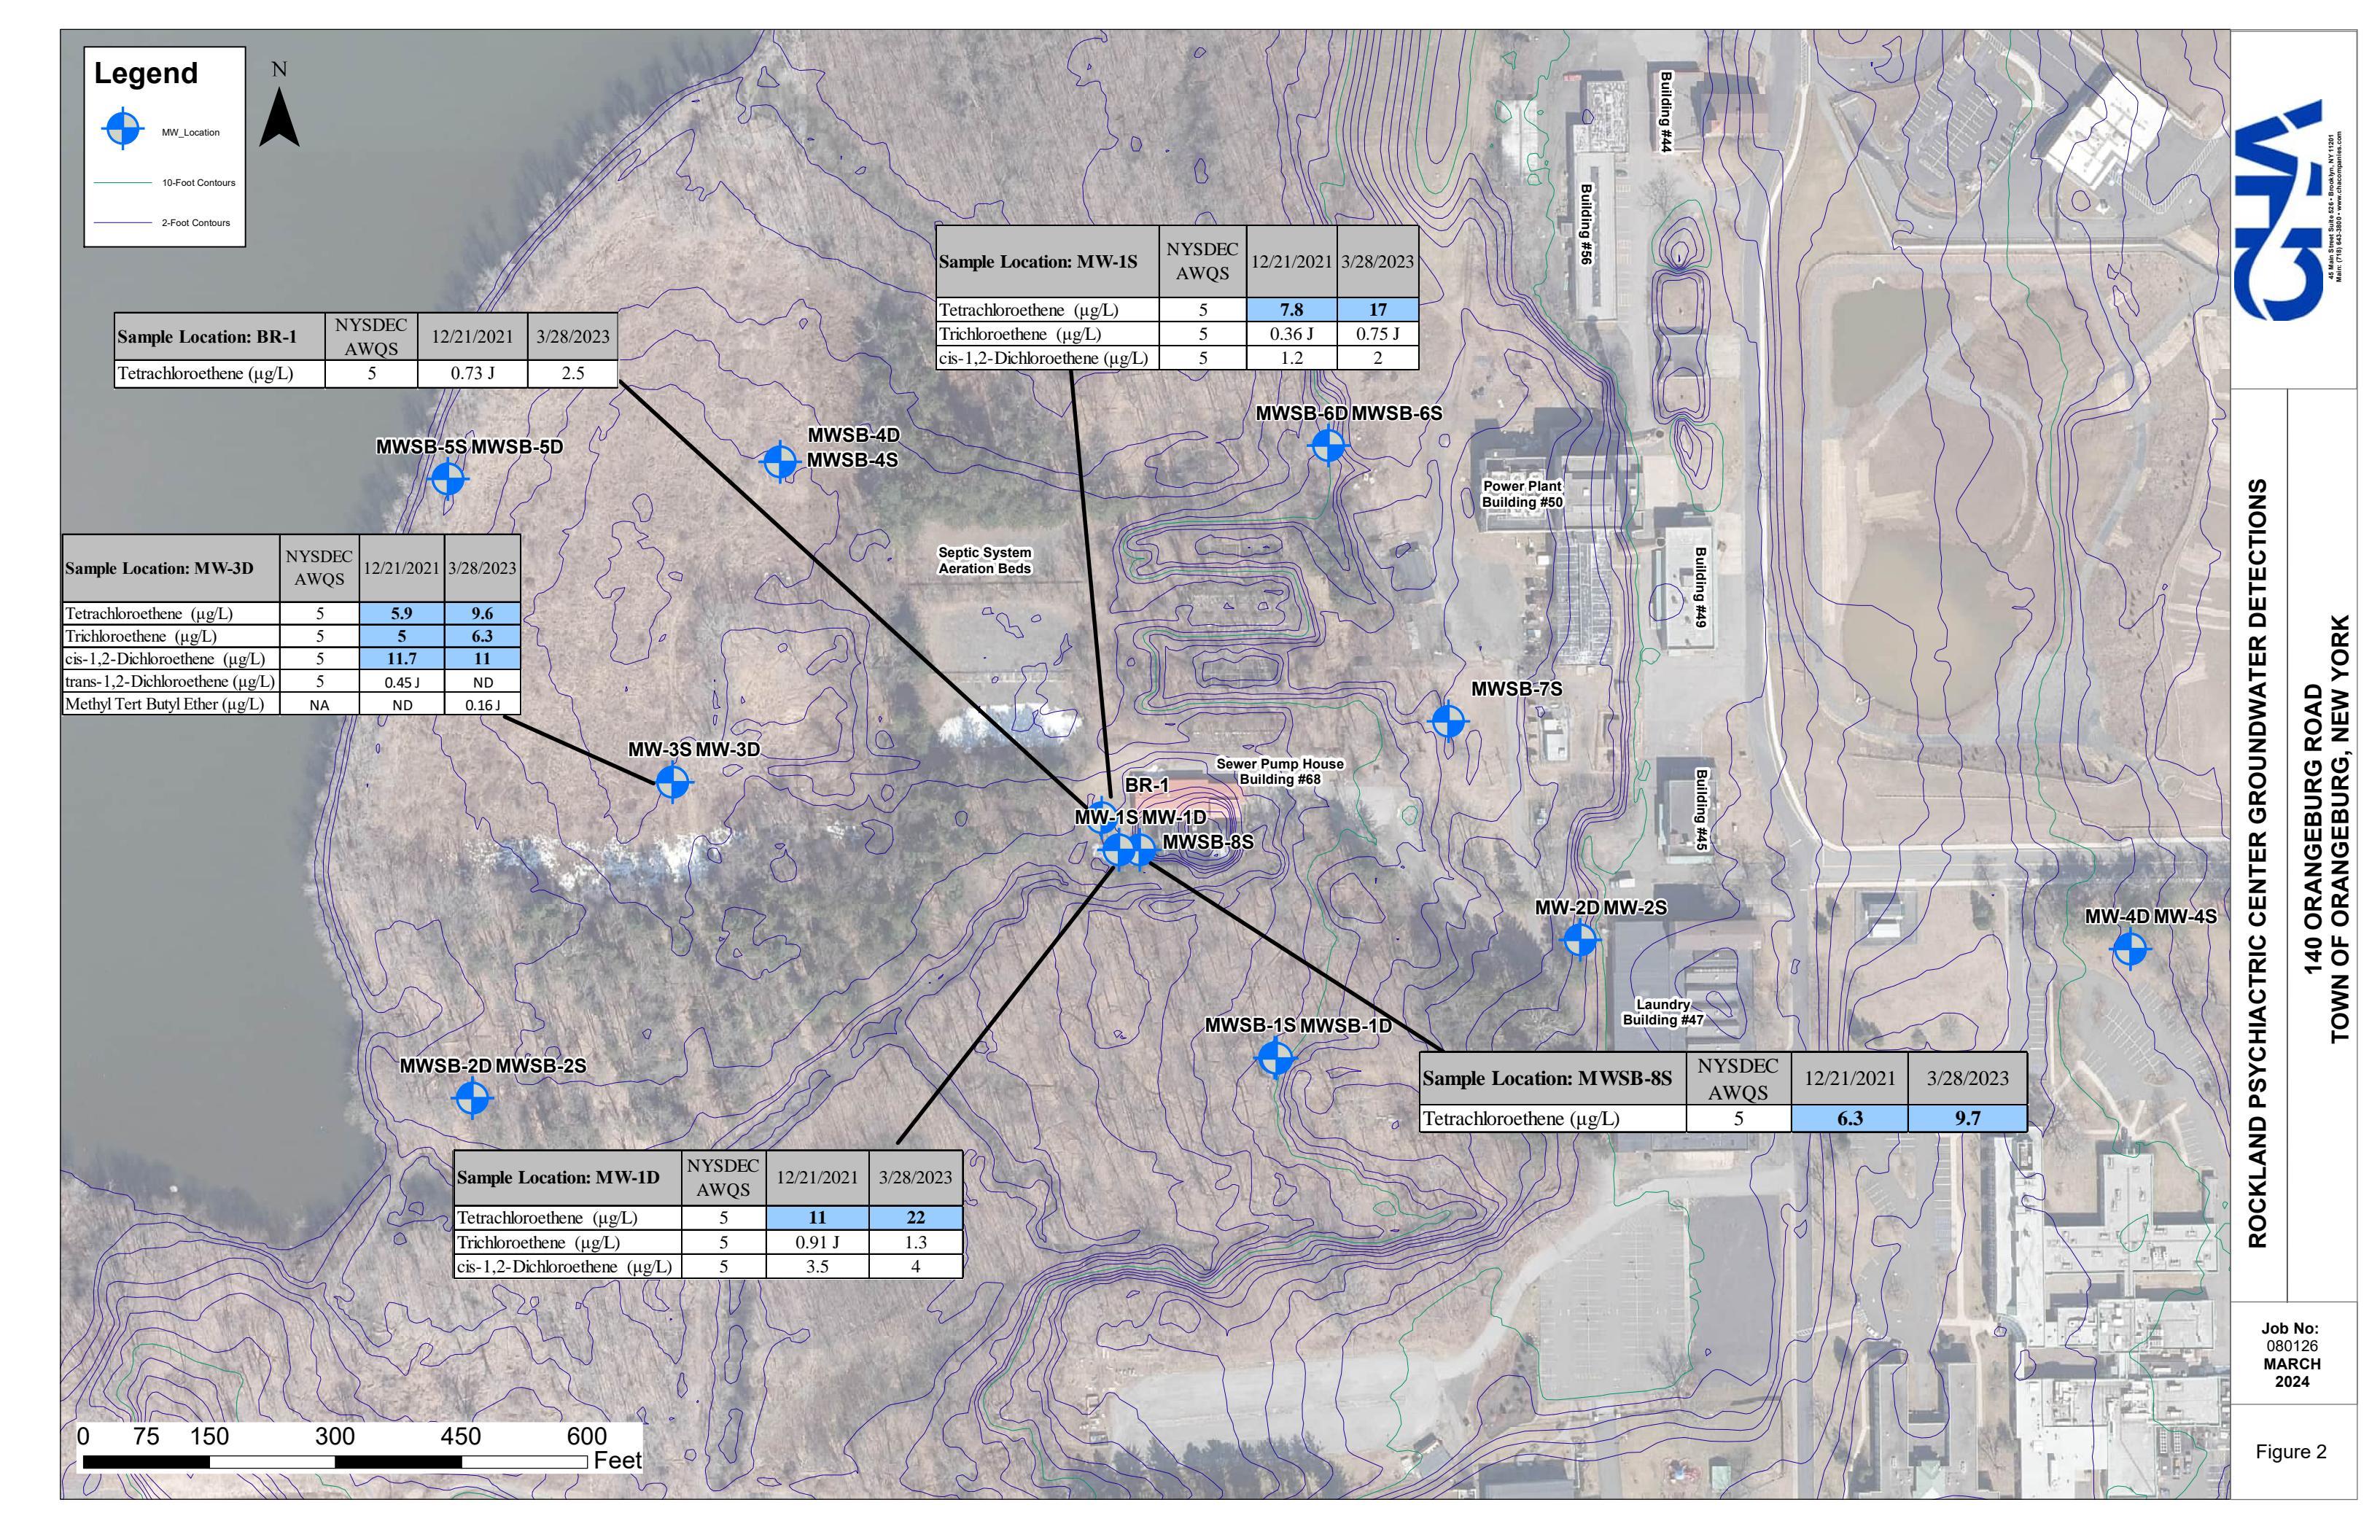
Analytical results for the groundwater samples are presented in Tables 3 and 4 and Figures 2 and 3. Shallow groundwater contours and direction of groundwater flow are presented on Figure 4.

During the Q4 2021 sampling event performed by URS, PCE was detected at all five monitoring wells. PCE was detected at concentrations exceeding the laboratory reporting limit and NYSDEC's Technical & Operational Guidance Series (TOGS) 1.1.1 ambient water quality standard (AWQS) at monitoring wells MW-1D, MW-1S, MW-3D, and MWSB-8S. TCE was detected at concentrations exceeding the method detection limit at monitoring wells MW-1D, MW-1S, and MW-3D. TCE was detected at a concentration exceeding TOGS 1.1.1 AWQS standard at monitoring well MW-3D. Trans-1,2-dichloroethene was detected at concentrations exceeding the method detection limit at monitoring exceeding the method detected at concentrations exceeding the method detected at concentrations exceeding the method detection limit at monitoring well MW-3D. Trans-1,2-dichloroethene was detected at concentrations exceeding the method detection limit at monitoring well MW-3D. The VOC cis-1,2- DCE was detected at concentrations exceeding the method detection limit at MW-1S and MW-1D. DCE was detected at a concentration exceeding TOGS 1.1.1 AWQS standard at monitoring well MW-3D. No other VOCs were detected at concentrations exceeding the laboratory reporting limits at the monitoring wells sampled during the Q4 2021 monitoring event. The Q4 2021 analytical results for groundwater samples were generally consistent with results observed during previous monitoring events and generally lower than the historical high concentrations detected.

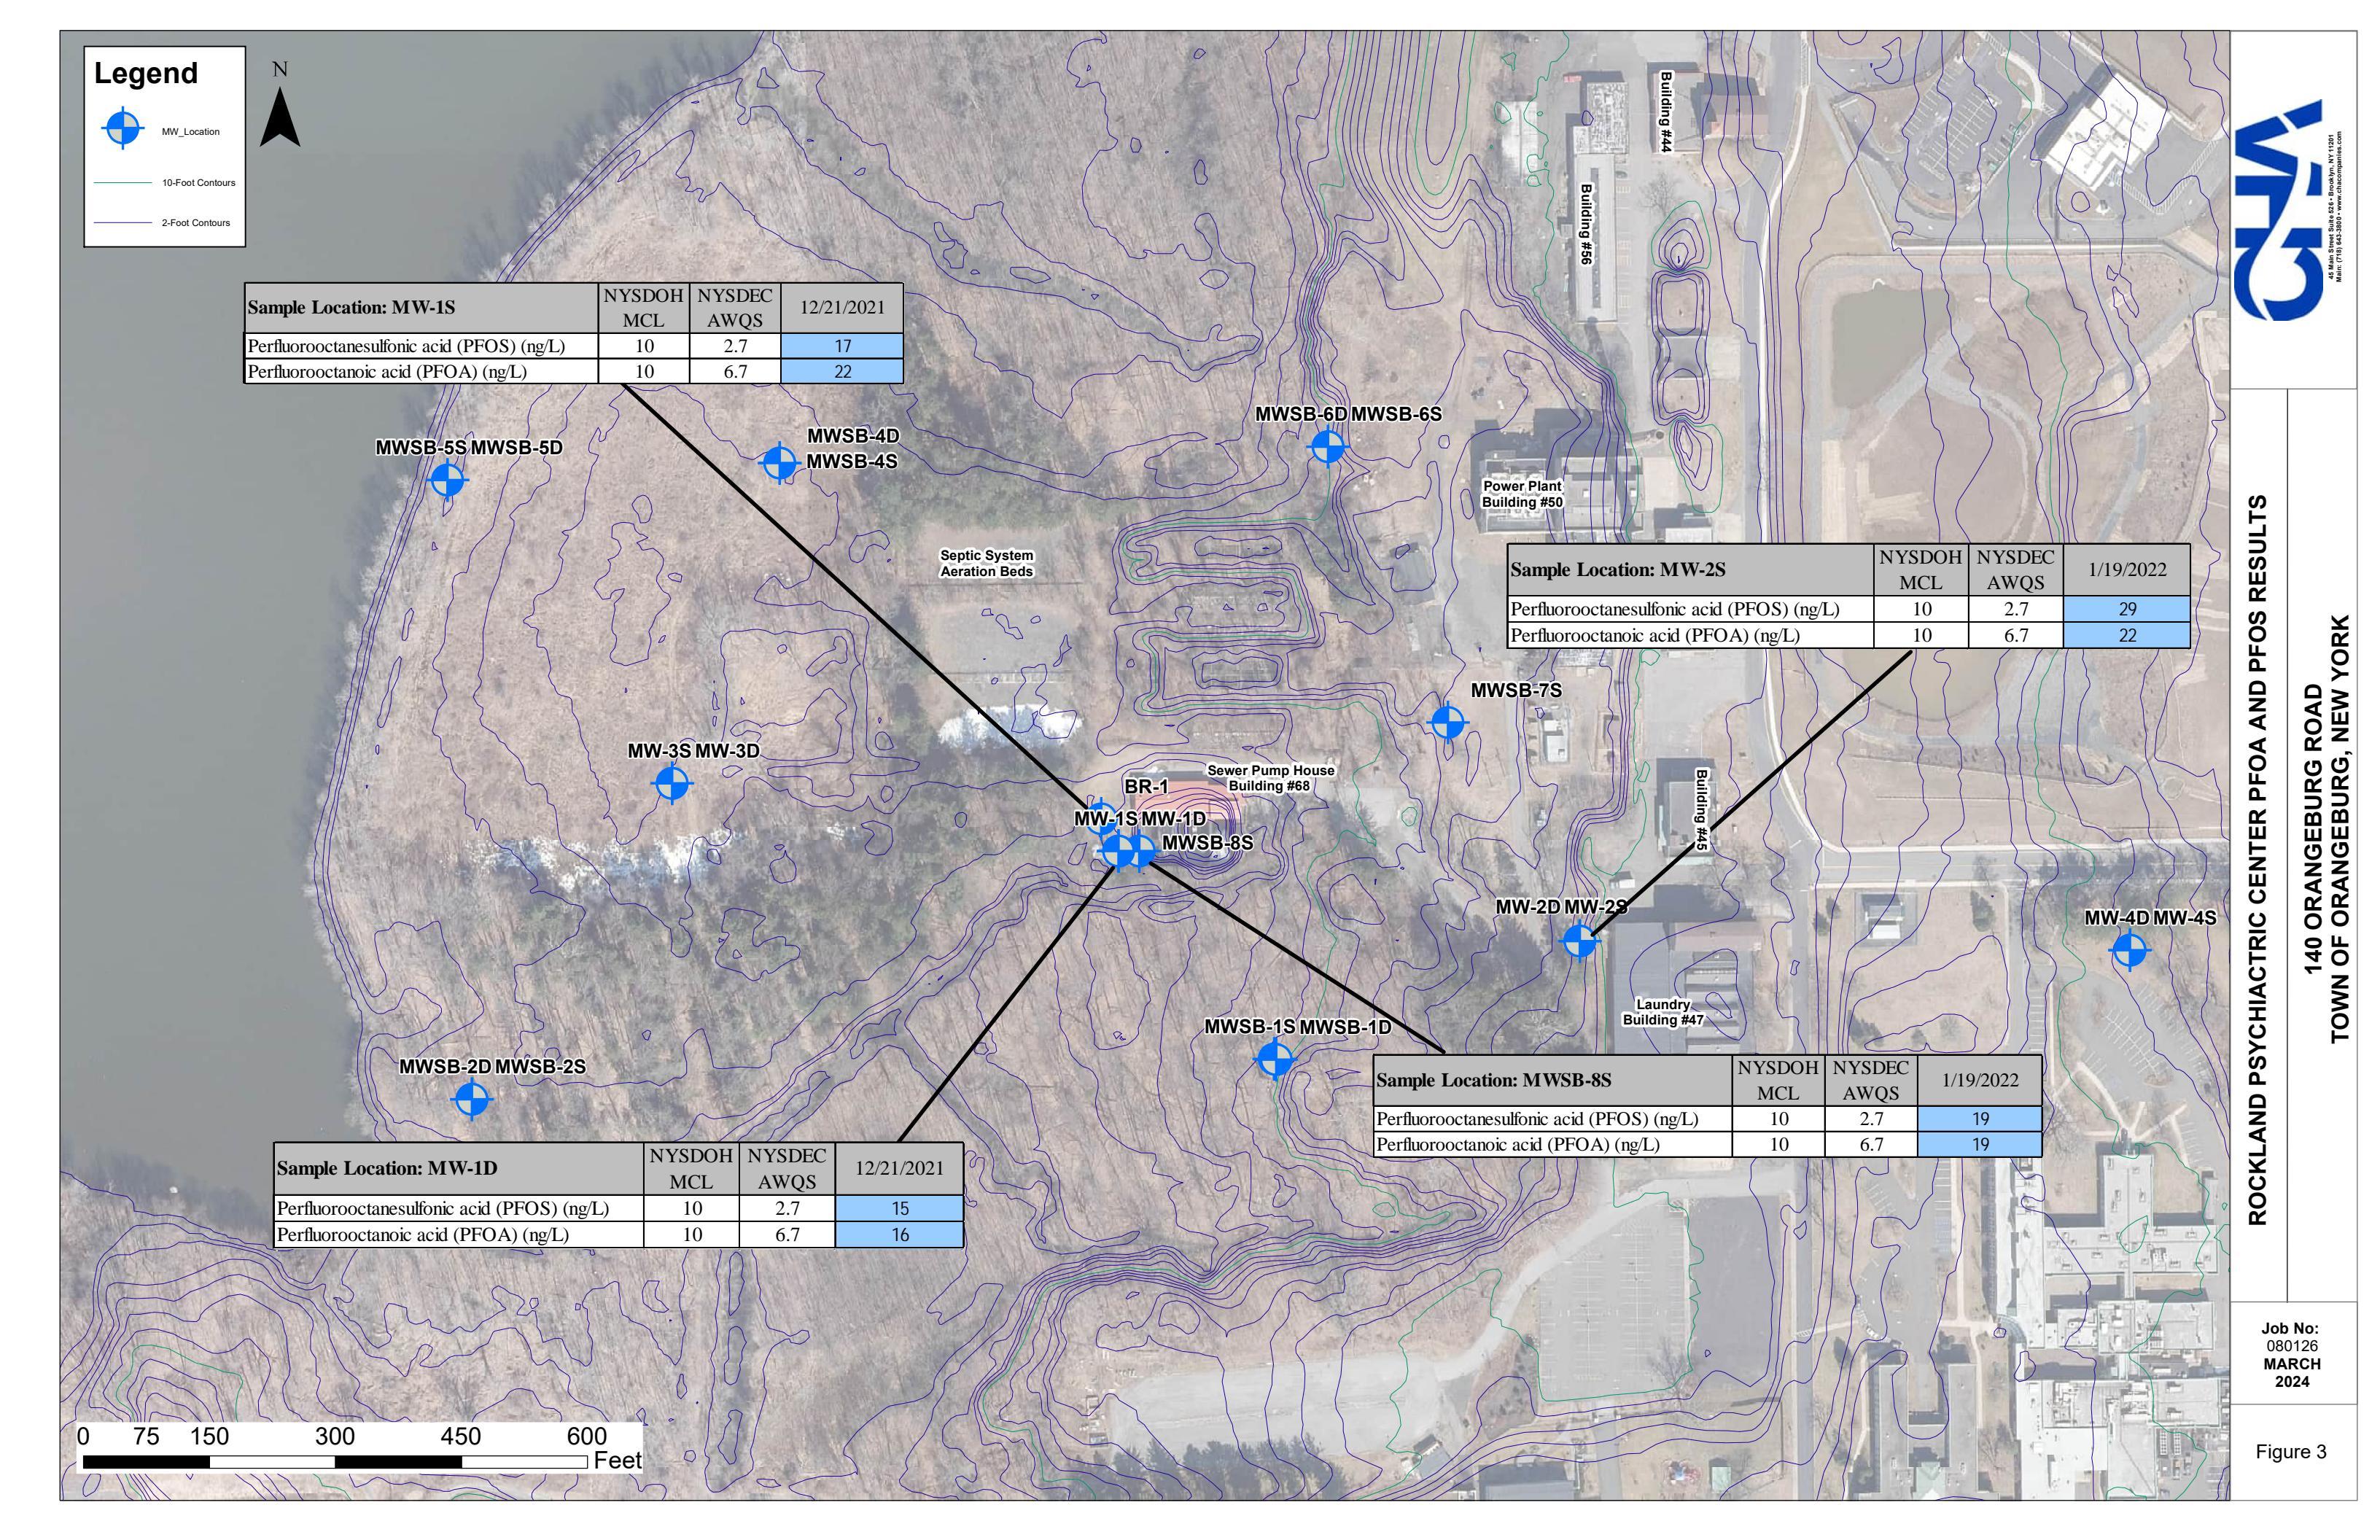
Results from the four monitoring wells sampled for emerging contaminants were compared to the New York State Department of Health Maximum Contaminant Level for drinking water and the NYSDEC guidance value proposed in the *Sampling, Analysis, and Assessment of PFAS Under NYSDEC's Part 375 Remedial Programs* (last updated April 2023). The monitoring wells contained exceedances in perfluorooctanesulfonic acid (PFOS) and perfluorooctanoic acid (PFOA) ranging from 15 to 29 nanograms per liter (ng/L) for PFOS [versus a guidance value of 2.7 ng/L) and ranging from 16 to 22 ng/L for PFOA [versus a guidance value of 6.7 ng/L]. Considering the upgradient monitoring well, MW-2S, was found to have the highest concentrations of PFOS and negligibly different concentrations for PFOA, it is anticipated that PFAS is ubiquitous across the Site.

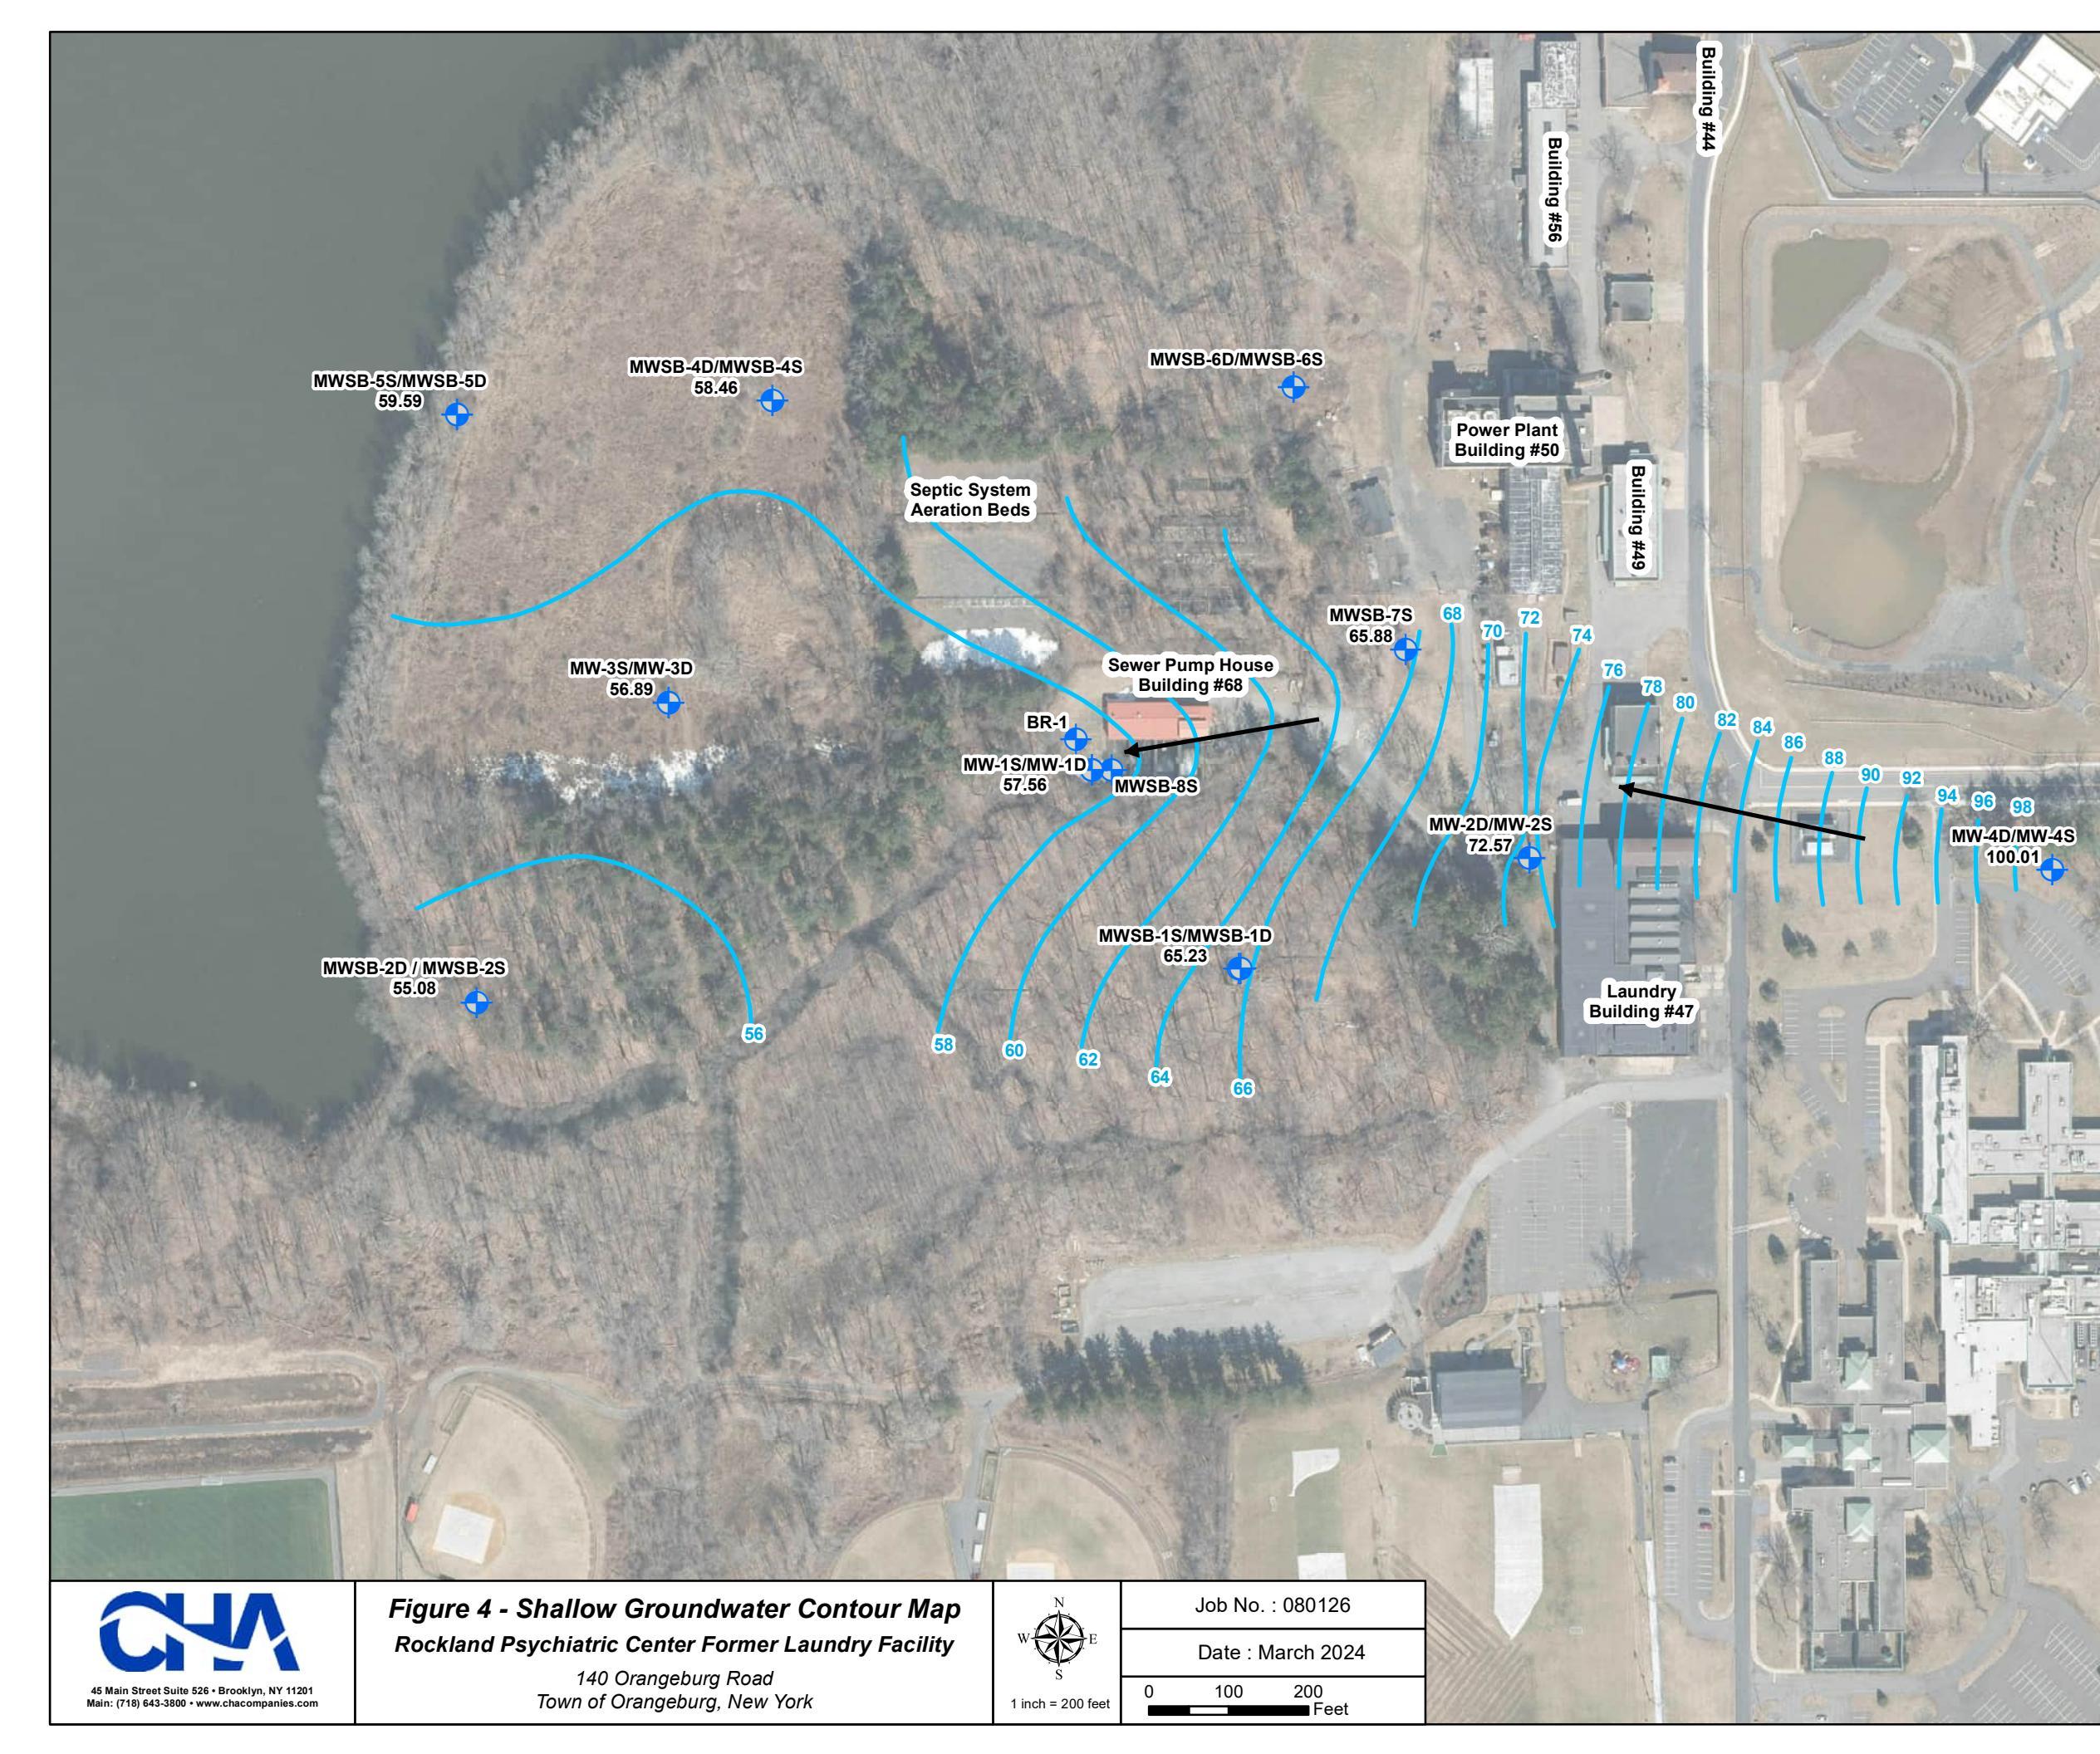
**Directional arrows indicate** general direction of groundwater flow.
