2024 Periodic Review Report

Nyack Manufactured Gas Plant Site Village of Nyack, Rockland County, New York

NYSDEC Site Number: 344046 Index # D3-001-98-08

December 2024 – Revised May 2025 Project 2202333

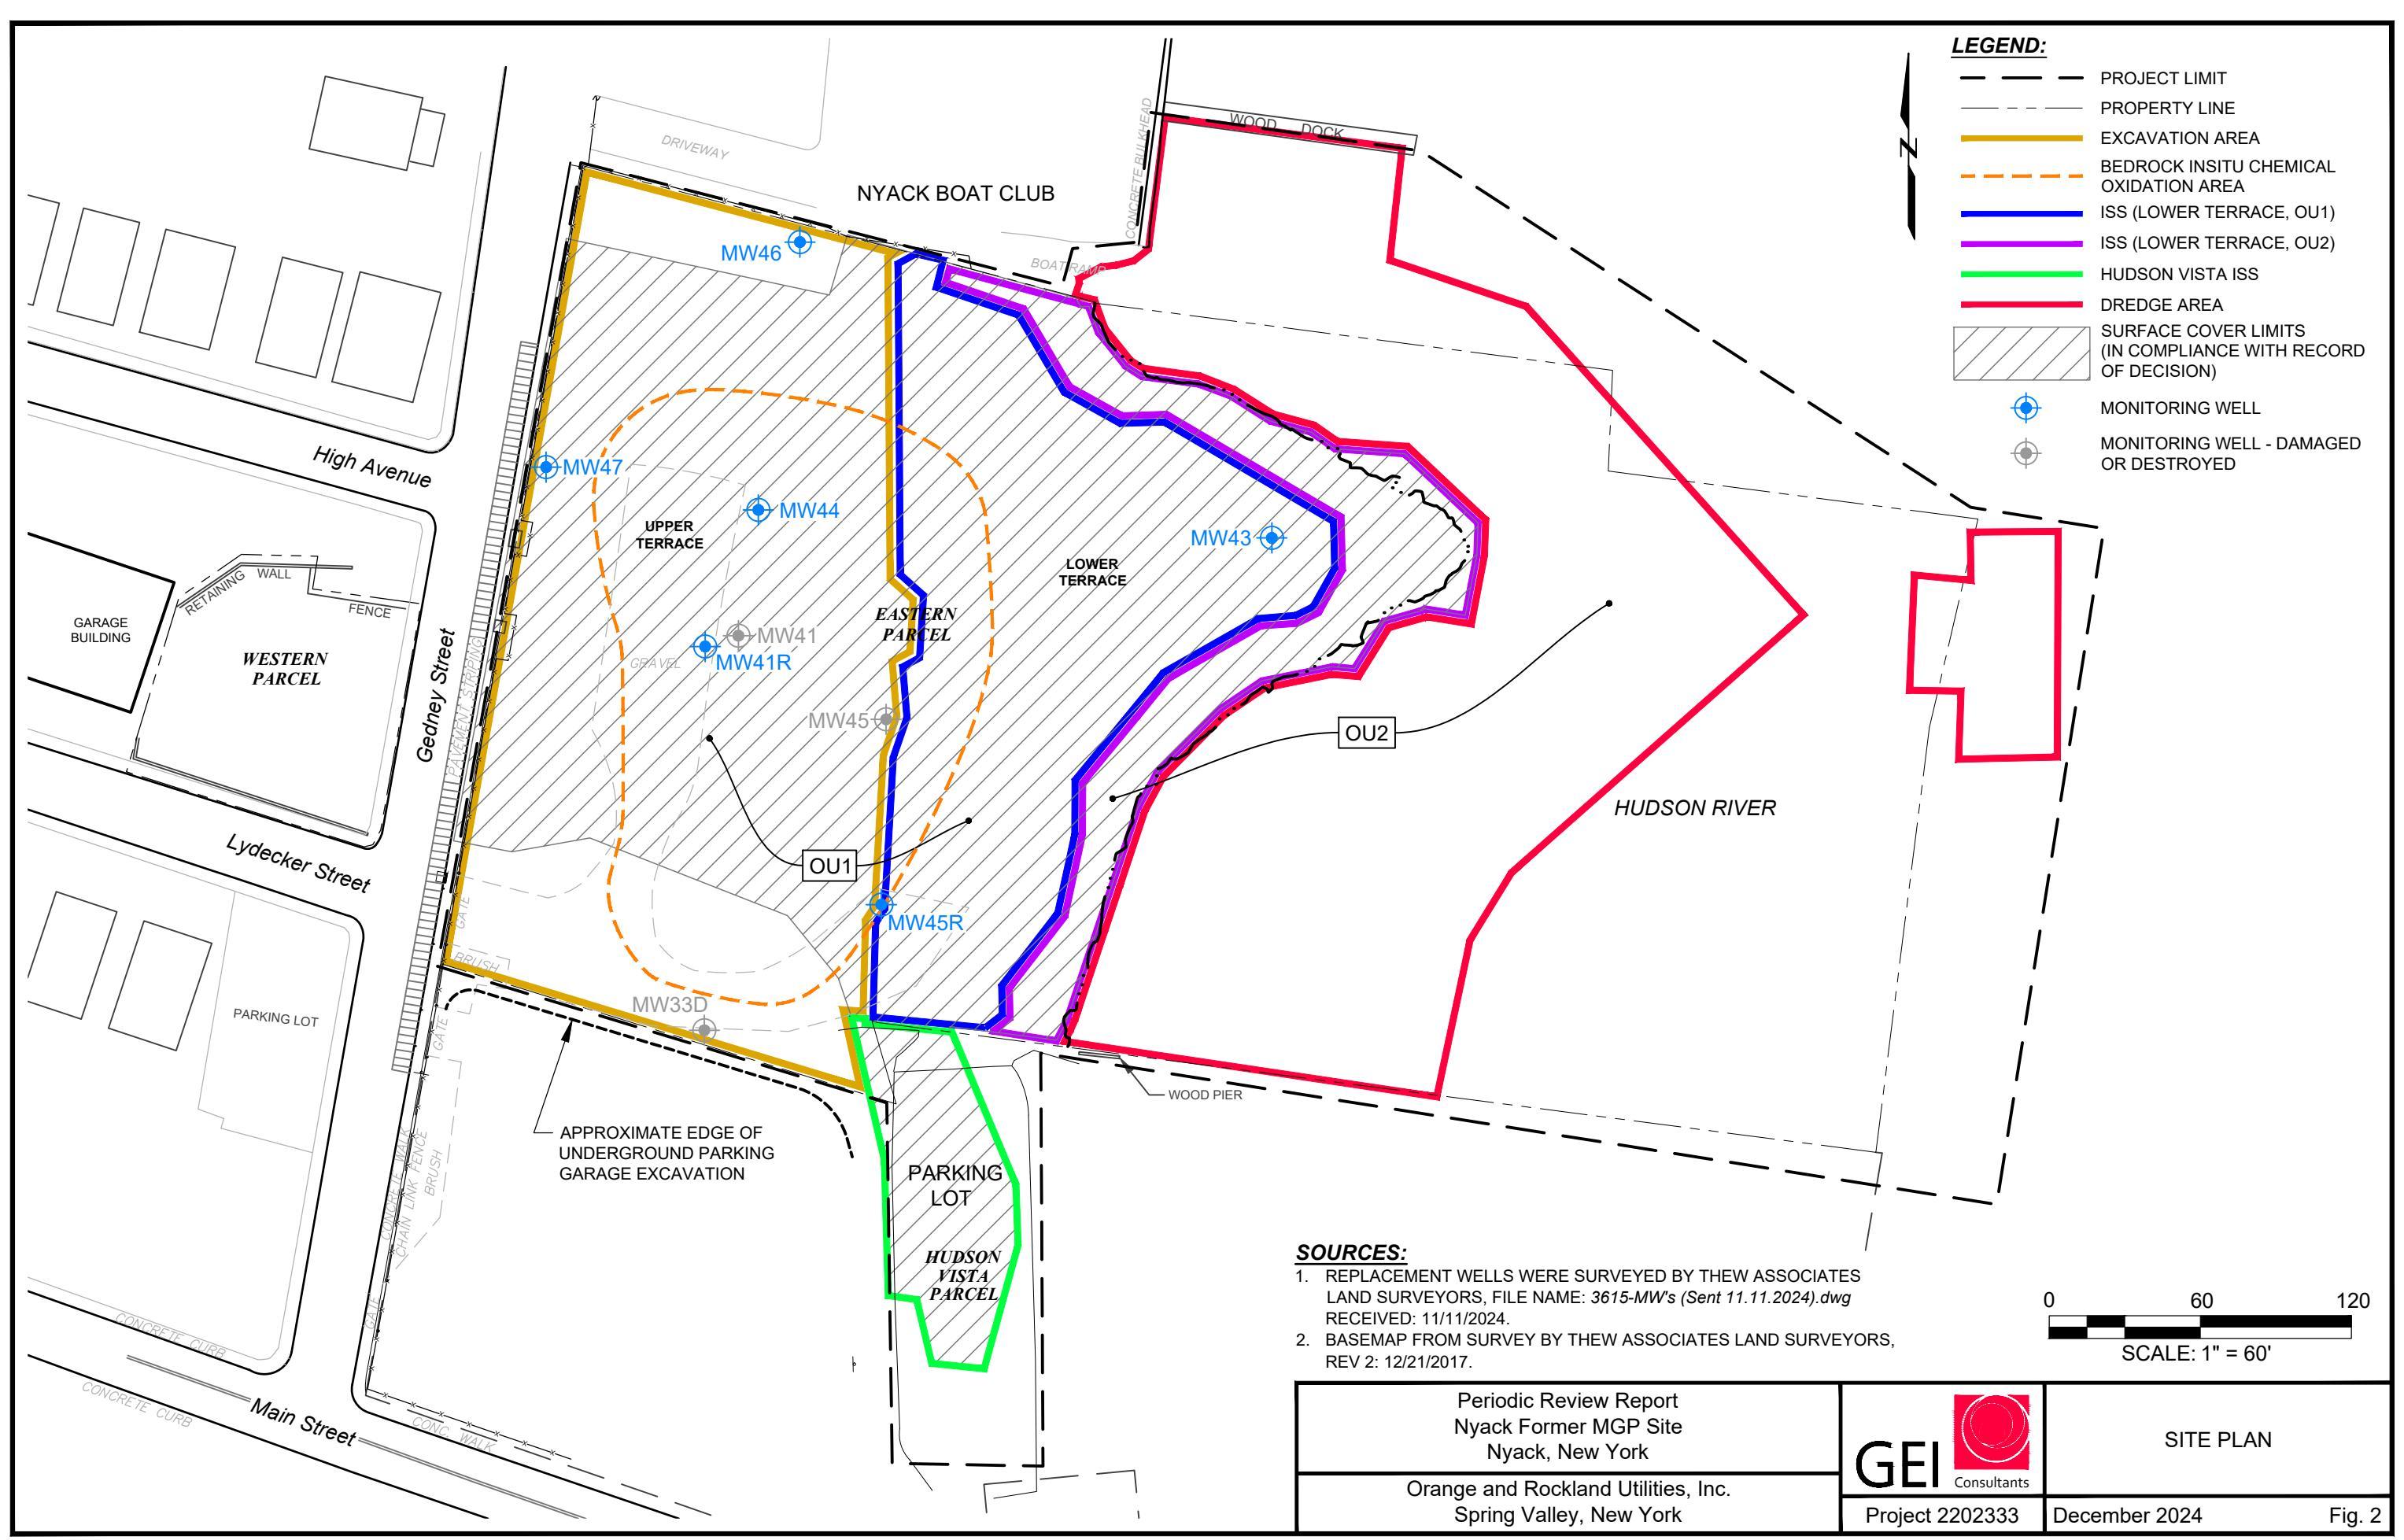
Impacted soil and former MGP subsurface foundations in the Upper Terrace were addressed during remediation through excavation to the top of bedrock and disposal off site (area outlined in gold on Figure 2). In situ chemical oxidation was used to treat impacts remaining within bedrock to the extent possible (area outlined in orange dashed line on Figure 2). However, MGP-related constituents of concern (COCs) remain in groundwater within the bedrock unit present approximately 20 feet below the ground surface of the Upper Terrace area. A soil cover system consisting of at least 2 feet of imported general fill was installed during implementation of the remedy in the Upper Terrace (western area with diagonal grey hatching on Figure 2).¹

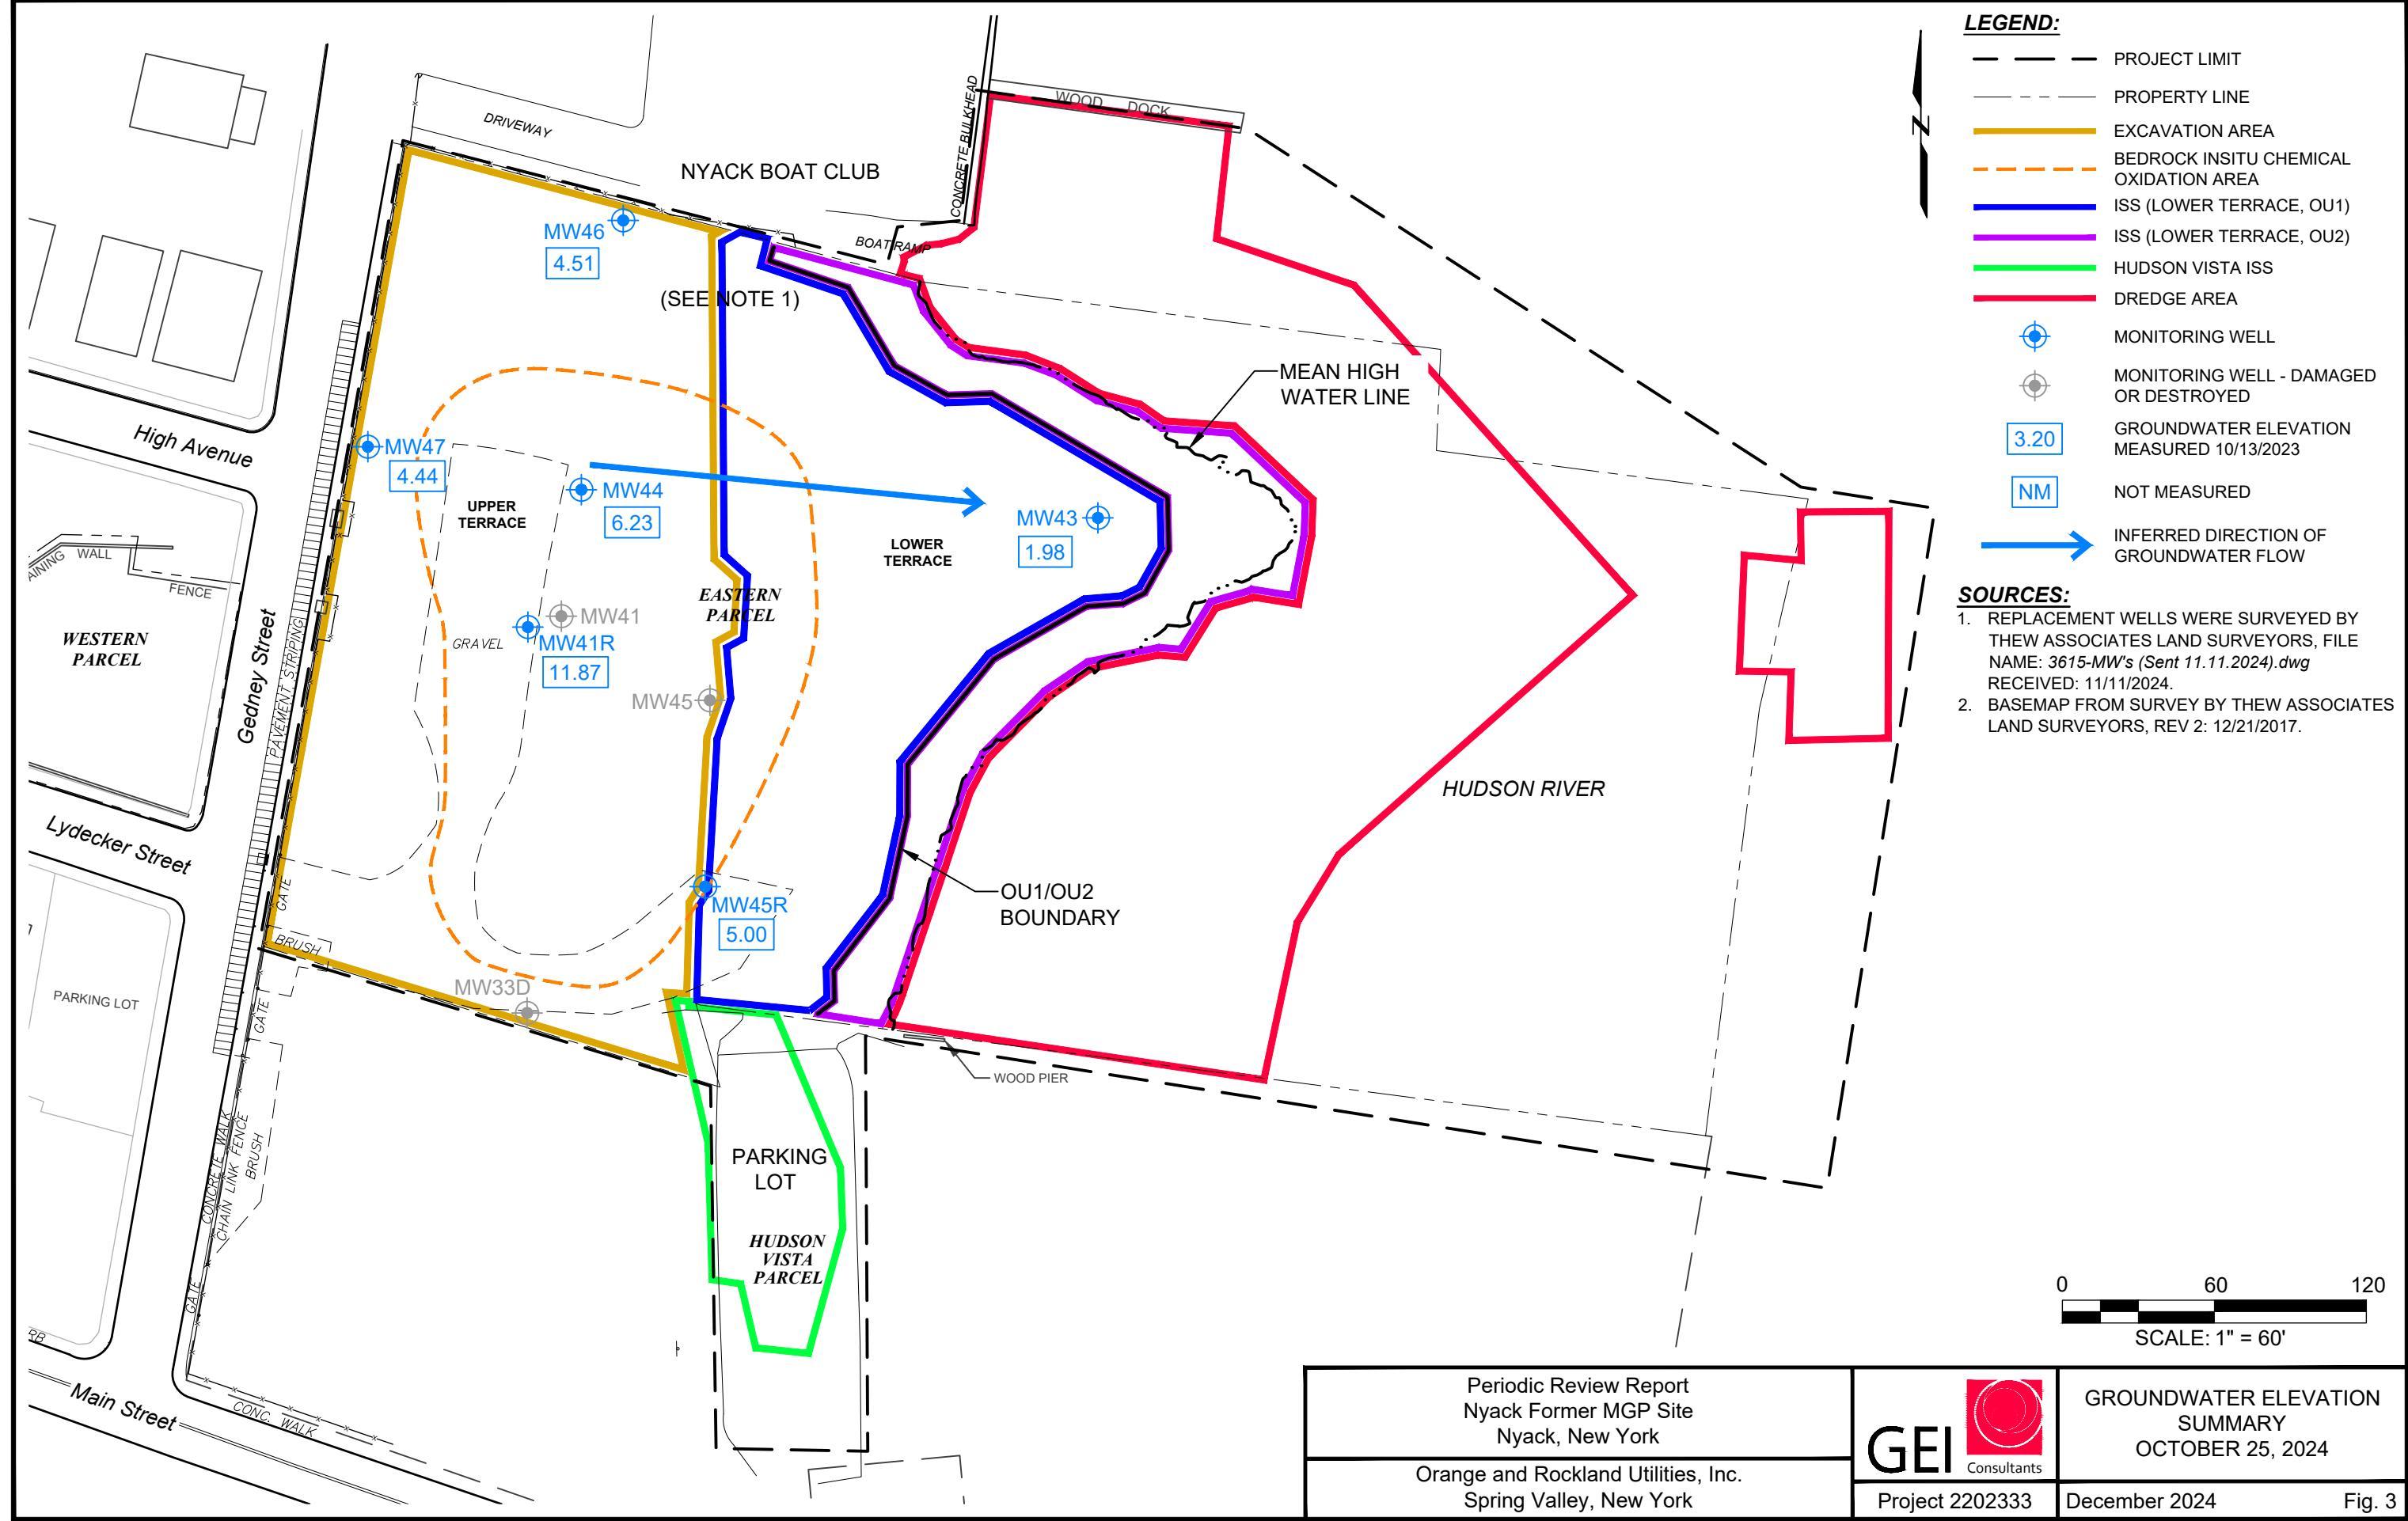
Monitoring well details are summarized in Table 1 and the well locations are shown on Figure 3. A reconnaissance of existing wells was performed on October 25, 2024, to observe the location and condition of each of the monitoring wells identified in the SMP prior to implementing SMP activities. The conditions observed at each well, and the activities performed at each location in 2024 are summarized as follows:

Regardless of the influence that the ISS mass has on local Site conditions, groundwater is expected to continue moving from west to east in bedrock, toward the Hudson River, consistent with the results of the RI and prior SMP gauging events. The inferred direction of groundwater flow is shown on Figure 3.

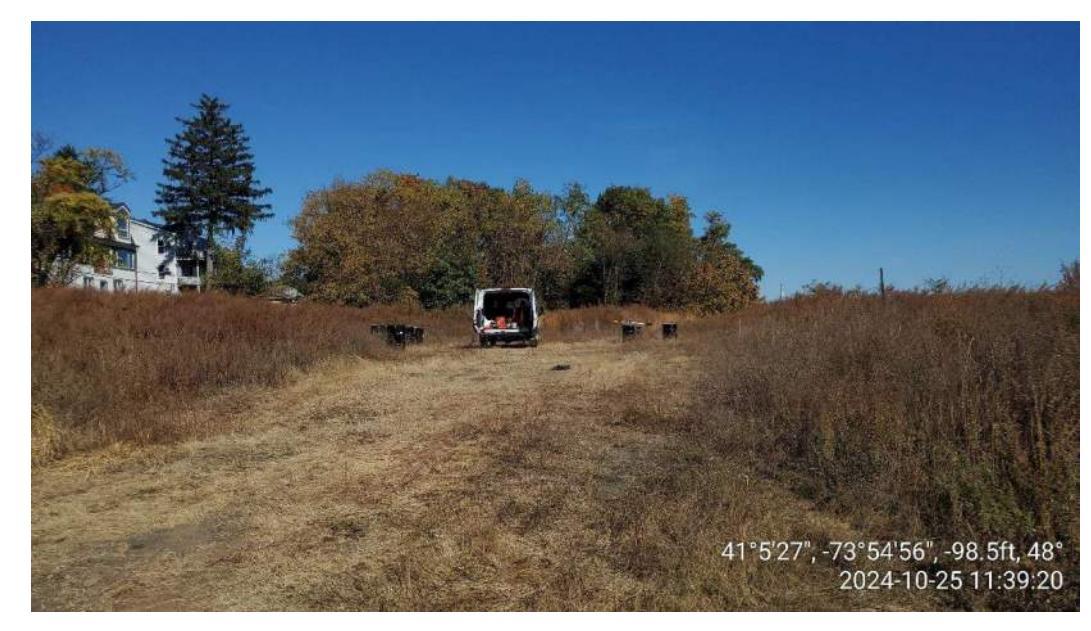
Photo No.:1Photographer:S. DiBartoloDate:10/25/2024Direction:North

Comments: Upper Terrace

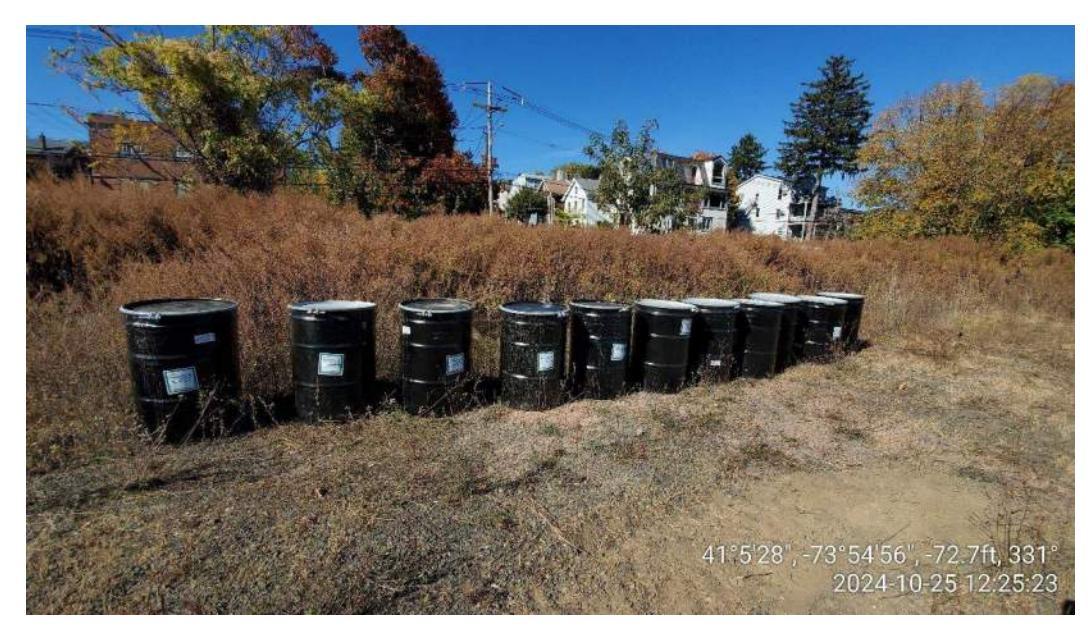
Photo No.:2Photographer:S. DiBartoloDate:10/25/2024Direction:Northwest

Comments: Upper Terrace

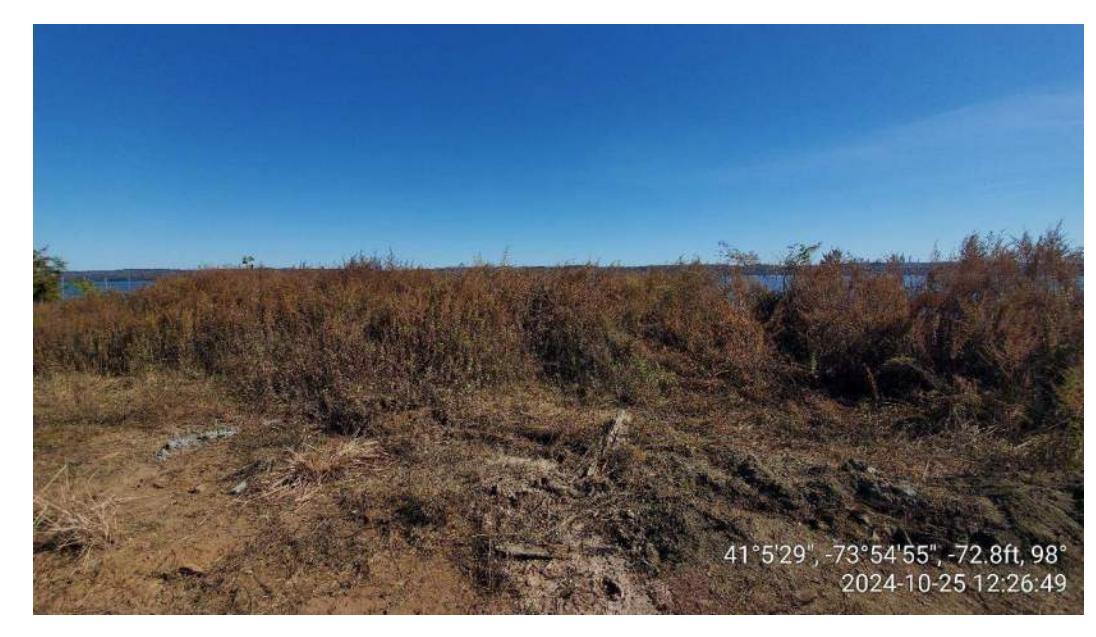
Photo No.:3Photographer:S. DiBartoloDate:10/25/2024Direction:East

Comments: Upper Terrace

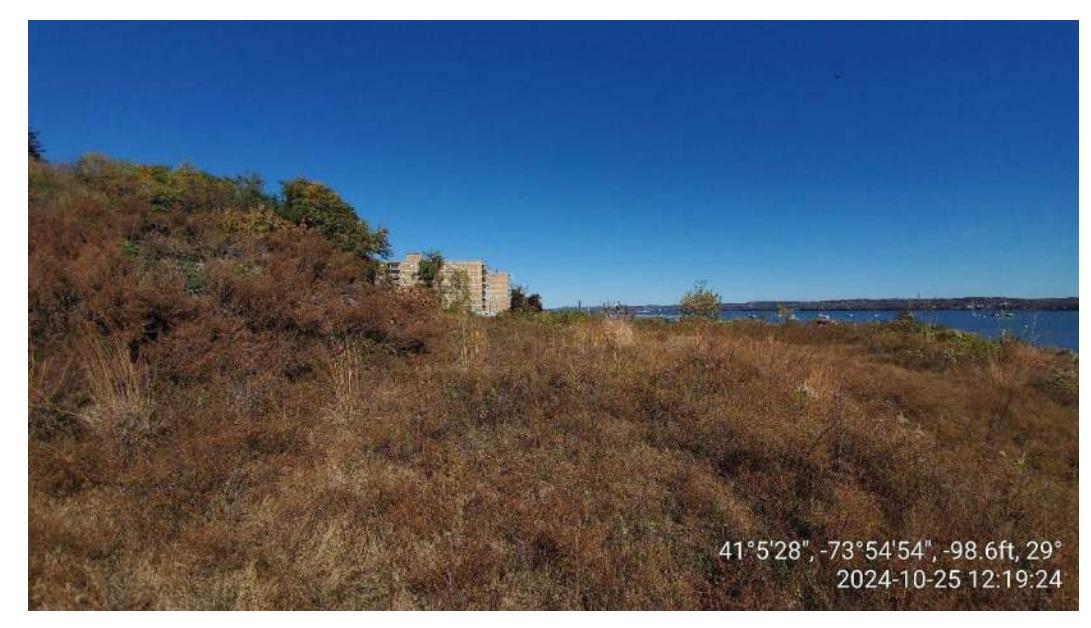
Photo No.:5Photographer:S. DiBartoloDate:10/25/2024Direction:North

Comments: Lower Terrace

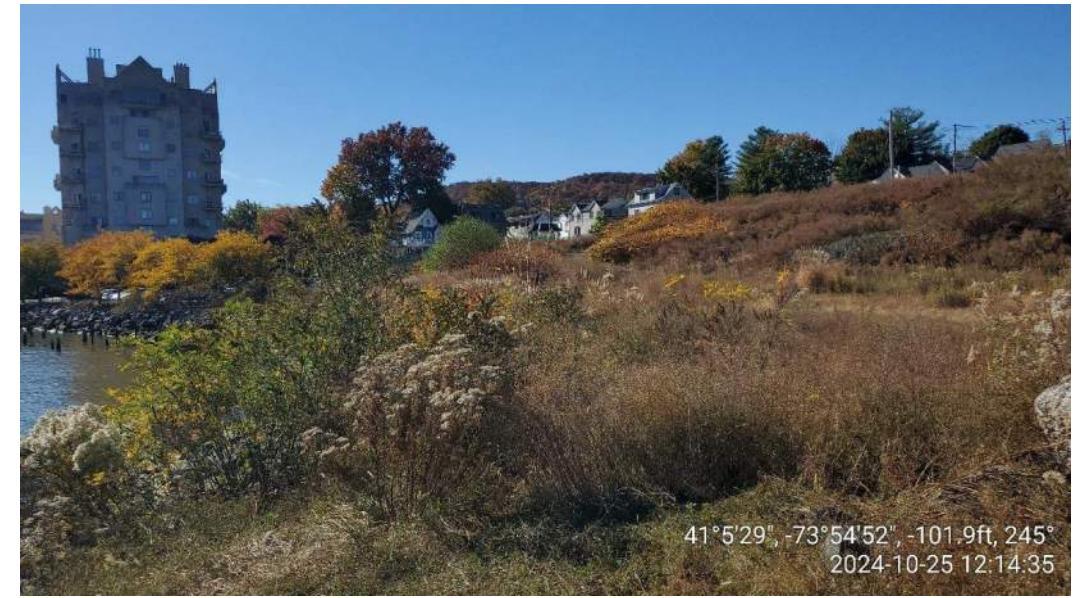
Photo No.:6Photographer:S. DiBartoloDate:10/25/2024Direction:Southwest

Comments: Lower Terrace

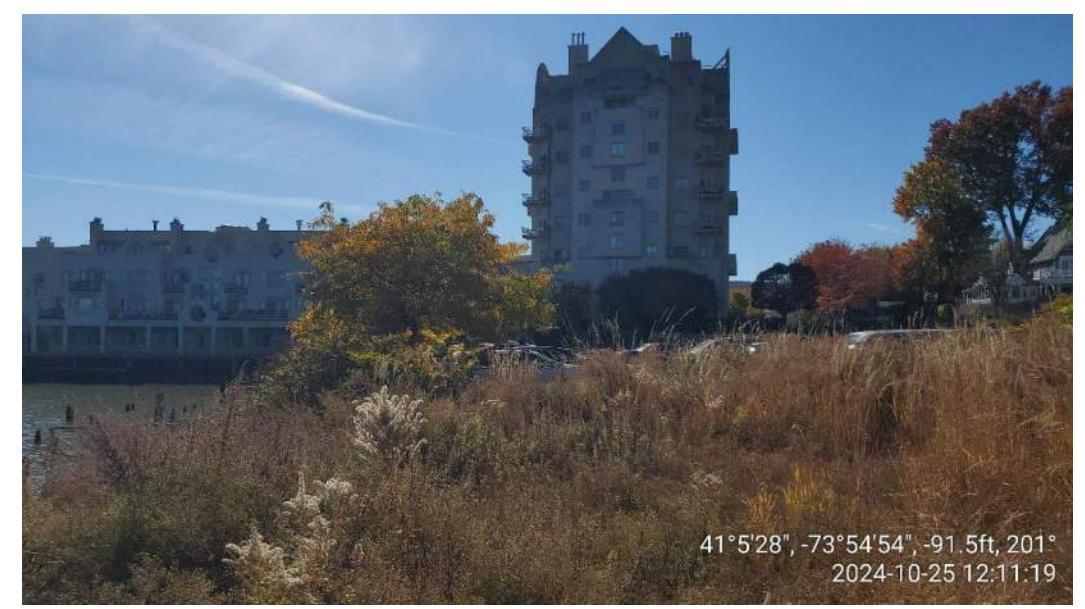
Photo No.:7Photographer:S. DiBartoloDate:10/25/2024Direction:South

Comments: Lower Terrace towards Hudson Vista Parking Lot

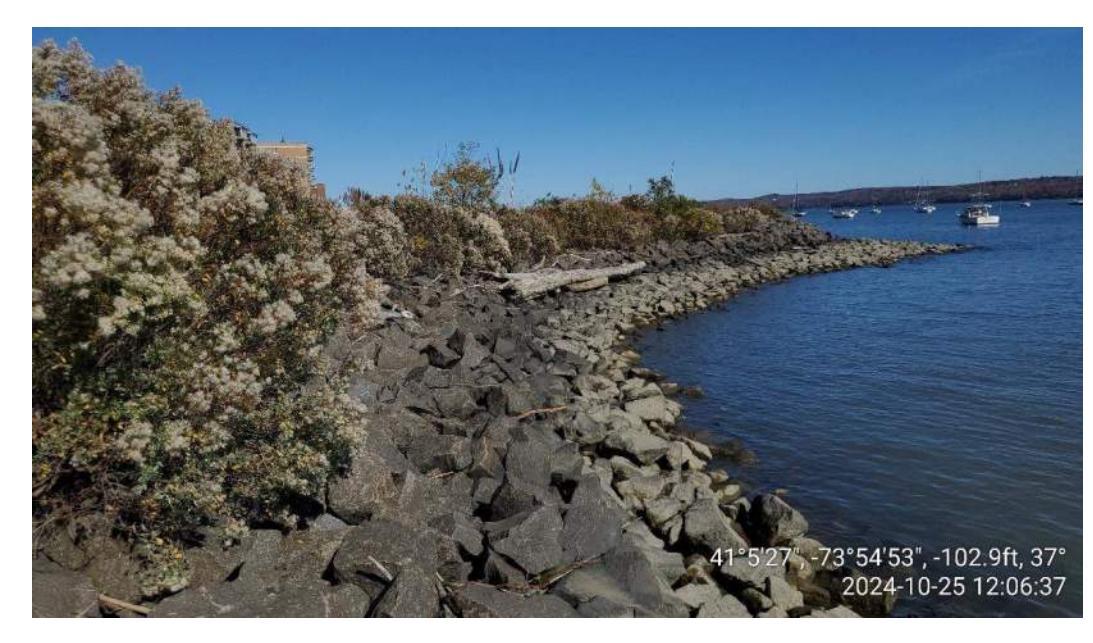
Photo No.:9Photographer:S. DiBartoloDate:10/25/2024Direction:Northeast

Lower Terrace and Riprap Slope

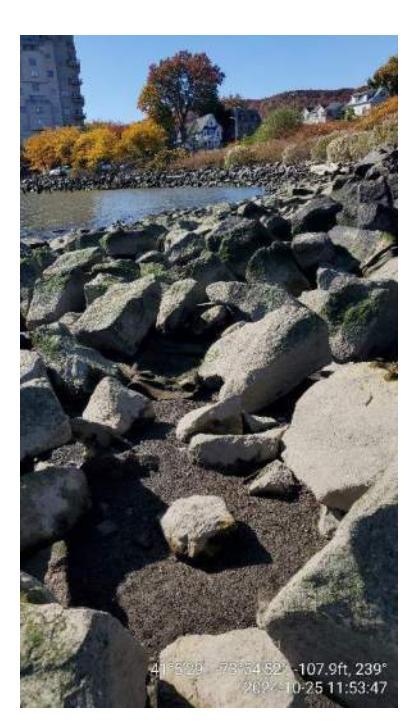
Photo No.:10Photographer:S. DiBartoloDate:10/25/2024Direction:Southeast

Along the Lower Terrace shoreline, the ISS materials are protected from contact by site users and erosion by the installation of riprap above filter fabric during the remedial action, and by the placement of additional riprap at the shoreline by the Site Owner. Riprap areas were observed by GEI to be in good condition. Sediment has partially covered small portions of the riprap area, but evidence of movement or undermining was not observed anywhere in the riprap areas. Photographs of the shoreline are included in the Photographic Record in Appendix C.

Comments: Riprap Slope at Hudson River at Low Tide

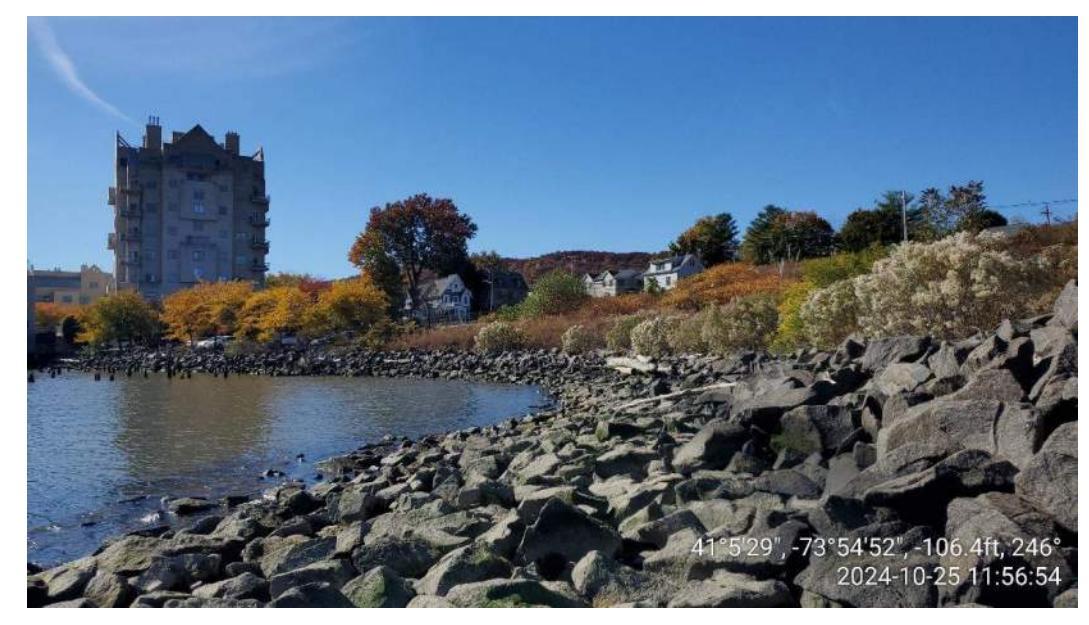
Photo No.:11Photographer:S. DiBartoloDate:10/25/2024Direction:Southwest

Comments: Riprap Slope at Hudson River at Low Tide

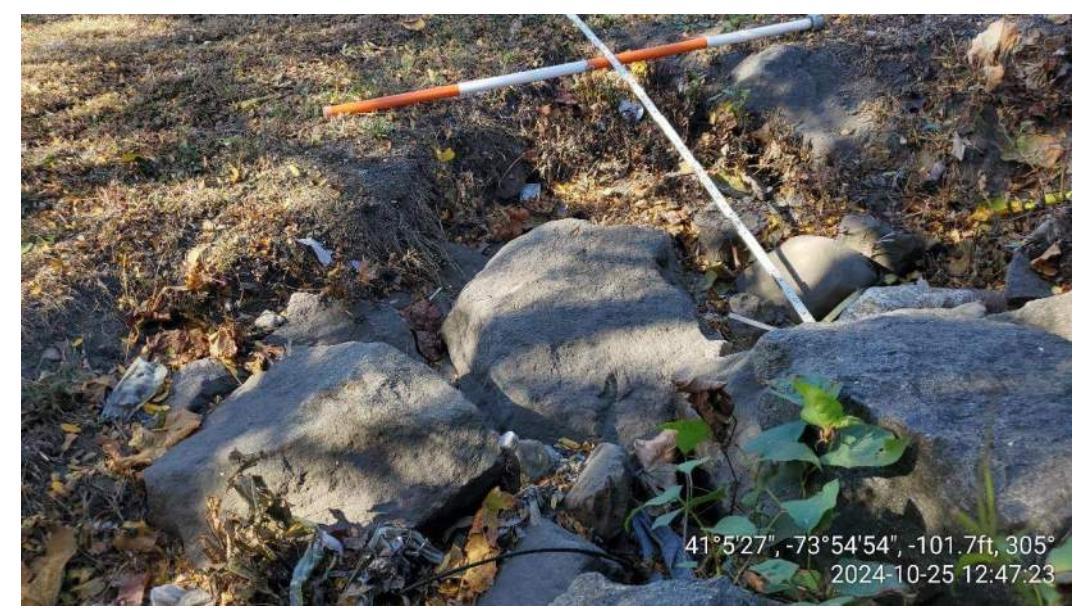
Photo No.:13Photographer:S. DiBartoloDate:10/25/2024Direction:Northwest

These features were observed to be present, and not disturbed at the time of the October 25, 2024, site inspection. Some minor erosion continues to be observed at the storm sewer outlet. It remains localized but has increased in size from what was observed during prior events. The erosion has not affected the surface cover to the extent that there is a danger of exposing underlying ISS material; however, the Site Owner should consider repairing the outfall to prevent further erosion. A photograph of the storm sewer outlet is included in the Photographic Record in Appendix C.

Stormwater CMP Outfall at North end of Hudson Vista Parking Lot

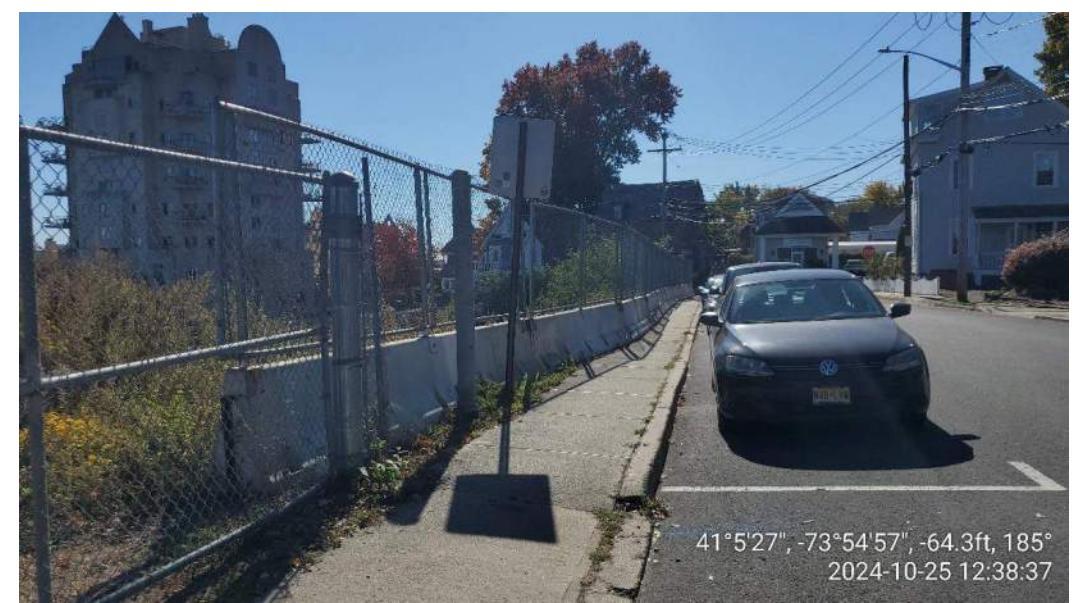
Photo No.:14Photographer:S. DiBartoloDate:10/25/2024Direction:South

It should be noted that large gaps were observed between some of the fence panels during the annual inspection. Although fences are not a part of the remedy, the Site Owner should consider repairing the fence to prevent unauthorized access to the Site.

Comments: Perimeter fence at Gedney Street

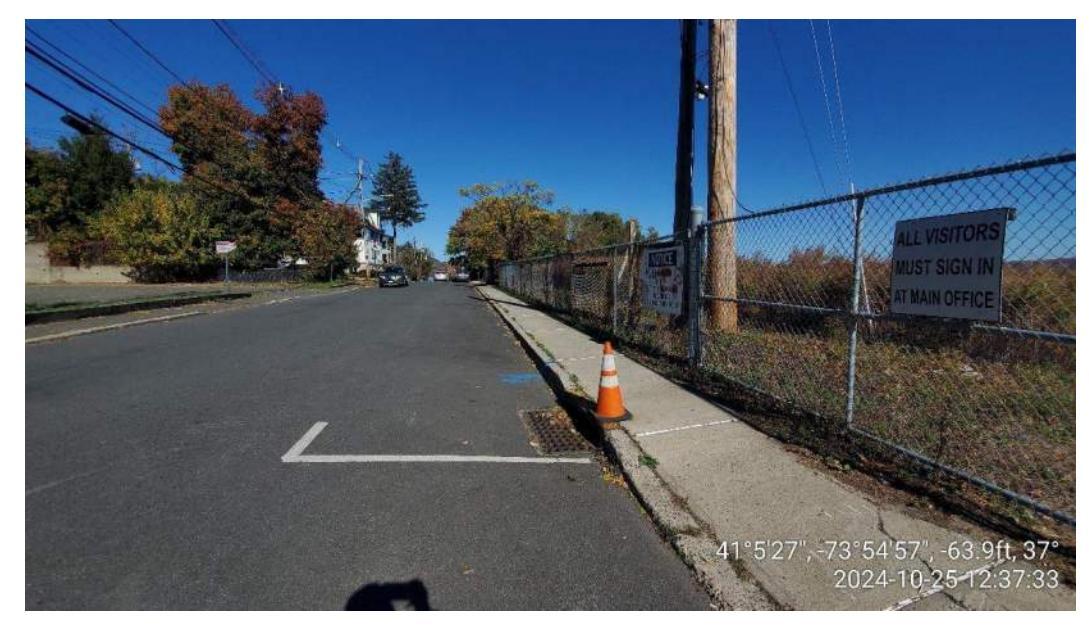
Photo No.:15Photographer:S. DiBartoloDate:10/25/2024Direction:Northeast

Comments: Perimeter fence at Gedney Street

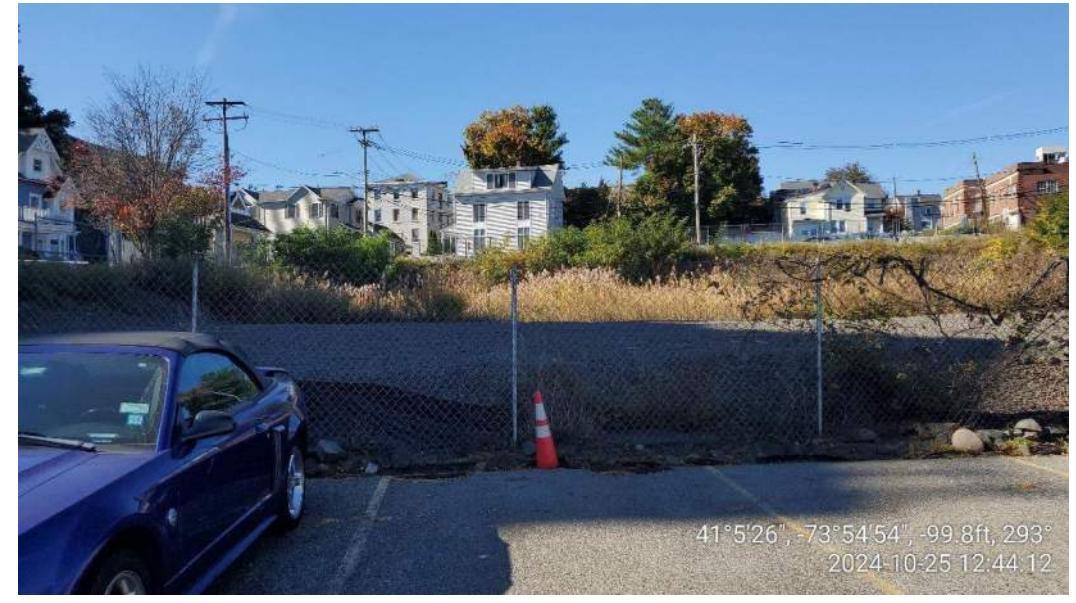
Photo No.:17Photographer:S. DiBartoloDate:10/25/2024Direction:West

Comments: Perimeter fence at Hudson

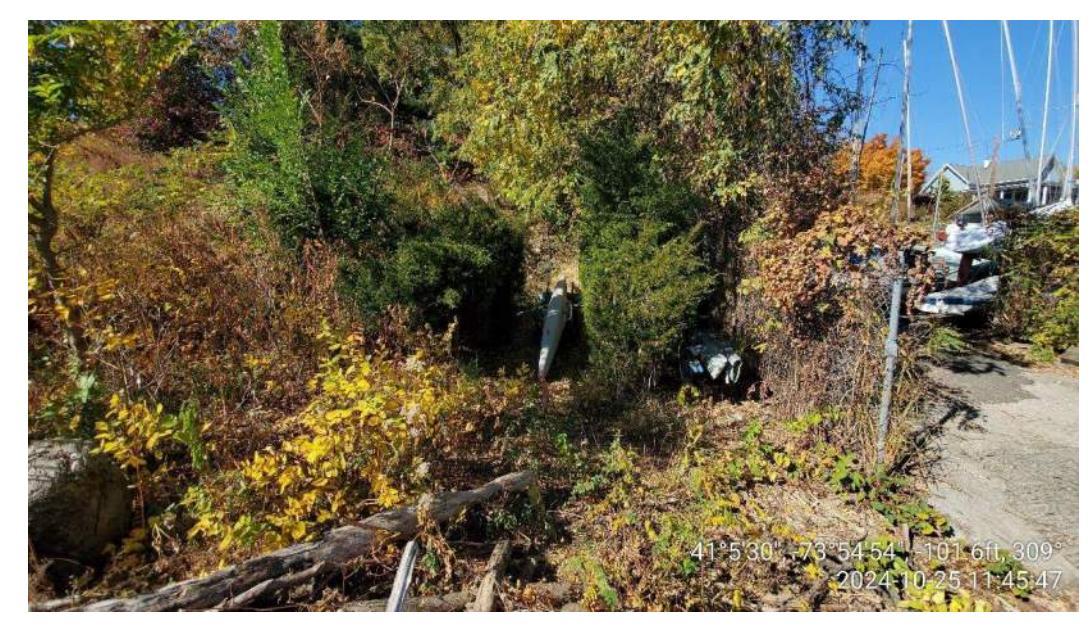
Photo No.:19Photographer:S. DiBartoloDate:10/25/2024Direction:Northwest

Storage of boating equipment on Property. North perimeter fence does not extend onto the riprap slope and the site can be accessed from adjacent boat club to the north.

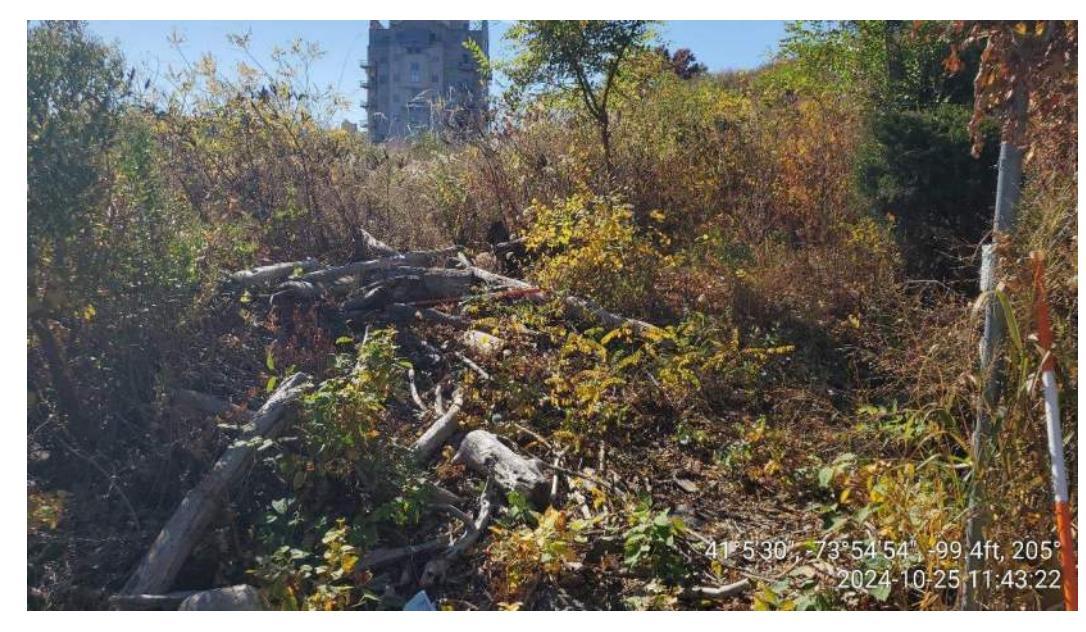
Photo No.:21Photographer:S. DiBartoloDate:10/25/2024Direction:South

Pieces of cut wood stockpiled on Property. North perimeter fence does not extend onto the riprap slope and the site can be accessed from adjacent boat club to the north.

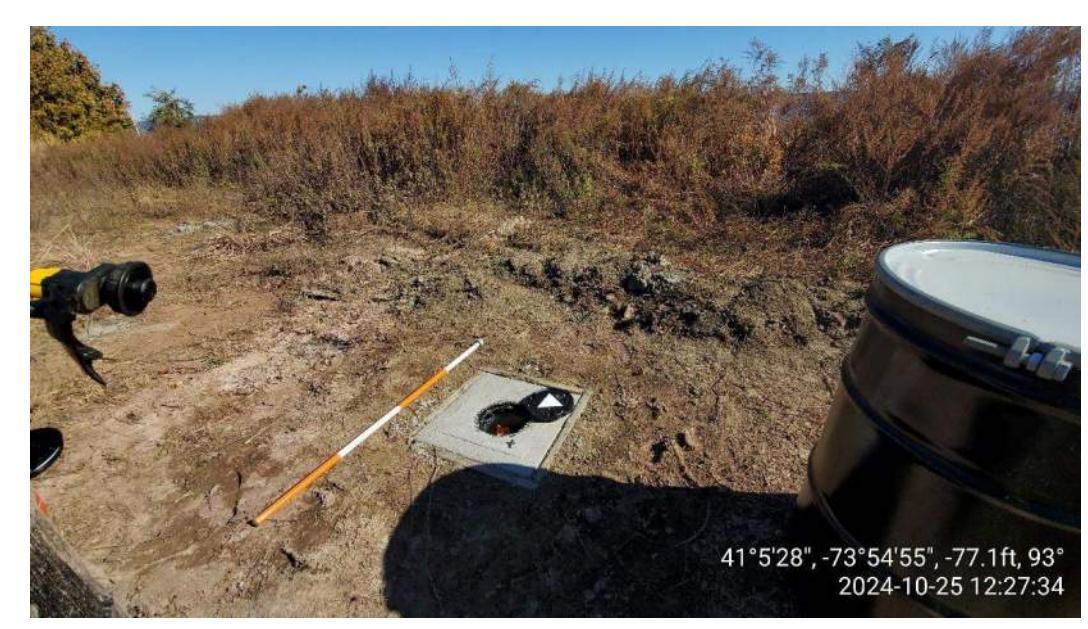
Photo No.:
 23

- **MW41R** Trace amounts of LNAPL and DNAPL were observed during postremedial sampling events performed in 2015 at the original MW41 location. The well was destroyed prior to the 2017 SMP event and was replaced in October 2024. NAPL was not observed during the October 2024 gauging event.

Monitoring well (MW41R) on Upper Terrace installed on 10/18/2024.
