Site Investigation Report

Schmigel Site Hoosick Falls, New York NYSDEC Site ID No. 442002

CHA Project Number: 16426.1001.1102

November 19, 2008

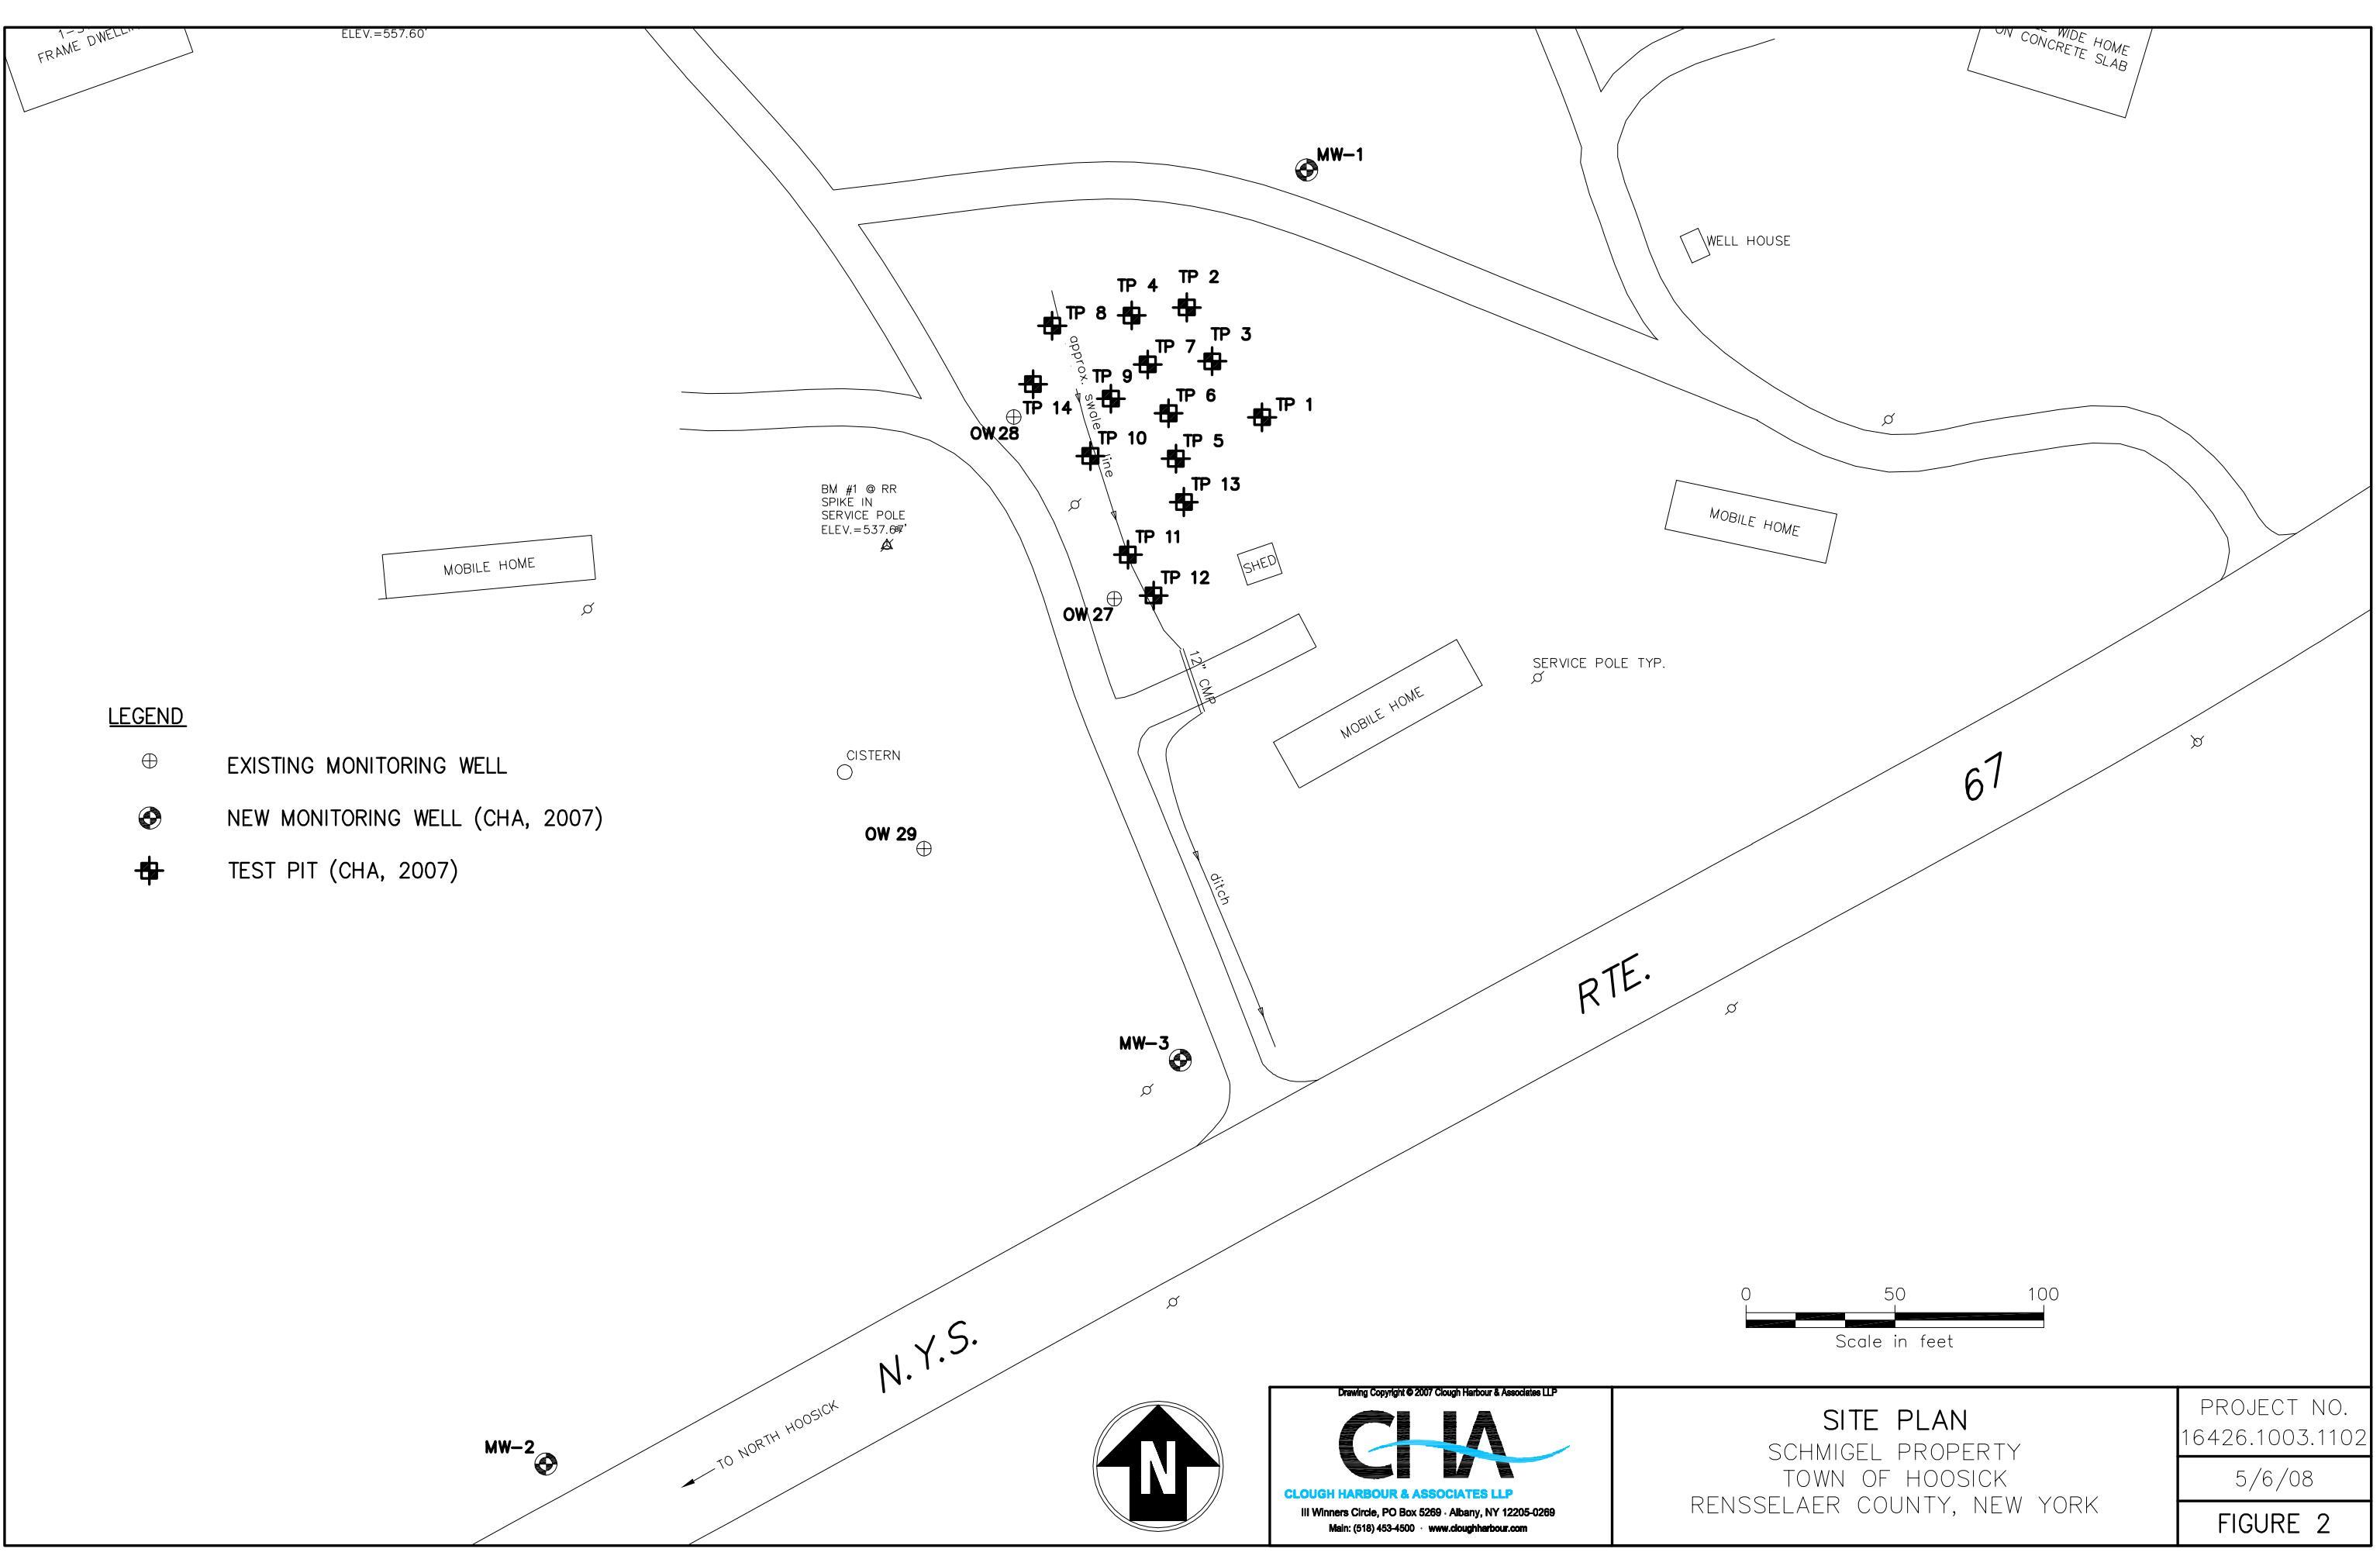
The subject site is located in Hoosick Falls, New York on State Route 67 (see Figure 1). The area around the site has a residential use with multiple mobile homes and a single-family house on the property. The site is the location of a former depression that was reportedly filled with residential refuse and demolition debris between 1977 and 1995. Exact dimensions of the disposal area have not previously been confirmed. Mr. Alexander Schmigel, the former property owner, reportedly stated that over an approximate two-week period in 1977 he allowed the disposal of 55-gallon drums containing various chemicals at the site. He indicated that the drums were from the former Norplex Oak Materials facility located in Hoosick Falls.

There are three existing groundwater monitoring wells located at the site. The existing groundwater monitoring wells are numbered OW-27, OW-28 and OW-29 and the locations of these wells are shown on Figure 2. The existing wells were inspected by CHA. Monitoring well OW-27 was found to be in good condition; however, it could not be locked due to a broken riser cap. Monitoring well OW-28 was damaged (the casing appeared to be pinched or bent below the ground surface) such that a bailer could not be inserted past the obstruction point. However, the well riser was sufficiently intact to allow pump tubing fitted with a bottom check valve to pass down the well to facilitate sampling. It was also noted that the protective steel casing of OW-28 was loose and could be pulled from the ground; thus the surface seal of the well appears to be compromised. Lastly, monitoring well OW-29 was inspected and found to be significantly compromised. The riser pipe had heaved to approximately 2" above the protective steel casing and the surface seal was broken. The well riser was blocked or broken at 1.5' bgs. No reliable depth-to-groundwater measurement or groundwater sample could be collected from OW-29

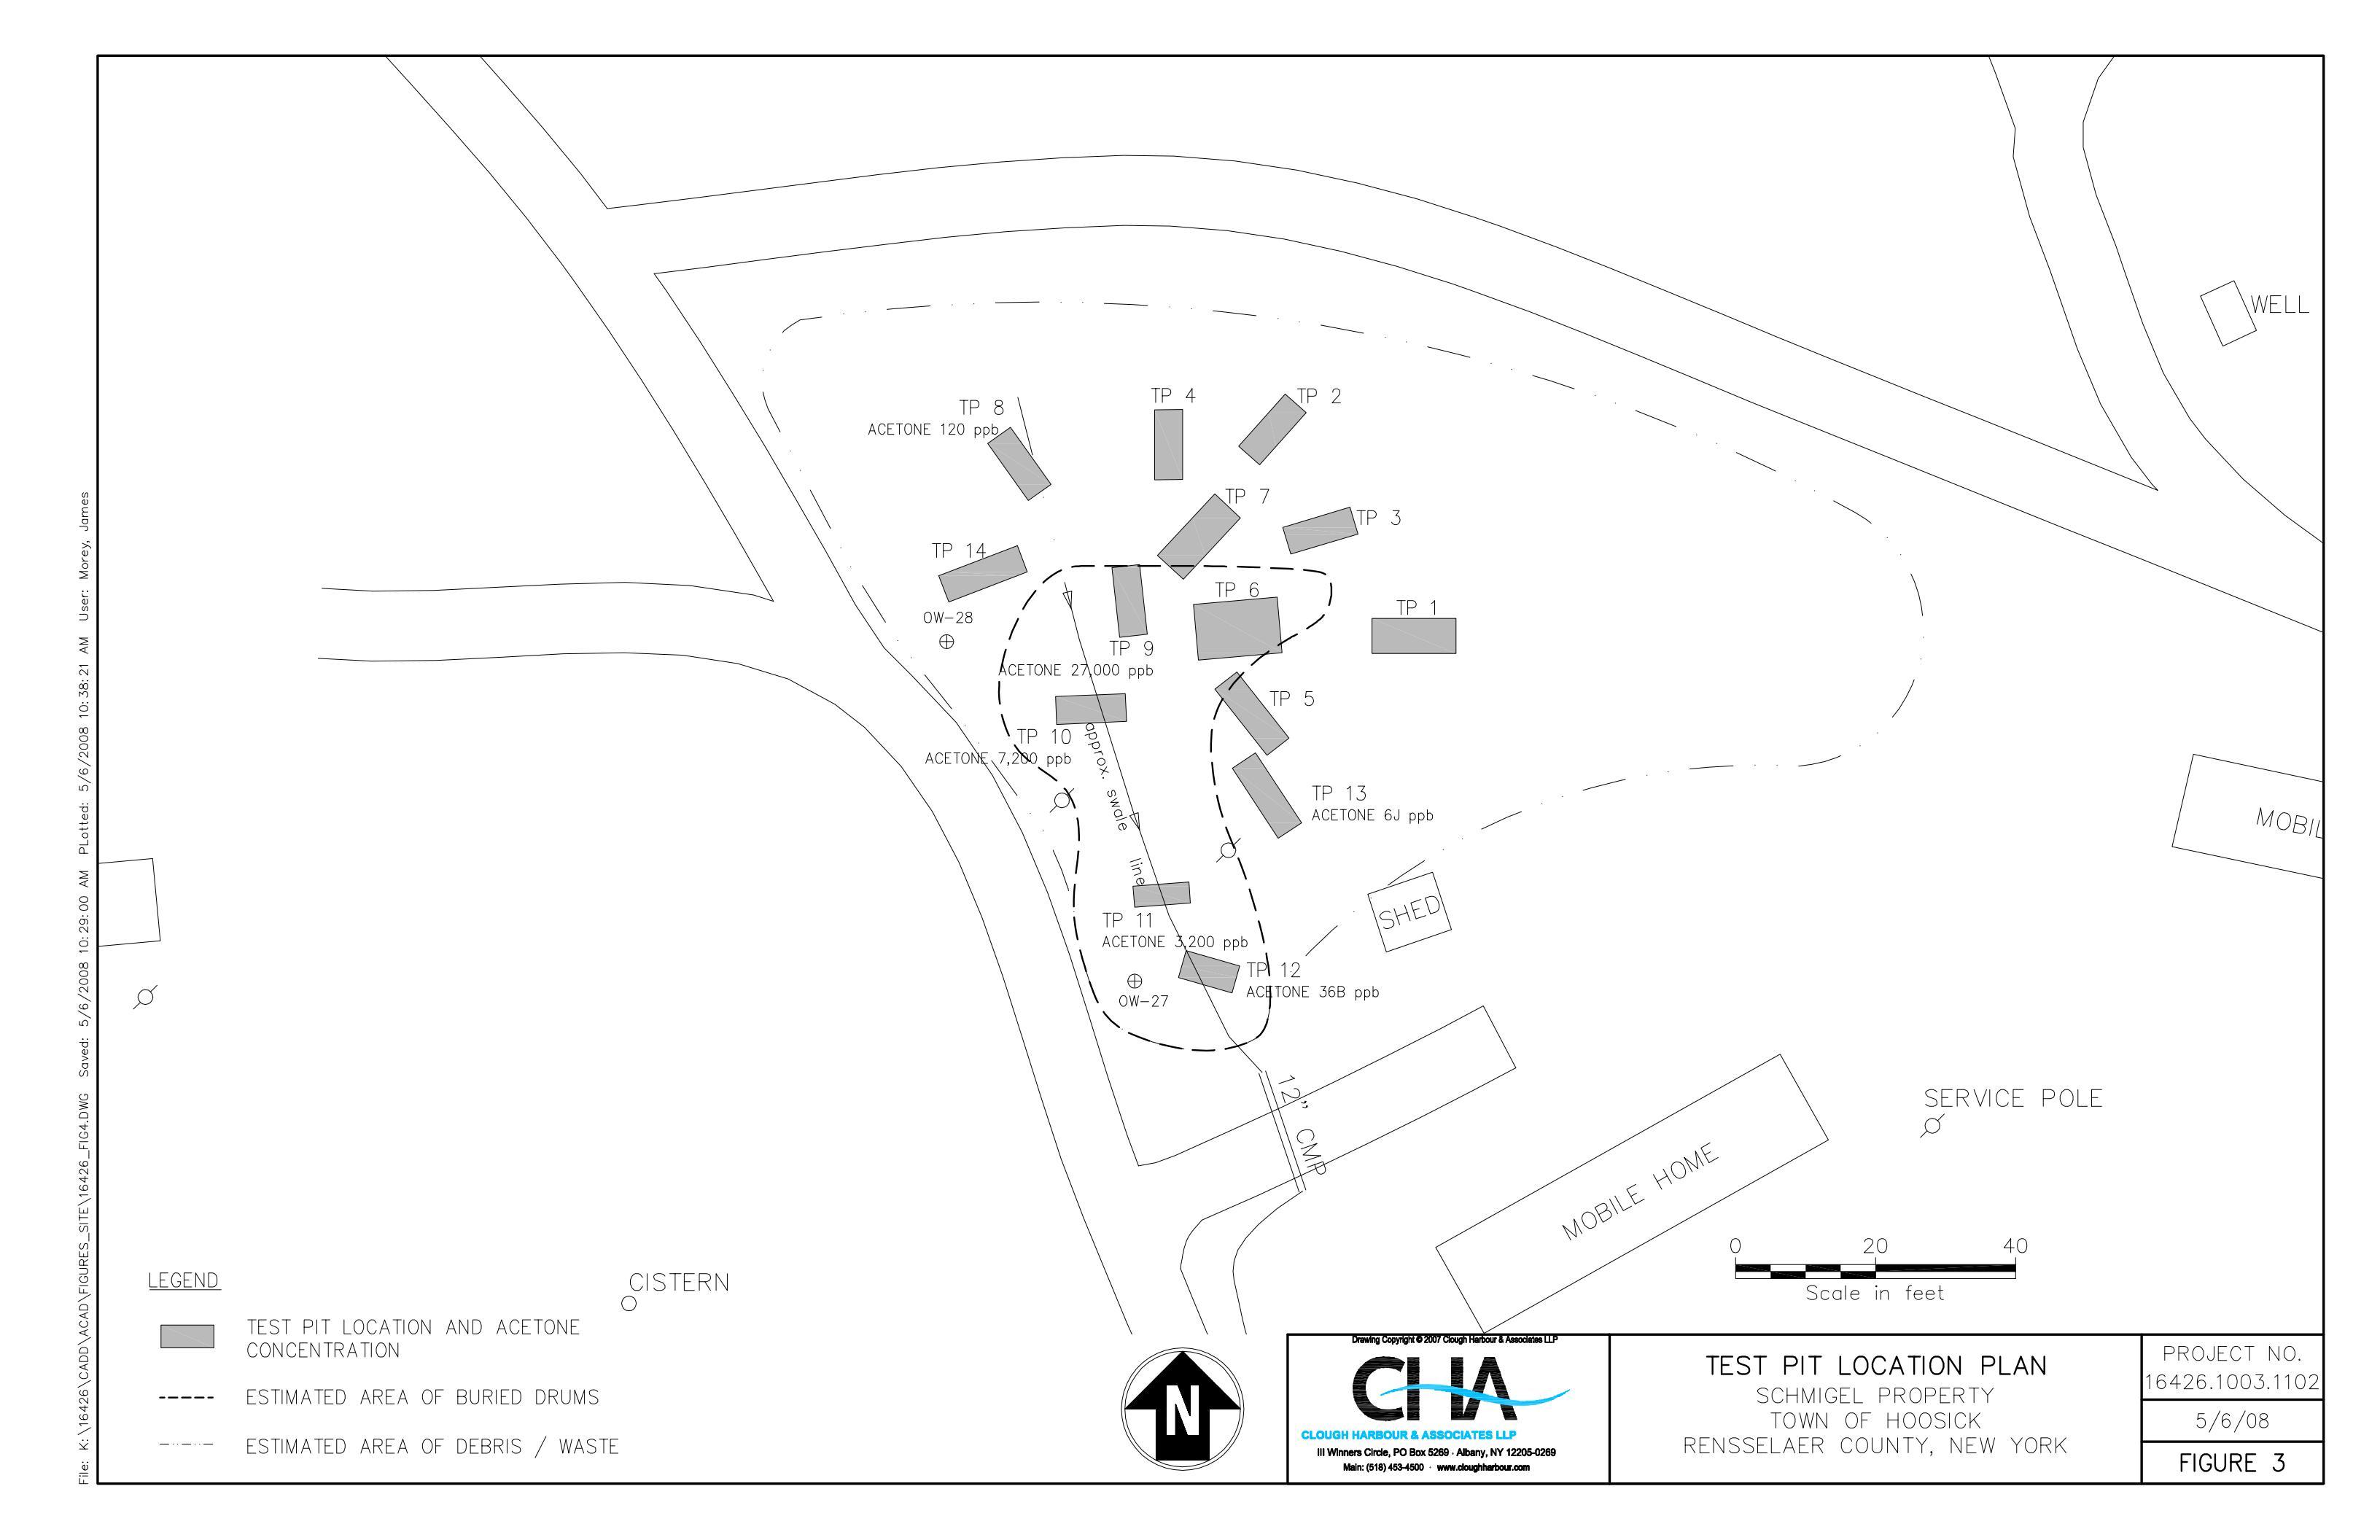
In summary, buried metal drums were encountered in 6 of the 14 test pits that CHA excavated within the disposal area. Most of the drums appeared to be crushed and empty, with no evidence of gross contamination adjacent to the drums. As shown on Figure 3, the buried drums appear to be limited to the central and western portions of the disposal area. There was buried solid waste/debris observed in all 14 test pits. This waste/debris appears to extend past the area of the installed test pits in some areas based on observations of surface debris and the topography of the area. The approximate area of buried solid waste and debris is also shown on Figure 3.

- Buried drums were encountered in the area of test pits TP-6, TP-9, TP-10, TP-11, and TP-12. The majority of the drums observed were crushed and appeared to be empty. The estimated area of buried drums is shown on Figure 3. The extent of this area is approximately 2,000 square feet. The depth of the fill/waste and drums is estimated to be up to 9' bgs however most of the test pit locations where drums were observed were not excavated to the underlying bedrock and therefore the depth of buried drums, the volume of the fill area with drums present is approximately 18,000 cubic feet or 665 cubic yards of material (soil/drums/waste). It is estimated that the drums and solid waste (metal, wood, tires, concrete) account for approximately 10-15% of this overall volume.

- As noted in Section 2.1, buried solid waste/debris such as metal, tires, wood, plastic, and glass were observed in each of the test pits installed. The estimated area of this waste/debris based on perimeter test pit observations, surface debris observations and the topography of the fill area, is shown in Figure 3. This area, excluding the buried drum area, is approximately 8,500 square feet in size. Assuming an average depth to bedrock in this area of 6', the entire volume of waste/debris/fill, excluding the area of confirmed buried drums, is approximately 51,000 cubic feet or 2,333 cubic yards of material.

- The overpacked drum from TP-6 should be managed and disposed of as hazardous waste and the overpacked drum associated with test pit TP-9 can be managed as non-hazardous waste.
- CHA recommends that a remedial work plan be prepared to address the waste disposal area. Specifically, the work plan should address the remaining buried drums and soil/waste that contains acetone above the Unrestricted Use SCO.
- Based on the groundwater sample results, no further action with respect to site groundwater is necessary assuming that the source area is remediated.

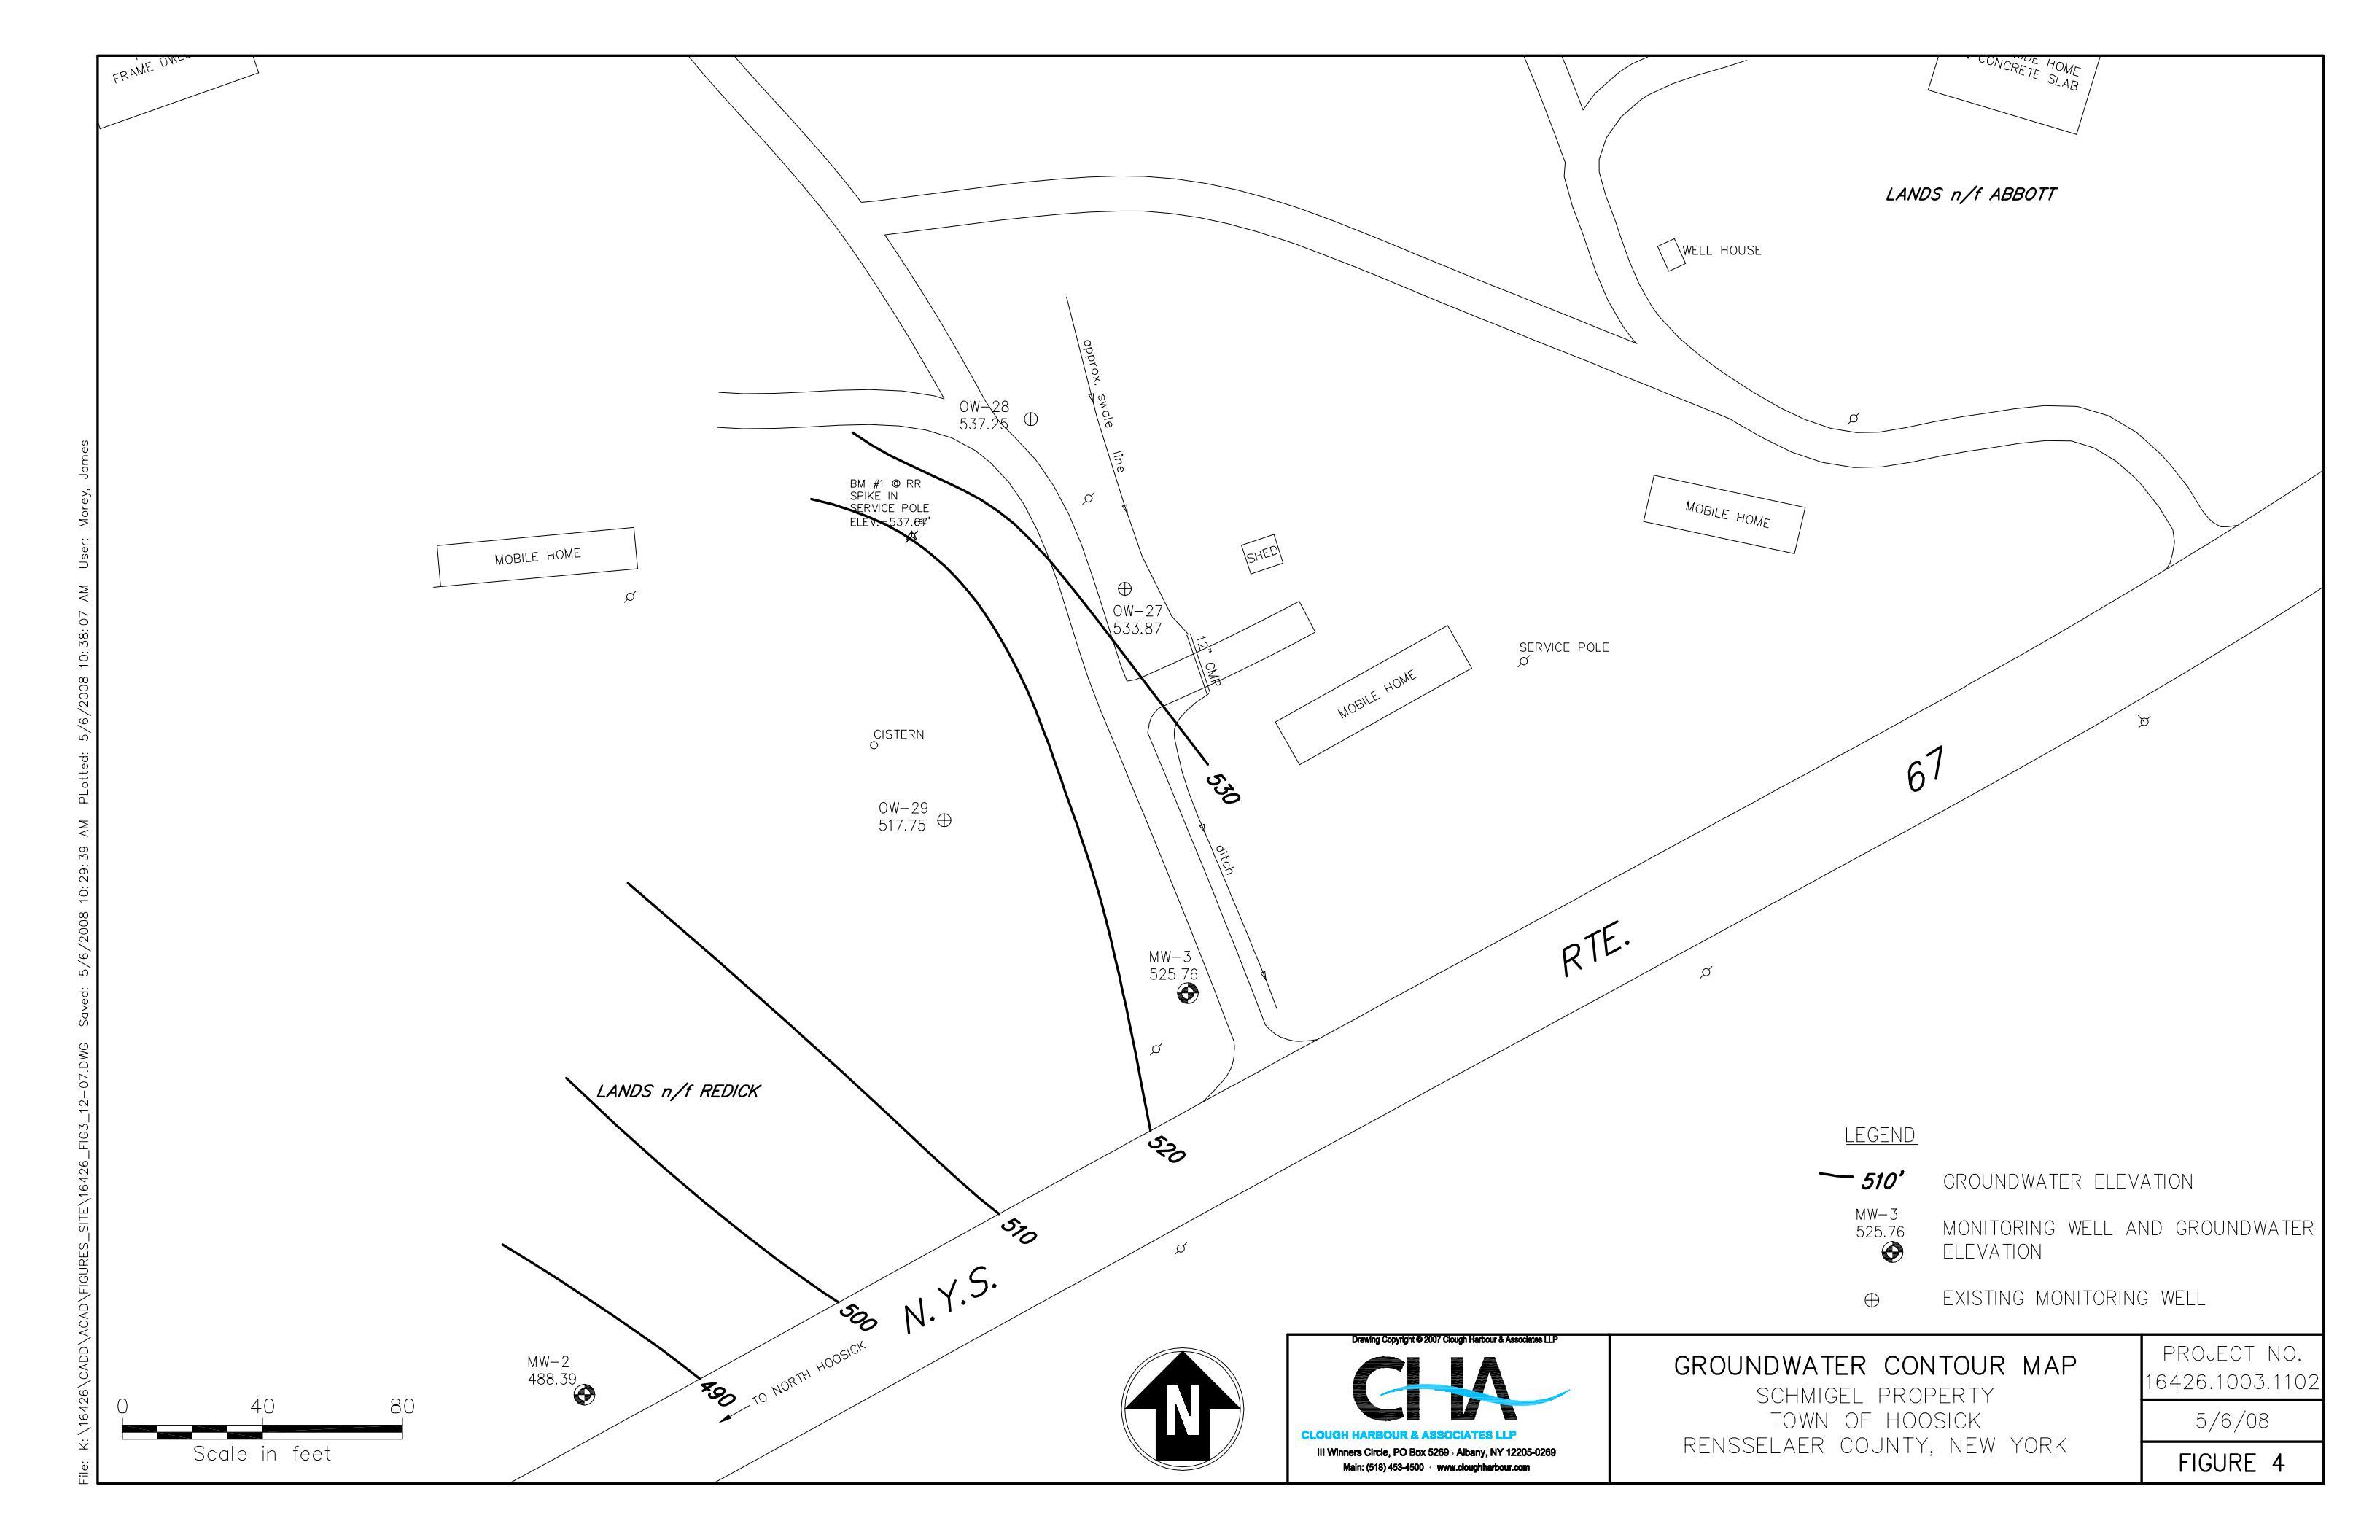
A groundwater contour map was developed using the groundwater elevations that were collected during the December 13, 2007 monitoring event as is included as Figure 4. Groundwater generally moves in a west/southwesterly direction across the subject site. The topography of the site and the geologic conditions indicate that groundwater moves in a slightly more westerly direction within the fill area.
