NORTHEASTERN ENVIRONMENTAL TECHNOLOGIES CORP.

December 16, 1997

RE: PHASE 2 SITE ASSESSMENT DAMBROSE CLEANERS SITE

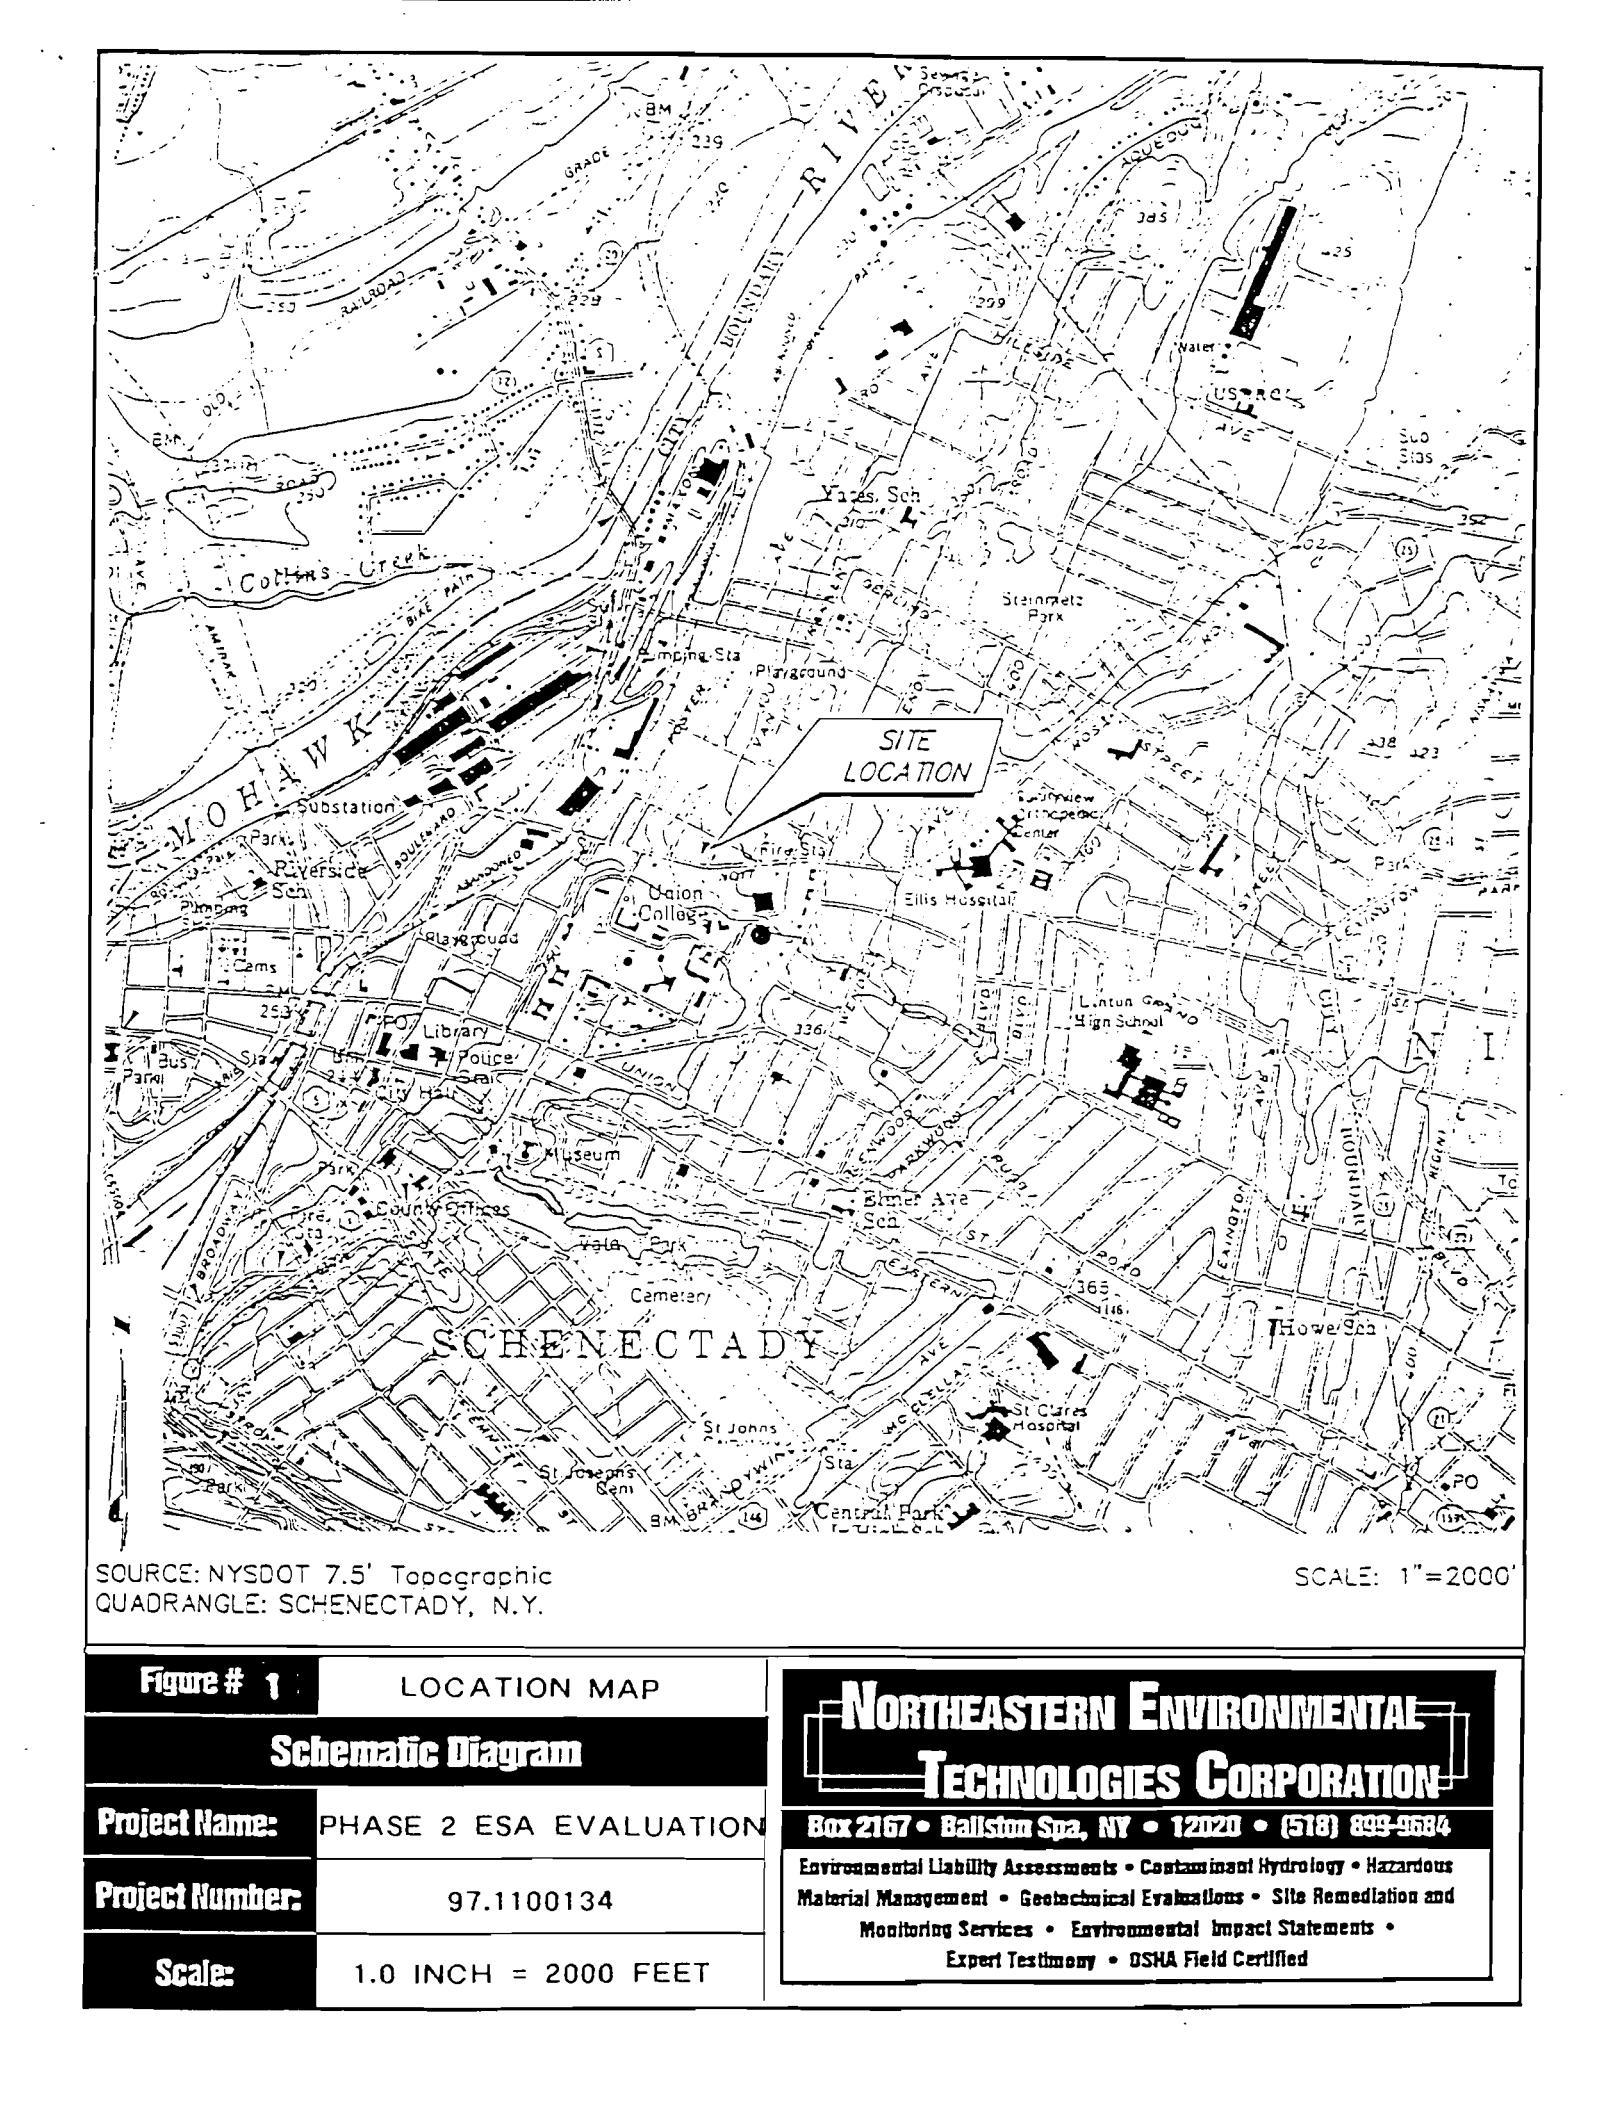
The following information has been assimilated to outline the results of a limited near surface subsurface evaluation (i.e., P2SA) performed at the above noted site (see Figure 1). This work was performed to evaluate the potential presence of soil and ground water contamination from historical dry cleaning practices on the subject site as outlined in NETC's contract for services dated November 4, 1997. The methods used to accomplish this work were based on recommendations outlined in a Phase 1 Environmental Site Assessment (P1ESA) previously completed by Clough Harbors & Associates (CHA) during 1997. The objectives of this site assessment report is to present the results of the soil and ground water sampling work performed at the site. In order to address the issues germane to this site assessment, site specific improvements / facility information, soil, ground water and local hydrogeologic information were reviewed and / or considered. A discussion of the activities completed during this Phase 2 Site Assessment are included for consideration.

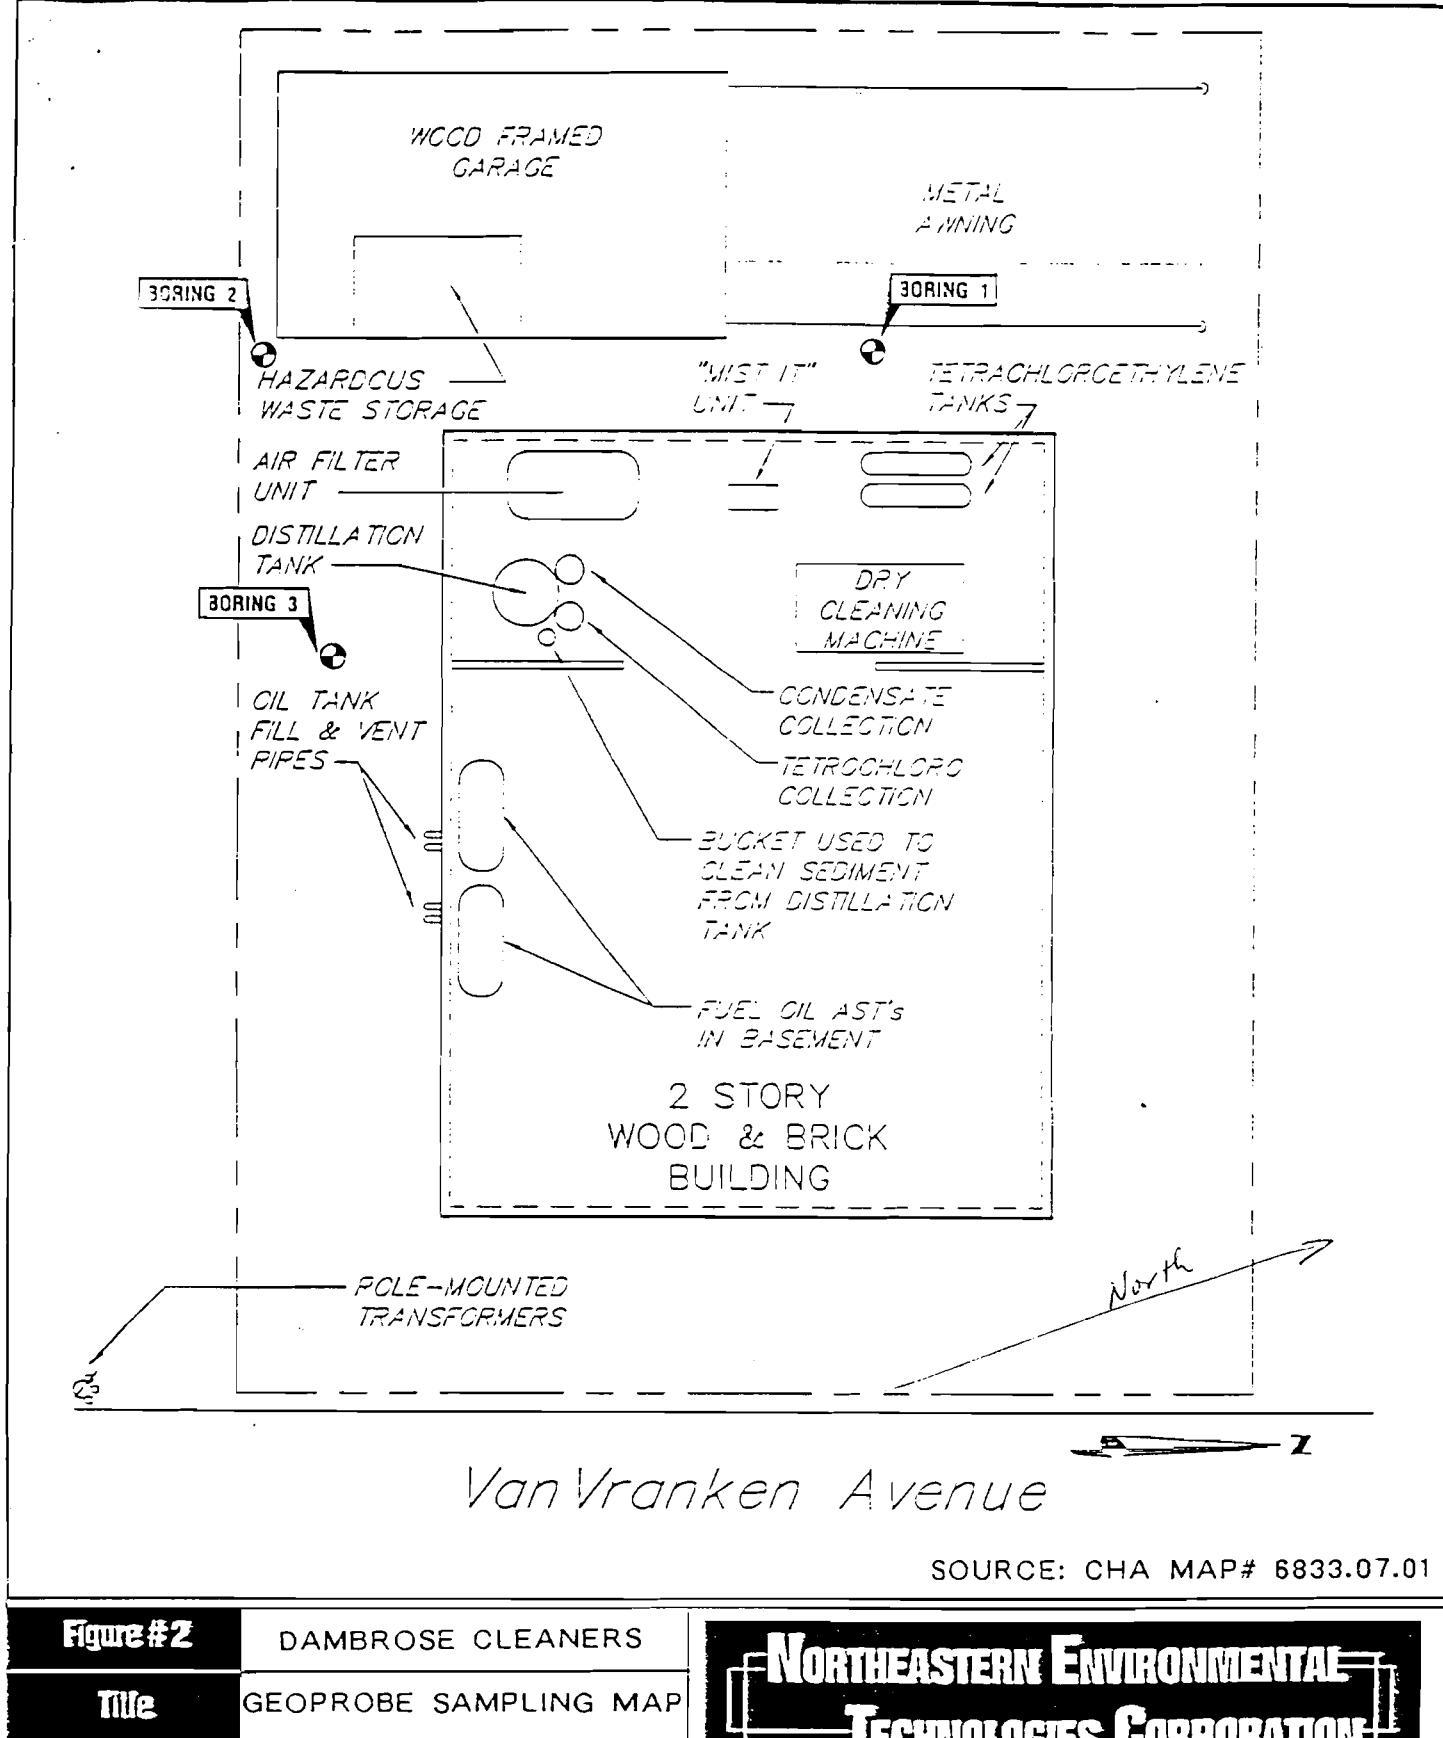
On November 13, 1997 a total of (3) soil borings and associated macro core soil samples were installed adjacent to the sites southern and southwestern property lines (see Figure 2). Each soil boring was installed to depths of \pm 12 - 19 feet. Each soil boring was completed in a manner to provide a geological log of the subsurface conditions and provide necessary data on the sites ground water and soil quality. Each soil boring was installed via direct push methods utilizing NETC's truck mounted Geoprobe 540U sampling system following standard methods / techniques. NETC performed all aspects of the direct push survey and was responsible for detailed logging of all samples.

The soil borings were located in an area of the site believed to have been subjected to historical storage of chlorinated solvents used at the site. This opinion was based on information assimilated by CHA during their P1ESA.
