MEMORANDUM

Subject: McMaster Street Former Manufactured Gas Plant (MGP) 2020 Maintenance Summary

APPENDIX A MCMASTER STREET MGP 2020 MAINTENANCE SUMMARY PHOTOGRAPHIC LOG

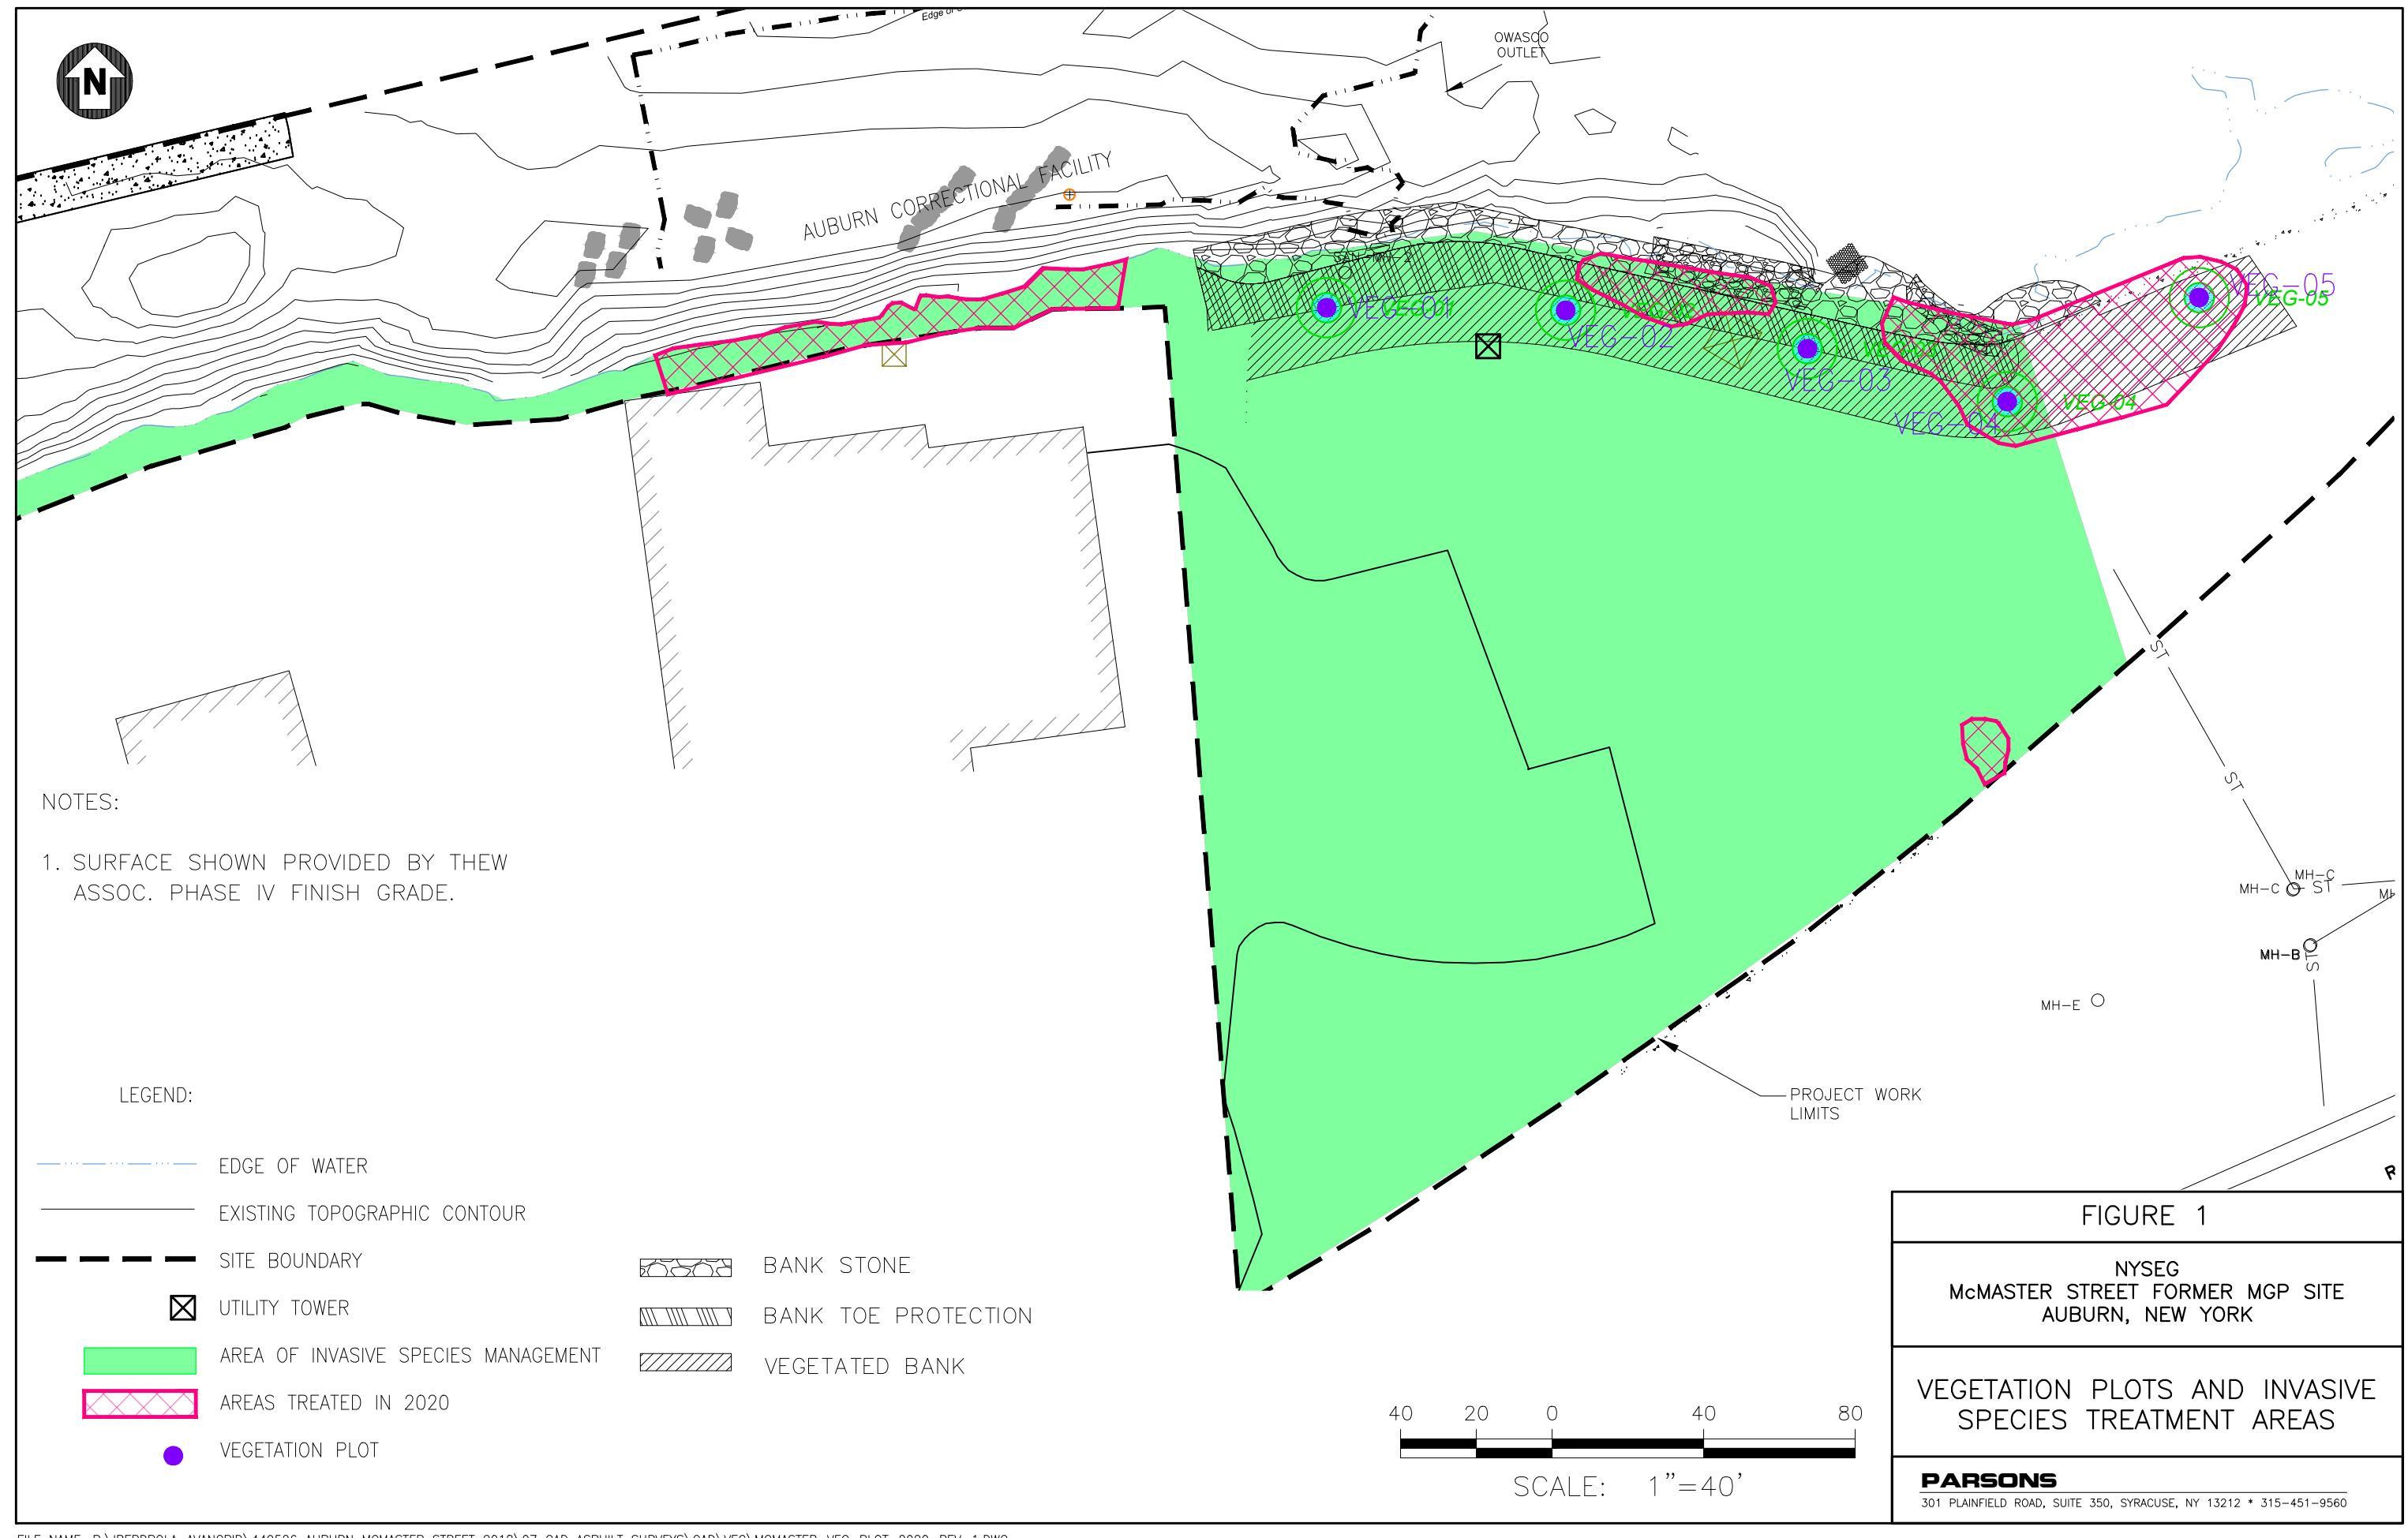
A comprehensive vegetation assessment was performed on September 18^{th} , 2020 to determine whether seeded and planted areas at McMaster Street Former MGP site are on track to meet performance goals. Five $1m^2$ plots were selected across the site to represent the plant community as accurately as possible (Figure 1). All plots surveyed were all dominated by the perennial native grass Canada wildrye (*Elymus canadensis*). Overall percent cover of seeded areas was 89 percent, exceeding the performance goal of 85 percent cover.

- April 28th, 2020: Invasive species reconnaissance site visit. Several isolated patches of Japanese knotweed were identified.
- July 6th, 2020: First invasive species treatment. Triclopyr was applied at 3% concentration to isolated patches of Japanese knotweed (Figure 1). Triclopyr is a translocated, broad-leaf specific herbicide which is most effective during peak growth.
- September 18th, 2020: Comprehensive vegetation assessment.
- October 2nd, 2020: Second invasive species treatment. Aquaneat® was applied at 2.5% concentration to isolated patches of Japanese knotweed (Figure 1). Aquaneat's® active ingredient, glyphosate, is a non-selective herbicide which affects the site of direct application. This is more effective than Triclopyr in fall when plants are approaching senescence and translocating less.

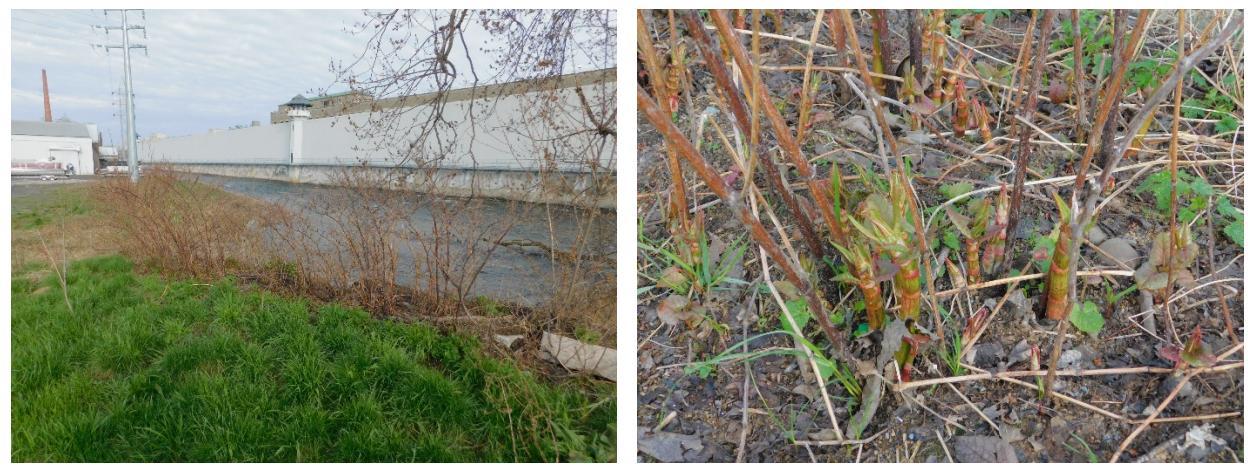
Photograph 1

Photographs 1 and 2 show the Isolated patches of Japanese knotweed (*Reynoutria japonica*) at McMaster Street former MGP during the April reconnaissance site visit. Photos 3 and 4 show the July herbicide treatment of Japanese knotweed (*Reynoutria japonica*). Photos 5 and 6 show a vegetation plot and a surviving silver maple (*Acer saccharinum*) from the September vegetation survey. Photos 7 and 8 show the October herbicide treatment.

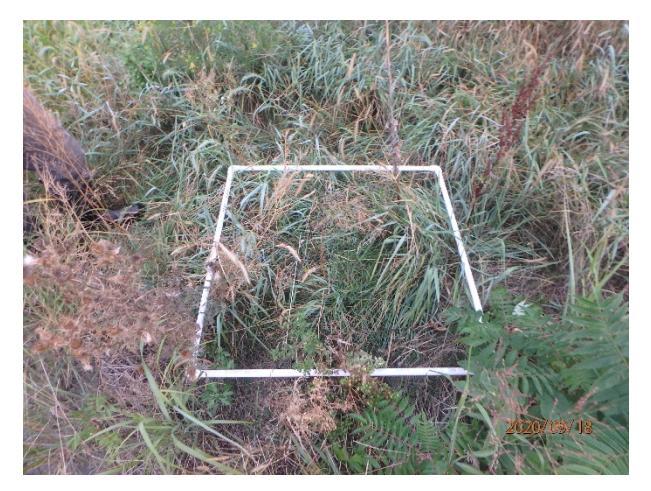
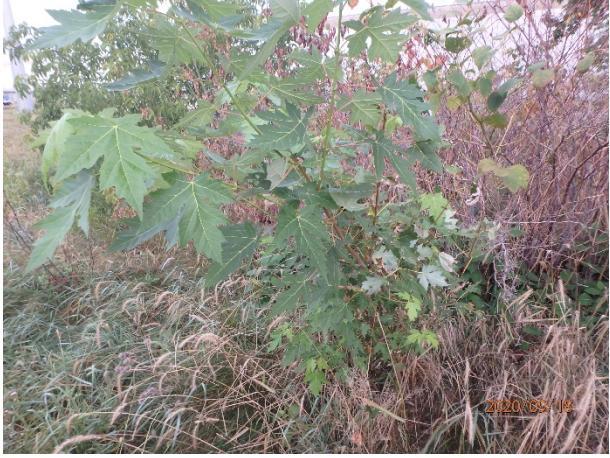
Photograph 5

Planted trees and shrubs were also inventoried to determine survival rates. Overall, 51 percent of planted shrubs were found surviving on site. Based on site conditions and typical outcomes for small potted woody plantings, this rate of survival is consistent with expectations. Dogwoods (*Cornussp.*) had the highest rate of survival at 67 percent and red chokeberry (*Aronia arbutifolia*) had the lowest rate of survival at 27 percent. Overall, 38 percent of planted trees were found surviving on site. Black willow (*Salix nigra*) had the highest rate of survival at 80 percent and silver maple (*Acer saccharinum*) and cottonwood (*Populus deltoides*) had the lowest rate of survival at 20 percent.
