Re: McKesson Envirosystems Bear Street Site Syracuse, New York Site No. 07-34-020 BBL Project #: 0260.26003 #10

This *Biannual Process Control Monitoring Report* (Biannual Report) for the McKesson Envirosystems, Bear Street Site (the site), located at 400 Bear Street in Syracuse, New York has been prepared by Blasland, Bouck & Lee, Inc. (BBL), on behalf of McKesson Corporation (McKesson), to present a description of the operation and maintenance (O&M) activities conducted and the monitoring results obtained during the period from January 2004 through June 2004. Additionally, this report also presents a detailed description of the supplemental remedial activities conducted between August 2 and August 12, 2004. This report has been prepared in accordance with the requirements of the New York State Department of Environmental Conservation- (NYSDEC-) approved *Site Operation and Maintenance Plan* (BBL, Revised August 1999) and a December 29, 1999 letter from David J. Ulm of BBL to Michael J. Ryan, P.E. of the NYSDEC, presenting the long-term process control monitoring program as an addendum to the Site O&M Plan. The Site O&M Plan and the addendum are collectively referred to herein as

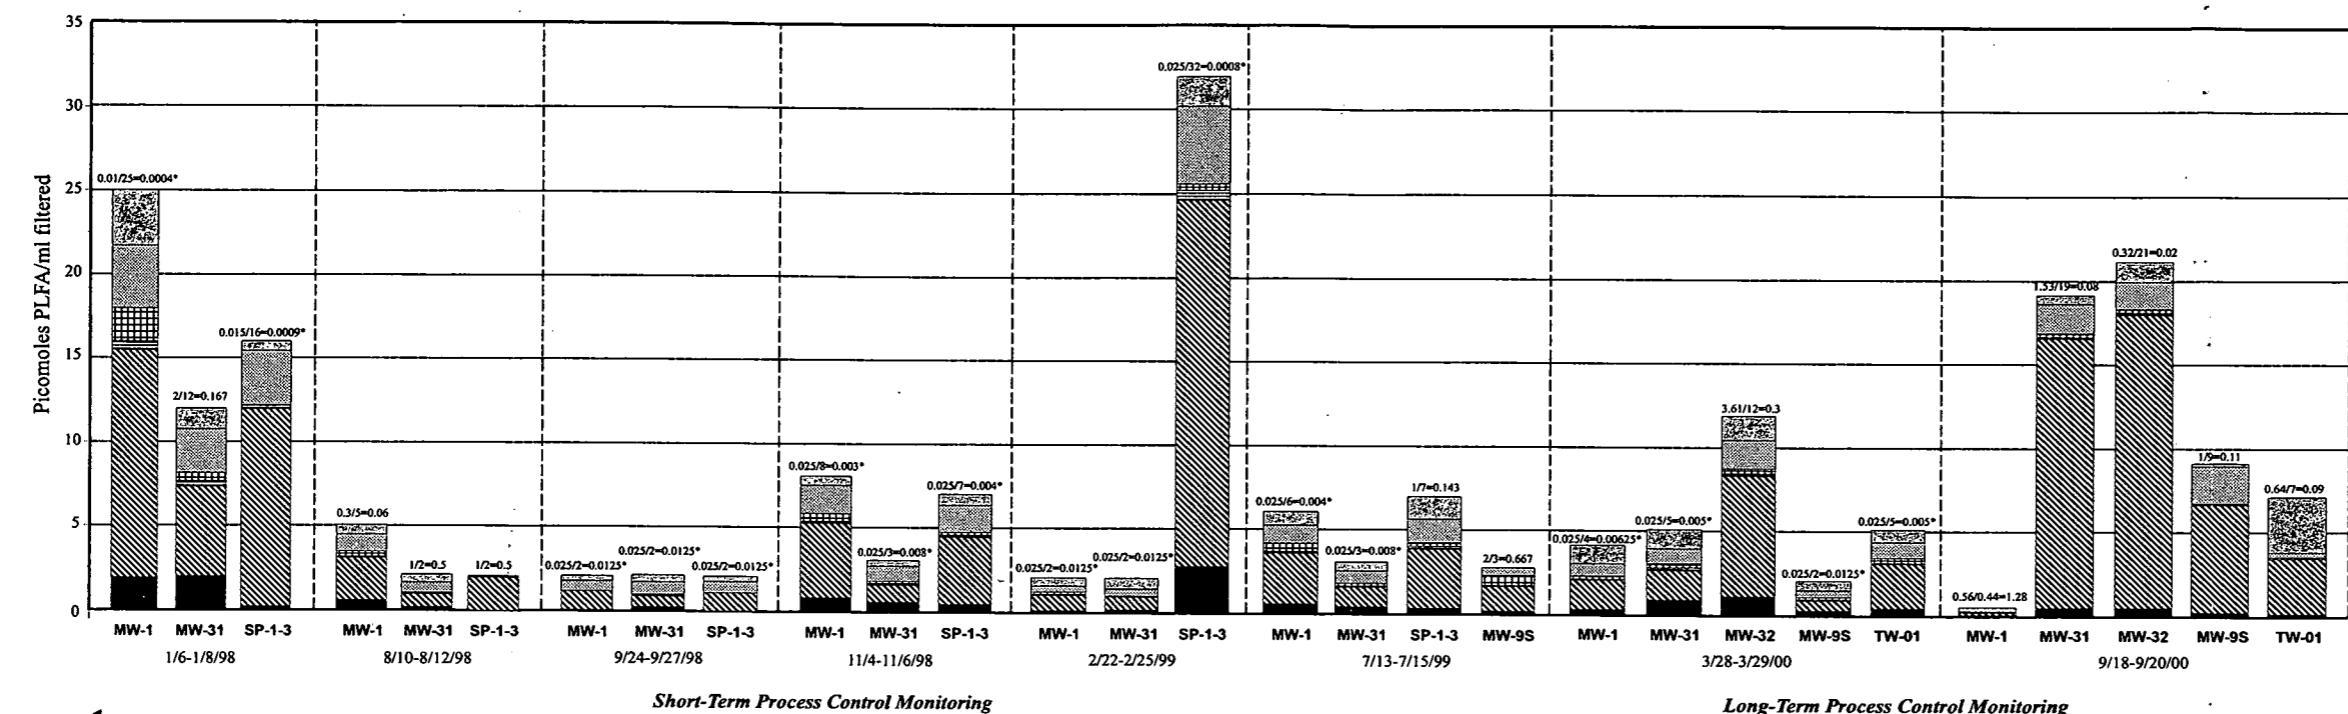
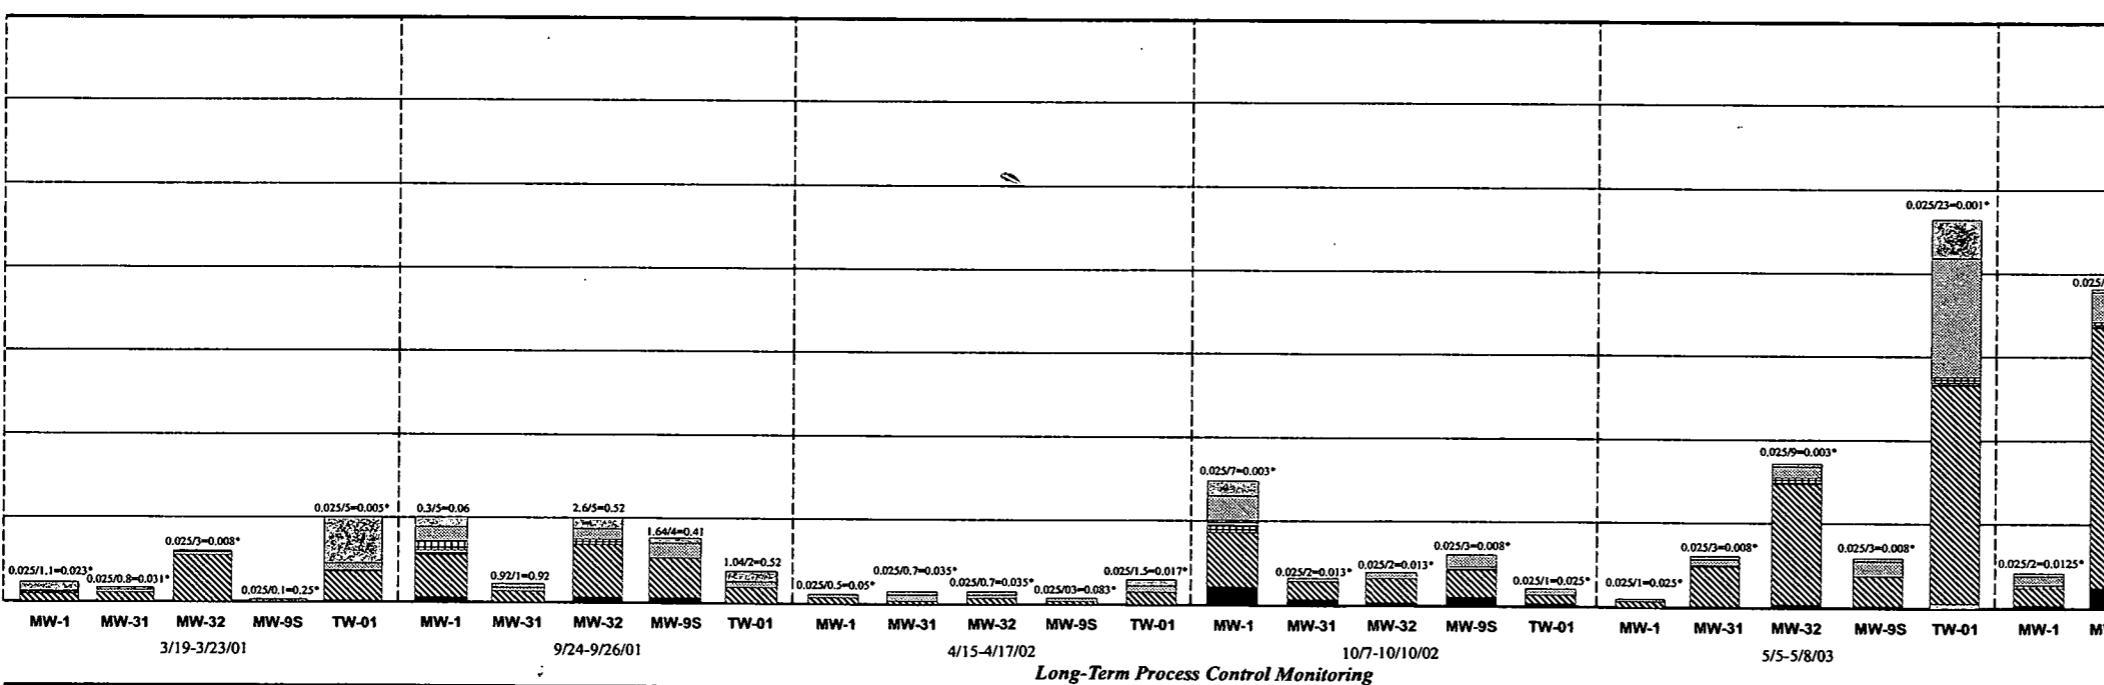
1. Ratio above stacked bar graph is PHA to PLFA. PHA/PLFA ratio above 0.2 suggests unbalanced growth of the microbial community.

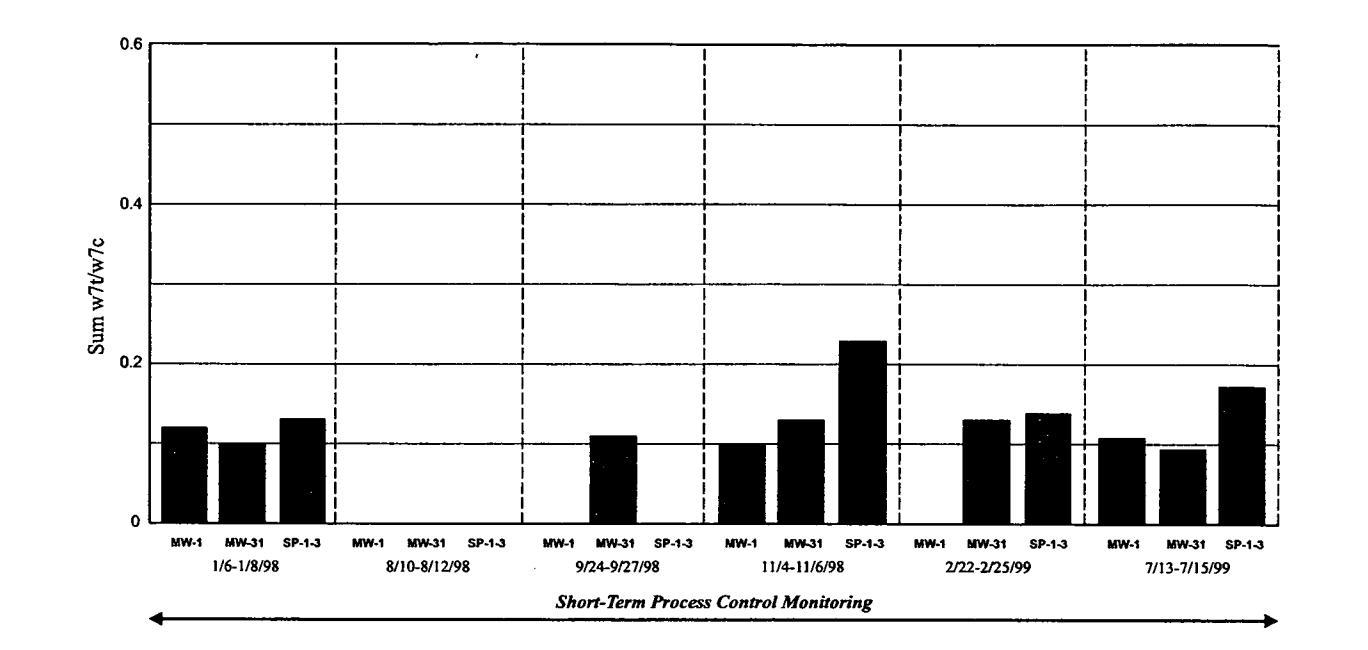
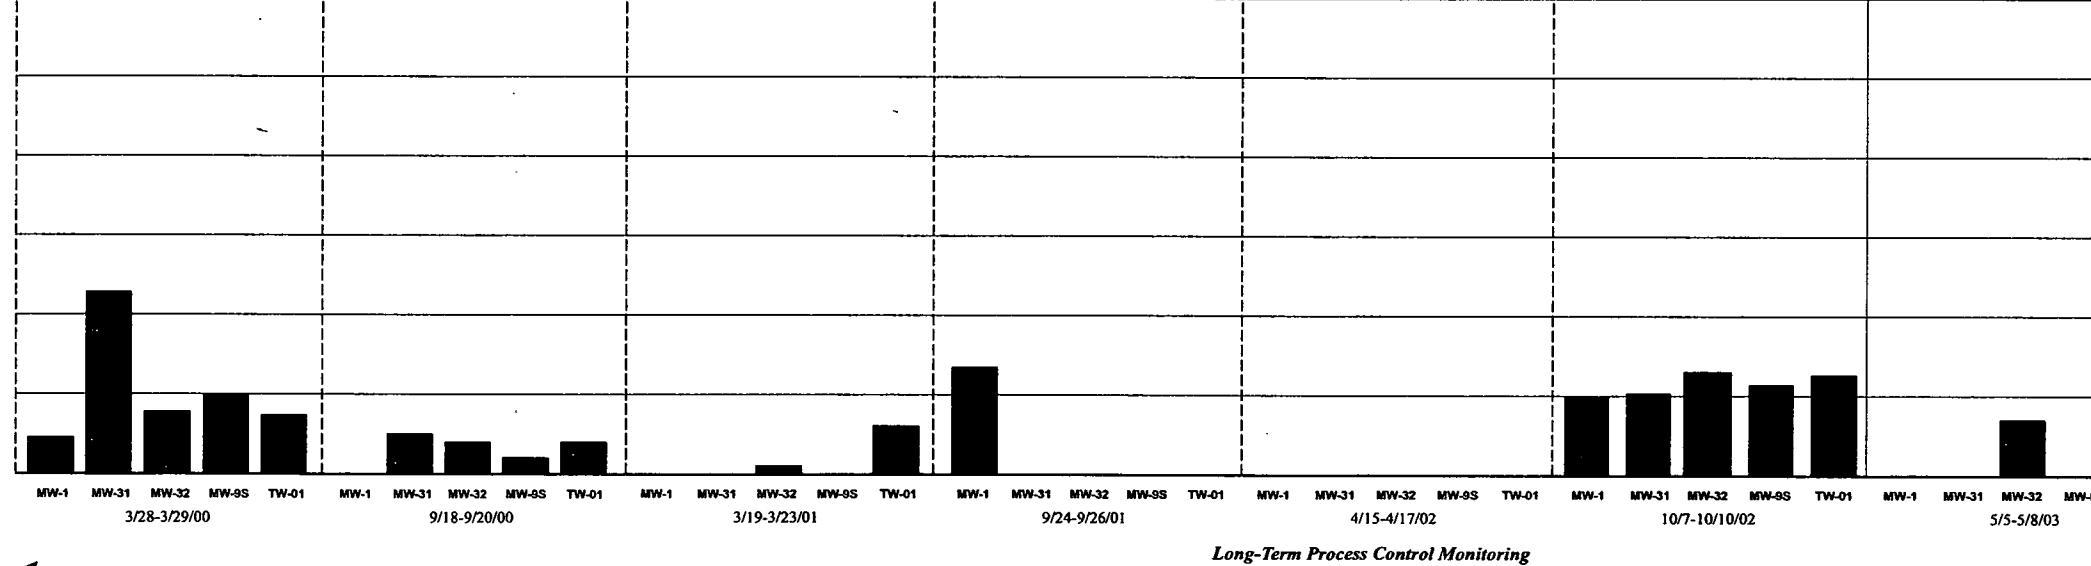
2. The ratios 16:1w7t/16:1w7c and 18:1w7t/18:1w7c show the effect of toxicity or starvation on the microbial community.

- The range (for the sum w7t/w7c) is generally between 0.1 (healthy) to 0.6 (starved). A higher ratio indicates increased stress. 3. MW-9S was not scheduled to be sampled during the short-term process control monitoring program, but was sampled in July 1999 (week 52)
 - to provide additional information regarding Area 1. This well is part of the long-term process control monitoring program.

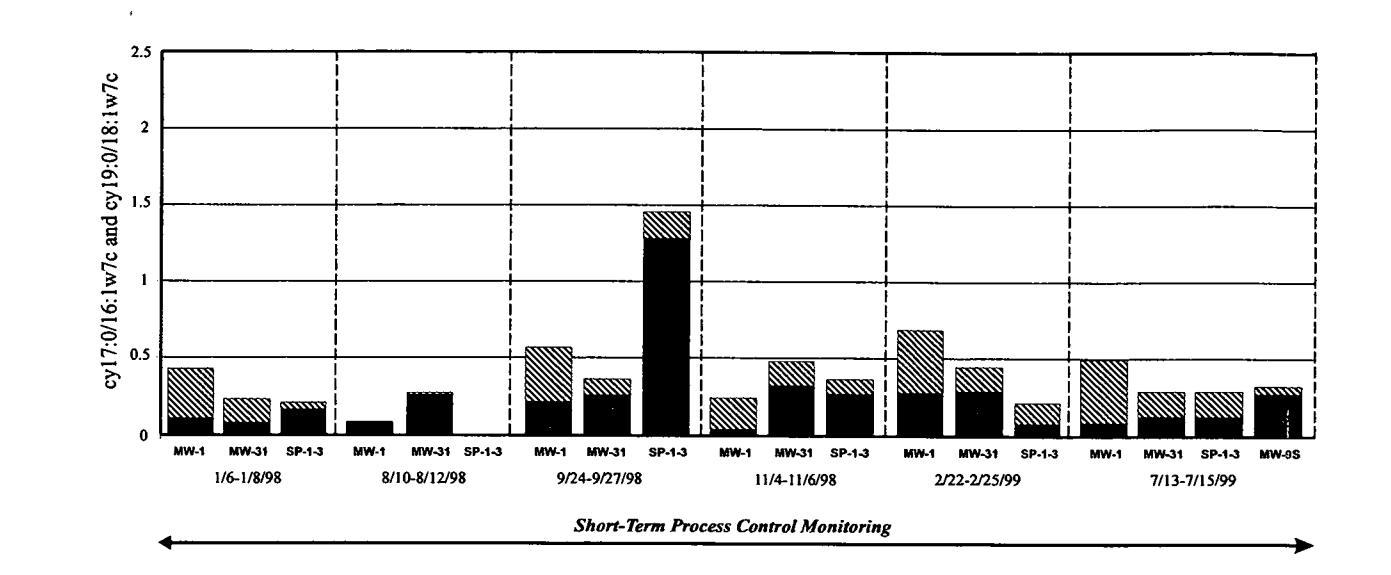
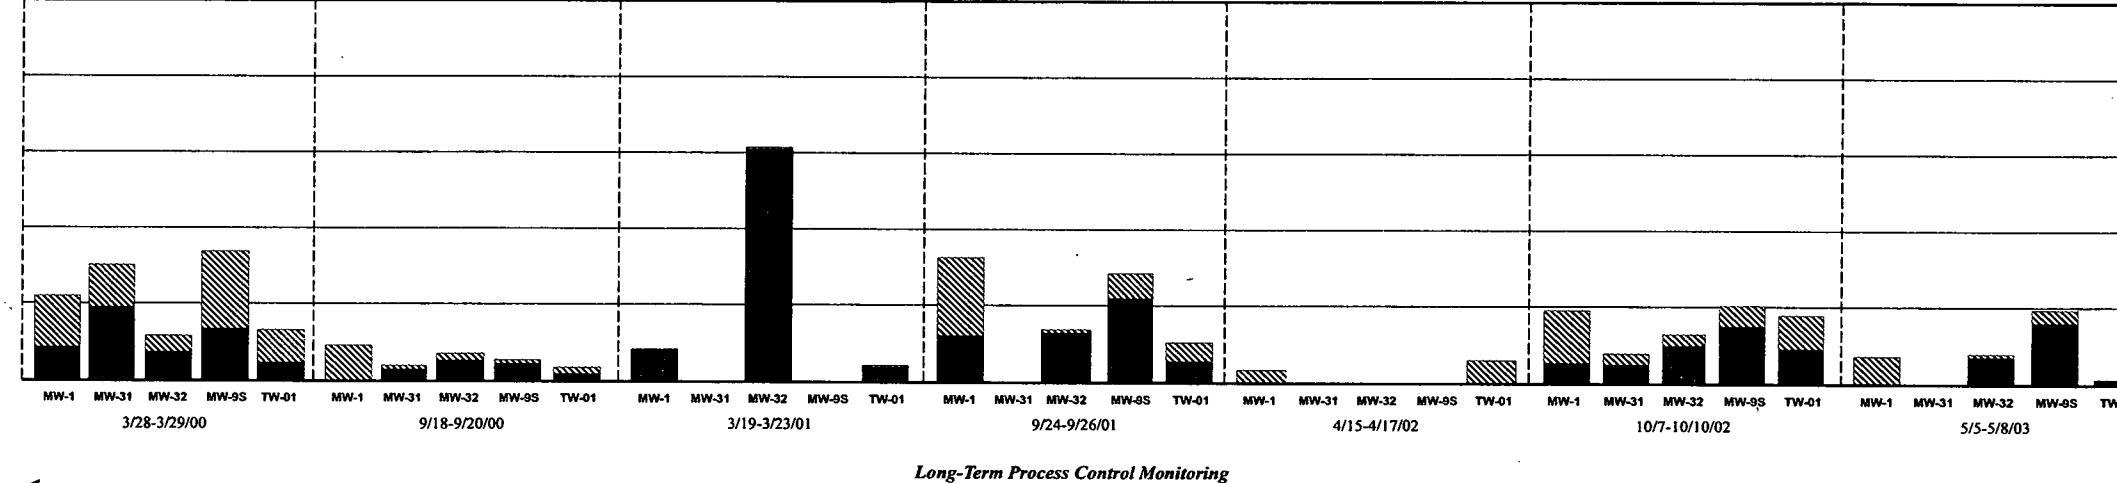
- 1. The two ratios: cy17:0/16:1w7c and cy19:0/18:1w7c express a growth rate of the microbial community. The sum of these two ratios falls within the range of 0.1 (log phase) to 5.0 (stationary phase). A lower ratio suggests a higher turnover rate.
- 2. MW-9S was not scheduled to be sampled during the short-term process control monitoring program, but was sampled in July 1999 (week 52) to provide additional information regarding Area 1. This well is part of the long-term process control monitoring program.

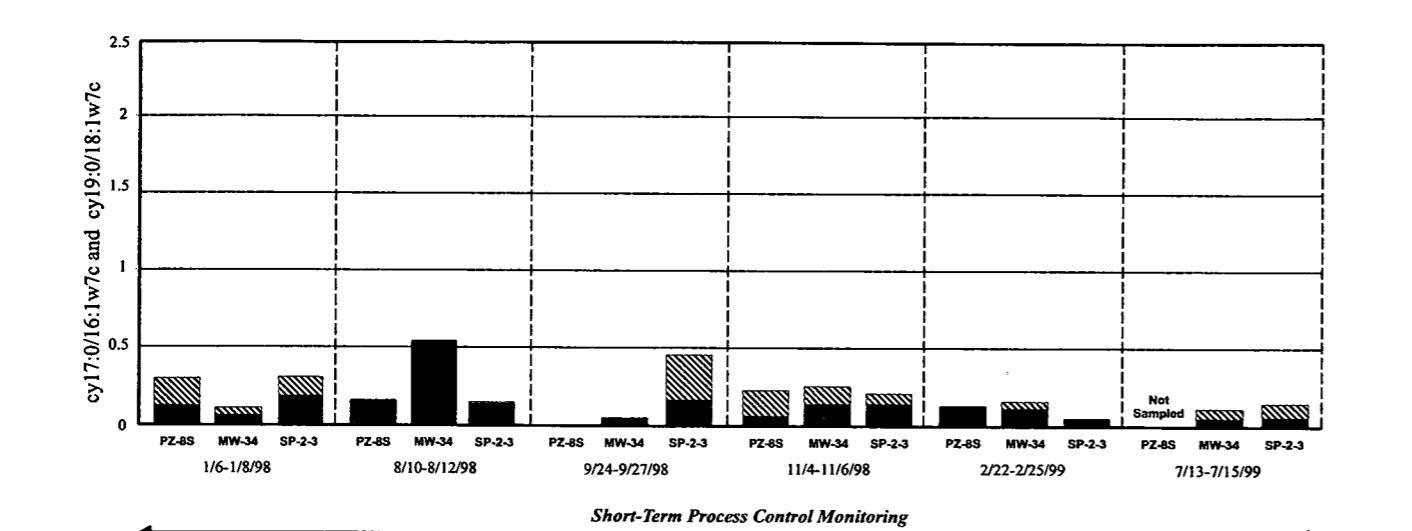
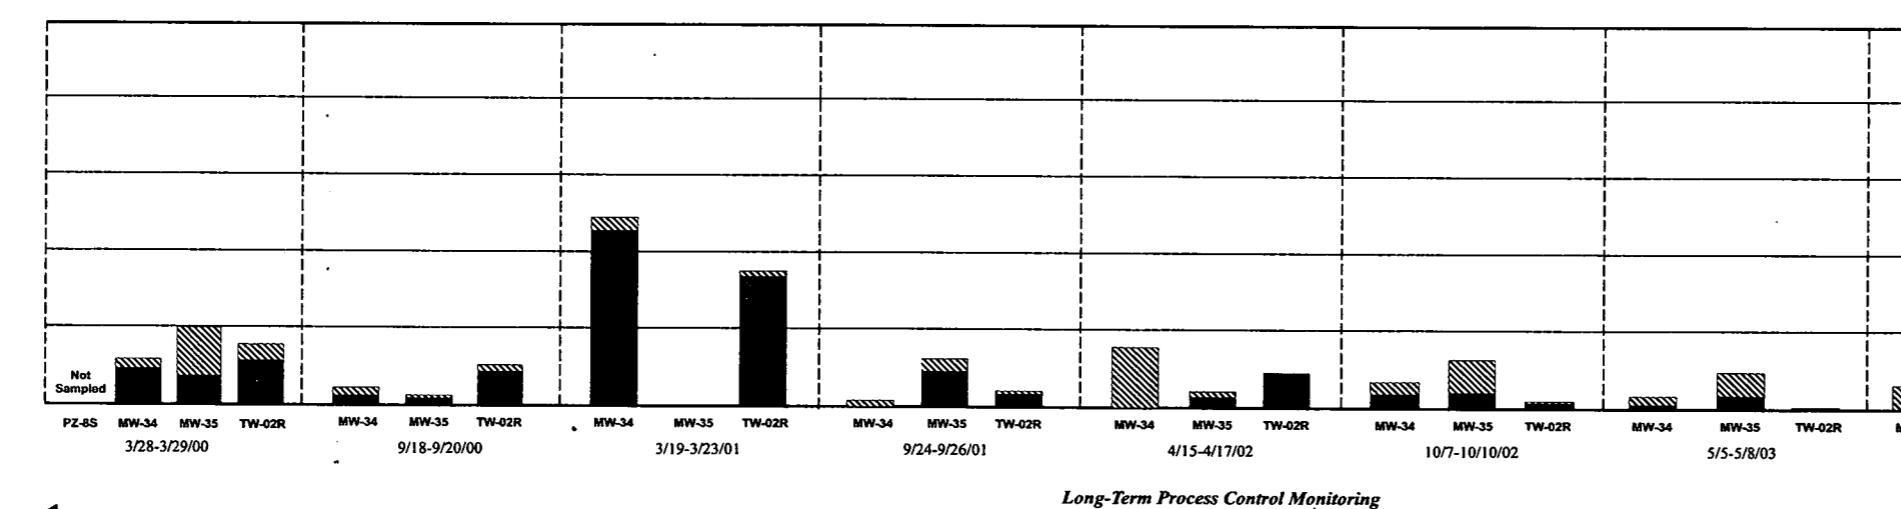
- 1. The two ratios: cy17:0/16:1w7c and cy19:0/18:1w7c express a growth rate of the microbial community. The sum of these two ratios falls within the range of 0.1 (log phase) to 5.0 (stationary phase). A lower ratio suggests a higher turnover rate.
- PZ-8S was not sampled in July 1999 and in March 2000 because this piezometer was damaged. This piezometer was decommissioned in August 2000.

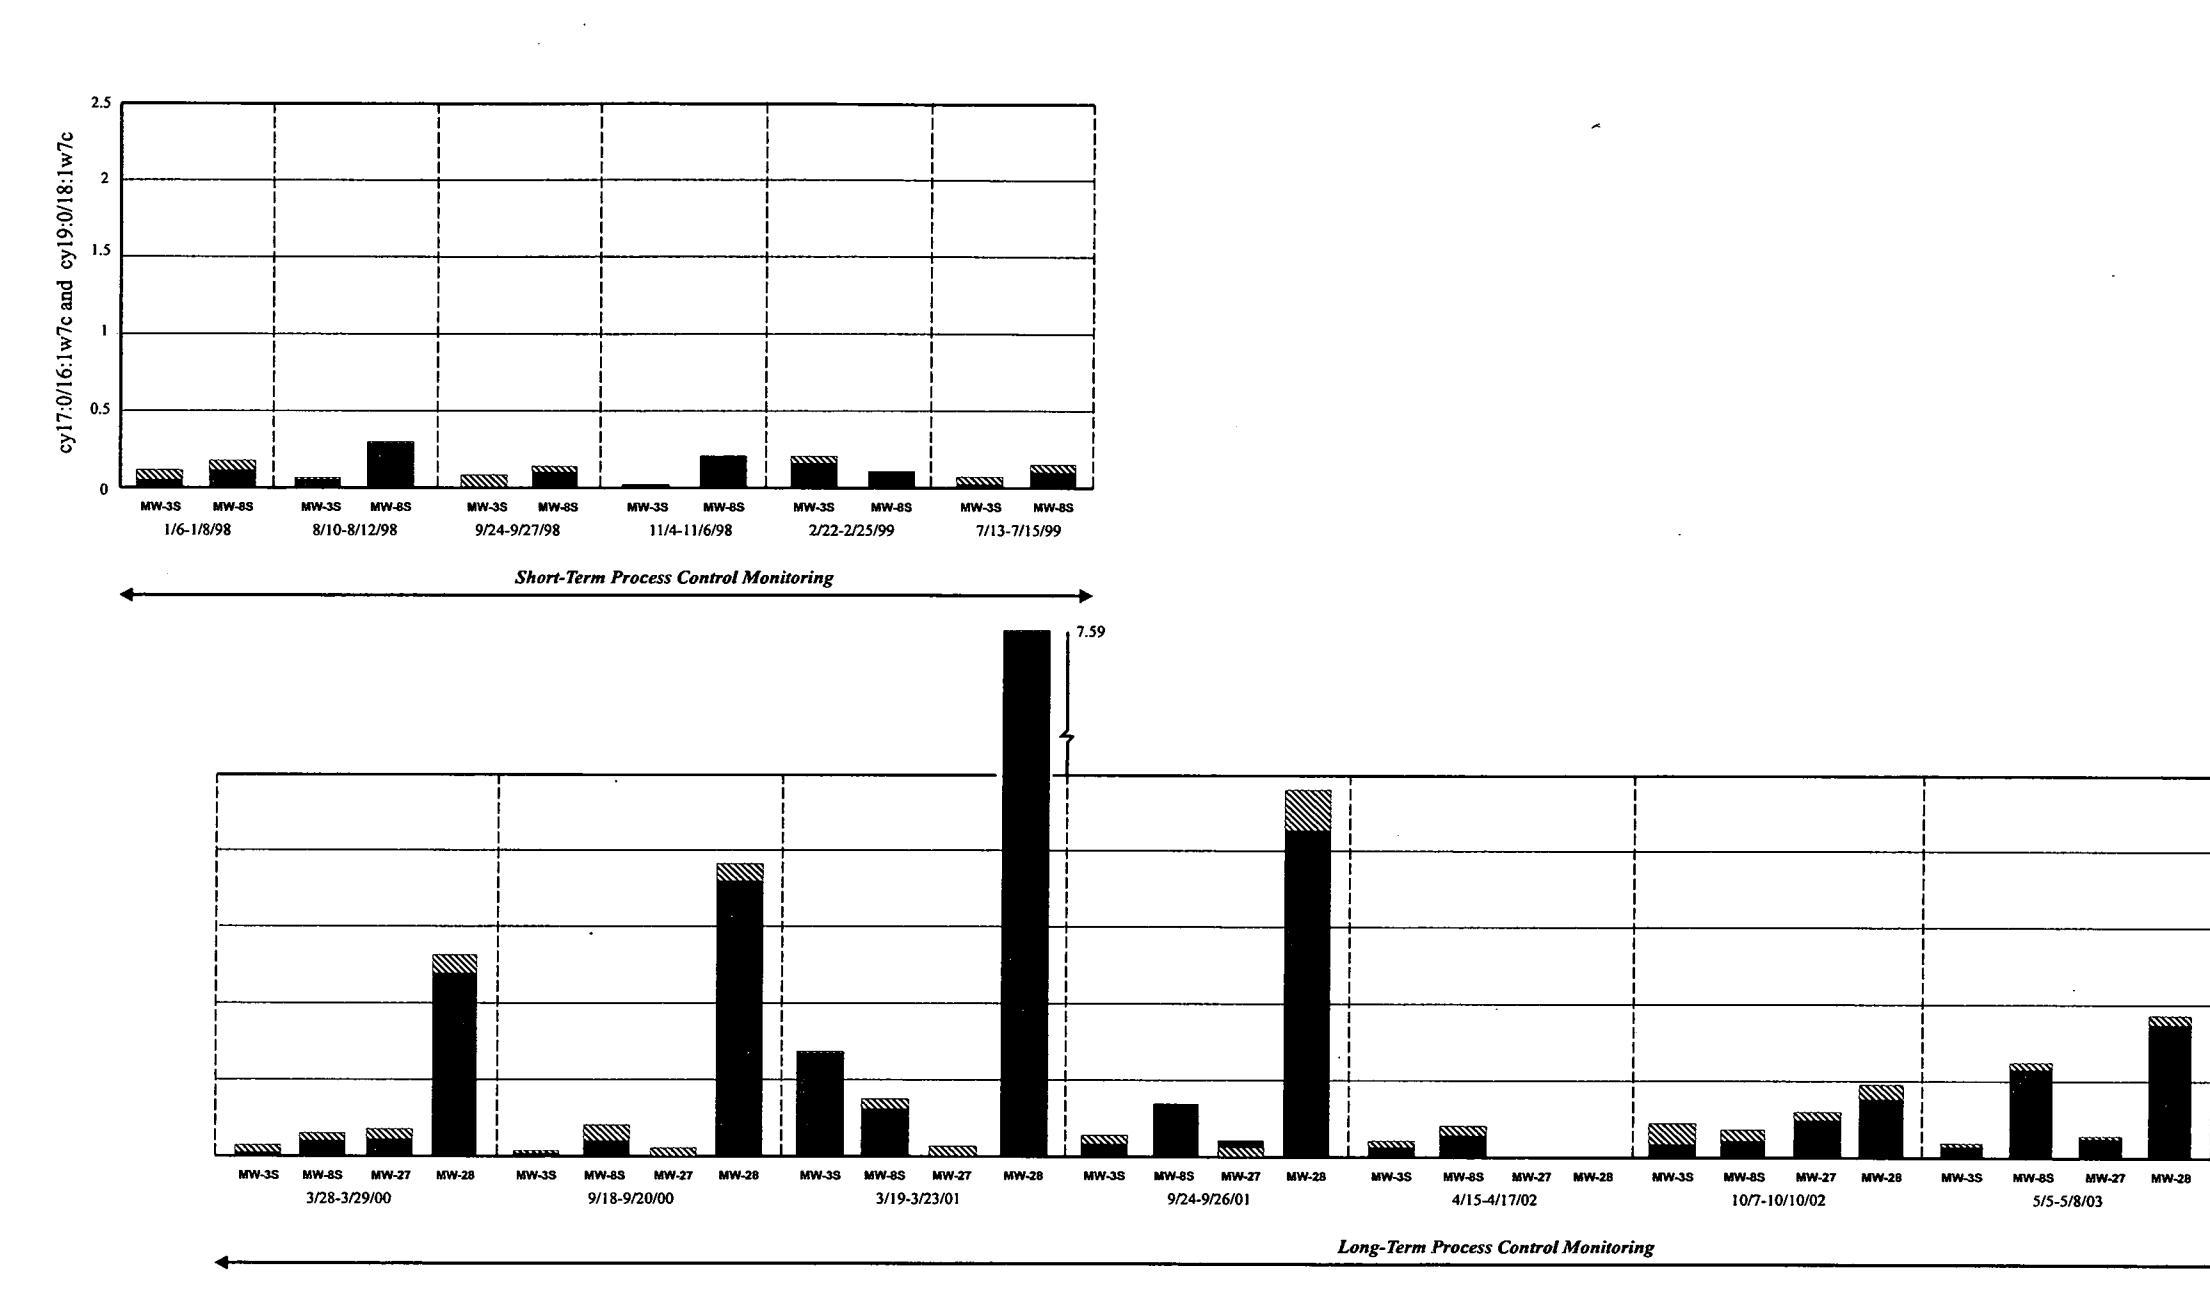
The two ratios: cy17:0/16:1w7c and cy19:0/18:1w7c express a growth rate of the microbial community. The sum of these two ratios falls within the range of 0.1 (log phase) to 5.0 (stationary phase). A lower ratio suggests a higher turnover rate.
 MW-8S was inadvertently not sampled during the October 2003 sampling event.
