## SSDS As-Built Drawings – Building 3

# THE SHOPS AT ATLAS PARK **BUILDING 3 SUB-SLAB DEPRESSURIZATION SYSTEM AS-BUILT DRAWINGS** QUEENS, NEW YORK

#### Re: Atlas Park Sub-Slab Evaluation Buildings 3 & 8, Glendale, Queens, NY LEA Project #06-274

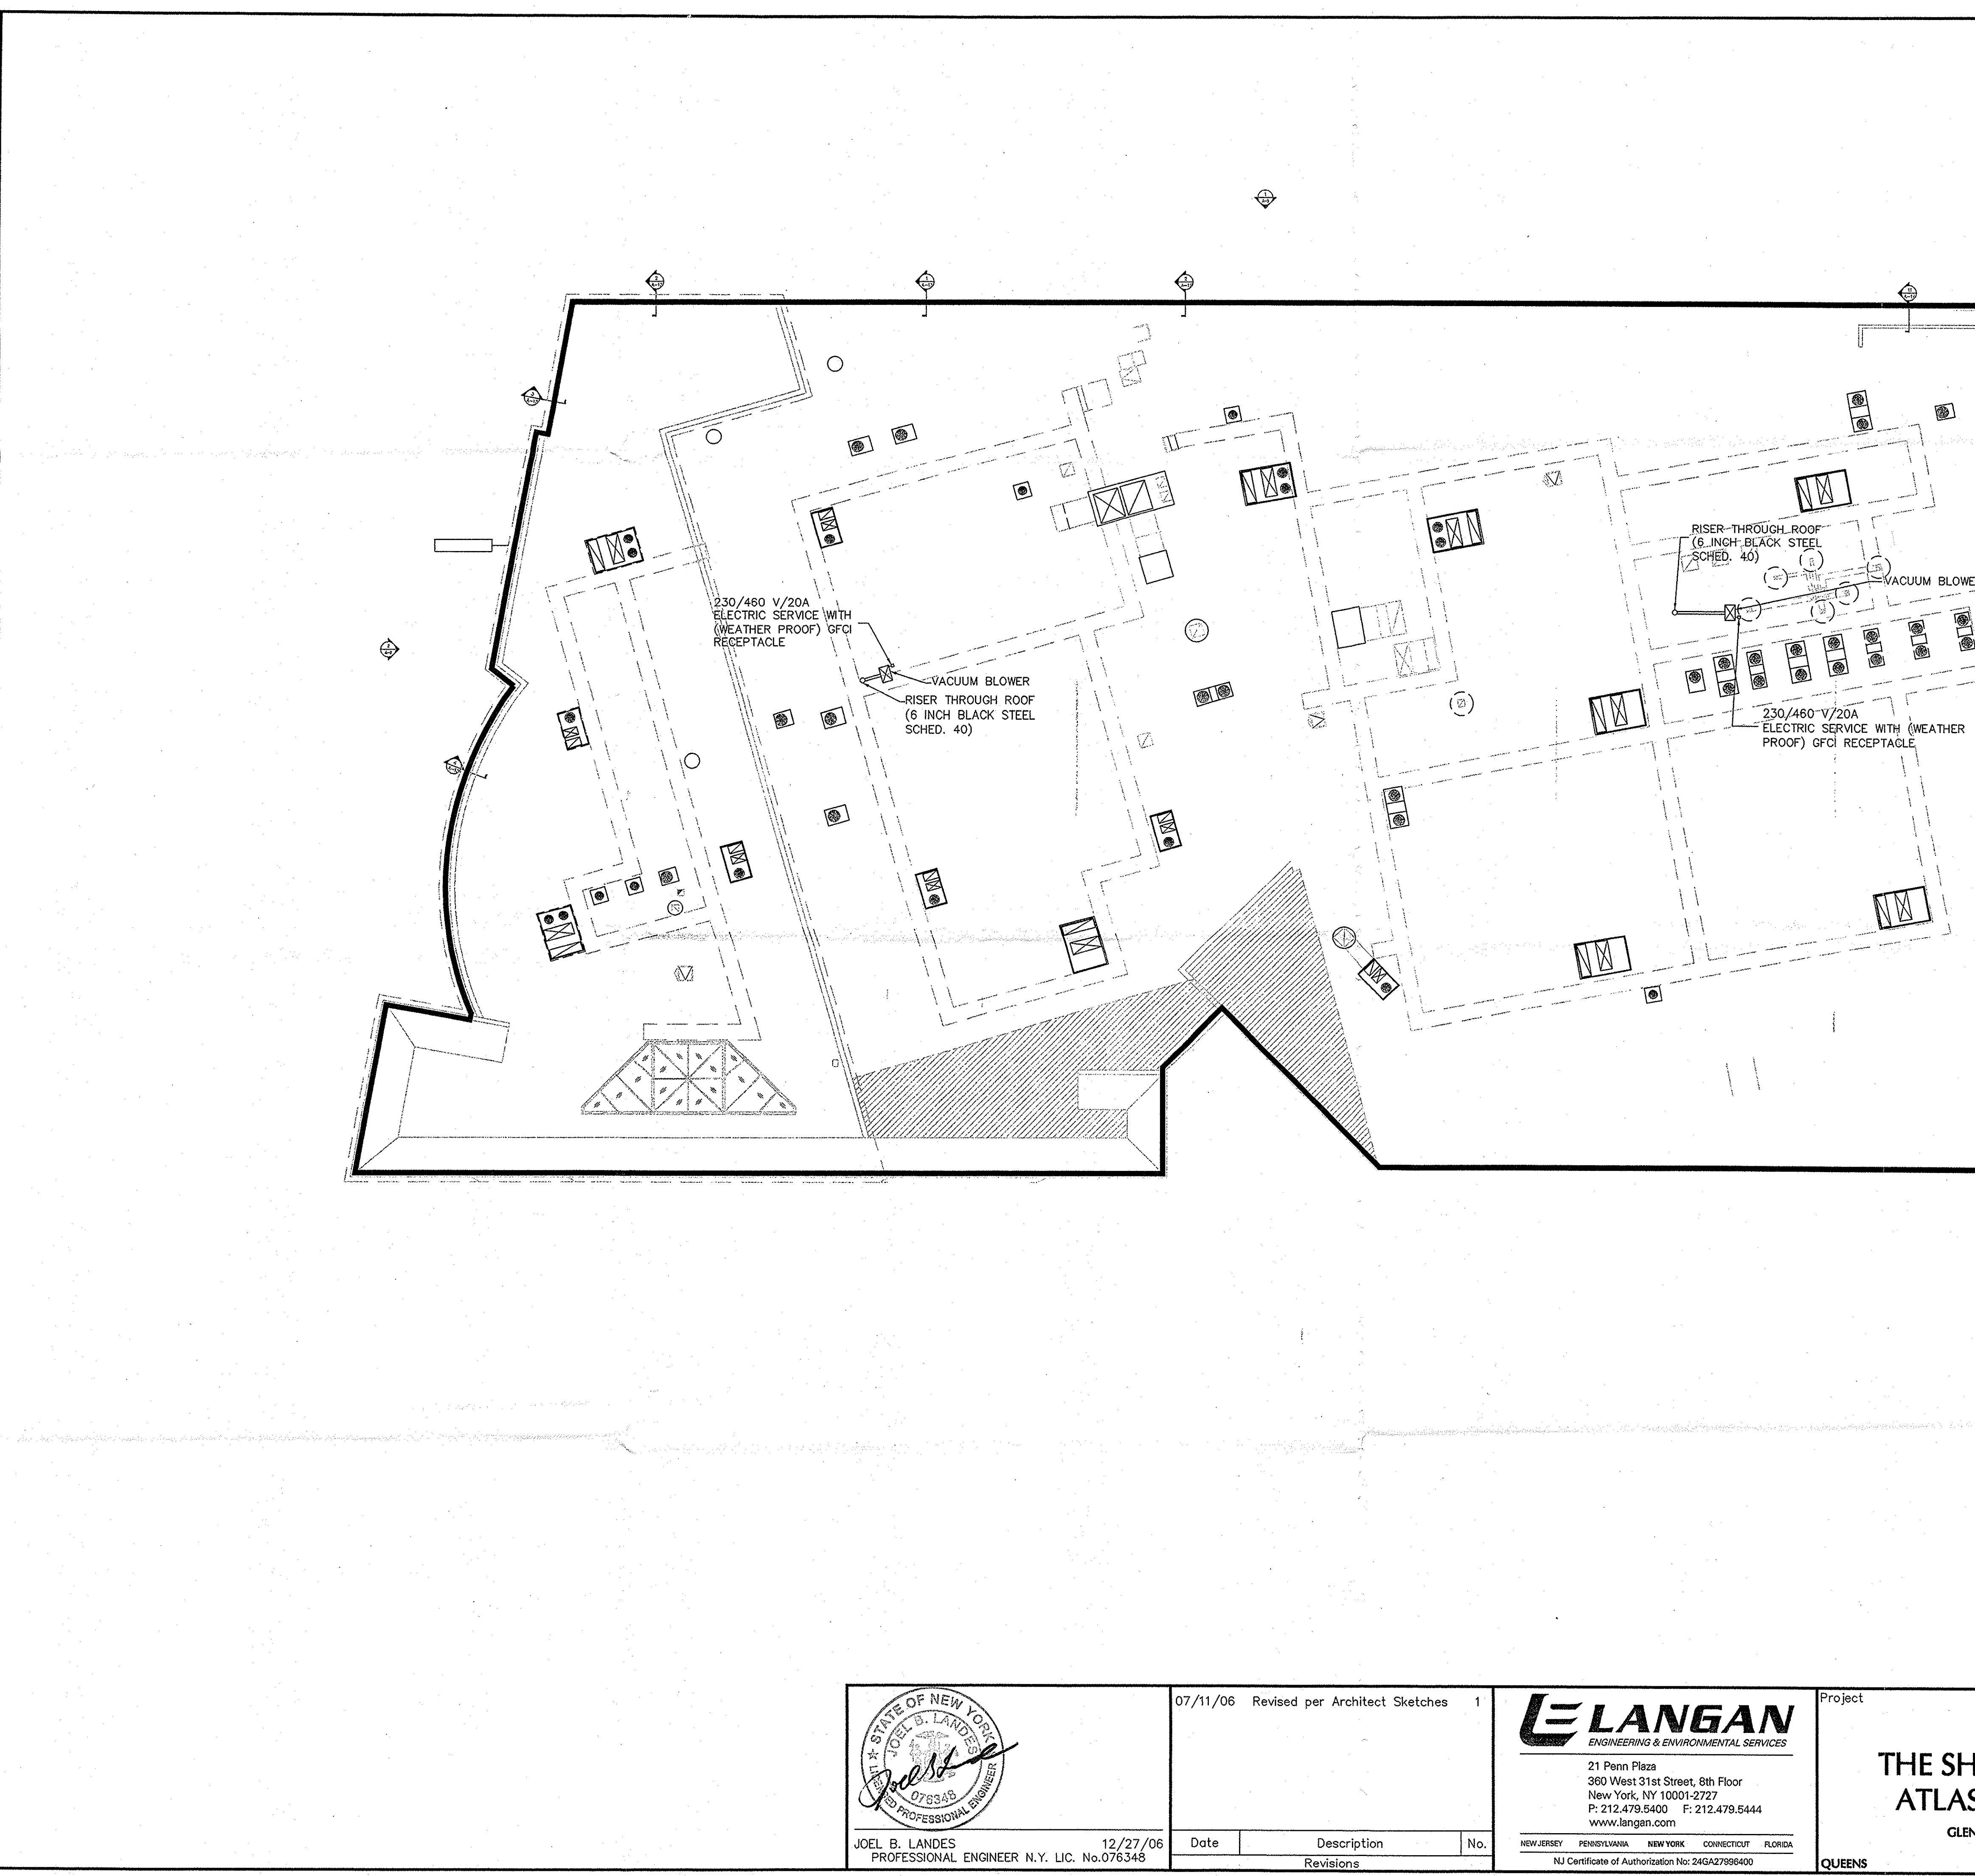
· Buildings 3 and 8\BLDG 3 AS-BUILTS\B3-SSDS-rooftop.dwg, A-4, 12/26/2006 8:49:12 PM, vtglao, NY Oce TDS600 Bond.pc3

5. BLOWER UNIT TO BE LOCATED ATLEAST 15 FT FROM ANY HVAC SYSTEM.
