RE: National Fuel Gas Corrective Measures Completion Report Mineral Springs Works Former MGP Site RECEIVED

Prepared for: National Fuel Gas Buffalo, NY Prepared by: AECOM Chelmsford, MA 60250836 October 10, 2014

Corrective Measures Completion Report Mineral Springs Road Former MGP

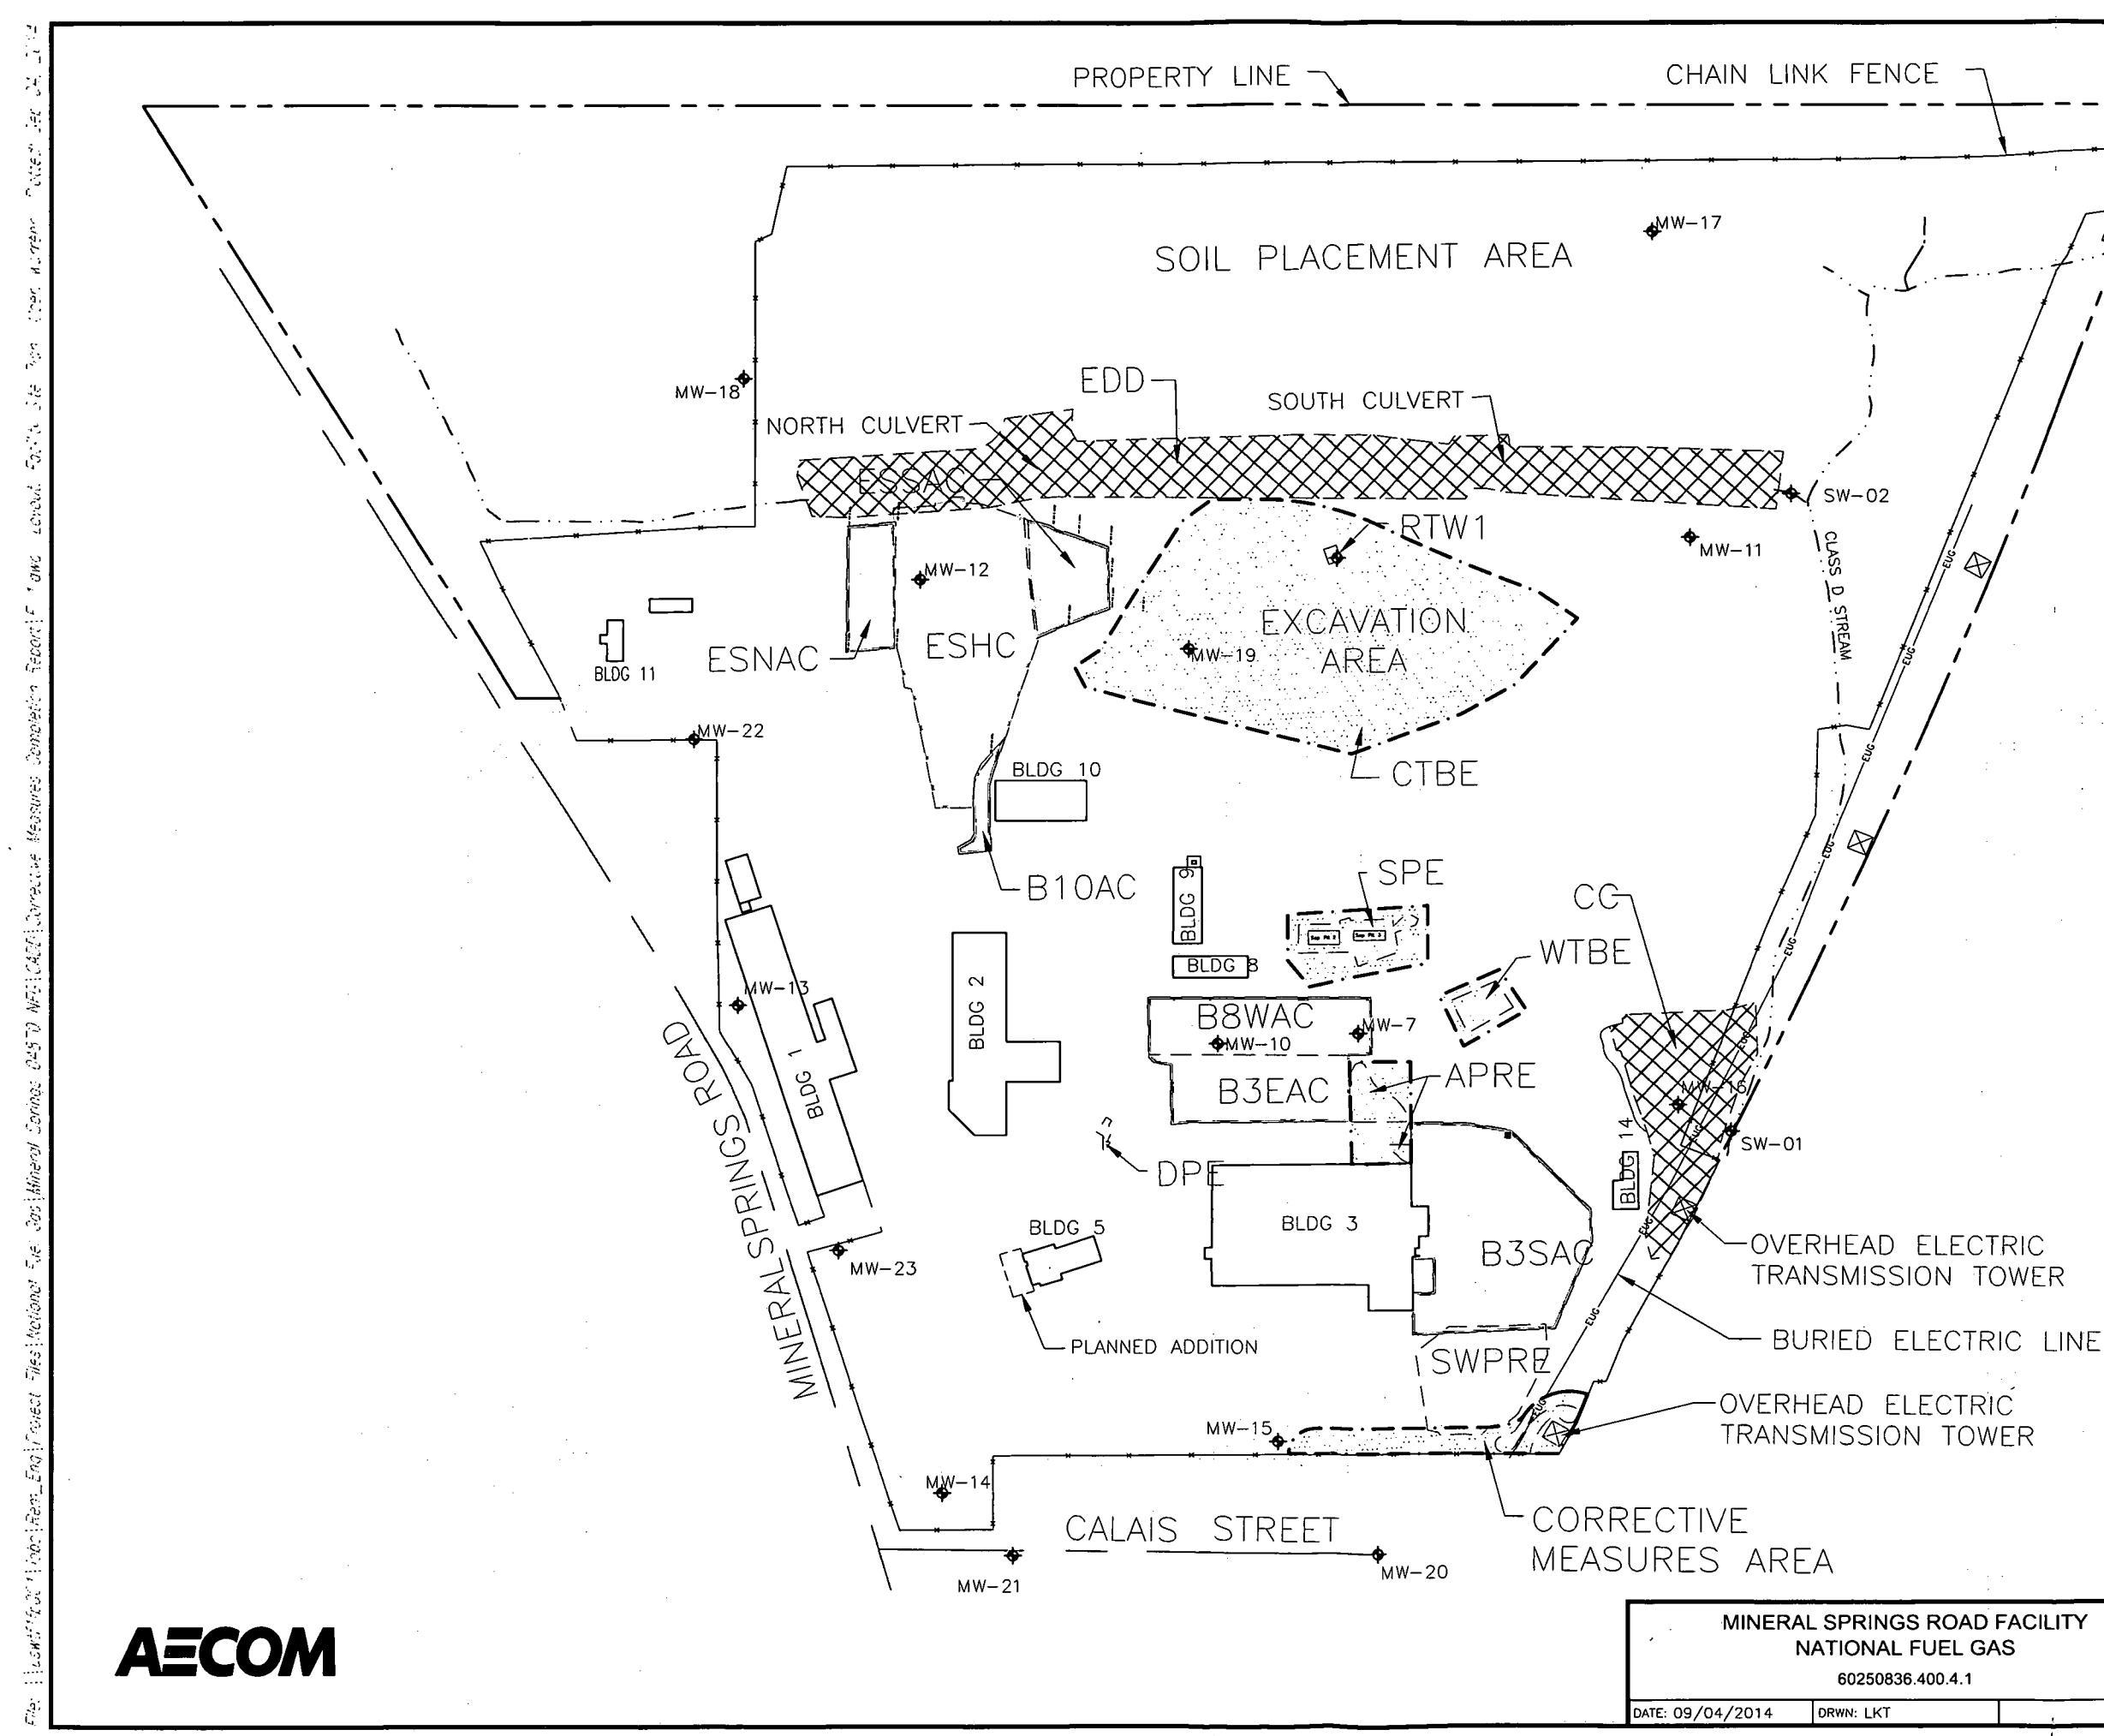
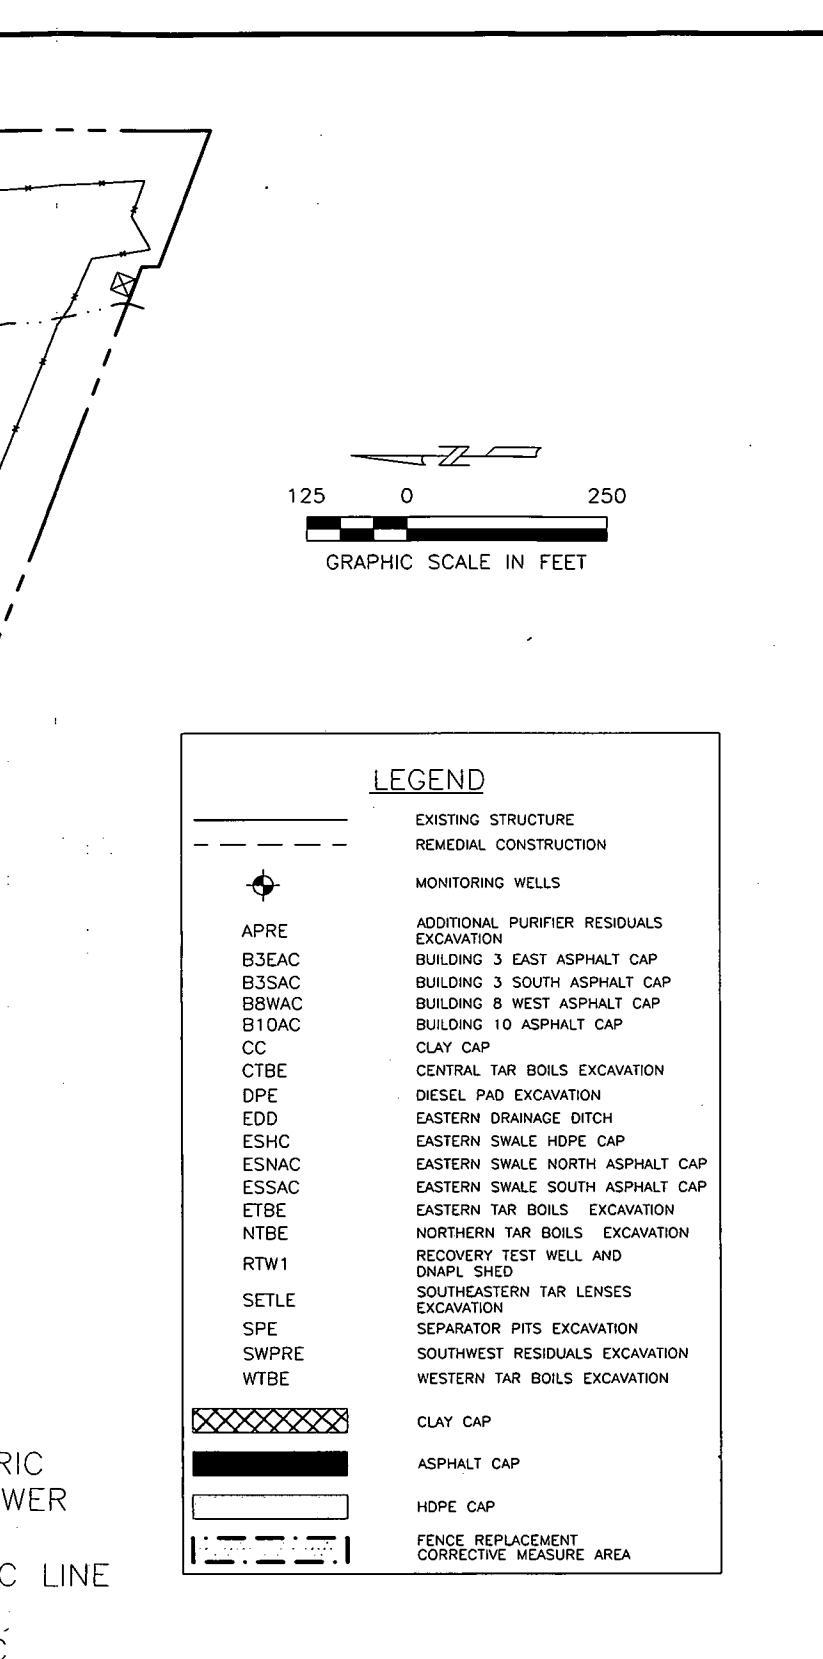
· · · · · · · · · · · · · · · · · · ·	
AD FACILITY _ GAS	FACILITY SITE PLAN
.1	
	FIGURE 1

A remedial action to address MGP residues in soil was completed in 2001. The locations of these remedial actions are shown on the Facility Site Plan (Figure 1).

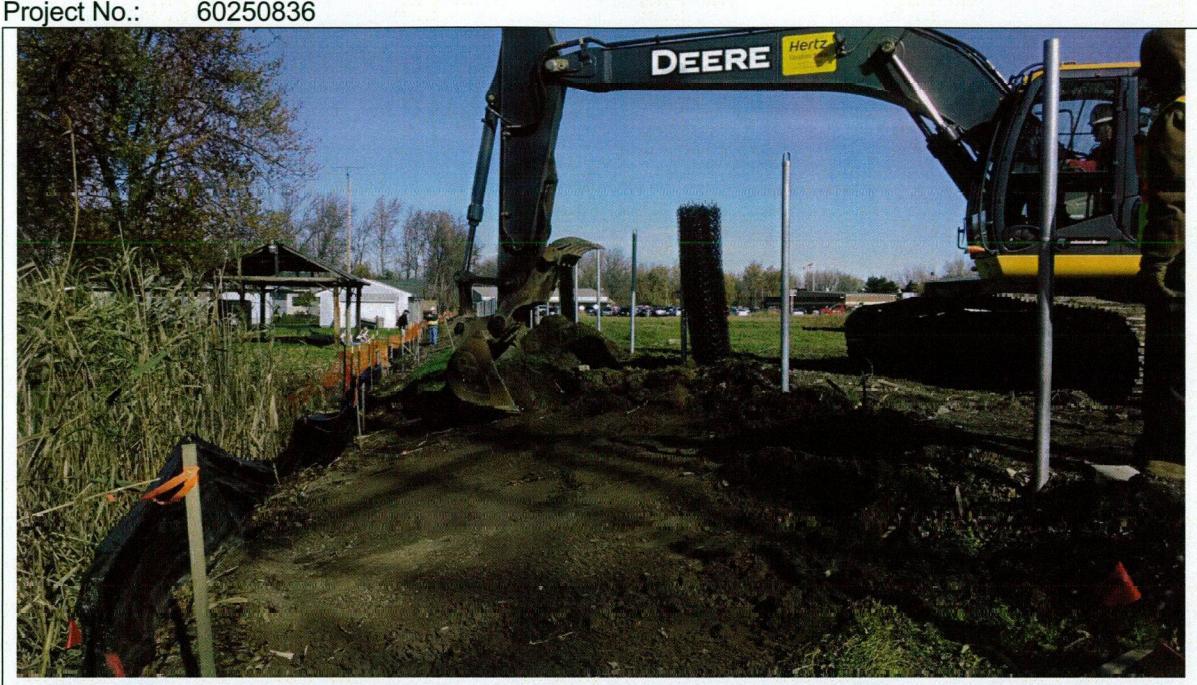
Photo 1: November 4, 2013. Facing North. Clearing western property boundary. Note black silt fence in place along downslope area. Silt fence is approximately located on property boundary.

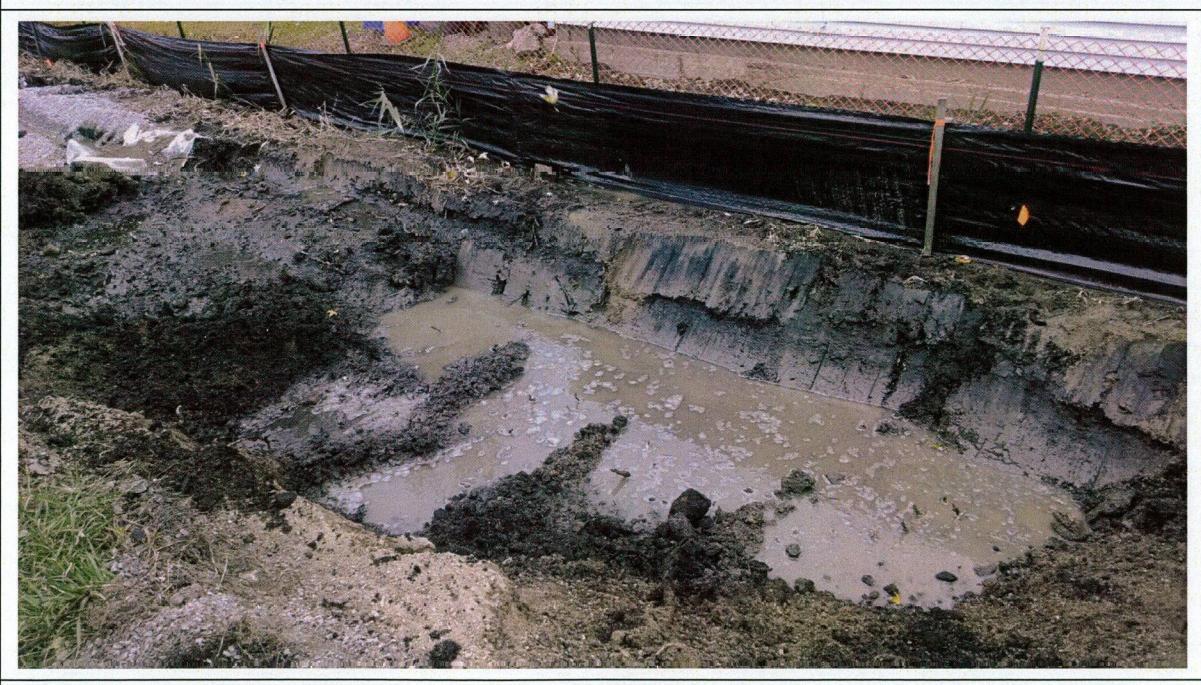
Photo 2: November 6, 2013. Facing West. Visual impact excavation along western property boundary.

During slope grading and drainage berm installation in the fence replacement area next to the residential properties, four locations with stained soil were identified. These locations are shown on Figure 3. These locations were excavated to a depth of two to four feet and then backfilled. Geotextile fabric, gravel, and ornamental stone were used to provide erosion control and improve the area's appearance. In addition, hardy deer-resistant shrubs were planted along the slope to improve slope stability and create a visual barrier. Gravel and stone placed in this area are not considered an engineering control. When these activities were completed, a chain-link fence was installed along the bottom of the slope along the National Fuel property boundary as described in Section 2.5.

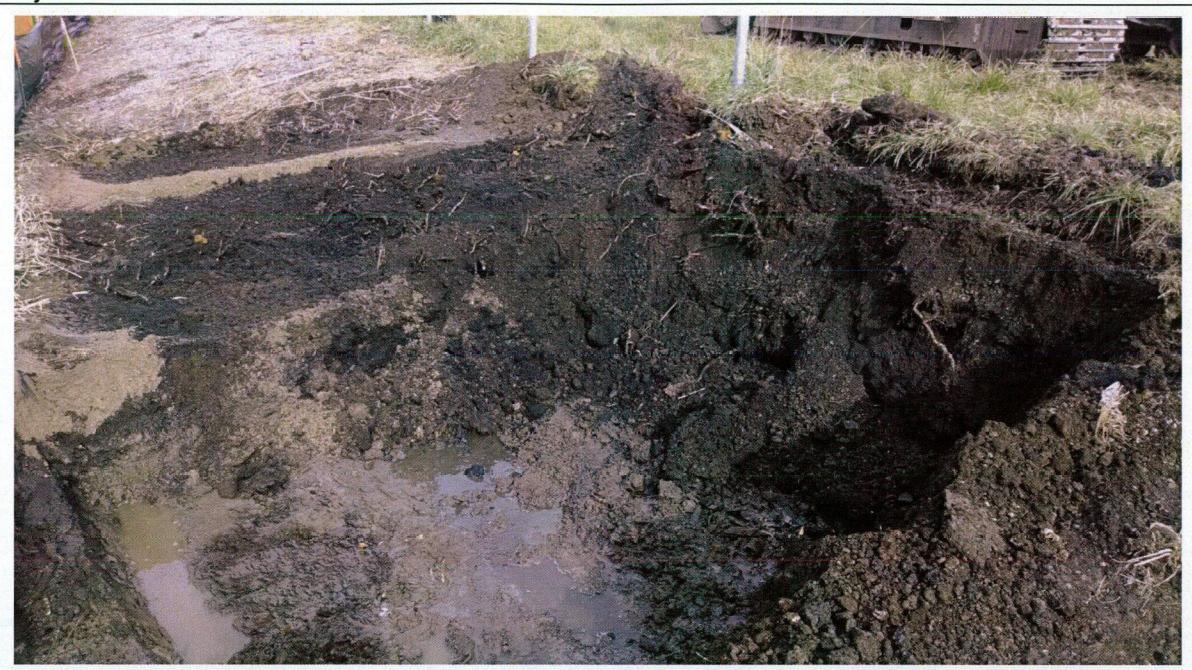
Photo 3: November 4, 2013. Facing Northeast. Visual impact excavation, along western property boundary, starting to fill with water. Water eventually filled excavation to ground surface (see Photo

Groundwater began infiltrating into the drainage ditch during excavation. AECOM reviewed the boring log for well MW-15, adjacent to the excavation area which indicated that that the minimum historic depth to groundwater is 7.95 feet bgs. The bottom of the ditch and surface of the water in the ditch are much shallower than the historic groundwater table. Based on this information, the water in the ditch was determined to be perched groundwater located within the fill layer above the shallow, naturally occurring, clay layer.

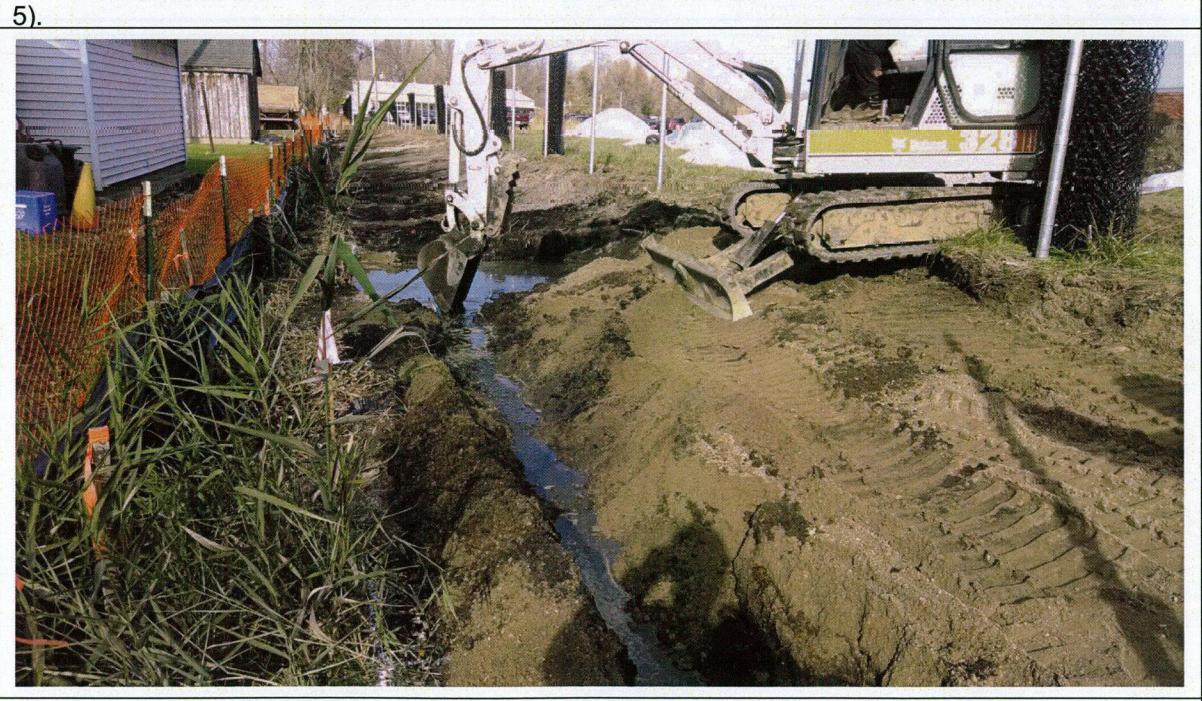
Photo 4: November 5, 2013. Facing North. Drainage ditch excavation. Note water level in excavation from Photo 4.

A drainage ditch was excavated approximately two feet east of National Fuel's western property boundary to a depth of one foot, from the northern end of the fence replacement area south to the existing drainage feature in the southwest corner of the property. During excavation, the ditch filled with water to a depth of approximately three inches. The water source appeared to be a perched zone within the fill layer placed on top of a naturally occurring, less permeable clay layer. During excavation, it was also determined that the low point in the surface topography was approximately 1 to 2 feet west of the property line.

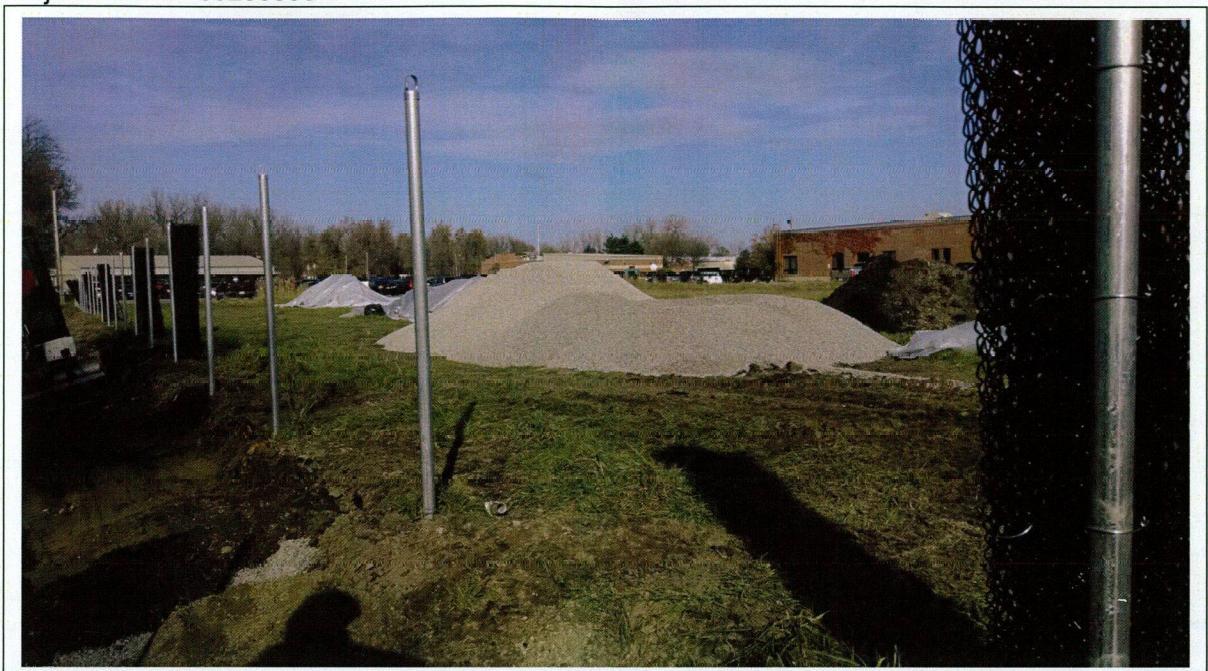
Photo 5: November 5, 2013. Facing Northeast. Gravel and drainage stone stockpile for backfill and cover. Plastic-covered stockpiles contain impacted materials.

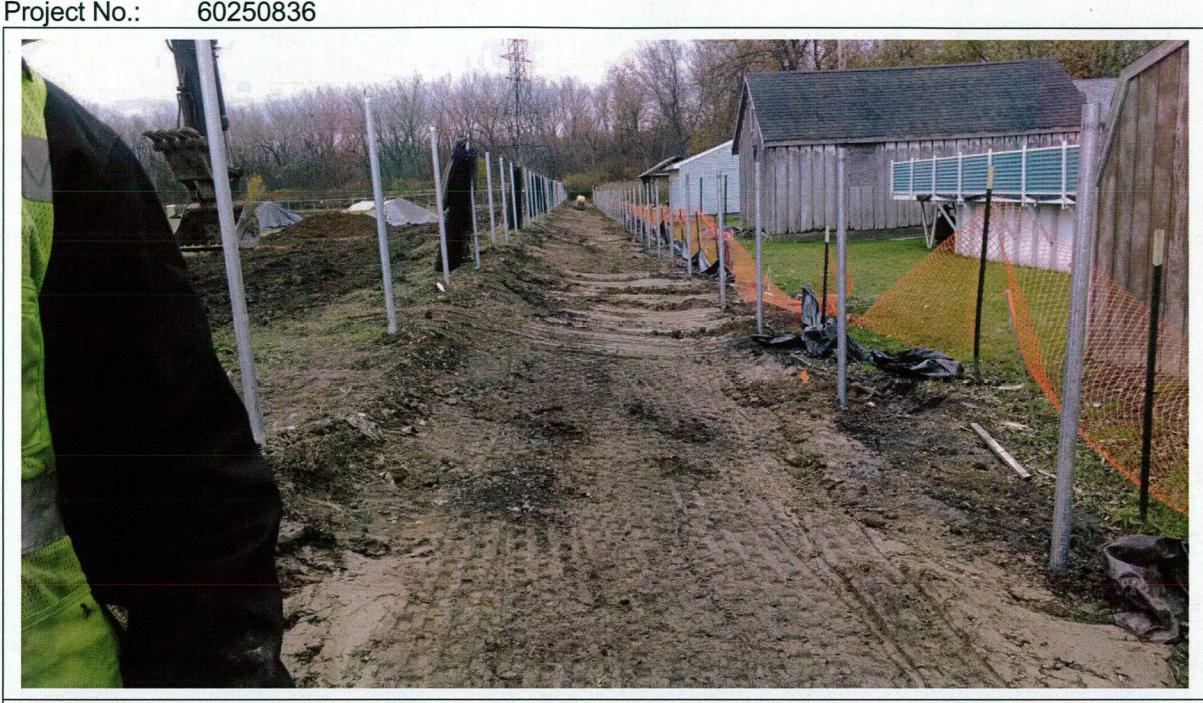
Photo 7: November 8, 2013. Facing South. Drainage ditch filled with clay and compacted with padfoot roller.

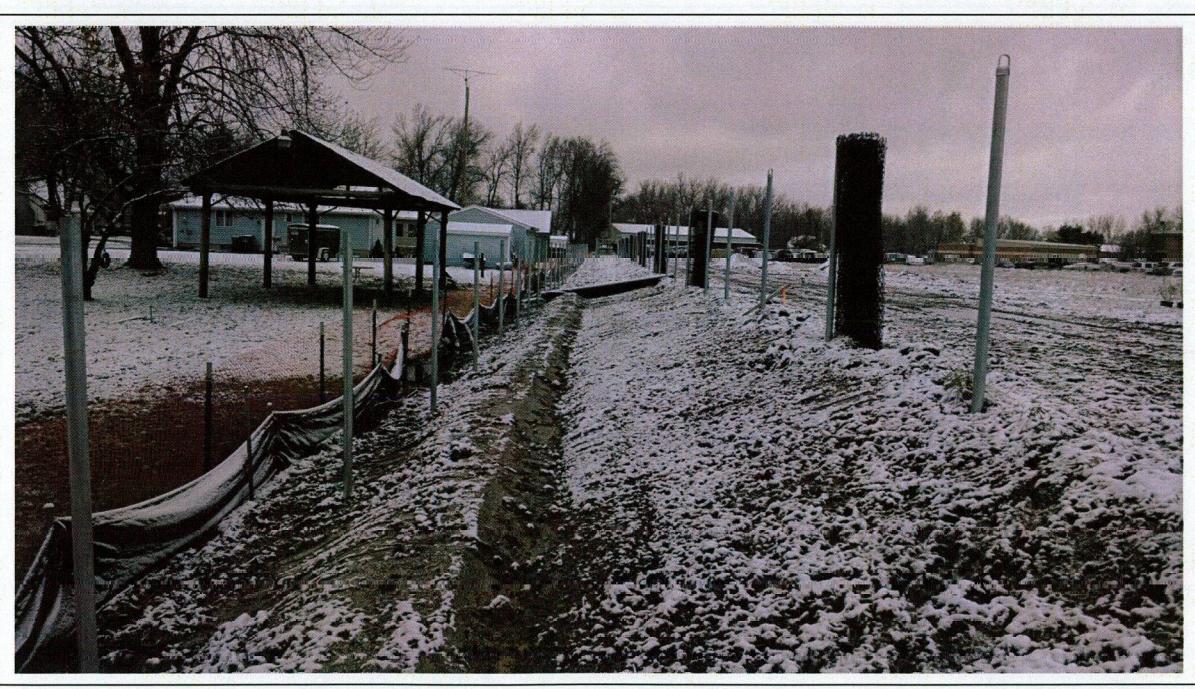
Photo 8: November 12, 2013. Facing north. Berm constructed with clay. Geotextile (Mirafi® 600X woven polypropylene) and gravel are spread on northern end of berm. Note roll of geotextile fabric placed on berm.

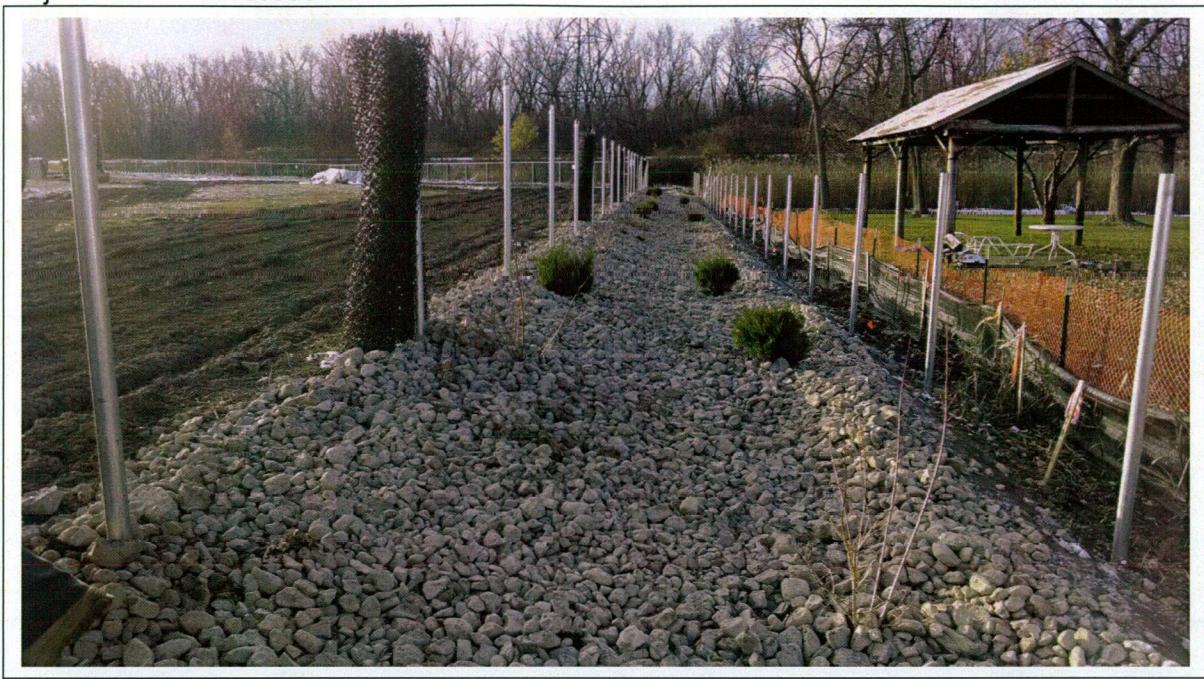
Photo 9: November 13, 2013. Facing South. Berm completed with most of ornamental stone placed. Plants planted according to planting plan.

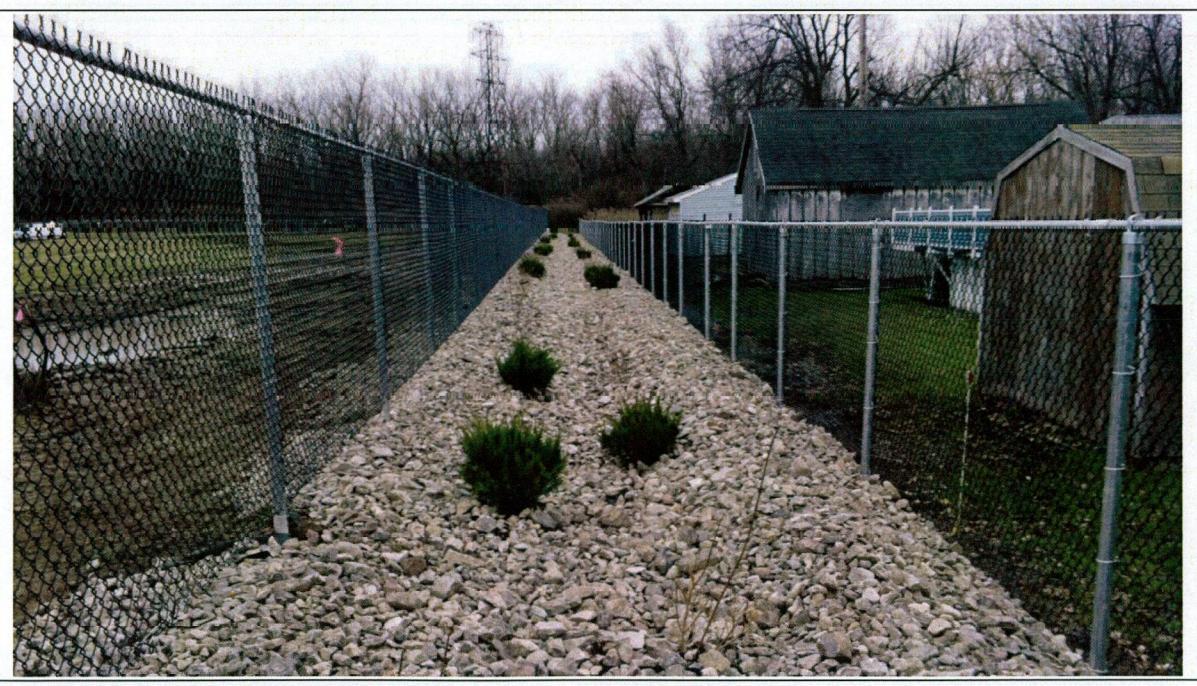
Photo 10: November 19, 2013. Facing South. Completed berm area with both fences installed.

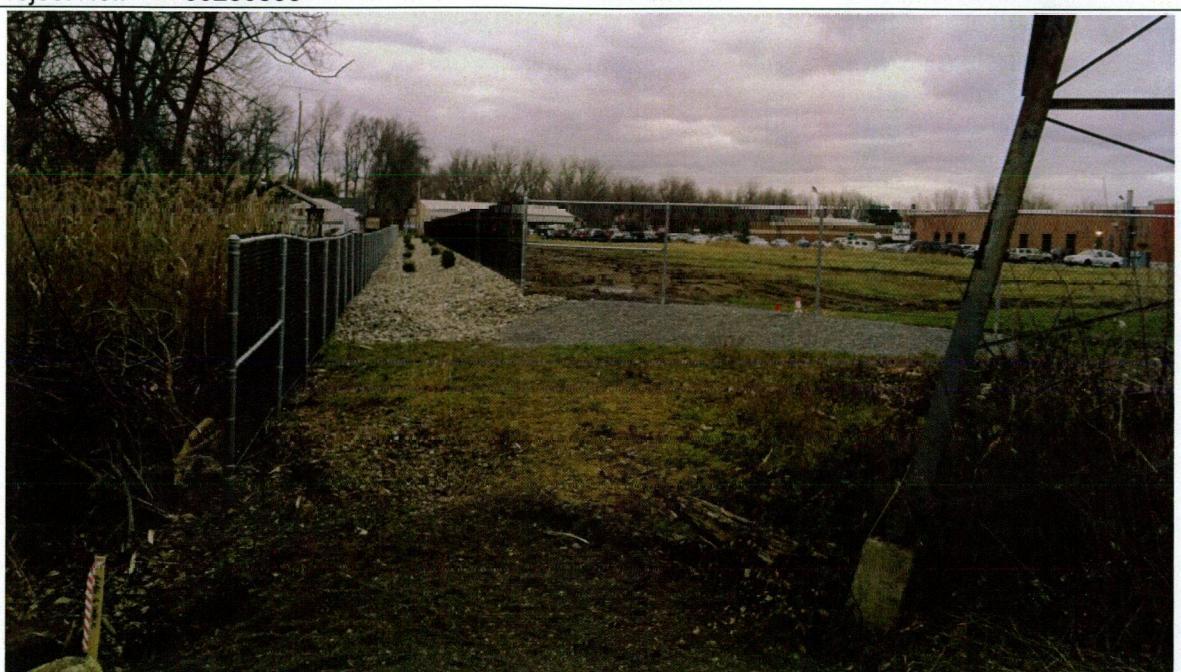
Photo 11: November 19, 2013. Facing North. Completed berm area with both fences installed.

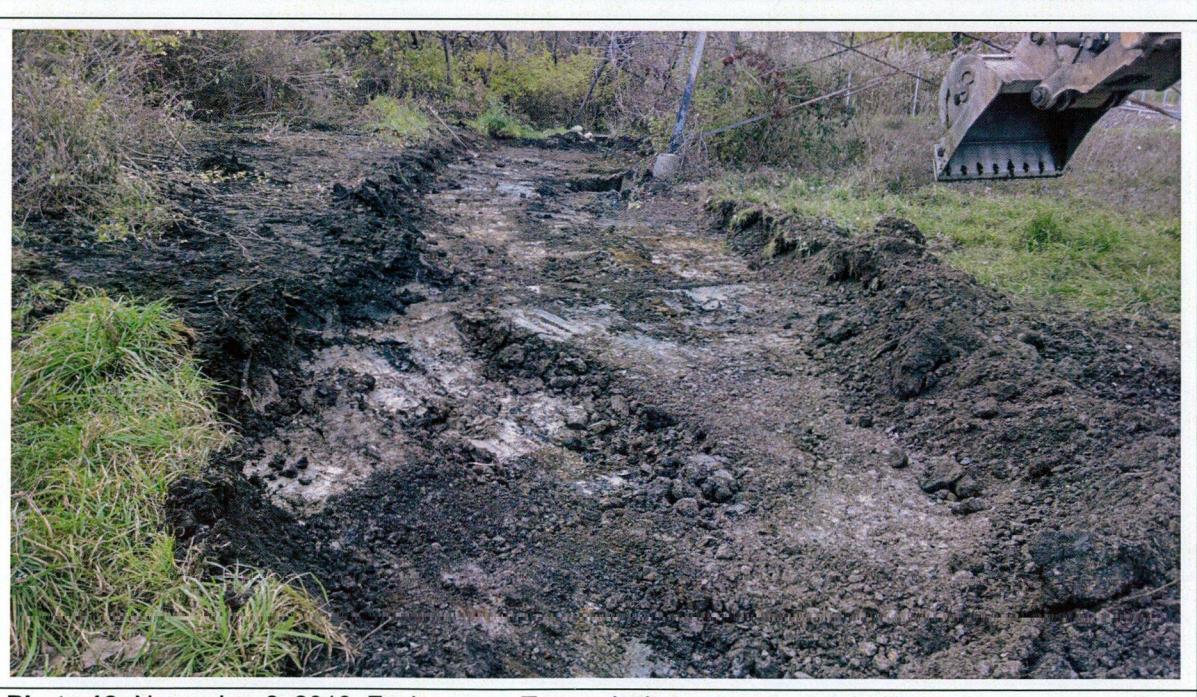
Photo 12: November 6, 2013. Facing west. Transmission tower excavation bottom.

Excavation and removal of soils beneath and south of the National Grid electric transmission tower were performed to remove surface and subsurface soils with visible blue green staining observed in the area. Soils were removed from an approximate 783 square foot area immediately south of the electric transmission tower, using mechanical equipment. Soils were excavated by hand immediately adjacent to sensitive utilities, foundations, and storm sewer structures within this area. The excavation depths and limits were based on visual observations. The minimum depth of the excavations was approximately one foot. Excavated areas were backfilled and capped using clay compacted with appropriate equipment (e.g., pad-foot roller). A final gravel cover was placed over the compacted clay surface.

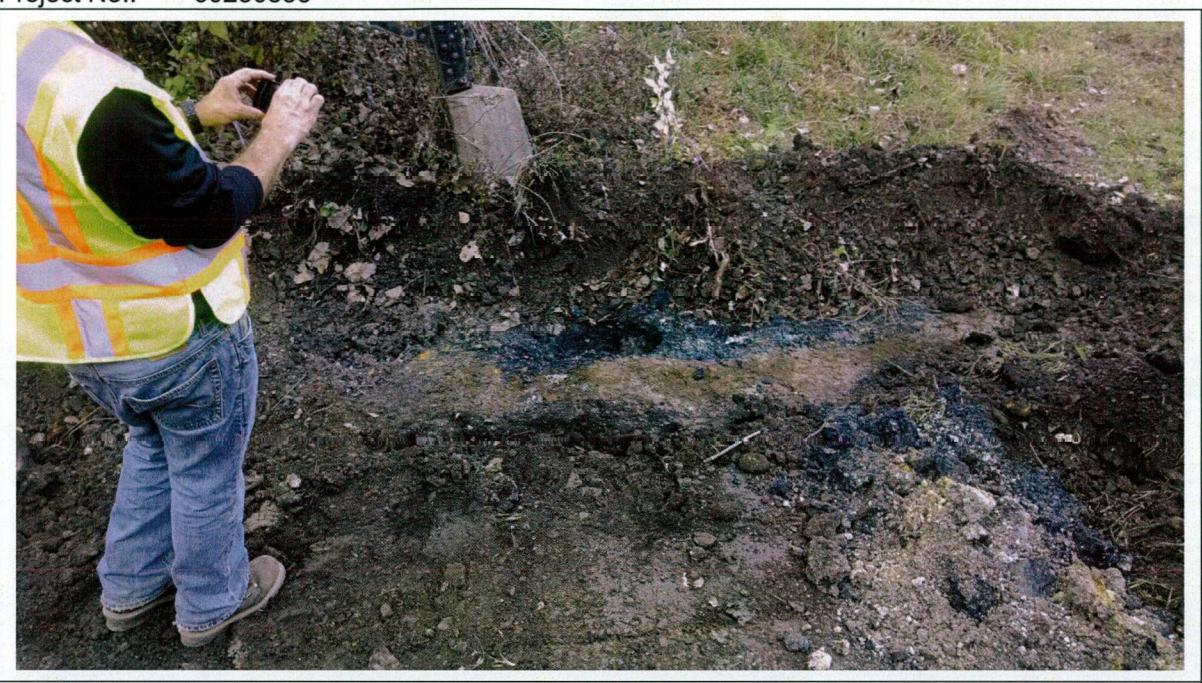
Photo 13: November 6, 2013. Facing North. Transmission tower visual impacts located adjacent to transmission tower footer.

goal of removing known impacts and eliminating the need for perimeter fencing along the adjacent railway property. All of the visual impacts were not able to be excavated, as they were located directly under the electric transmission tower footprint and adjacent to the foundation. These impacts were covered in a minimum 9-inch thick clay cap and gravel cover.

During excavation of the area adjacent to the electric transmission tower, visual impacts were observed directly adjacent to and below the electric transmission tower footings. These areas could not be excavated without structurally undermining the electric transmission tower. This area was covered by a minimum of a one foot clay cap to prevent future potential exposures.

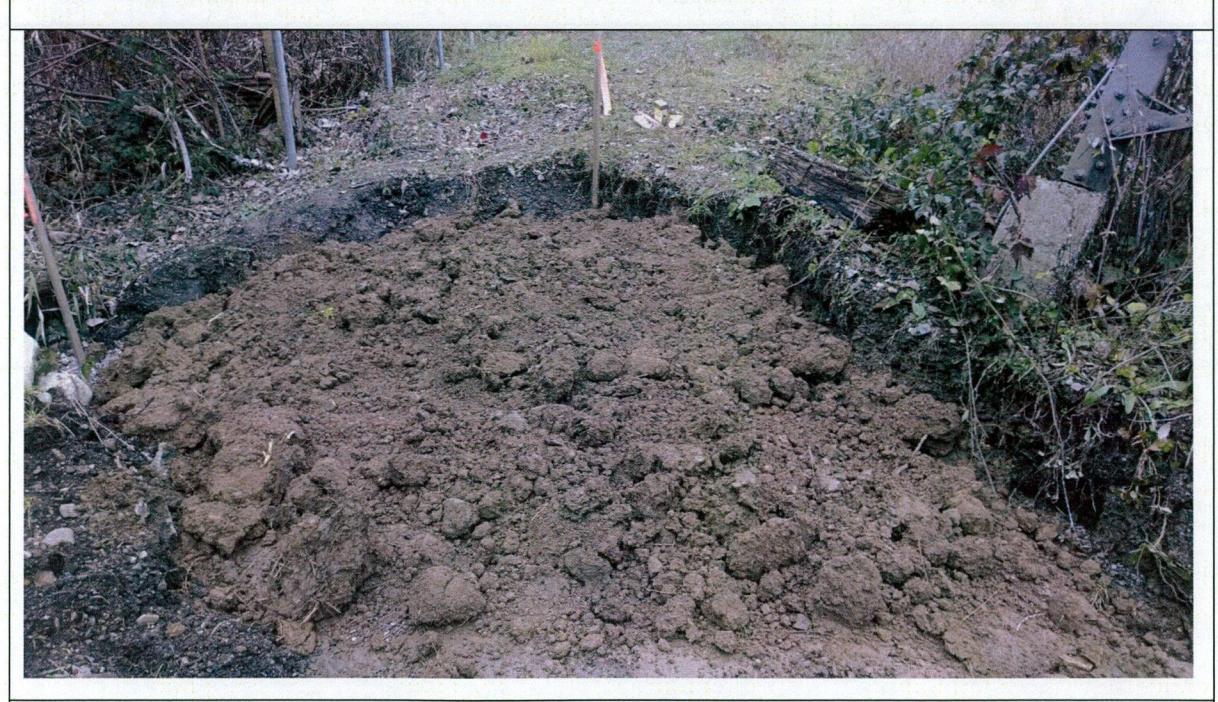
Photo 14: November 7, 2013. Facing North. Clay material backfilled into excavation west of tower. Note photo taken before clay was compacted.

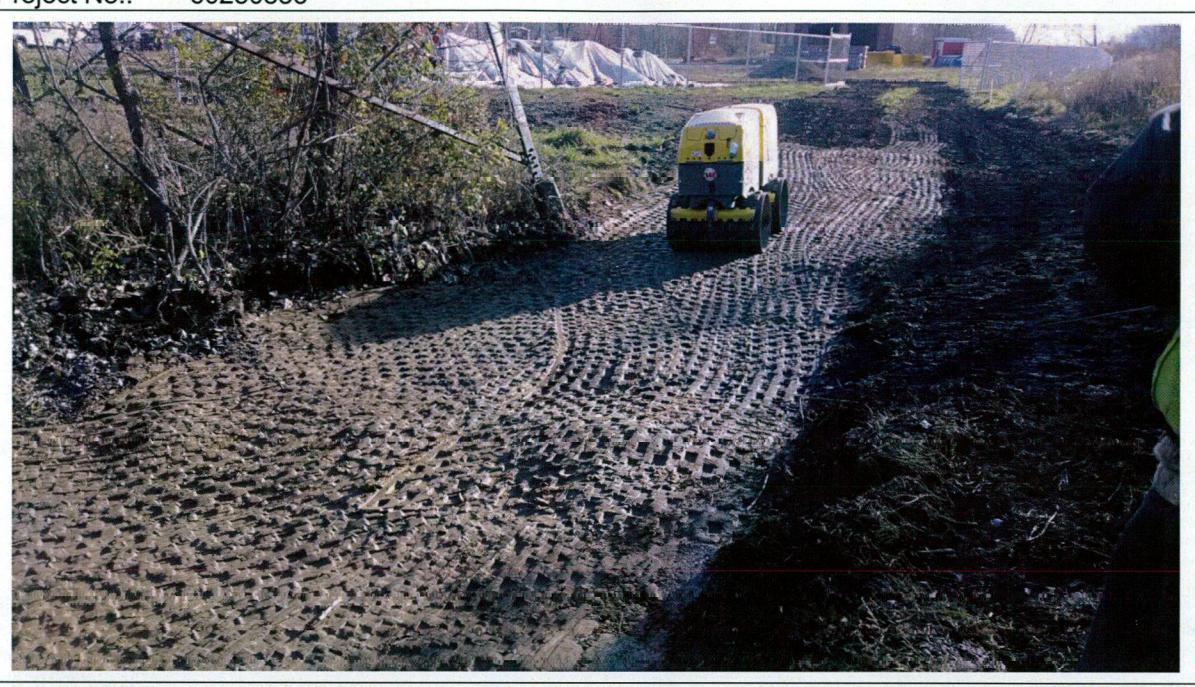
Photo 15: November 8, 2013. Facing East. Transmission tower excavation backfilled with clay and compacted with padfoot roller.

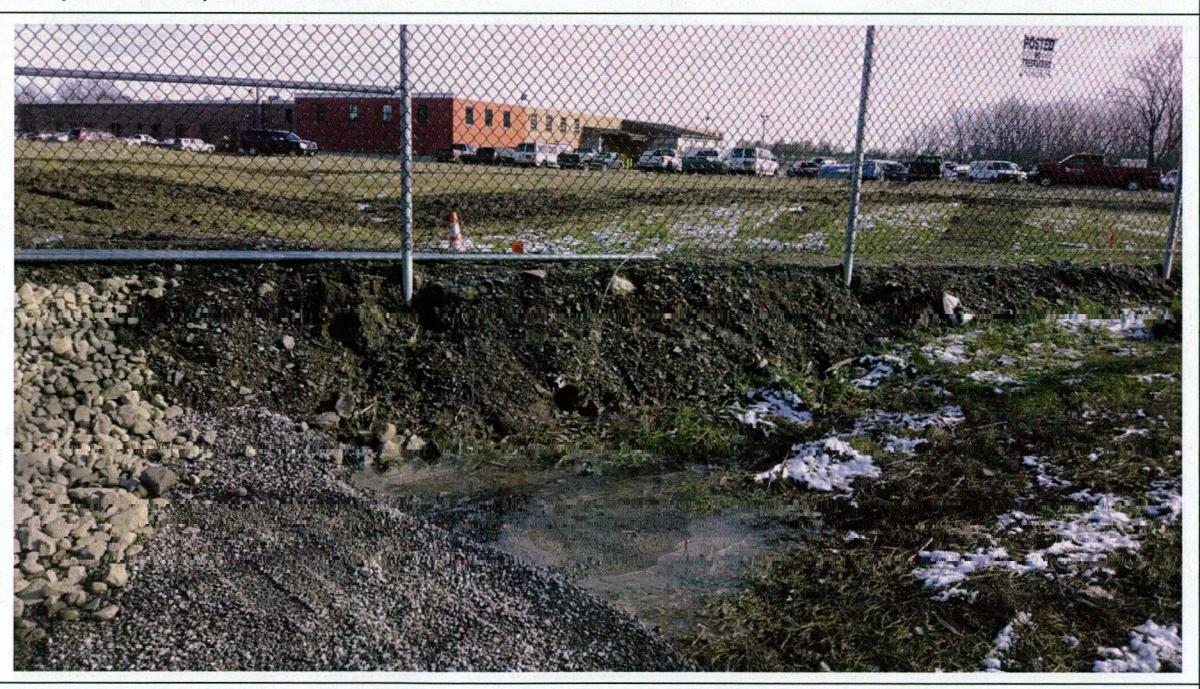
Photo 16: November 13, 2013. Facing Northeast. Known impacts area as identified in historic figure. Located north of transmission tower excavation. Note fill material used to grade fence sufficiently covers a portion of the area.

A small gravel cover was installed just northwest of the electric transmission tower, and just outside the southwest perimeter fence corner. The cover is shown on Figure 4. This area was covered with gravel based on the known presence purifier residuals remaining approximately one to two feet beneath the surface, adjacent to the buried National Grid high voltage cable. This area is referenced on a figure from the Southwestern Interim Remedial Measure completion report (RETEC, 1998), and coincides with the purifier residuals found while drilling the fence post holes in June 2013. The RETEC figure indicates that there is an area of known subsurface contamination located below the new perimeter fence. Part of this area is covered by a minimum of one foot of soil and the perimeter fence. These are considered an engineering control. A portion of this area is located outside of the perimeter fence. A geotextile fabric was placed against the slope and covered with one-foot of gravel as an engineering control to limit potential exposures. The locations where soil and gravel have been placed in this area are considered engineering controls.

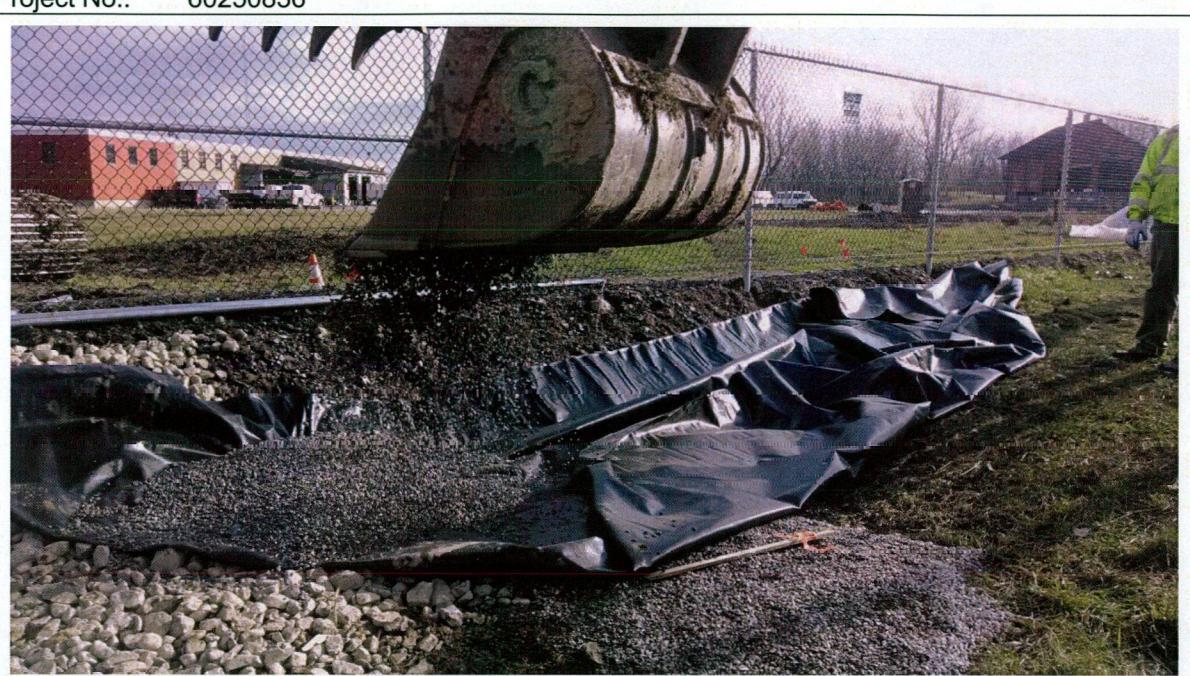
Photo 18: November 14, 2013. Facing Northeast. Known impacts area covered with geotextile fabric. Gravel cover in progress.

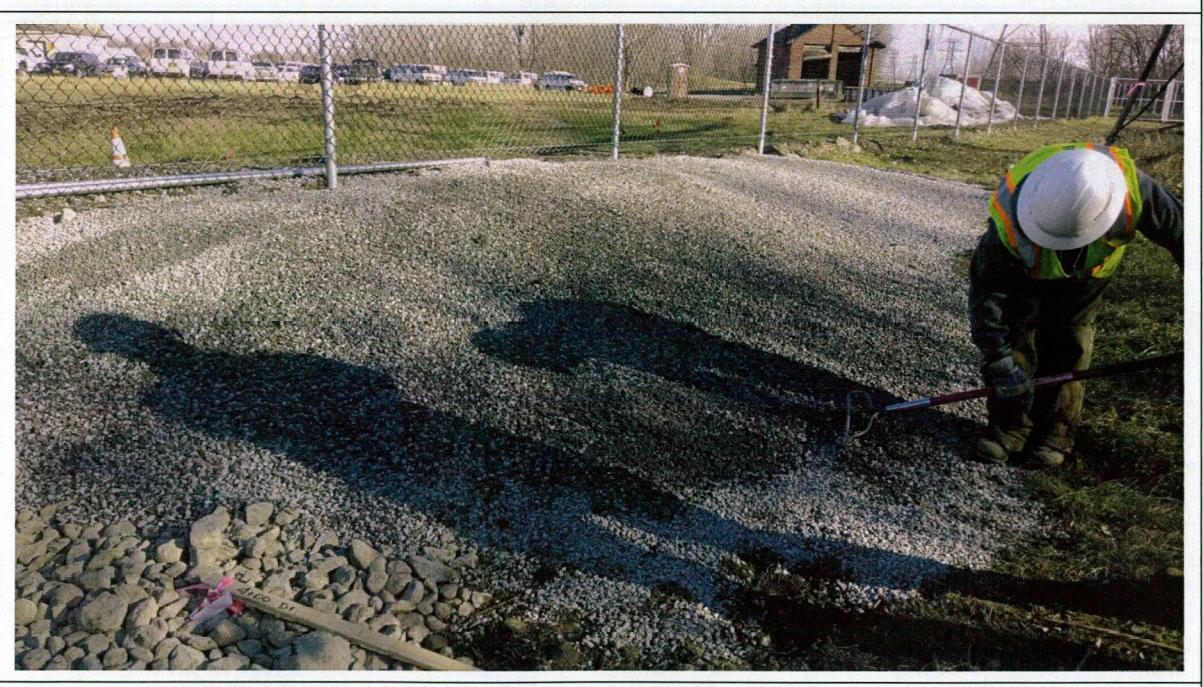
Photo 18: November 14, 2013. Facing Northeast. Additional gravel cover area complete.
