**Phase 2A Remedial Investigation
Work Plan Addendum No. 6**

Former Grumman Settling Ponds
(Operable Unit 3-Bethpage Community Park)
Bethpage, New York
NYSDEC Site# 1-30-003A

November 2006

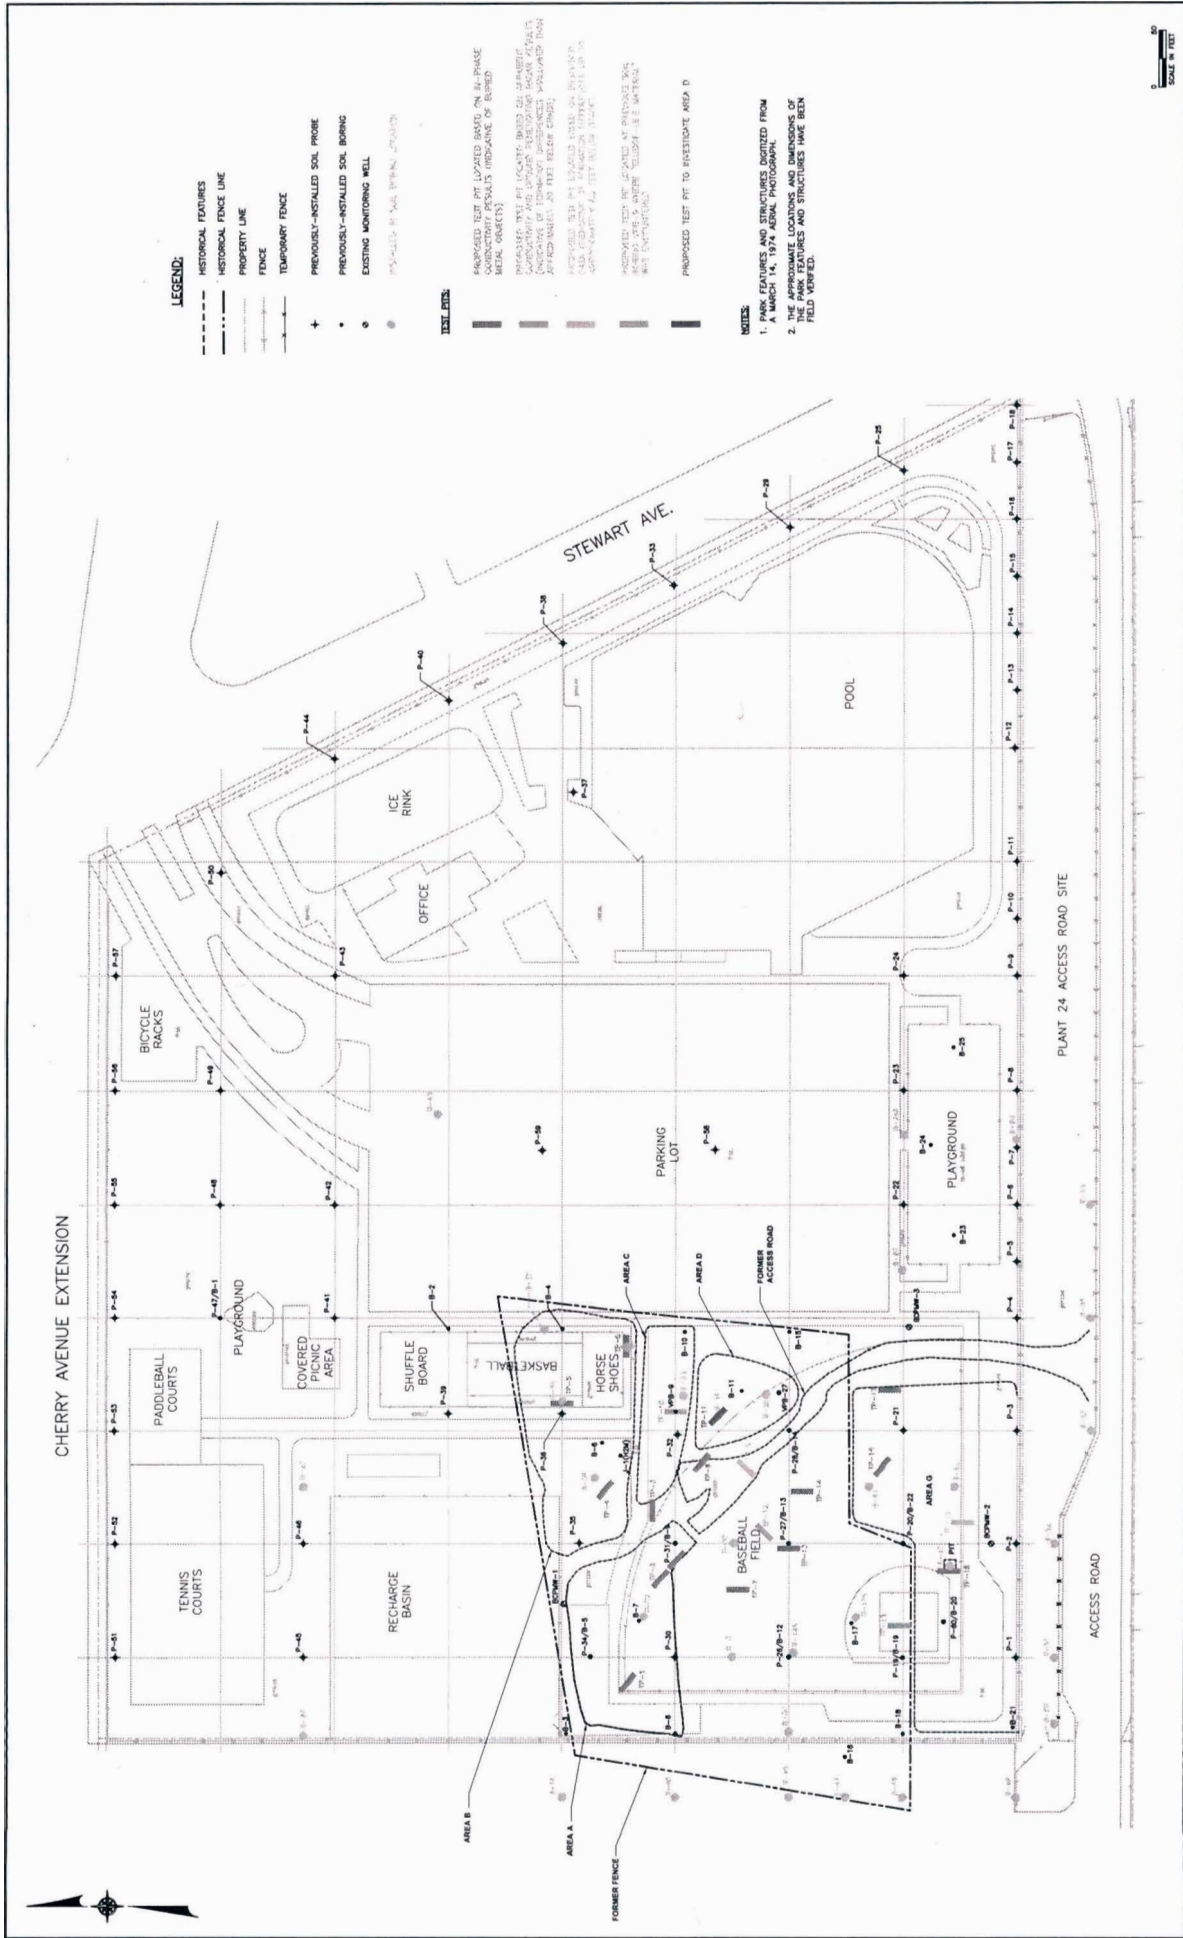
Nineteen test pits are proposed at the locations shown on Figure 3-1, "Proposed Test Pit Locations." The test pits are color coded on the figure to identify the specific geophysical method results that were used to support the need to further investigate the area. The geophysical method used to detect each anomaly is particularly helpful in anticipating the type of object/material that may be encountered during construction of each test pit. The test pit locations were selected based on the geophysical anomalies described in Section 2.0 of this plan. The proposed test pit locations overlain on the specific geophysical anomalies are provided on the following figures by geophysical method:

- Twelve test pits are located in areas within the park where in-phase conductivity anomalies are present (test pits TP-1, TP-2, TP-3, TP-4, TP-5, TP-6, TP-7, TP-8, TP-13, TP-14, TP-16 and TP-17).
