# **2014 Second Quarter Groundwater Monitoring Report**

**April - June 2014**

**Claremont Polychemical Corporation Site**

**Site Code: 130015**

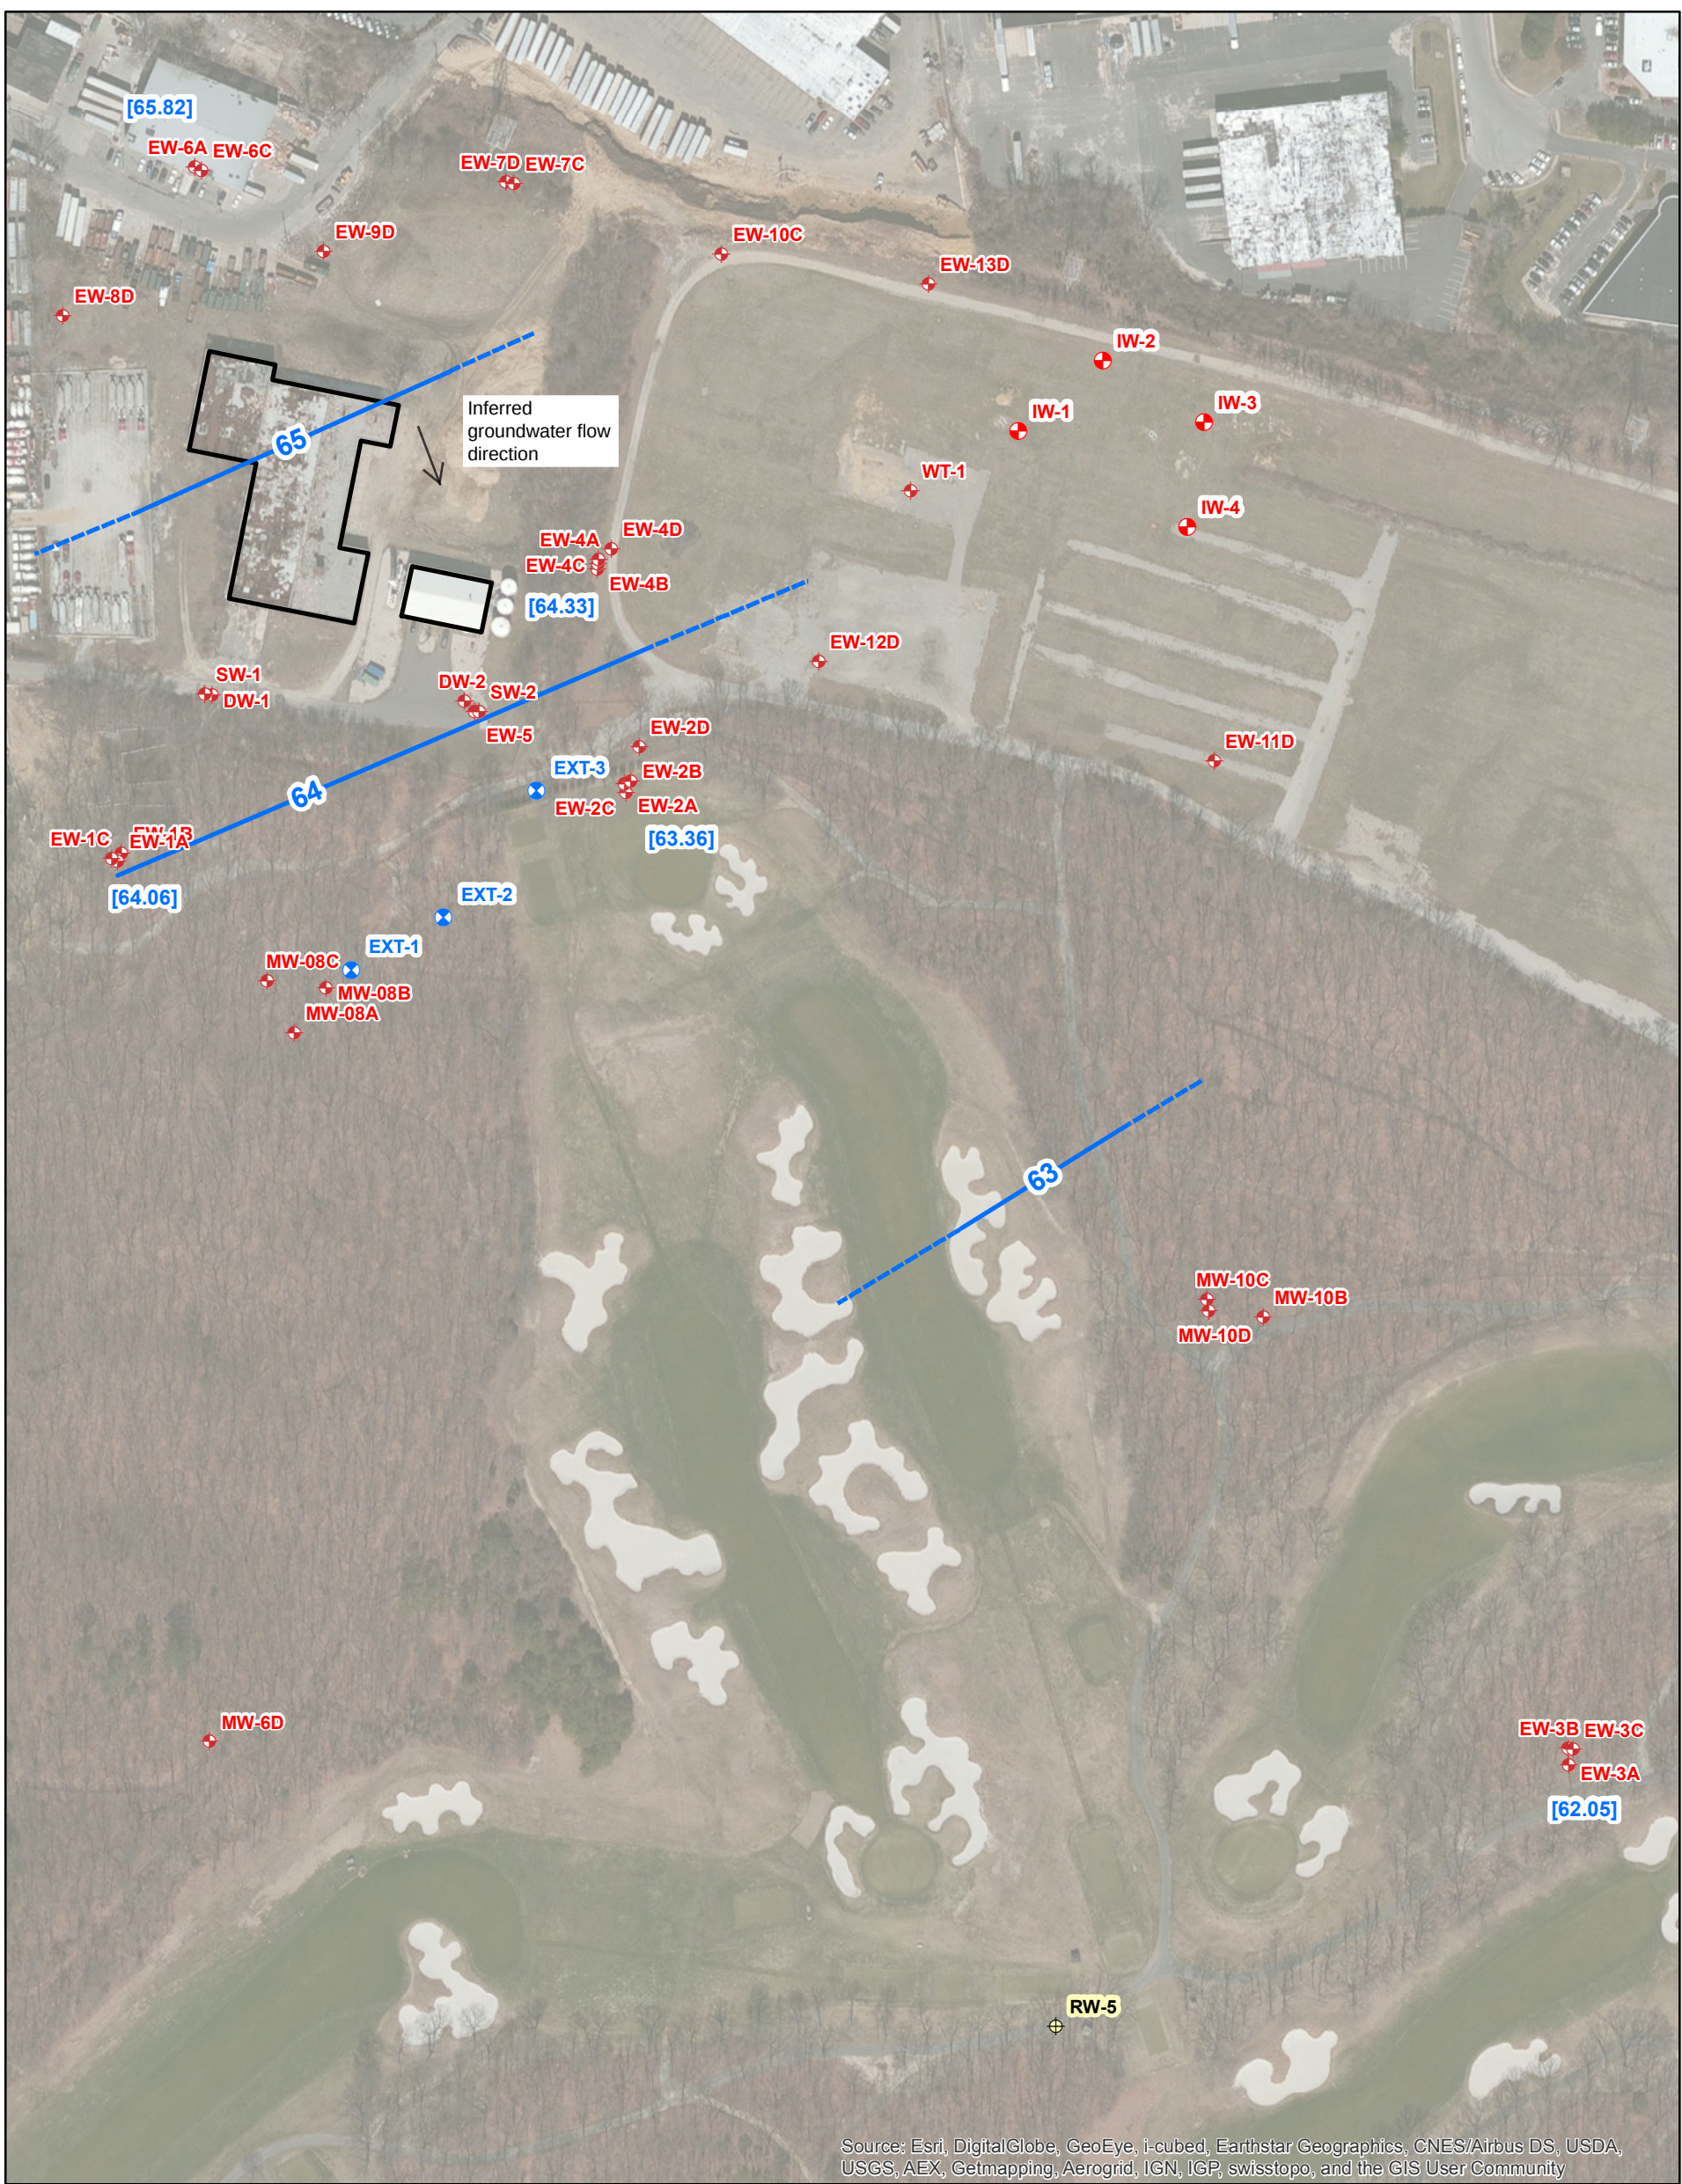
**Figure 2b**  
**Shallow Groundwater**  
**Elevation Contours**  
**June 2014**  
**Claremont Polychemical Corporation**  
**Old Bethpage, New York**  
**HRP # NEW9625.OM**  
**Site Code 130015**  
**Scale 1" = 200'**

Prior to sample collection, static groundwater levels were measured at the 41 groundwater well locations on June 6, 2014. Depths to groundwater in March 2014 when the PDBs were installed ranged from 44.00 ft (EW-14D) to 102.74 ft (EW-11D) below ground surface (bgs). Depths to groundwater in June 2014 when the PDBs were retrieved ranged from 41.99 ft (EW-14D) to 101.70 ft (EW-11D) bgs. The inferred groundwater flow direction is to south-southeast. Overall, groundwater elevations (Table 1) and inferred groundwater flow direction based on groundwater elevation contours (Figure 2b) were consistent with previous data.

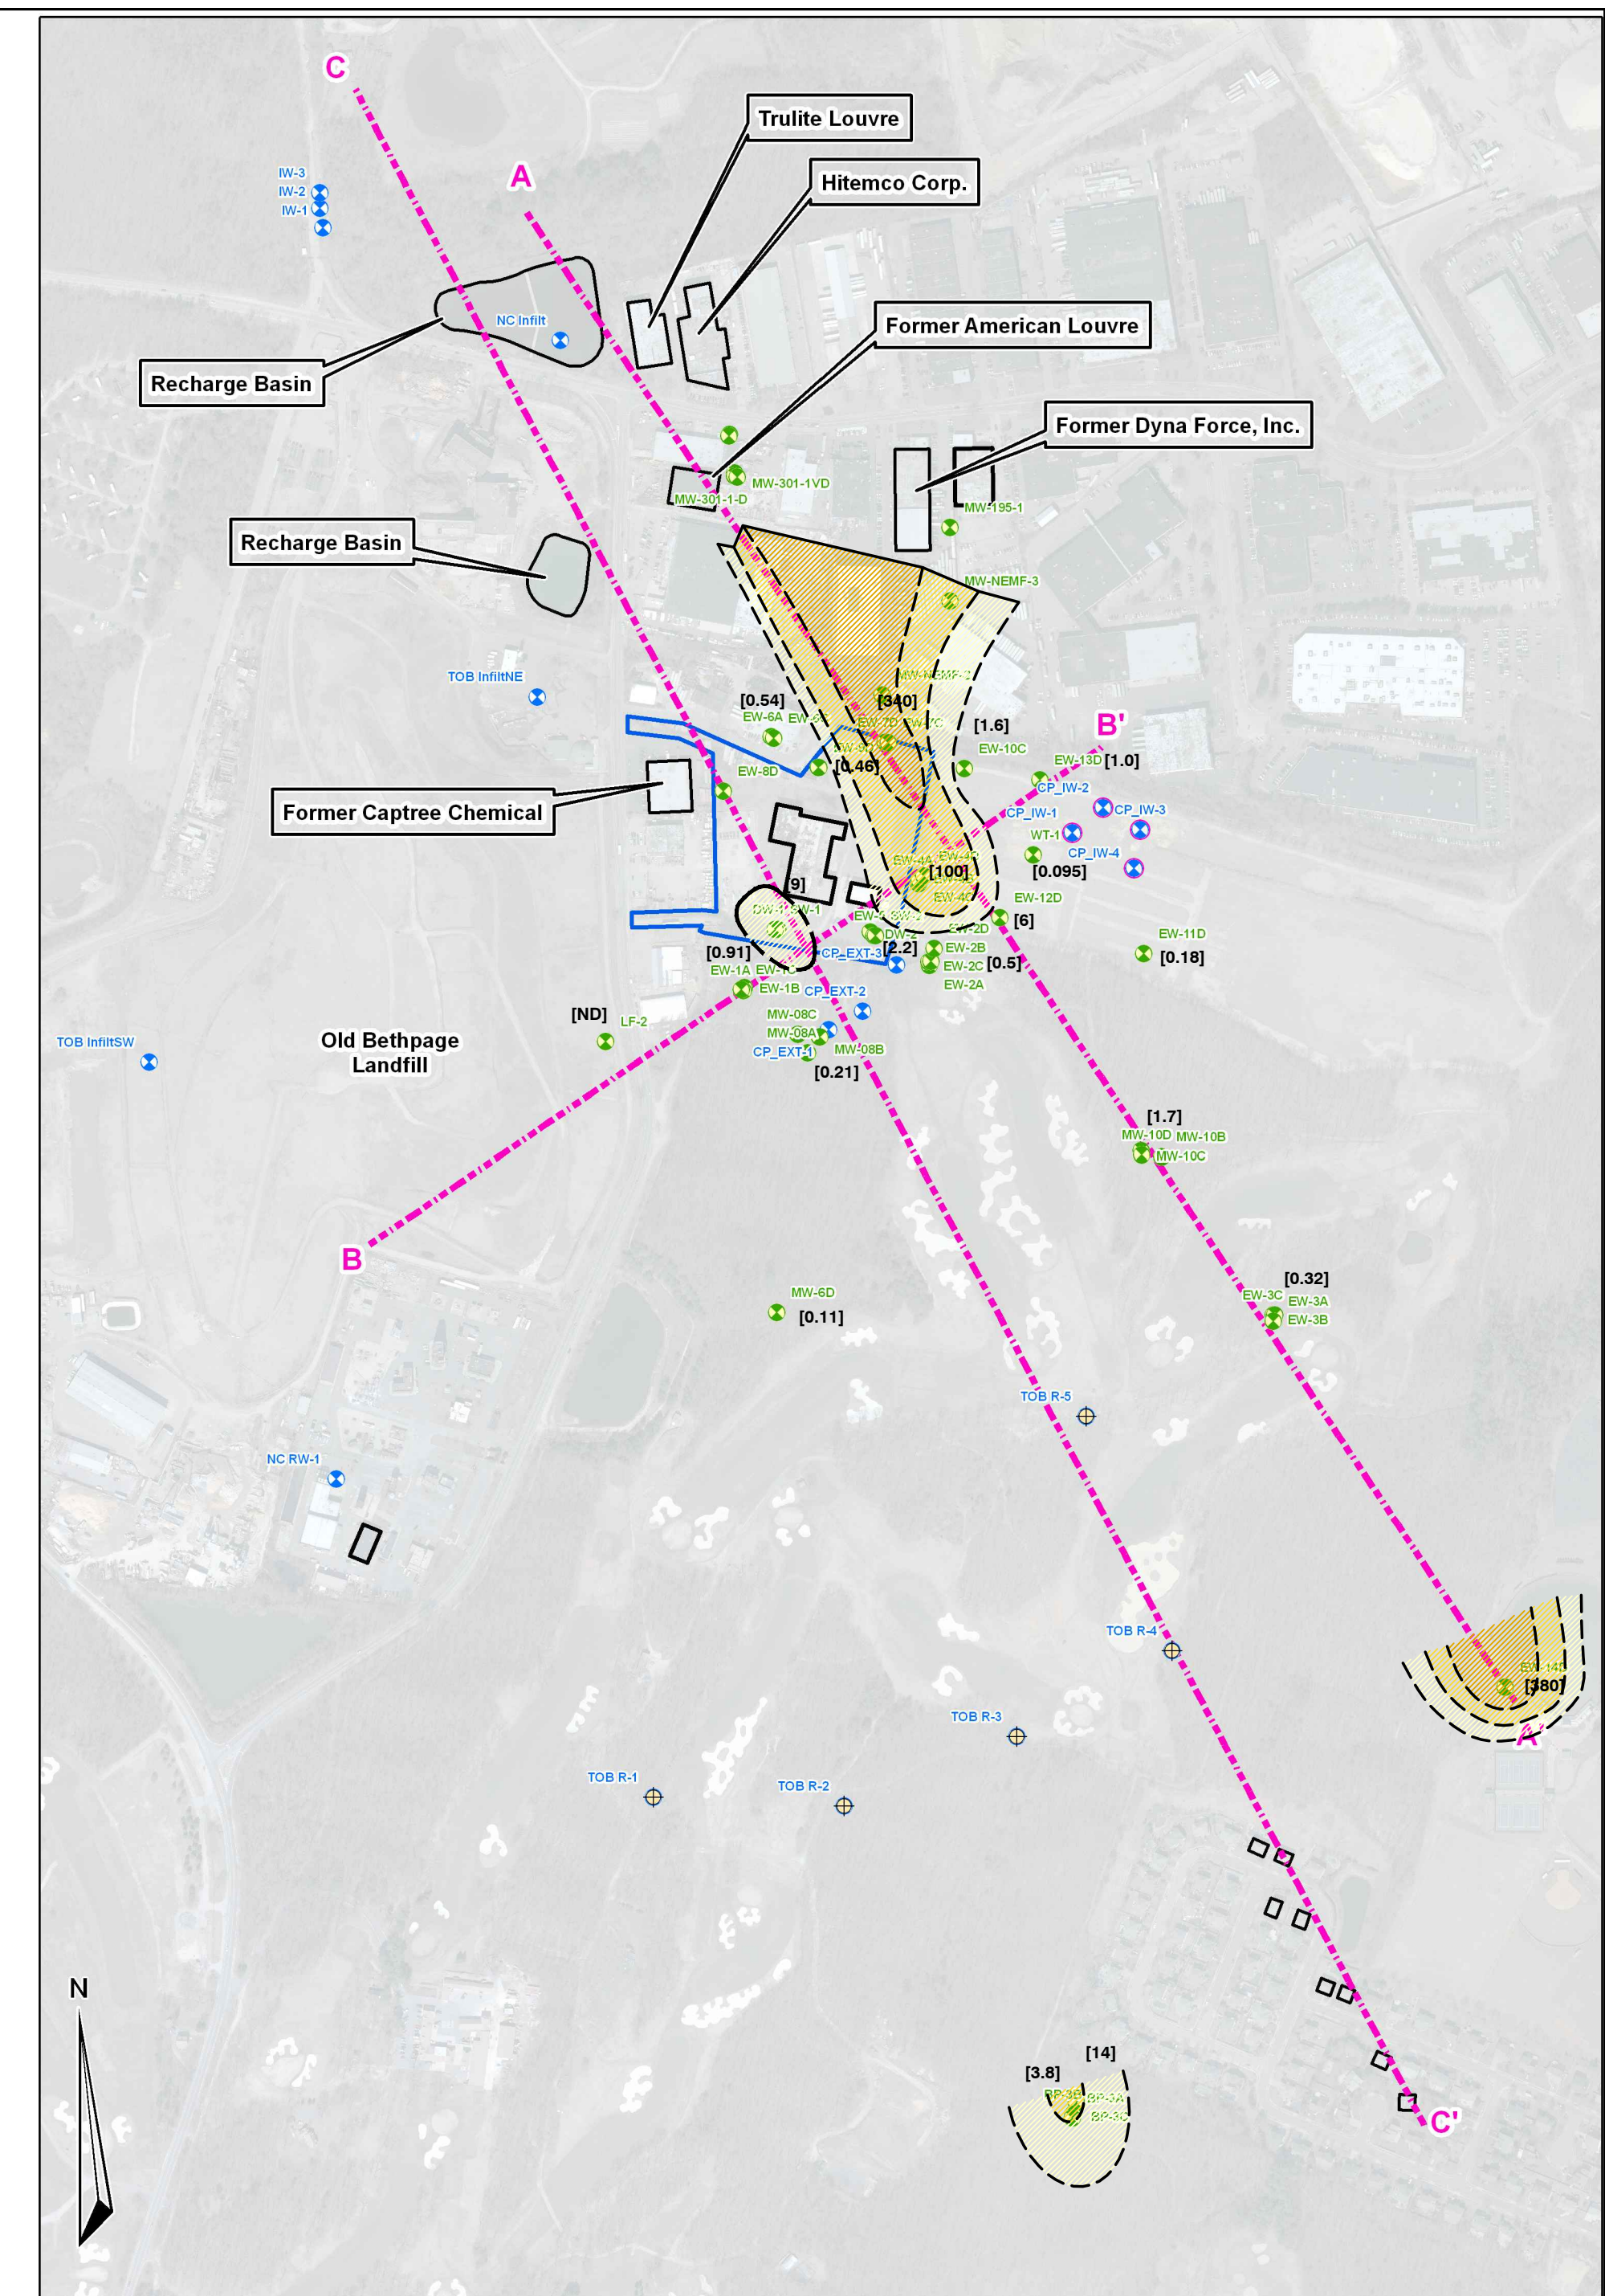
##### **PCE Contamination (Figure 3a)**

PCE has historically been present above groundwater criteria in two zones of the sampling area for the site. Cross section A-A' east of the site shows an on-site migrating PCE plume with maximum observed concentrations of 13 ug/l at EW-4D and EW-7C. A separate plume appears to originate on-site, with maximum concentrations of 55 ug/l in SW-1 (Cross Section C-C'). These plumes seem to be separate (Figure 3A, Cross Section Location cutout). Additional exceedances were noted in the southern portion of the study area, centered on wells BP-3B (32 ug/l) and BP-3C (160 ug/l).

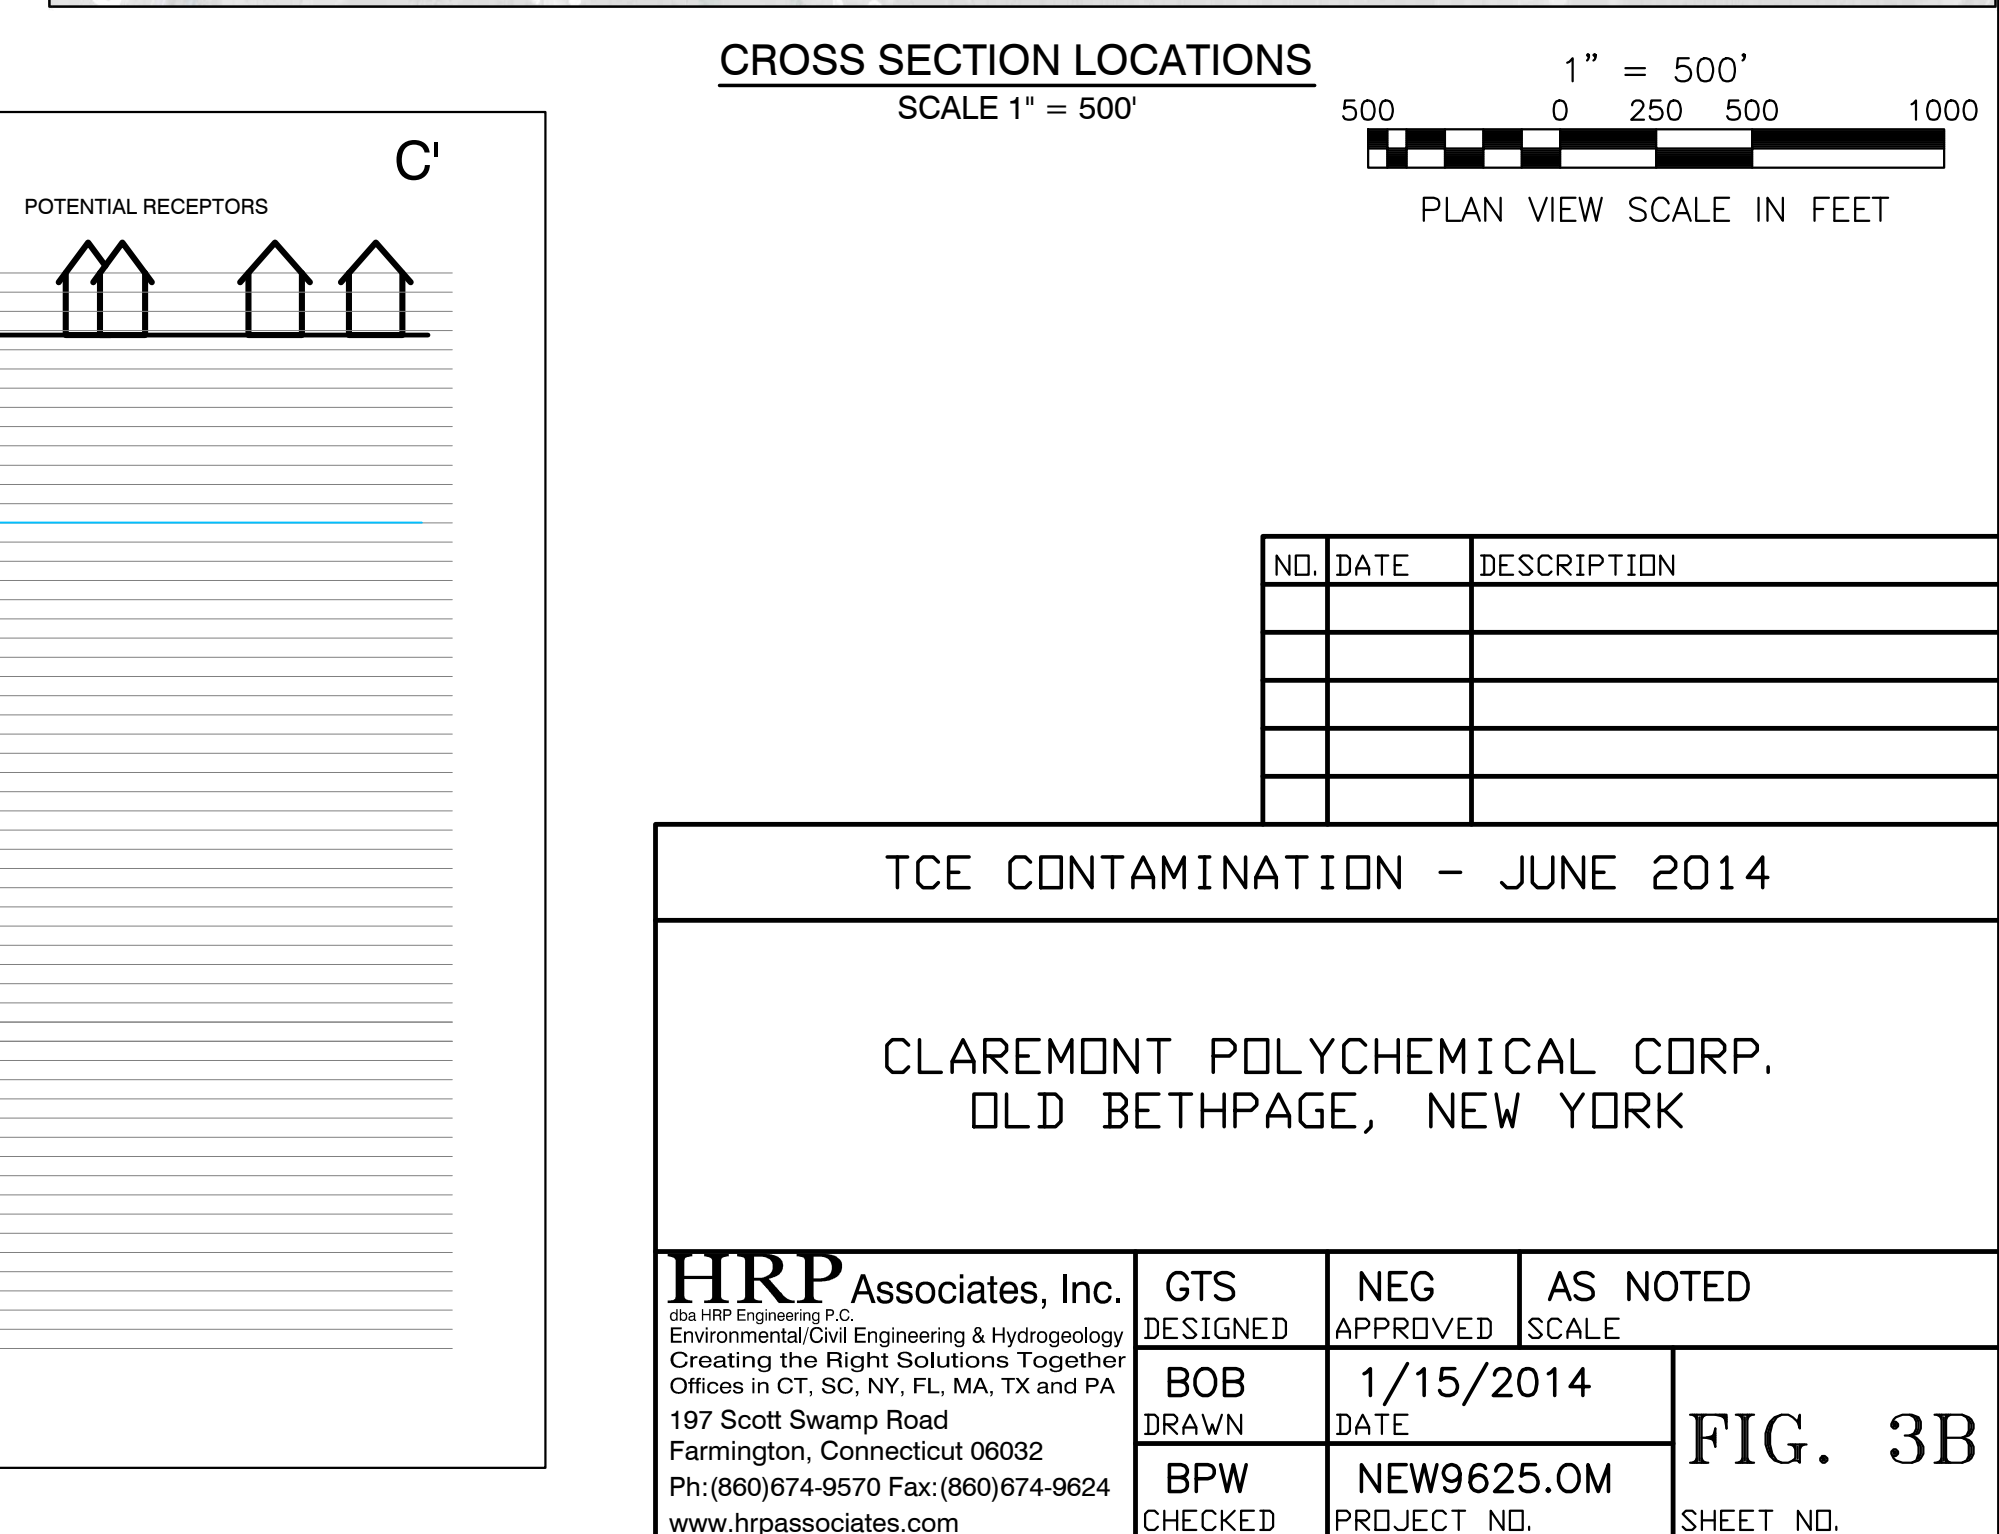
##### **TCE Contamination (Figure 3b)**

TCE contamination is predominant to the east of the Site building (Cross section A-A'), and is at its highest concentration (340 ug/l) in well EW-7C, upgradient of the site, and in the furthest downgradient monitoring well to

the southeast towards EW-14D (380 ug/l). This plume appears to be separate from an onsite generated plume (Cross section B-B'). The on-site generated plume has maximum observed concentrations of 9 ug/l in SW-1 (Cross section C-C'). As with PCE contamination, additional exceedances were noted in the southern portion of the study area, centered on well EW-3C.

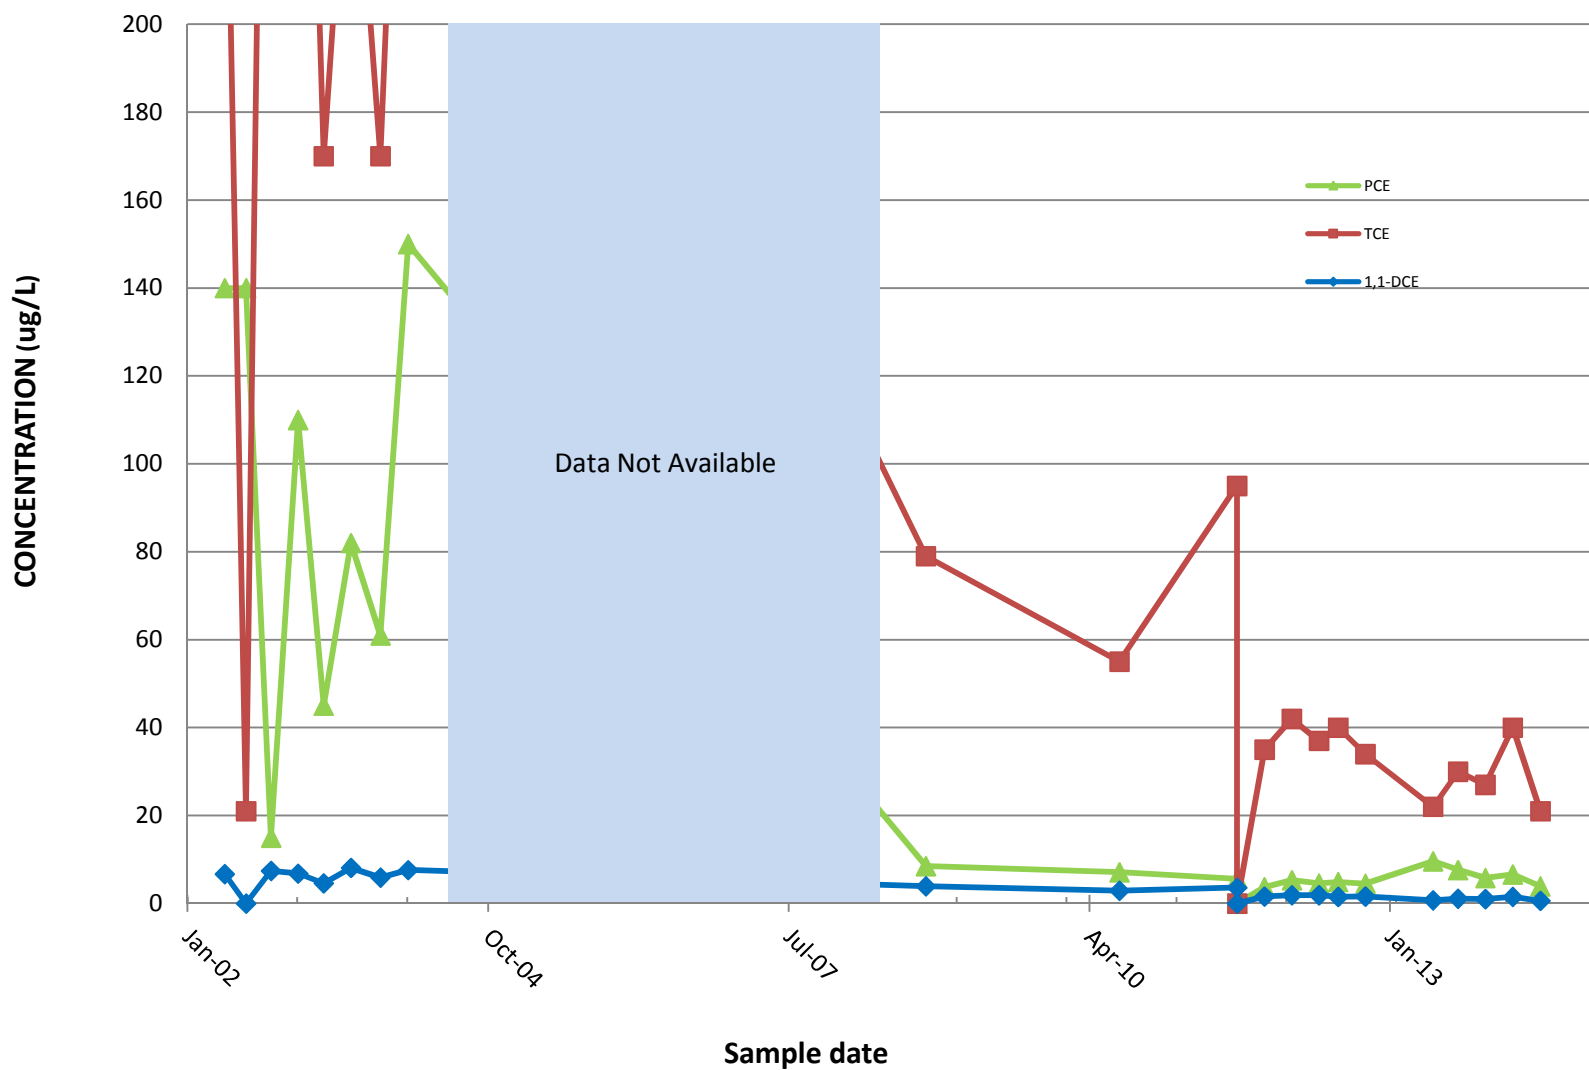
# Chart 1: Groundwater Influent Concentration (PCE, TCE, and 1,1-DCE) vs. Time

To evaluate the treatment system's contaminate influent rate (Chart 1) removal rate, HRP reviewed available treatment system inlet (Charts 1a, 1b, 1c and 2) and effluent analytical results from monthly operation and maintenance(O&M) sampling when the system is operational. Approximately 908 kilograms of chlorinated solvents have been removed since 2002. A plot of historic mass removal rates and cumulative PCE and TCE mass removal is presented as Chart 5. In addition, HRP prepares and submits monthly Groundwater Treatment System O&M Activities reports which discusses monthly O&M activities, technical support, remediation system sample results and project goals met.

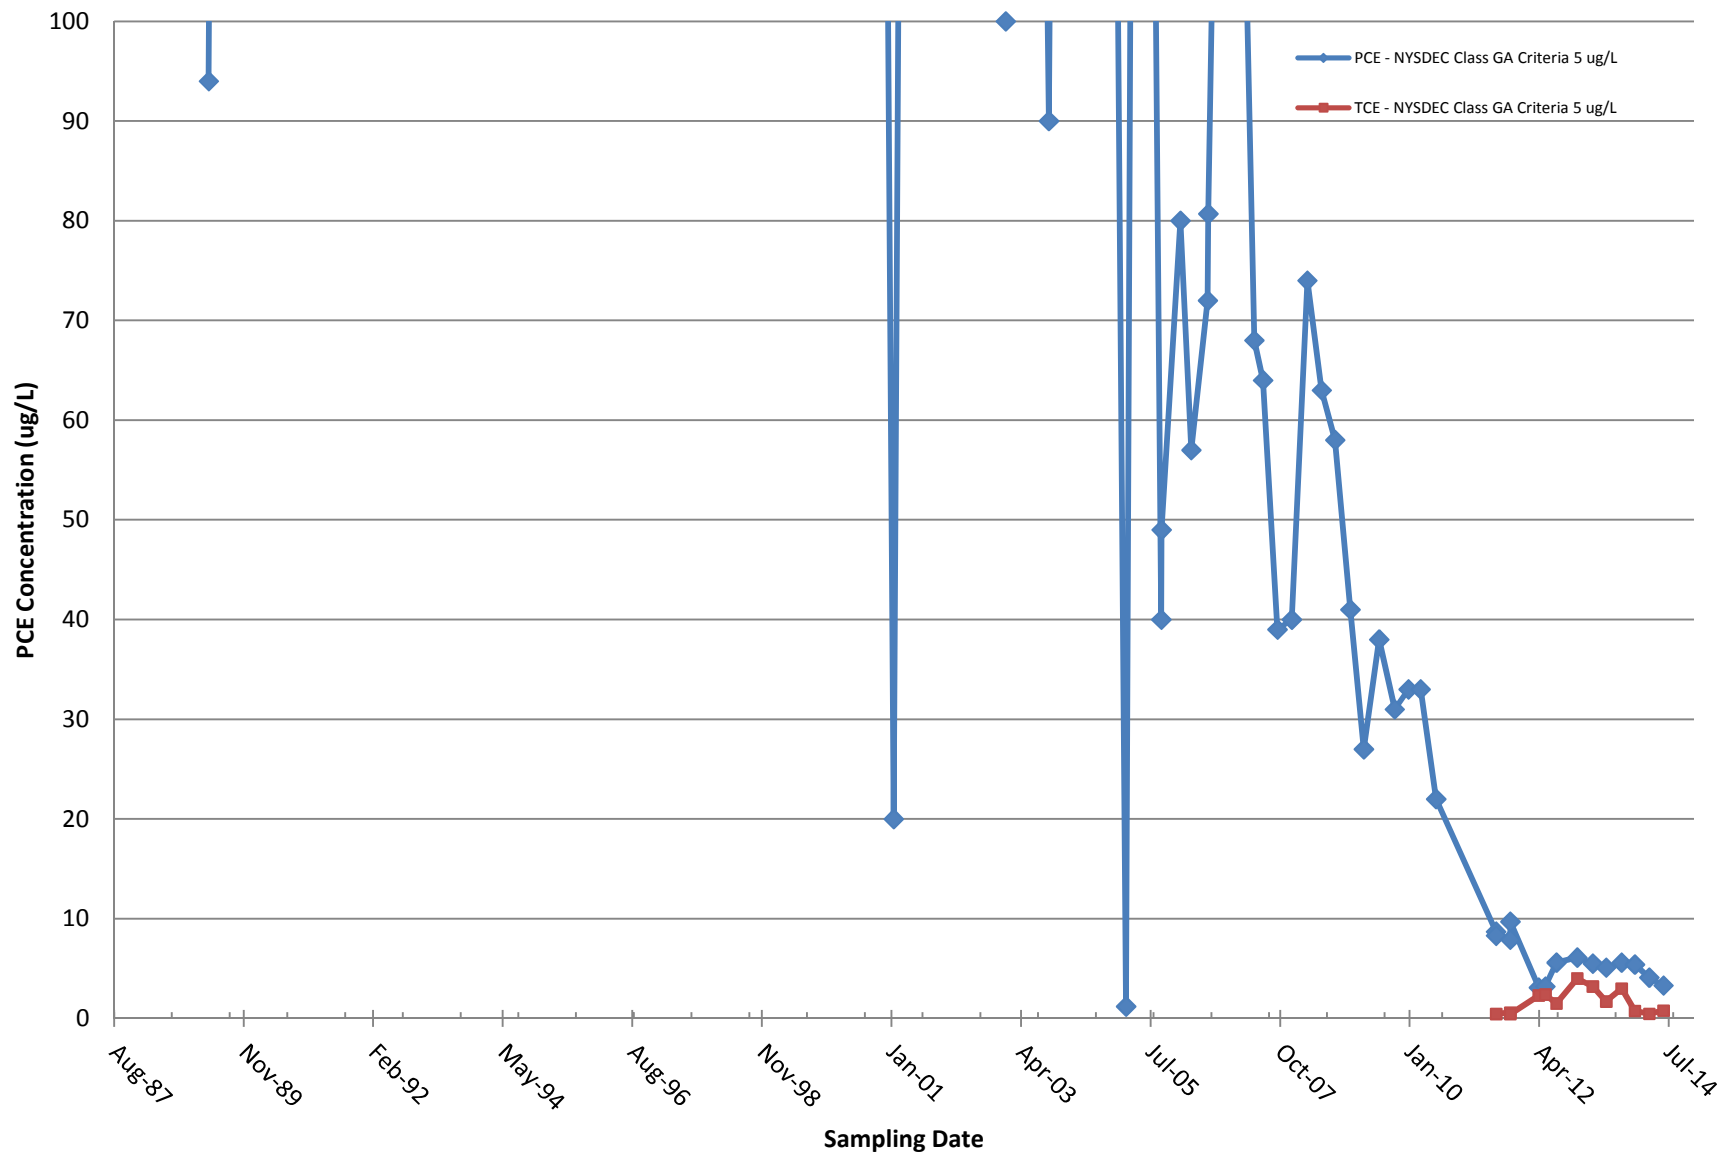
## Chart 6a - PCE and TCE Concentrations In EW-1a

The attached charts (Chart 6a through Chart 6c) illustrate the historical concentration trends for PCE and/or TCE in three wells (EW-1a, EW-4c, SW-1). These wells were selected due to consistent elevated VOC analytical results and the presence of sufficient historical data. In all cases with the exception of EW-4C EW-4D, and BP-3C, the results continue to indicate a general downward trend in VOC concentrations. EW-4C and EW-4D are sidegradient and upgradient from Claremont and the increases are not attributed to the Claremont spill. BP-3C is located downgradient from Claremont and the increases are not attributed to the Claremont spill.
