### 2014 Third Quarter Groundwater Monitoring Report July - September 2014 Claremont Polychemical Corporation Site 505 Winding Road Old Bethpage, Nassau County, New York 11804 Site Code: 130015 WA# D006130-19

### 2014 Third Quarter Groundwater Monitoring Report July – September 2014 Claremont Polychemical Corporation Site Old Bethpage, New York 11804

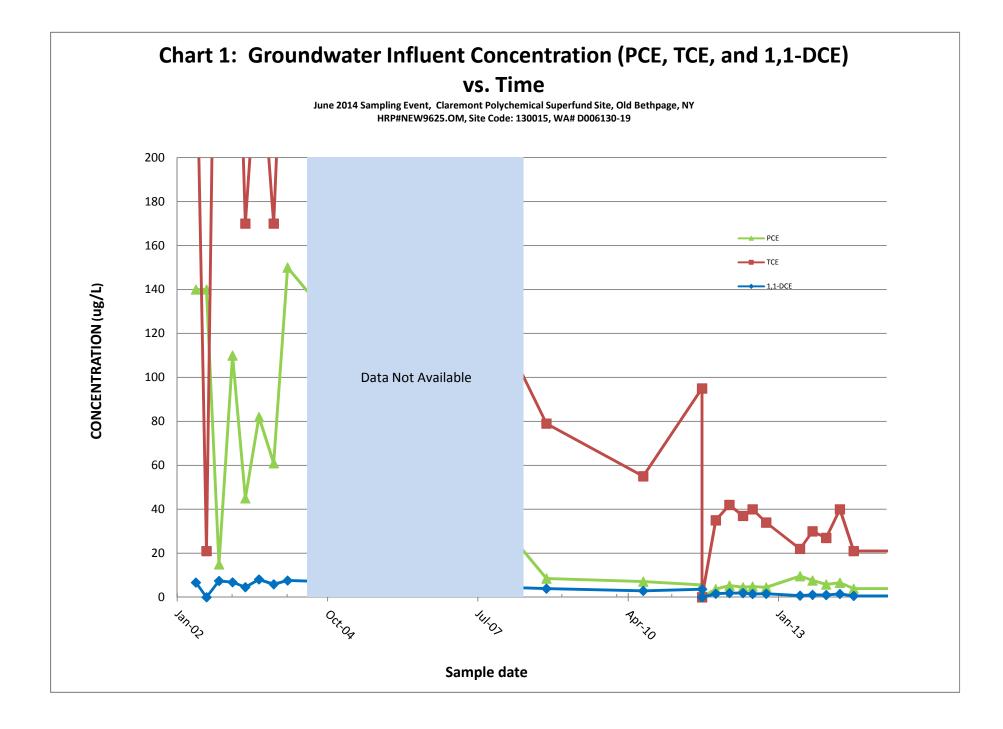
To evaluate the treatment system's contaminate influent rate (Chart 1) removal rate, HRP reviewed available treatment system inlet (Charts 1a, 1b, 1c and 2) and effluent analytical results from monthly operation and maintenance (O&M) sampling when the system is operational. Approximately 910 kilograms of chlorinated solvents have been removed since 2002. A plot of historic mass removal rates and cumulative PCE and TCE mass removal is presented as Chart 5. In addition, HRP prepares and submits monthly Groundwater Treatment System O&M Activities reports which discusses monthly O&M activities, technical support, remediation system sample results and project goals met.
