2019 Third Quarter Groundwater Monitoring Report

Claremont Polychemical Corporation Site

Contract/WA No. D0076025-28; Site No. 130015

November 1, 2019

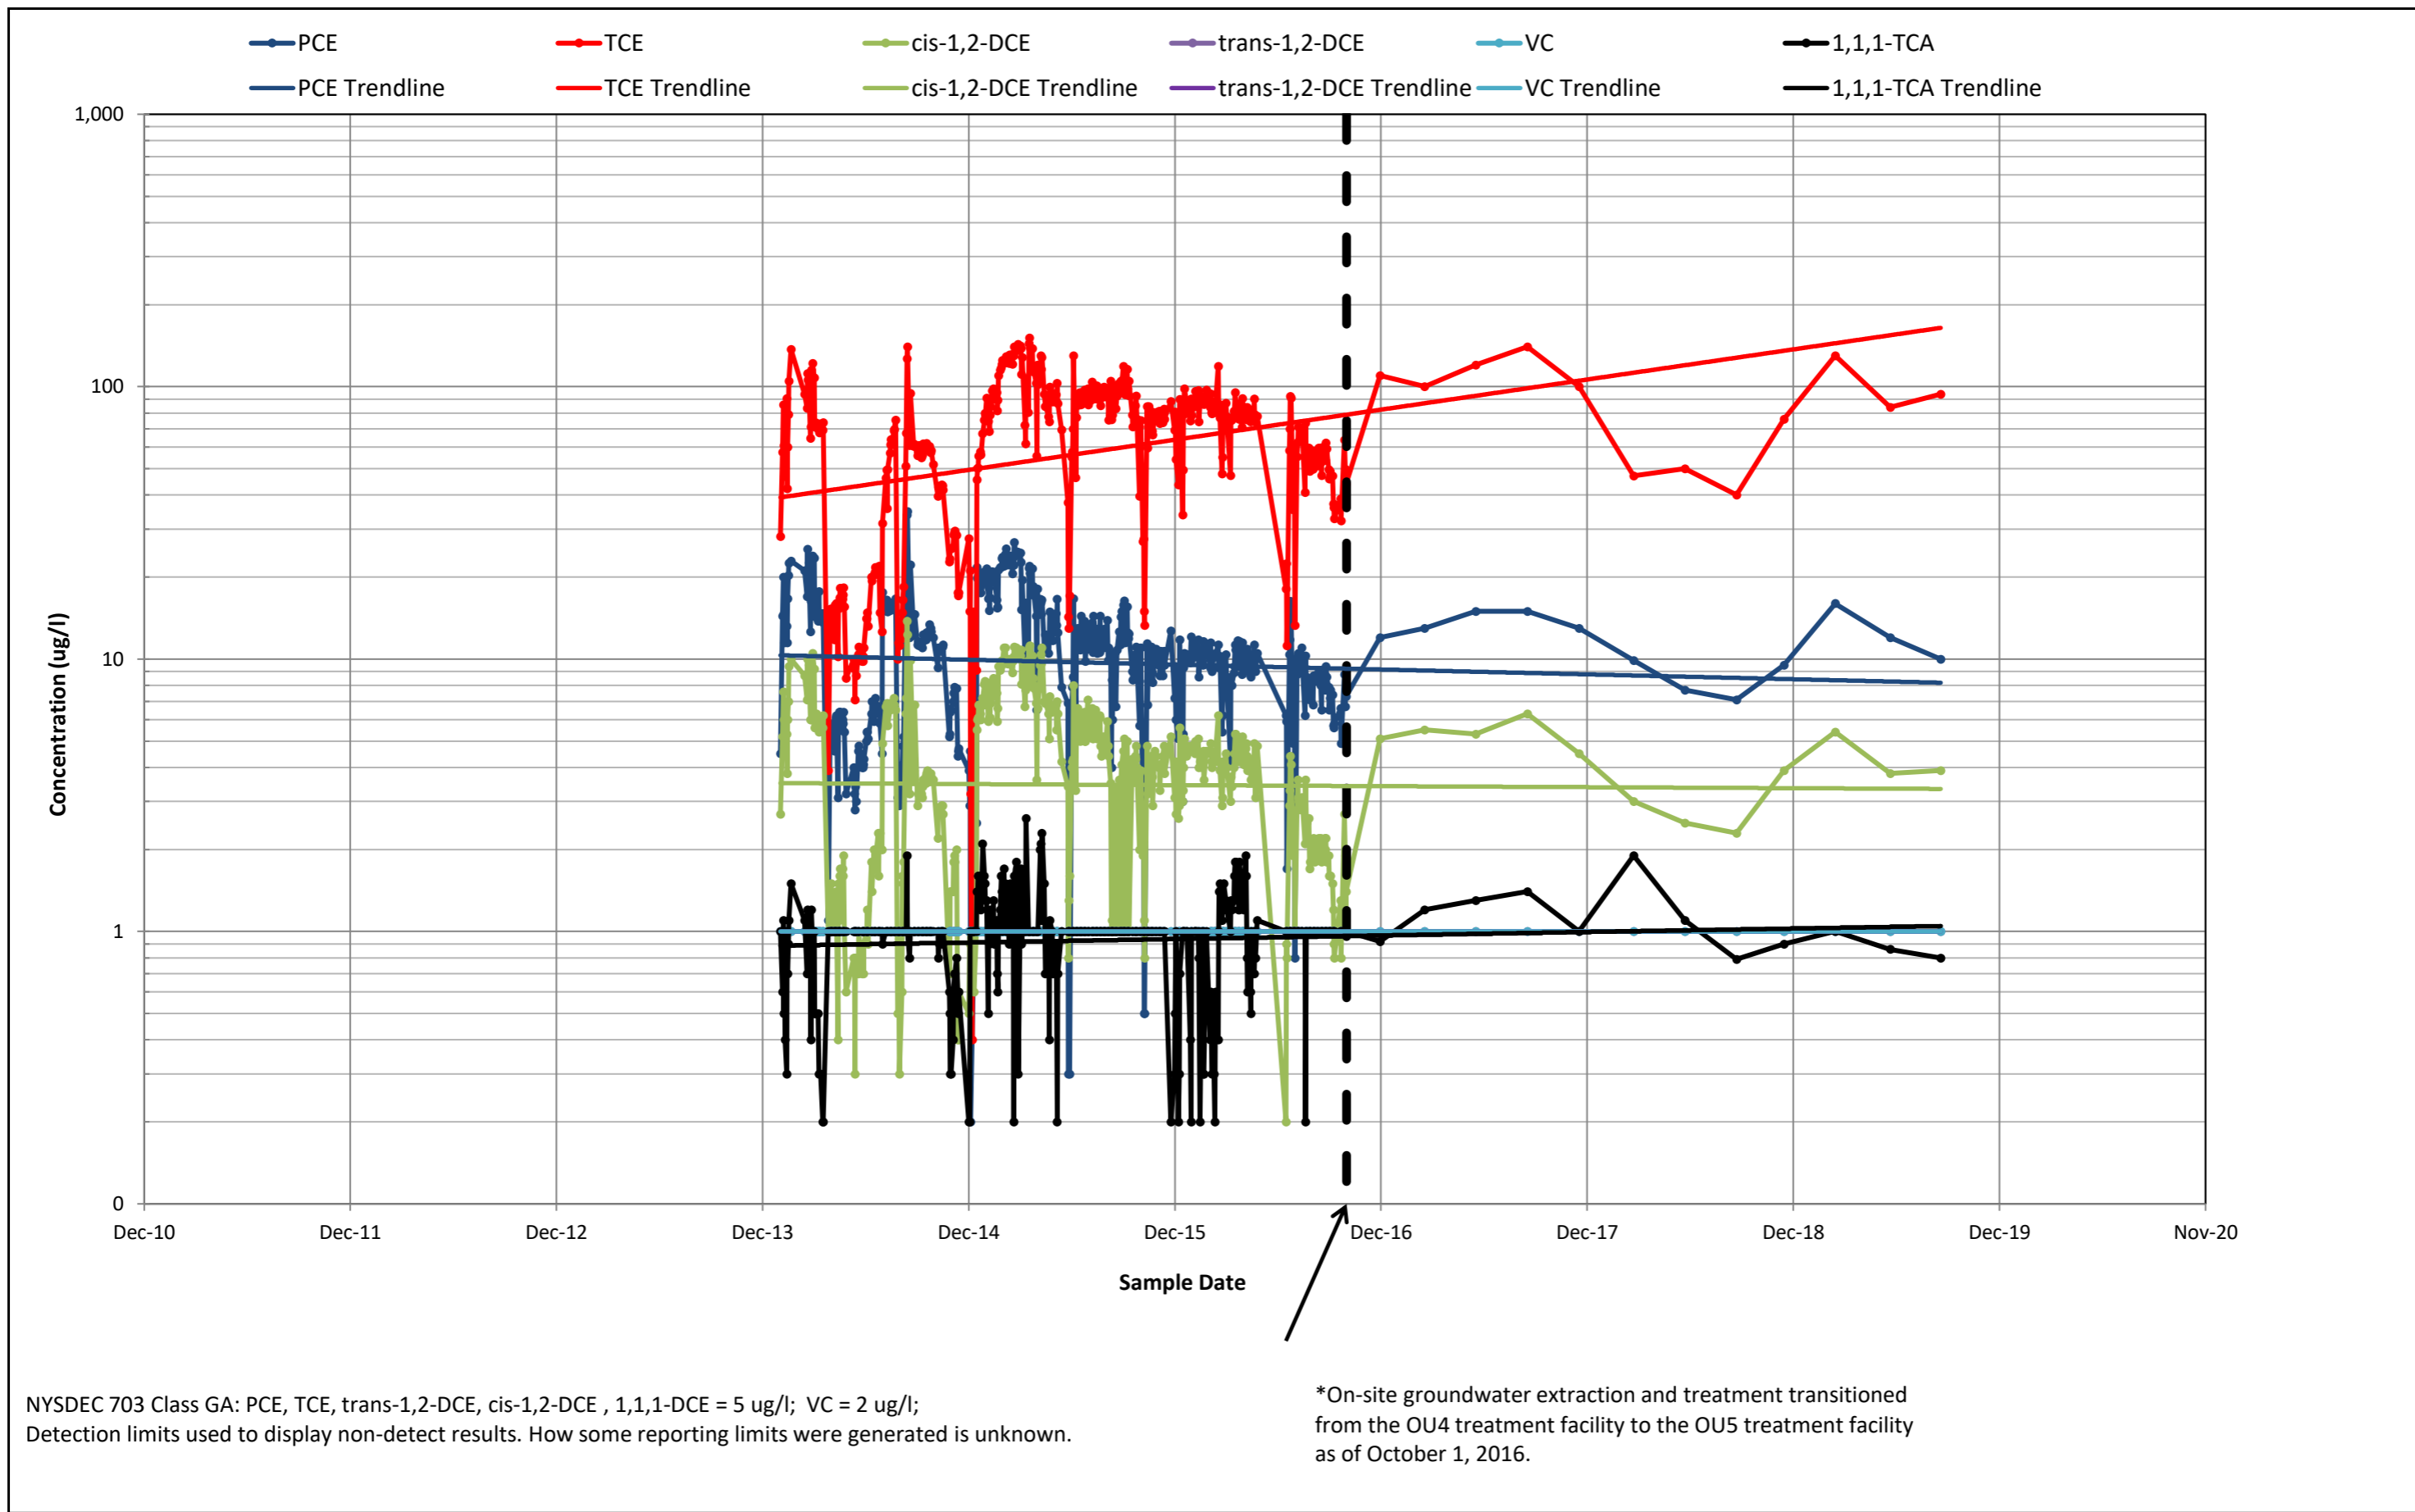
DATE
 SEPTEMBER 2019
FIGURE
 28

CHLORINATED VOC CONCENTRATIONS
WELL OU5 Influent
CLAREMONT POLYCHEMICAL CORPORATION OPERABLE UNIT 5
NYSDEC SITE #130015
