# Monthly Report of the Operations & Maintenance Activities

Claremont Polychemical Operable Unit 5  
Groundwater Treatment System

*Old Bethpage, New York*  
June, 2021

NYSDEC Standby Engineering Contract  
Work Assignment #D0076025-28

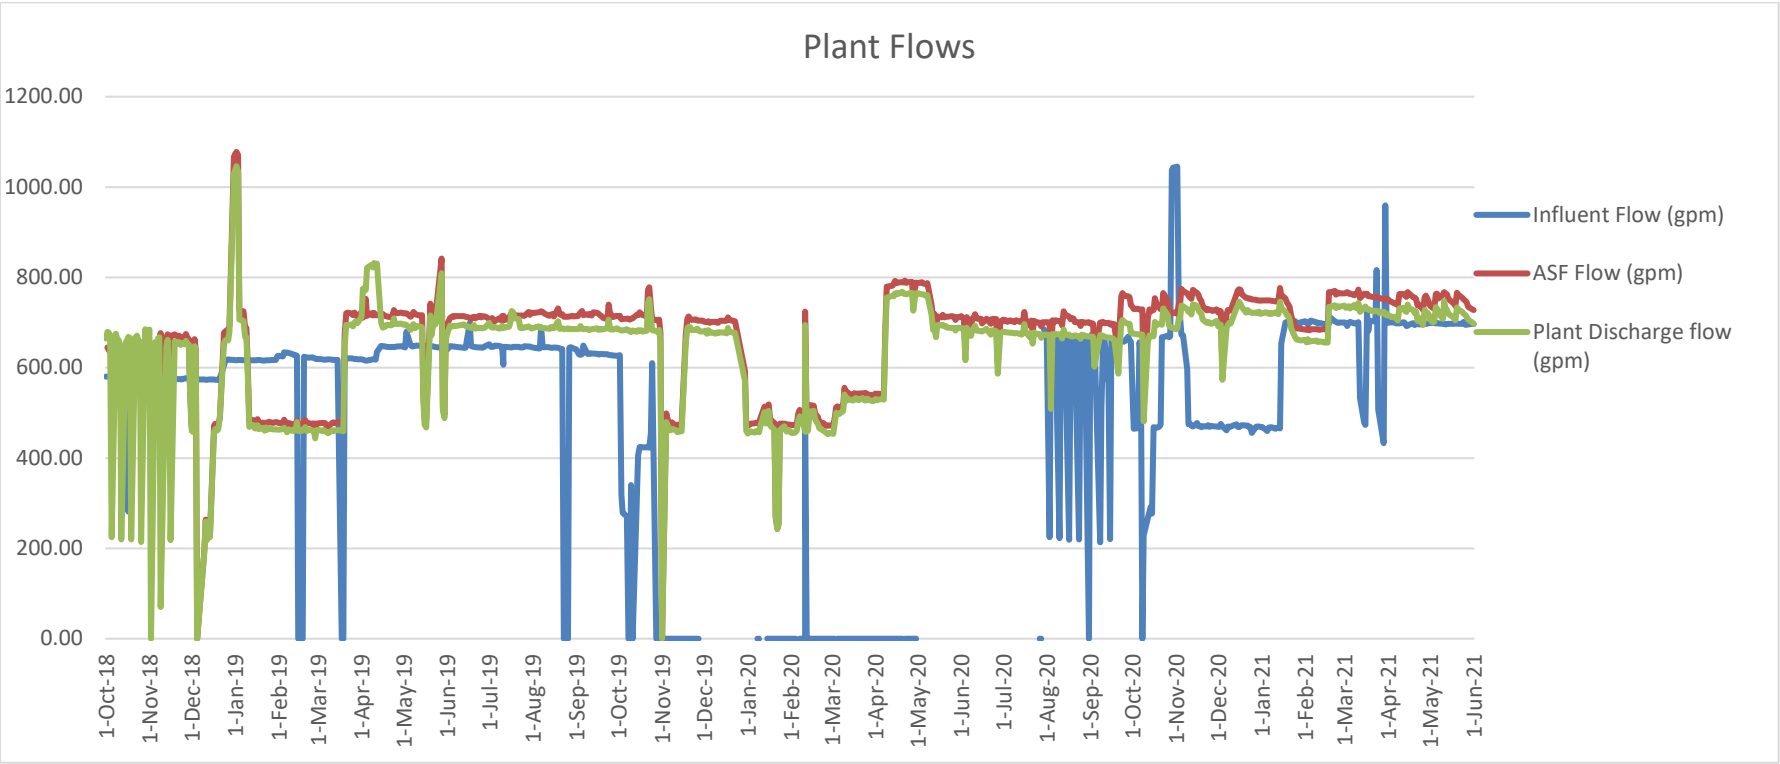
Figure 1 – Plant Discharge Daily Flow

The total volume of treated water discharged from ~0830 hours, June 1 to ~0830 hours July 1, was approximately 29,787,743 gallons. The plant discharge is currently directed to Recharge Basin No. 1 and partially to Recharge Basin 33. The data in **Table 2** is a summary of plant discharge flows.

A graphic representation of the system's daily plant discharge output is provided in **Figure 1** and the daily plant totalizer readings for June are provided in **Table 3**, both following the text of this report.
