MONTHLY REPORT OF THE OPERATIONS & MAINTENANCE ACTIVITIES (AUGUST 2022)

**CLAREMONT POLYCHEMICAL
OPERABLE UNIT 5 GROUND
WATER TREATMENT
SYSTEM, OLD BETHPAGE, NY**

Project name **Claremont Polychemical Corporation Site**
Project no. **1087815.1940101703**
Recipient **New York State Department of Environmental Conservation**
Document type **Report**
Version **[1]**
Date **November 4, 2022**
Prepared by **Pawel Mecinski – GES**
Checked by **Michael Grifasi - Ramboll**
Approved by **Andrew Leitzinger - Ramboll**

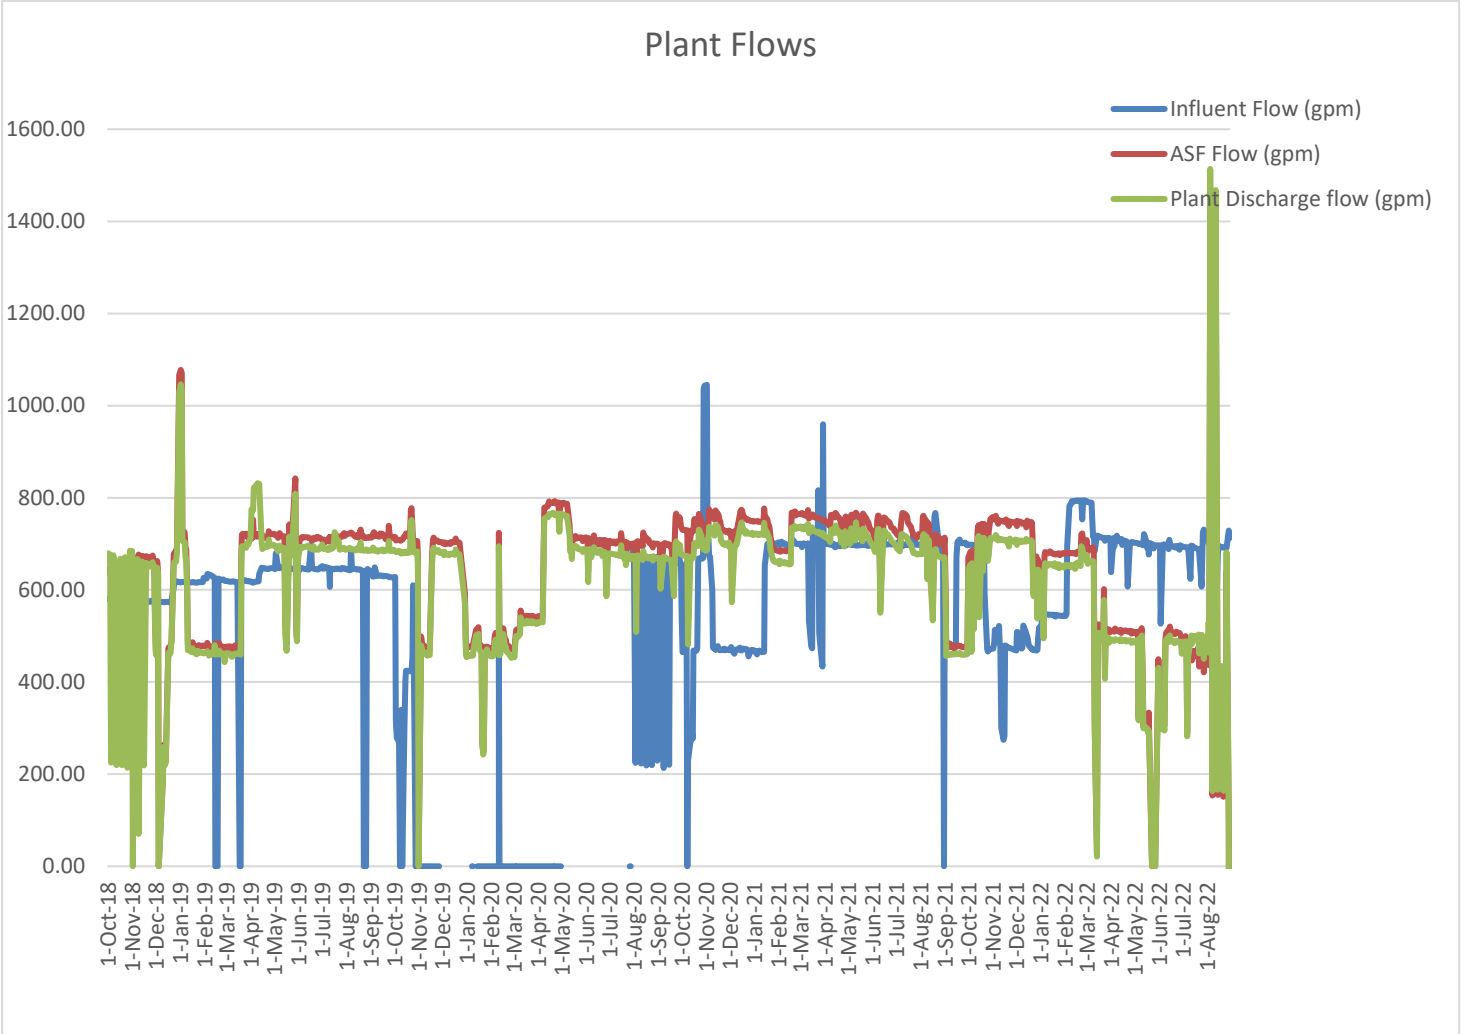
Figure 1
Plant Discharge Daily Flow

The total volume of treated water discharged from ~0830 hours August 1 to ~0730 hours September 1 was approximately 16,229,000 gallons. The data in **Table 2** is a summary of plant discharge flows.

A graphic representation of the system's daily plant discharge output is provided in **Figure 1** and the daily plant totalizer readings for August are provided in **Table 3**, both following the text of this report.

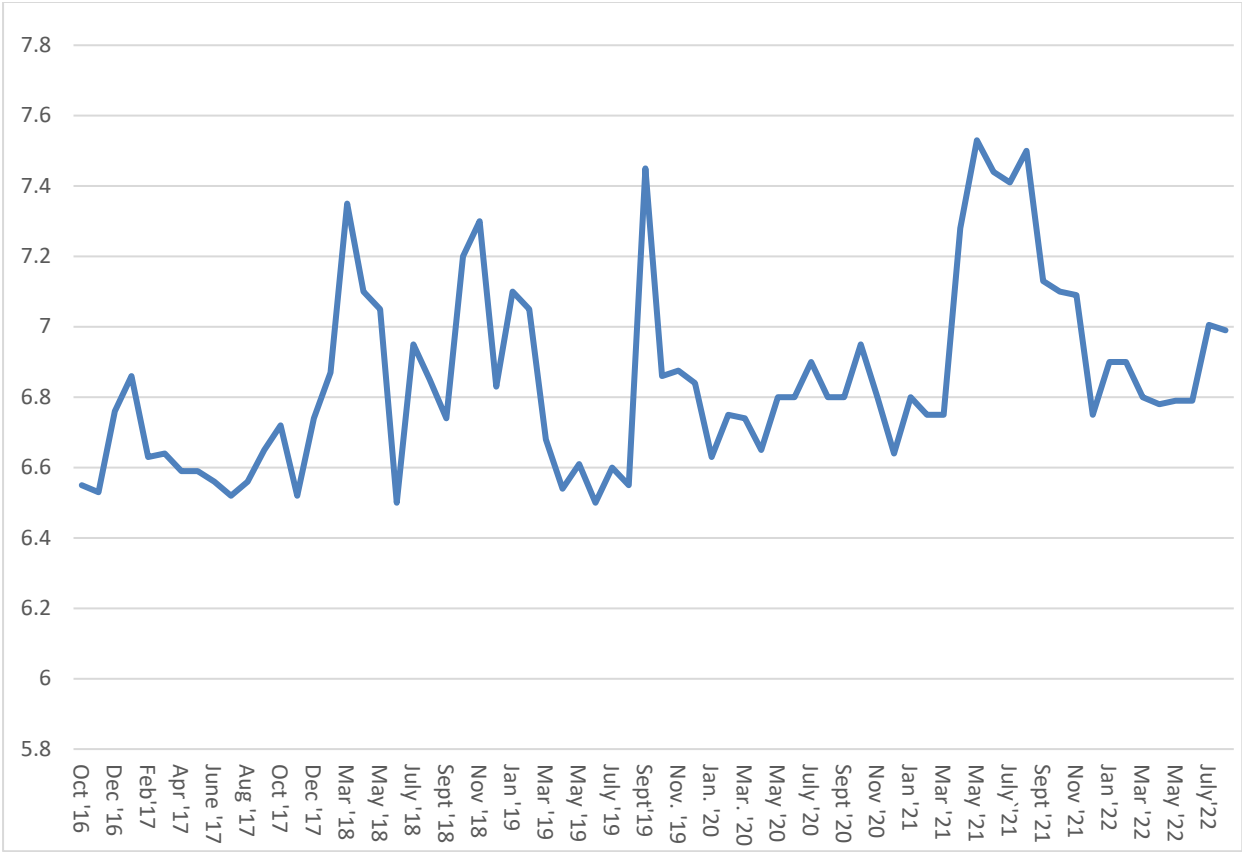
Plant Discharge Monthly Average pH Readings

The August 2022 average pH measurement was 6.99 standard units (su). The NYSDEC discharge permit requires the plant discharge to have an average monthly pH between 6.5 and 8.5 su. The results for this month meet this requirement. Data showing the plant discharge's monthly average pH trend over several months is provided in **Table 8** following the text of this report.

Month	pH(su)
Aug '19	6.56
Sept '19	7.45
Oct '19	6.86
Nov '19	6.88
Dec '19	6.84
Jan '20	6.63
Feb '20	6.75
Mar'20	6.74
Apr '20	6.65
May '20	6.8
June '20	6.8
July '20	6.9
Aug '20	6.8
Sept. '20	6.8
Oct. '20	6.95
Nov. '20	6.8
Dec '20	6.64
Jan '21	6.8
Feb '21	6.75
Mar '21	6.76
Apr '21	7.28
May '21	7.53
June '21	7.44
July '21	7.41
Aug '21	7.42
Sept '21	7.13
Oct '21	7.10
Nov '21	7.09
Dec'21	7.01
Jan '22	6.90
Feb '22	6.90
Mar '22	6.80
Apr '22	6.78
May '22	6.79
June '22	6.79
July '22	7.01
August '22	6.99
