MONTHLY REPORT OF THE OPERATIONS & MAINTENANCE ACTIVITIES (NOVEMBER 2022)

**CLAREMONT POLYCHEMICAL
OPERABLE UNIT 5 GROUND
WATER TREATMENT
SYSTEM, OLD BETHPAGE, NY**

Project name **Claremont Polychemical Corporation Site**
Project no. **1087815.1940101703**
Recipient **New York State Department of Environmental Conservation**
Document type **Report**
Version **[1]**
Date **December 12, 2022**
Prepared by **Pawel Mecinski – GES**
Checked by **Michael Grifasi - Ramboll**
Approved by **Andrew Leitzinger - Ramboll**

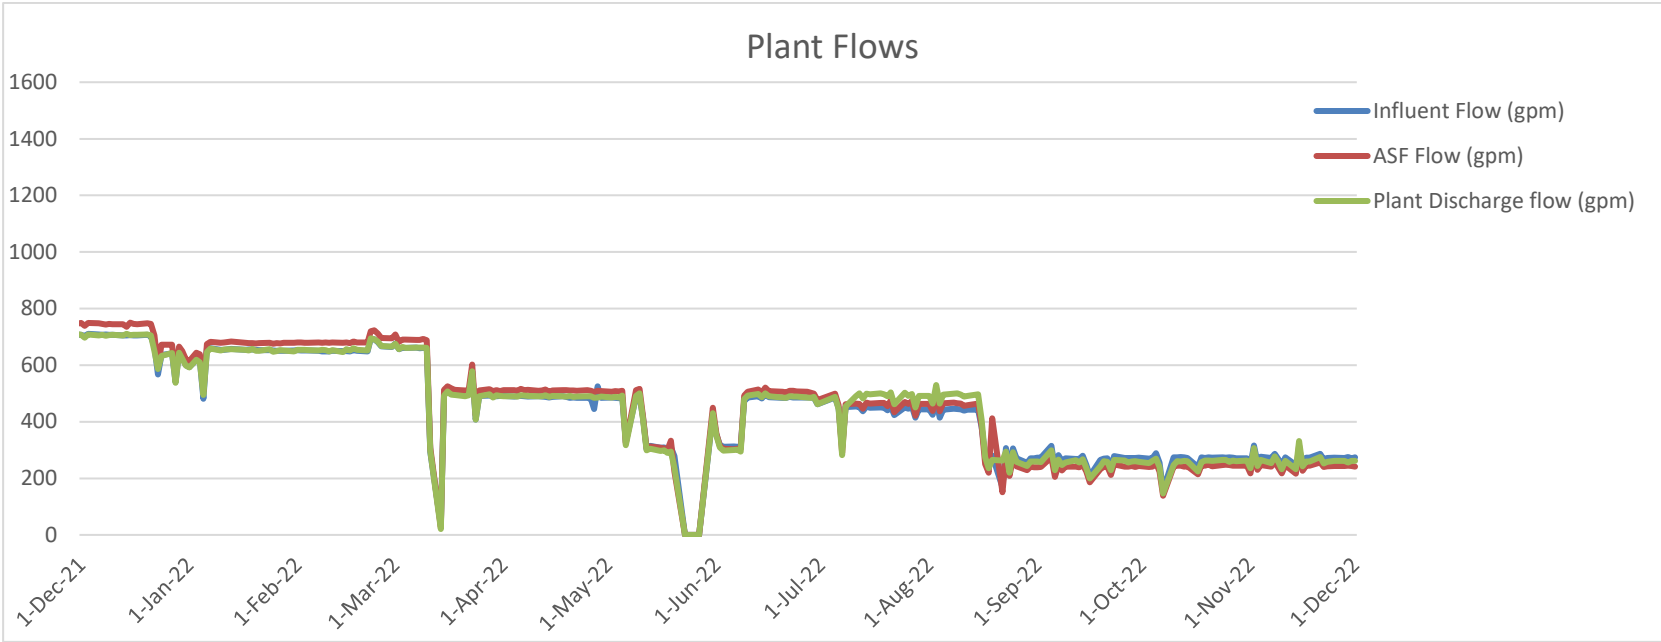
Figure 1
Plant Discharge Daily Flow

The total volume of treated water discharged from ~1000 hours November 1 to ~1000 hours December 1 was approximately 11,264,000 gallons. The data in **Table 2** is a summary of plant discharge flows.

A graphic representation of the system's daily plant discharge output is provided in **Figure 1** and the daily plant totalizer readings for November are provided in **Table 3**, both following the text of this report.

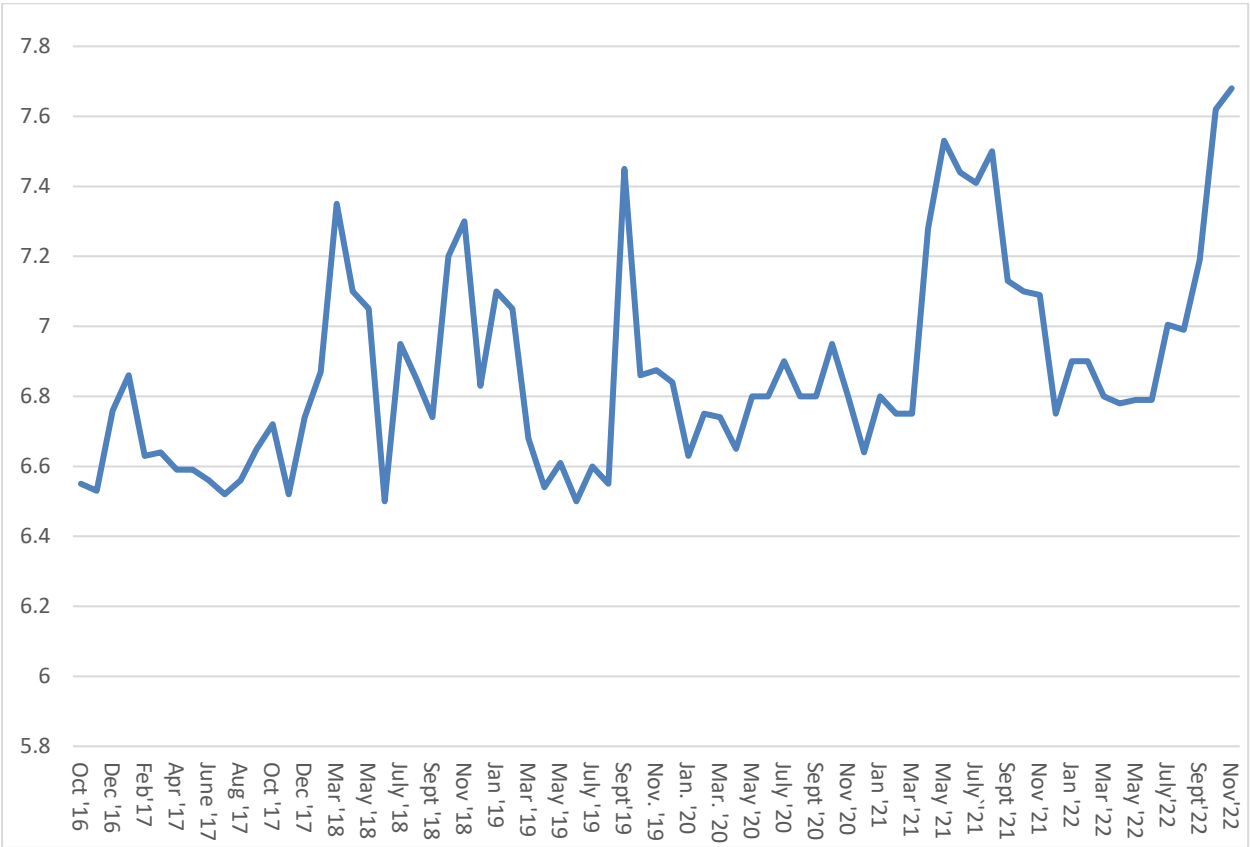
Plant Discharge Monthly Average pH Readings

The November 2022 average pH measurement was 7.68 standard units (su). The NYSDEC discharge permit requires the plant discharge to have an average monthly pH between 6.5 and 8.5 su. The results for this month meet this requirement. Data showing the plant discharge's monthly average pH trend over several months is provided in **Table 8** following the text of this report.

Month	pH(su)
Aug '19	6.56
Sept '19	7.45
Oct '19	6.86
Nov '19	6.88
Dec '19	6.84
Jan '20	6.63
Feb '20	6.75
Mar'20	6.74
Apr '20	6.65
May '20	6.8
June '20	6.8
July '20	6.9
Aug '20	6.8
Sept. '20	6.8
Oct. '20	6.95
Nov. '20	6.8
Dec '20	6.64
Jan '21	6.8
Feb '21	6.75
Mar '21	6.76
Apr '21	7.28
May '21	7.53
June '21	7.44
July '21	7.41
Aug '21	7.42
Sept '21	7.13
Oct '21	7.10
Nov '21	7.09
Dec'21	7.01
Jan '22	6.90
Feb '22	6.90
Mar '22	6.80
Apr '22	6.78
May '22	6.79
June '22	6.79
July '22	7.01
August '22	6.99
September'22	7.19
October'22	7.62
November'22	7.68
