RECORD OF DECISION

20 West Centennial Avenue
State Superfund Project
Roosevelt, Nassau County
Site No. 130154
March 2017

DECLARATION STATEMENT - RECORD OF DECISION

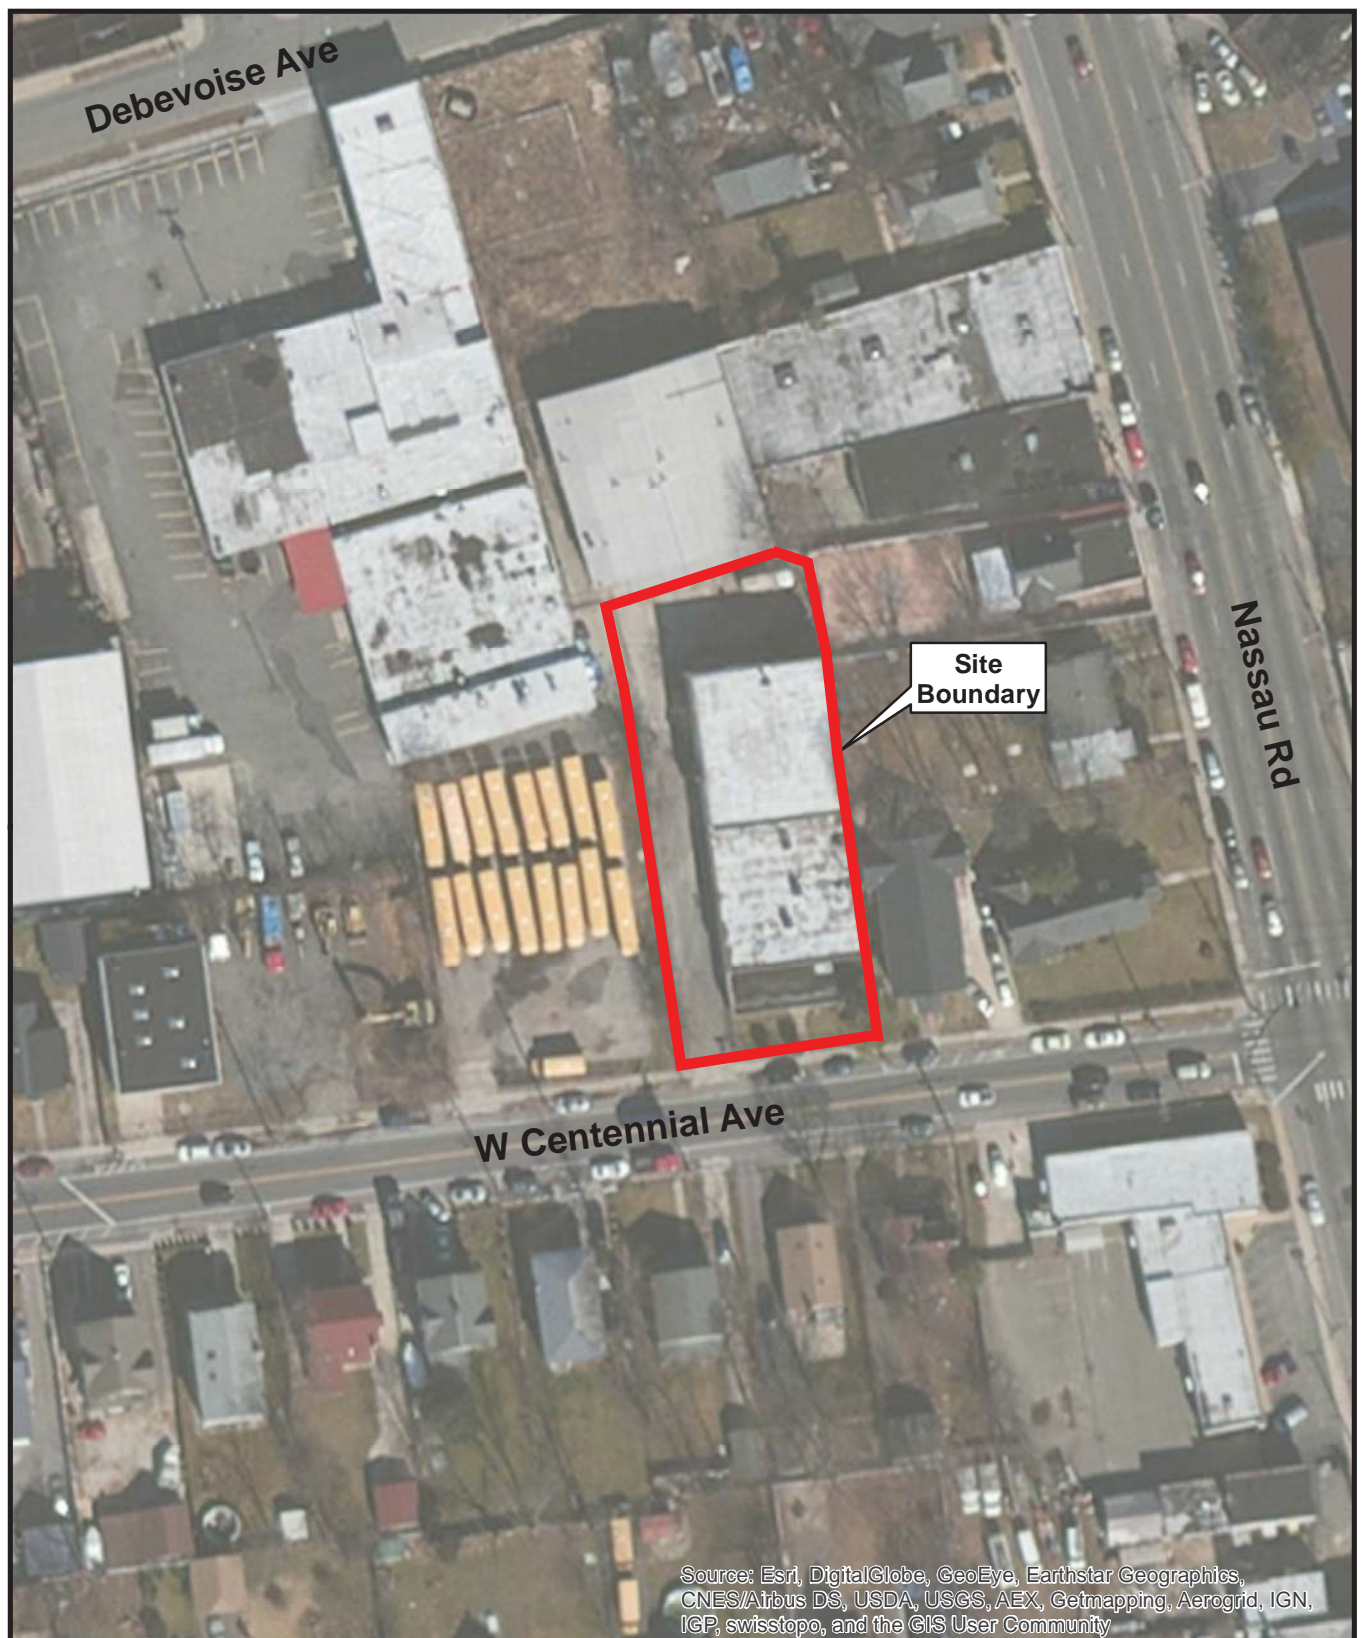
Figure 2 Site Perimeter Map

20 West Centennial Avenue
Town of Hempstead, Nassau
Site No. 130154

A site location map and a site boundary map are attached as Figure 1 and Figure 2.

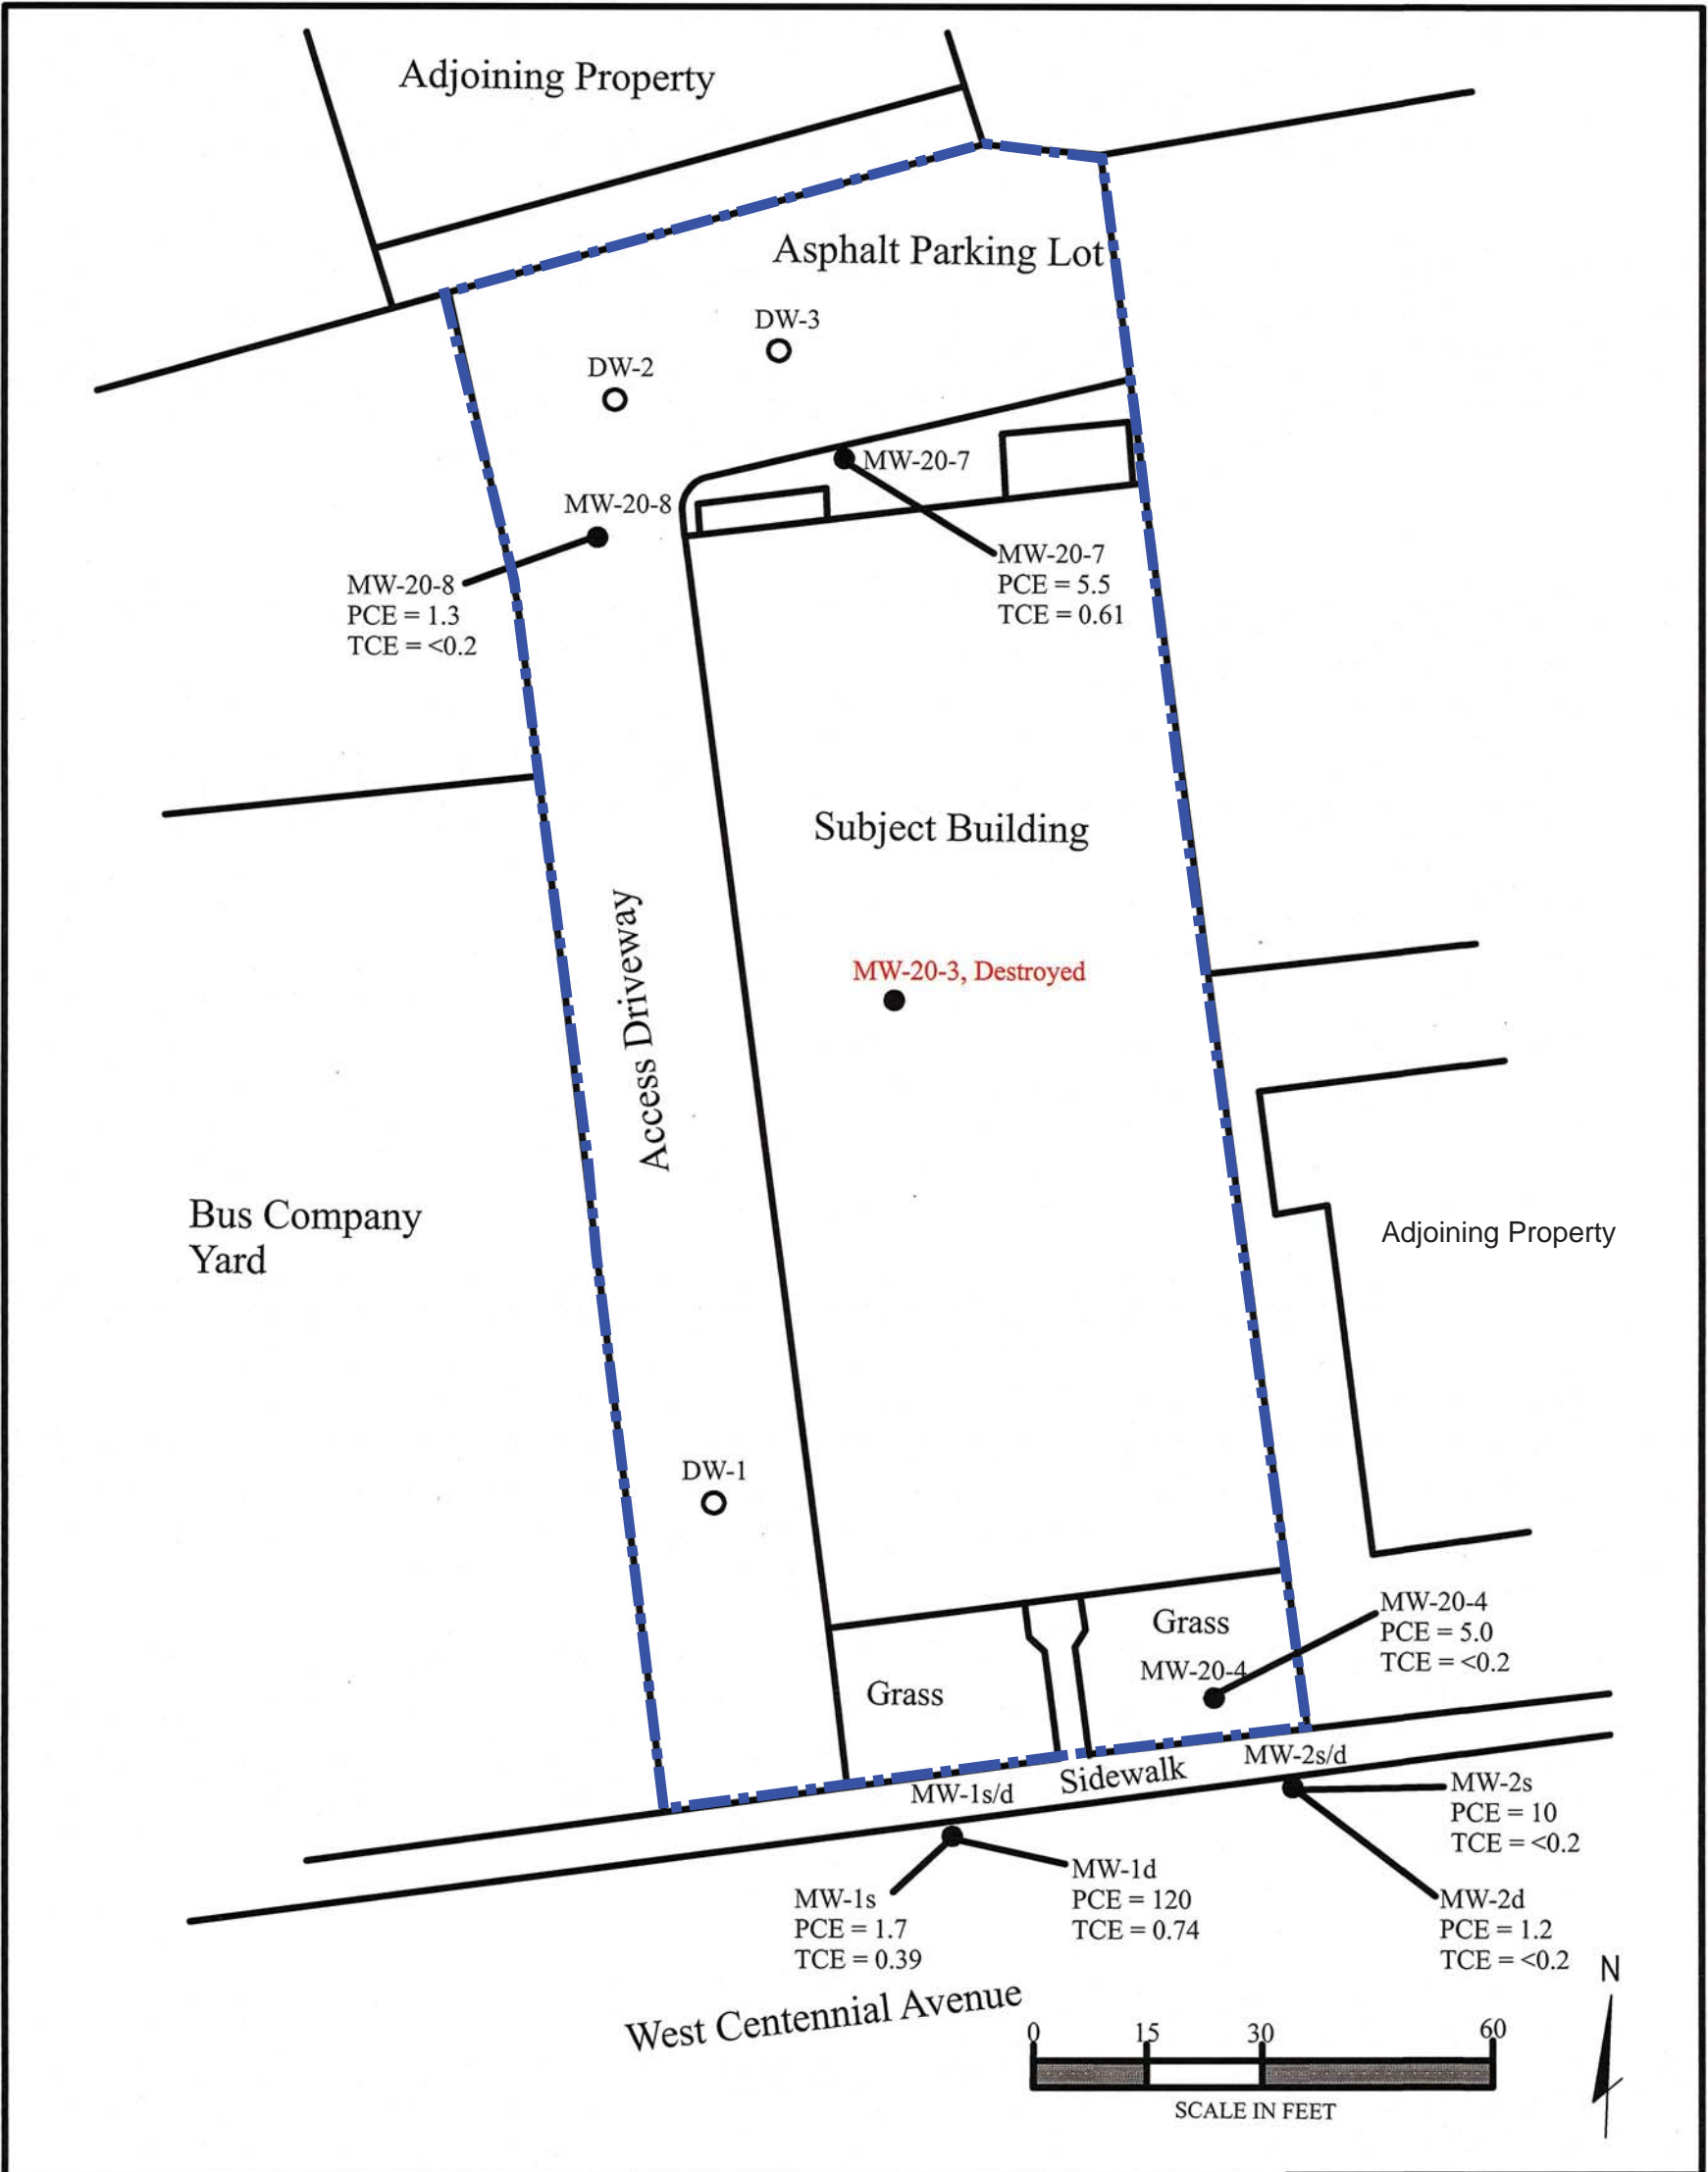
FIGURE 3
MONITORING WELL
LOCATIONS

LEGEND	
	= Fence
	= open grate manhole
Concentration in parts per billion (ppb), samples collected during the IRM

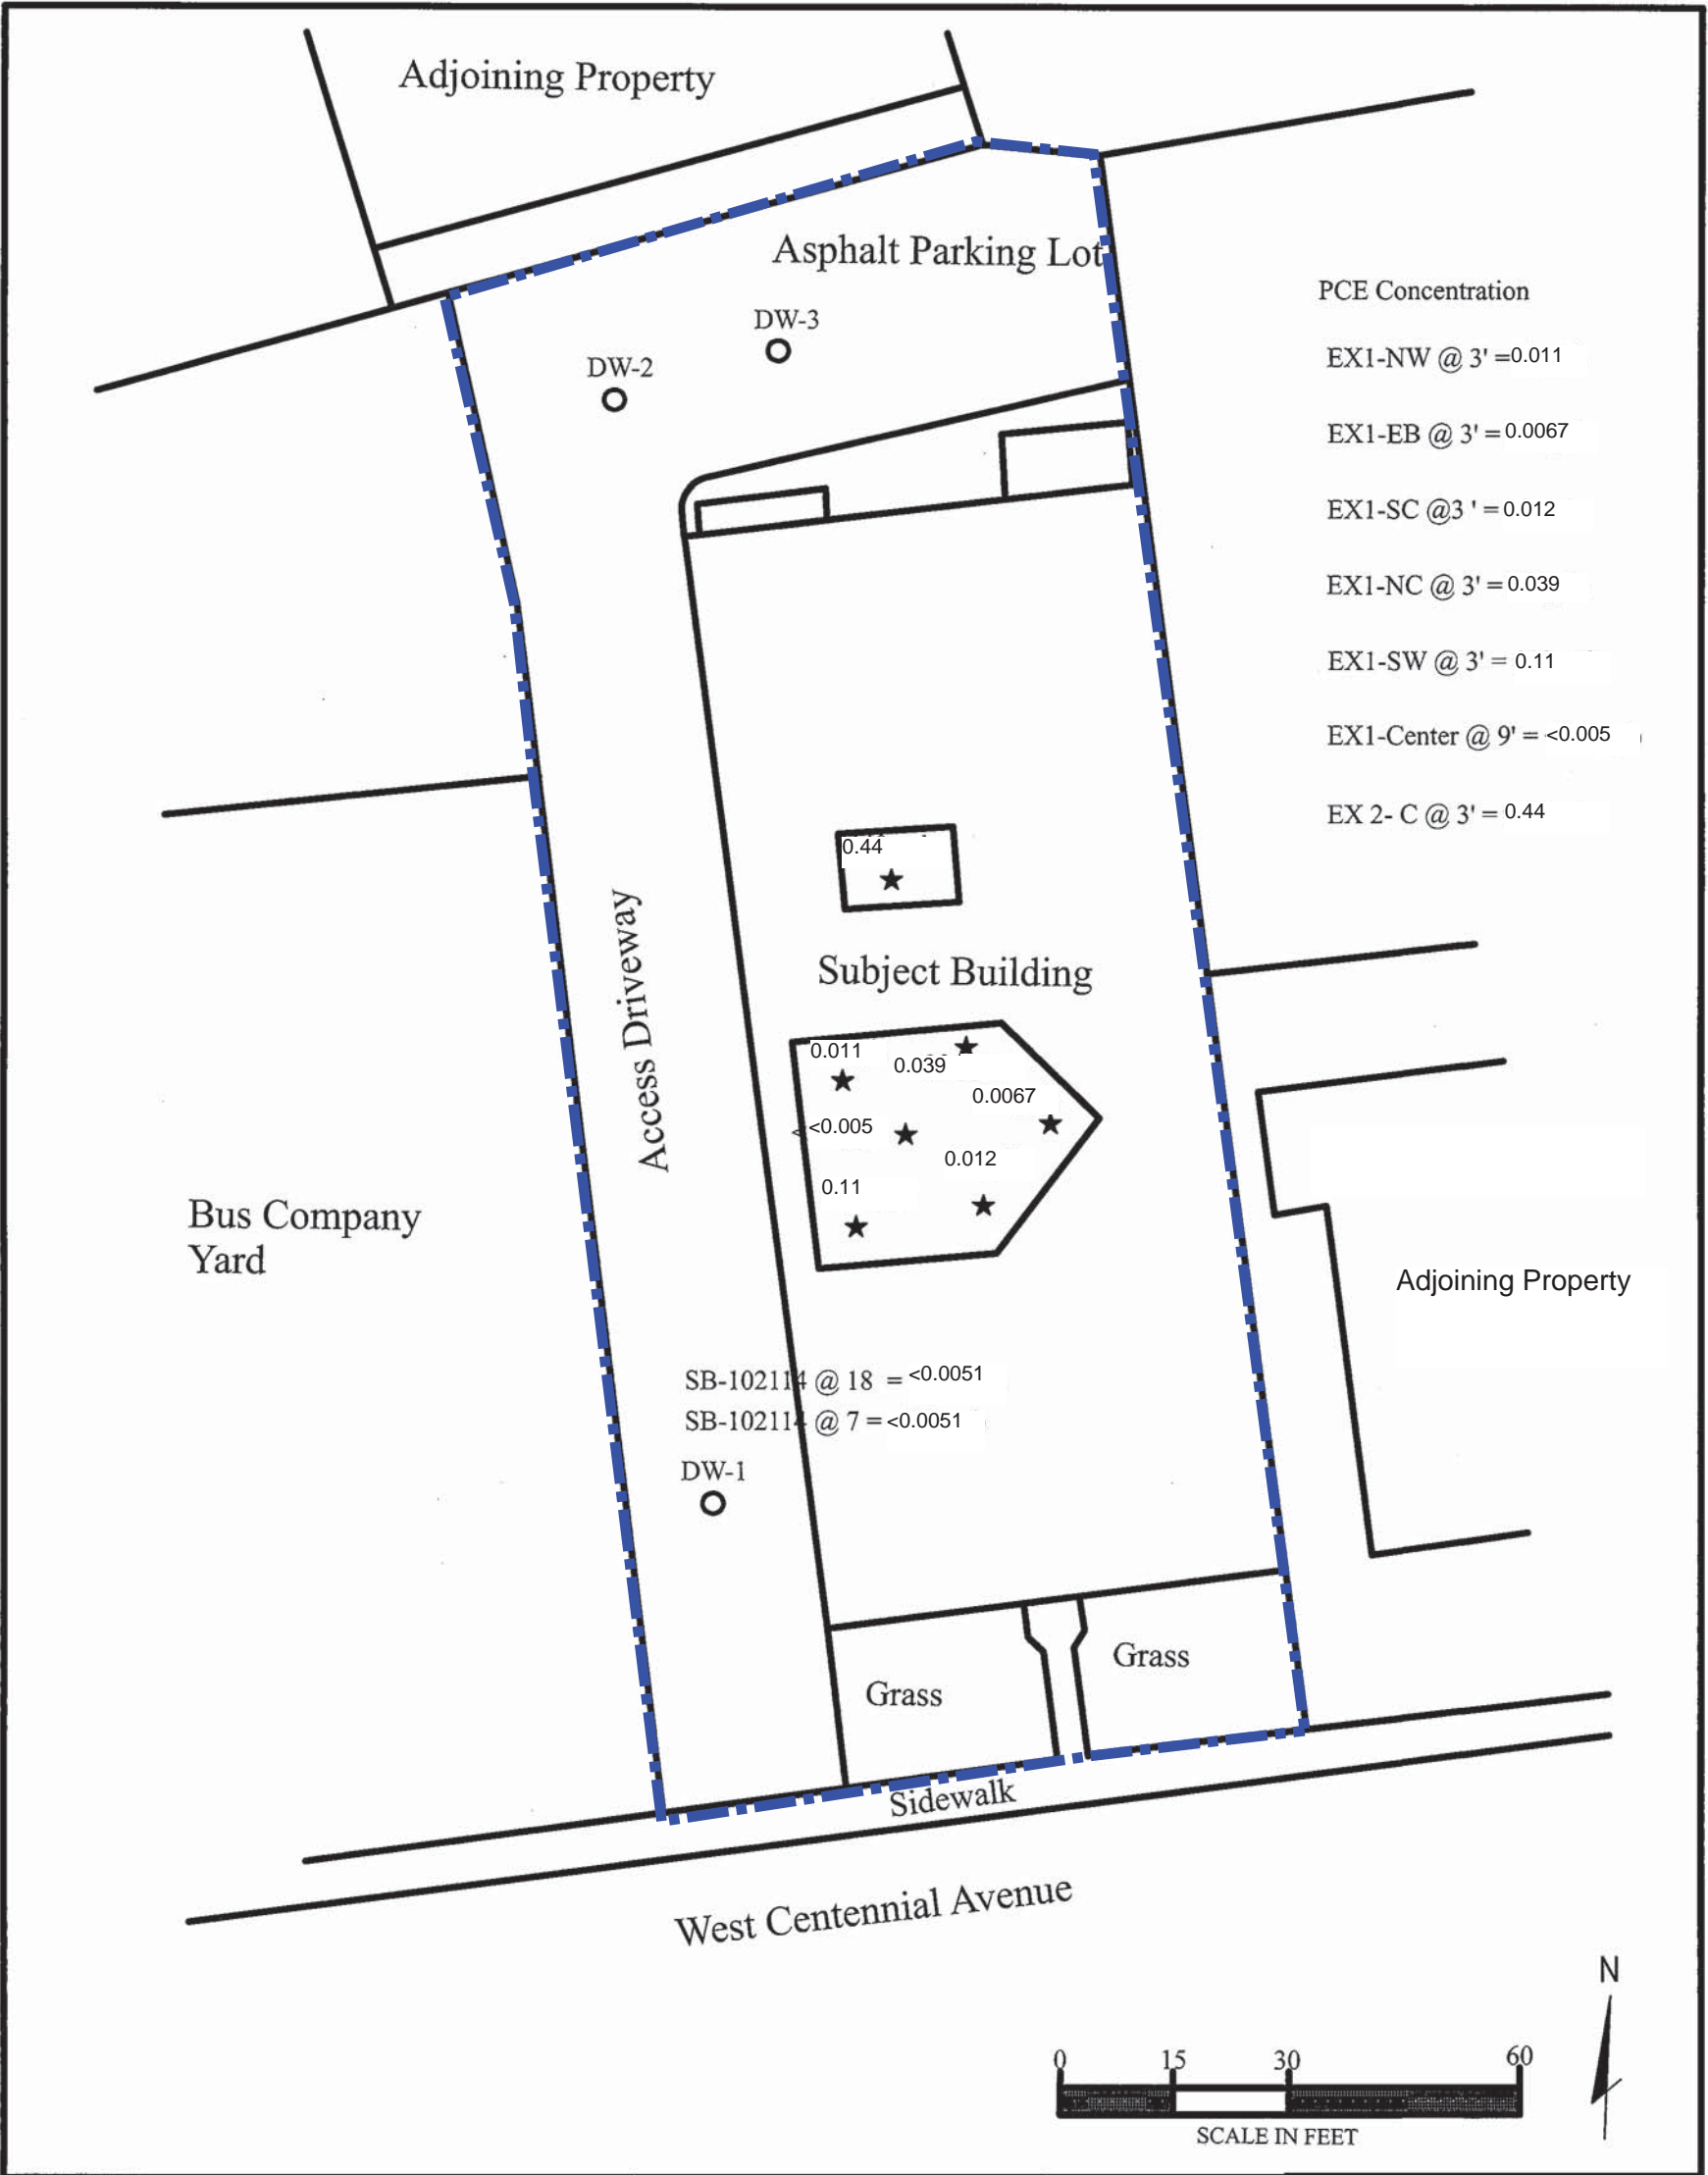
Department of Environmental Conservation	FIGURE 5 IRM Excavation Bottom Endpoint Sampling Results 20 WEST CENTENNIAL AVENUE ROOSEVELT, NEW YORK <small>LEA makes no guarantees to the accuracy of this drawing and it should only be used for informational purposes</small>	PROJECT NO.: 12-260	LEGEND
			DRAWING DATE: 8/24/12	
			DRAWN BY: BMC	— — — — — = Fence
			CHECKED BY: THJ	○ = open grate manhole
			REVISIONS: 10/08/12	★ = End point sample location with PCE concentrations in parts per million (ppm)
			REVISIONS:	
			SCALE: 1 : 30

In October 2014, the concrete floor was saw-cut by Laurel Environmental Associates, Ltd, on behalf of the PRP, at two locations within the on-site building, which represented the areas identified as containing the most heavily impacted soil. The first location was a 15' x 25' area in the central portion of the building ("Excavation 1"). The second location was an 10' x 10' area in the northwestern portion of the building ("Excavation 2"). Excavation 1 was completed to a depth of nine feet and Excavation 2 was completed to a depth of five feet, and approximately 50 cubic yards of impacted soil was removed and stockpiled for off-site disposal. Prior to backfilling the excavations, a total of seven endpoint soil samples were collected, PCE, TCE, cis-1,2-DCE and vinyl chloride were not detected in any of the samples at a concentration exceeding the New York State unrestricted use soil cleanup objectives (SCOs), the excavations were backfilled utilizing clean material and with clean fill. The excavations were backfilled to approximately 5" below the finished floor height to allow for replacement of the concrete floor. A new concrete slab was subsequently installed over the excavated areas.
