FORMER MILL NECK MARINA PROPERTY

FIGURE 5C
HISTORICAL SAMPLES
SUBSURFACE – MERCURY
FORMER MILL NECK
MARINA SITE
HERNAN AVE.
LOCUST VALLEY, NY
HRP# NEW9626.P2
SCALE: 1" = 60'

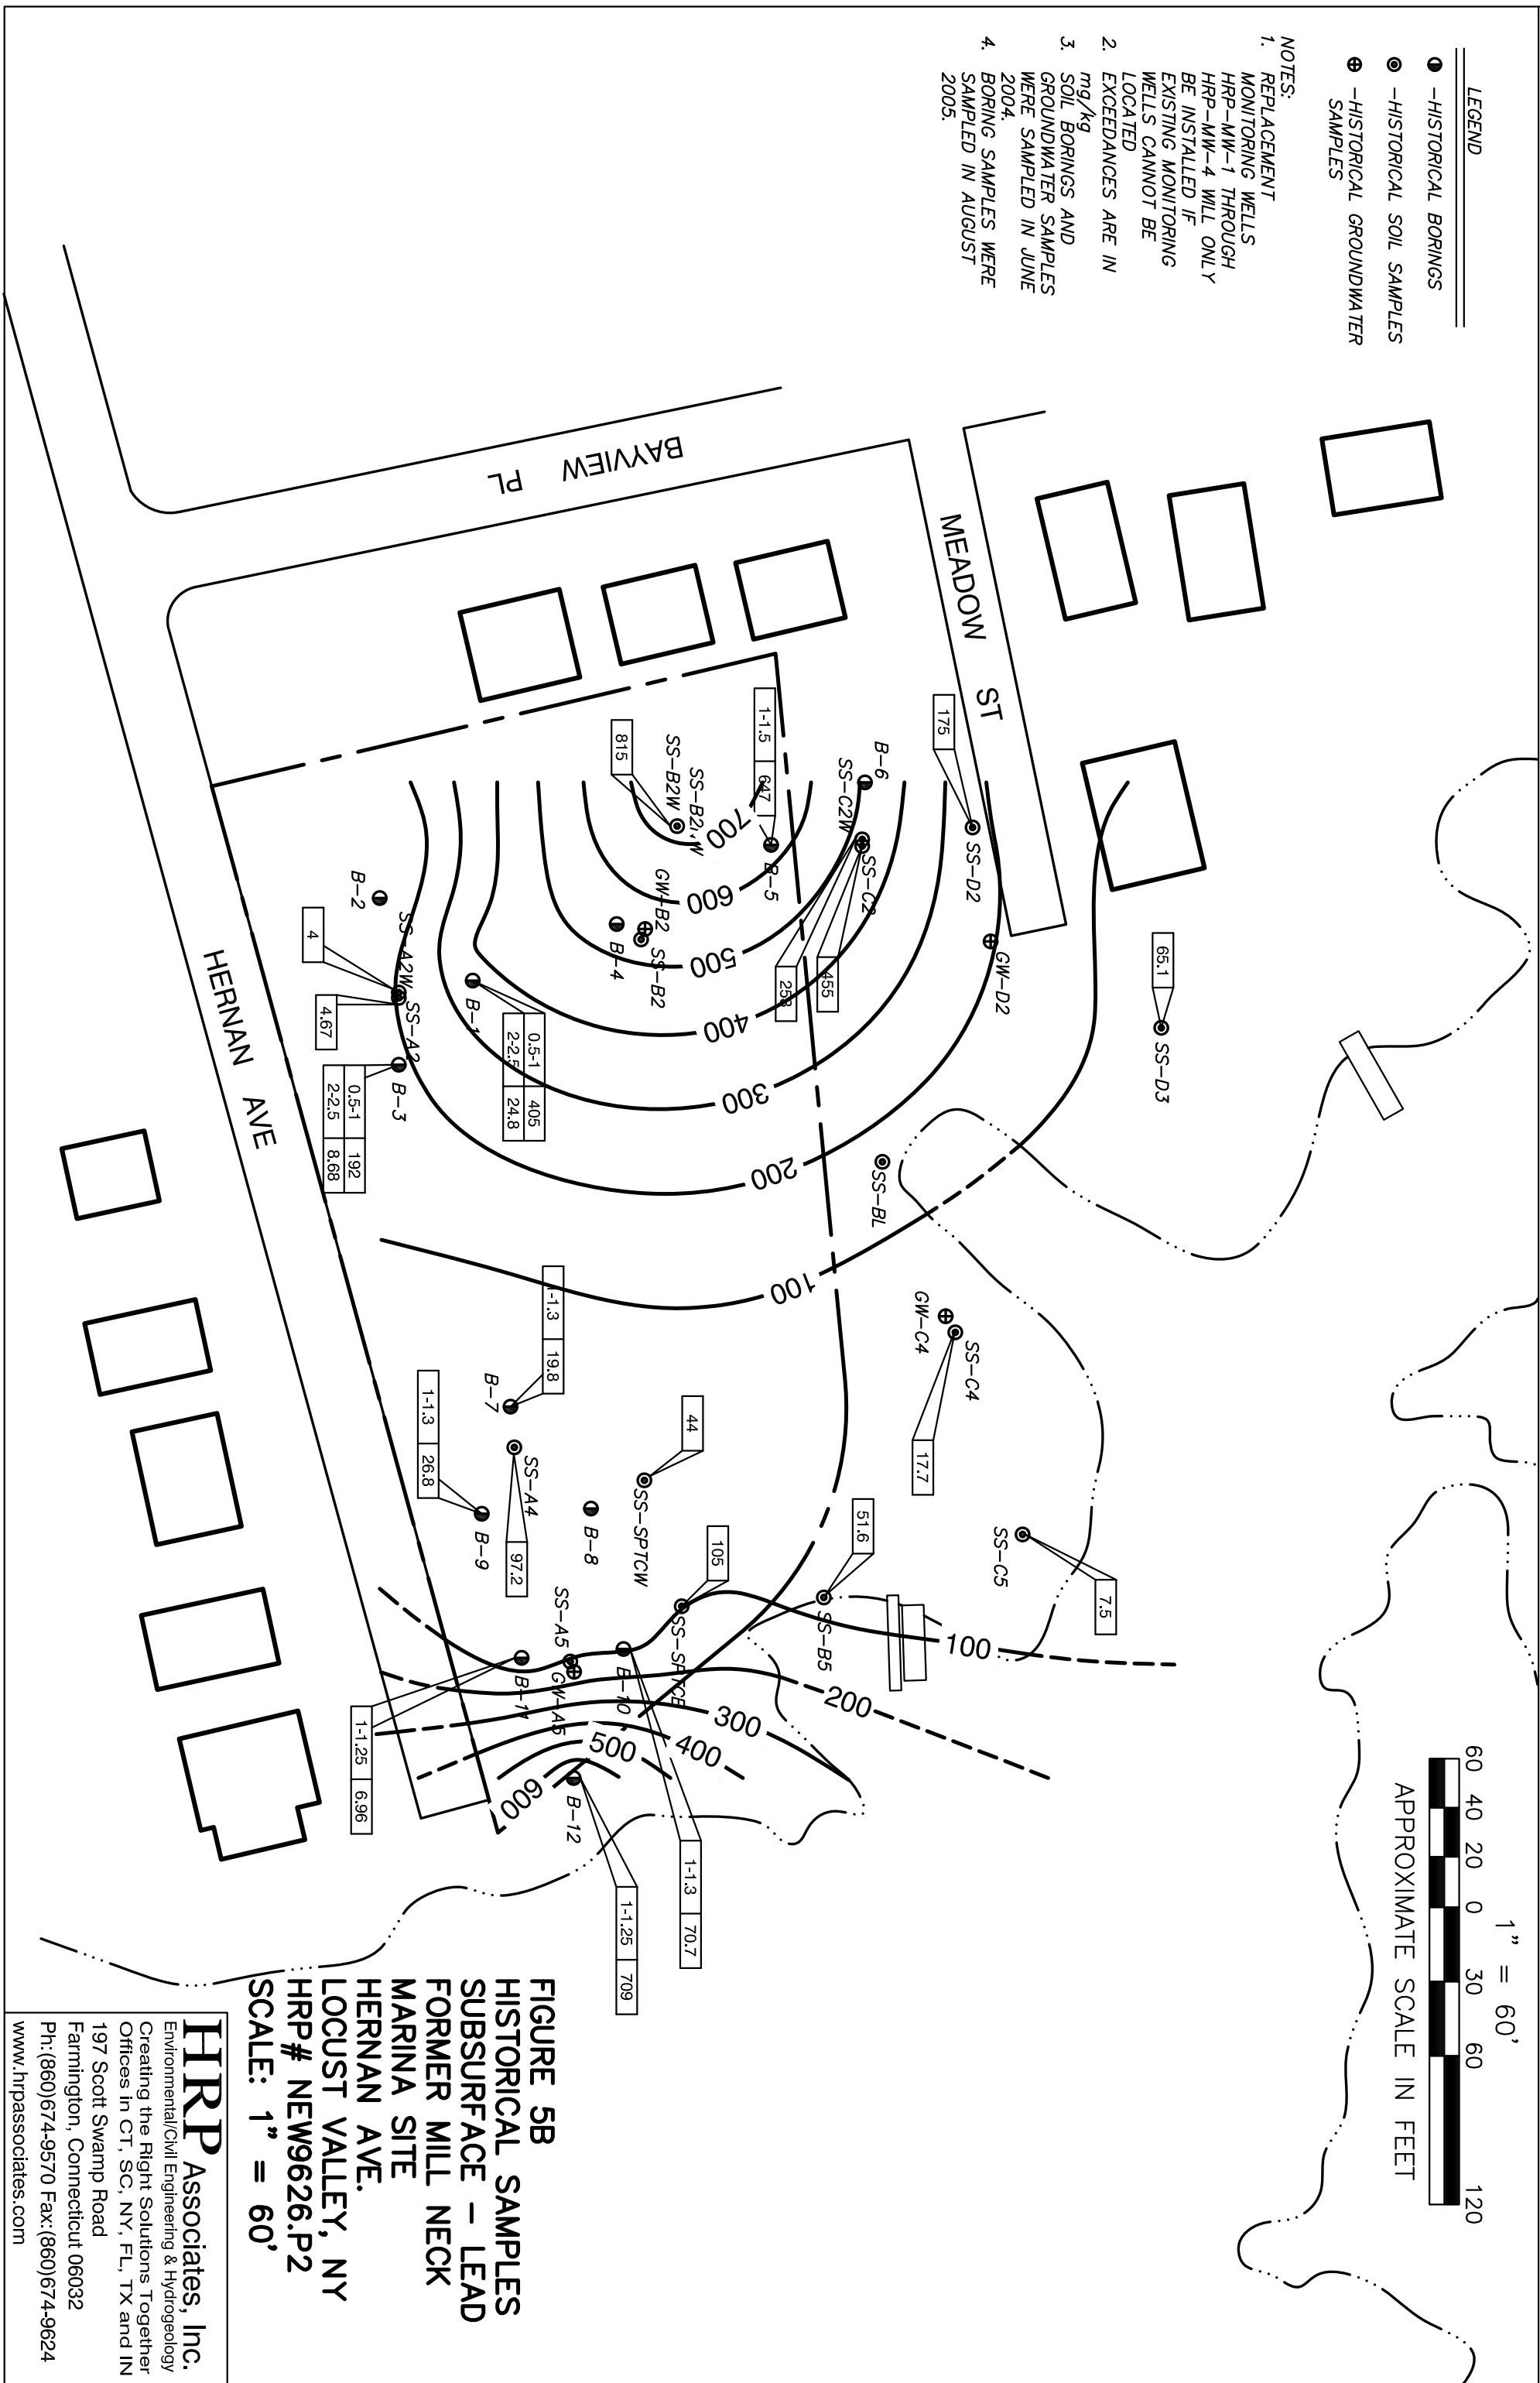
FIGURE 5B
HISTORICAL SAMPLES
SUBSURFACE - LEAD
FORMER MILL NECK
MARINA SITE
HERNAN AVE.
LOCUST VALLEY, NY
HRP# NEW9626.P2
SCALE: 1" = 60'

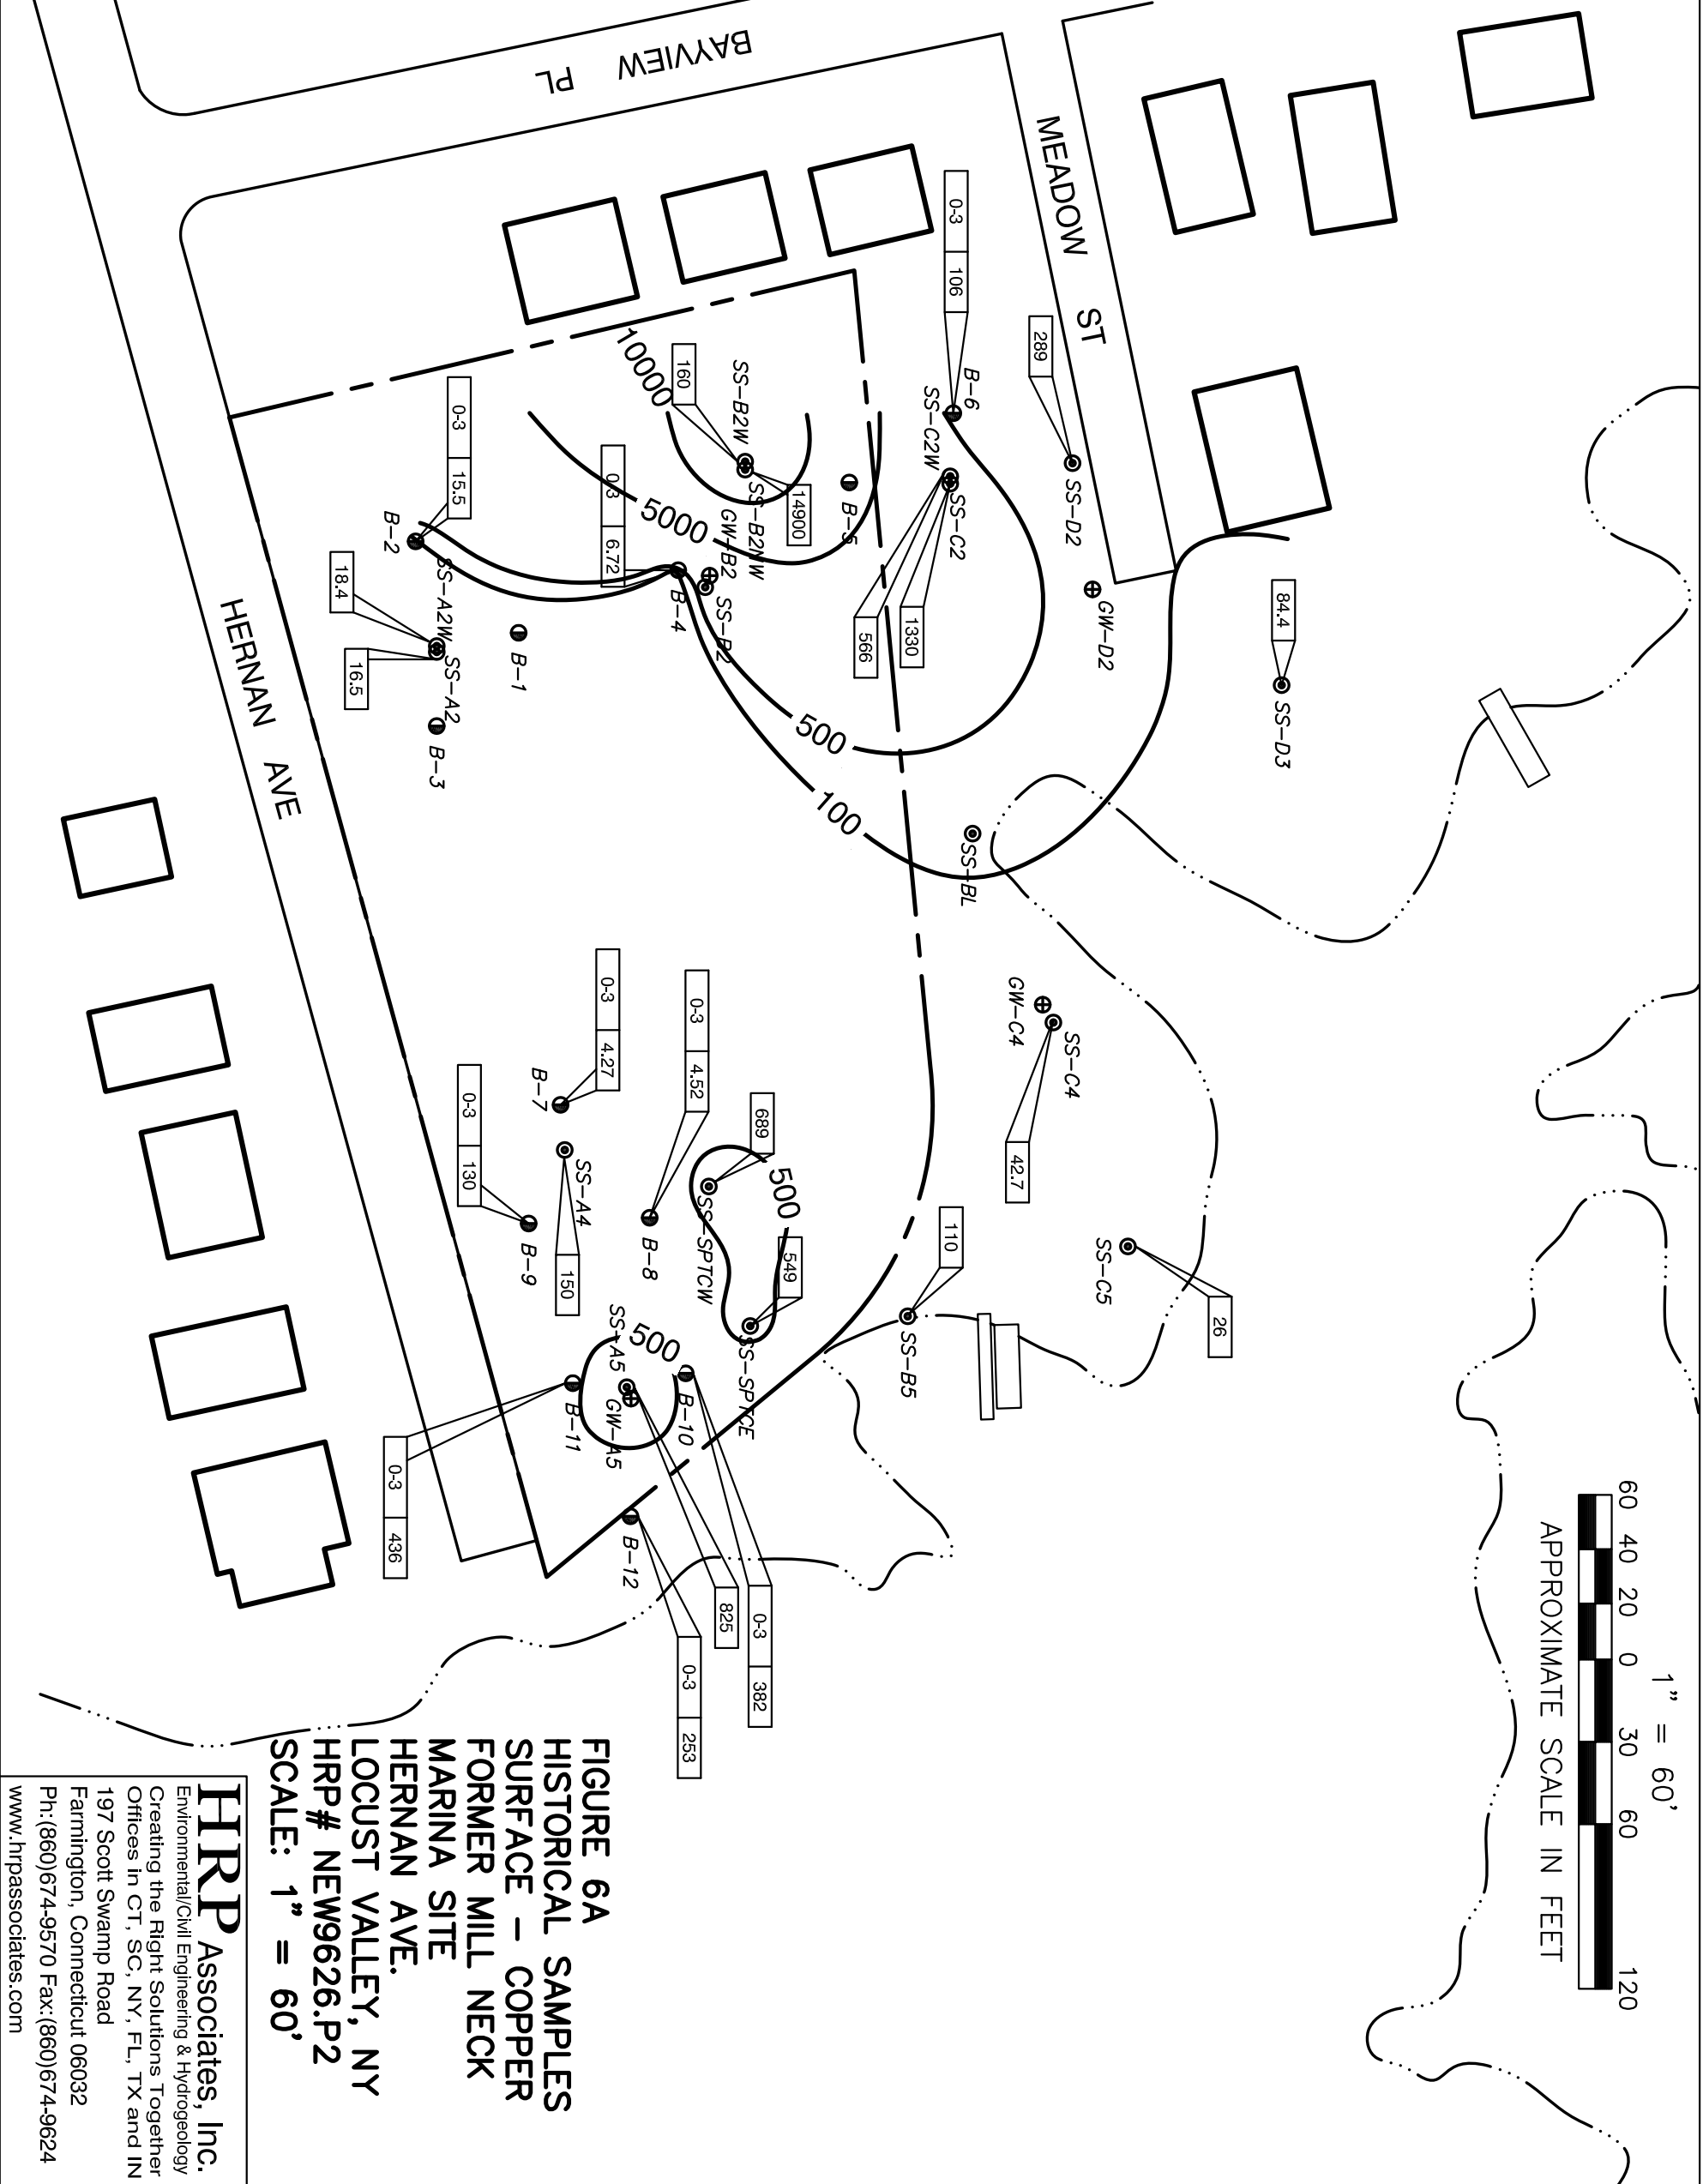
FIGURE 6A
HISTORICAL SAMPLES
SURFACE - COPPER
FORMER MILL NECK
MARINA SITE
HERNAN AVE.
LOCUST VALLEY, NY
HRP# NEW9626.P2
SCALE: 1" = 60'

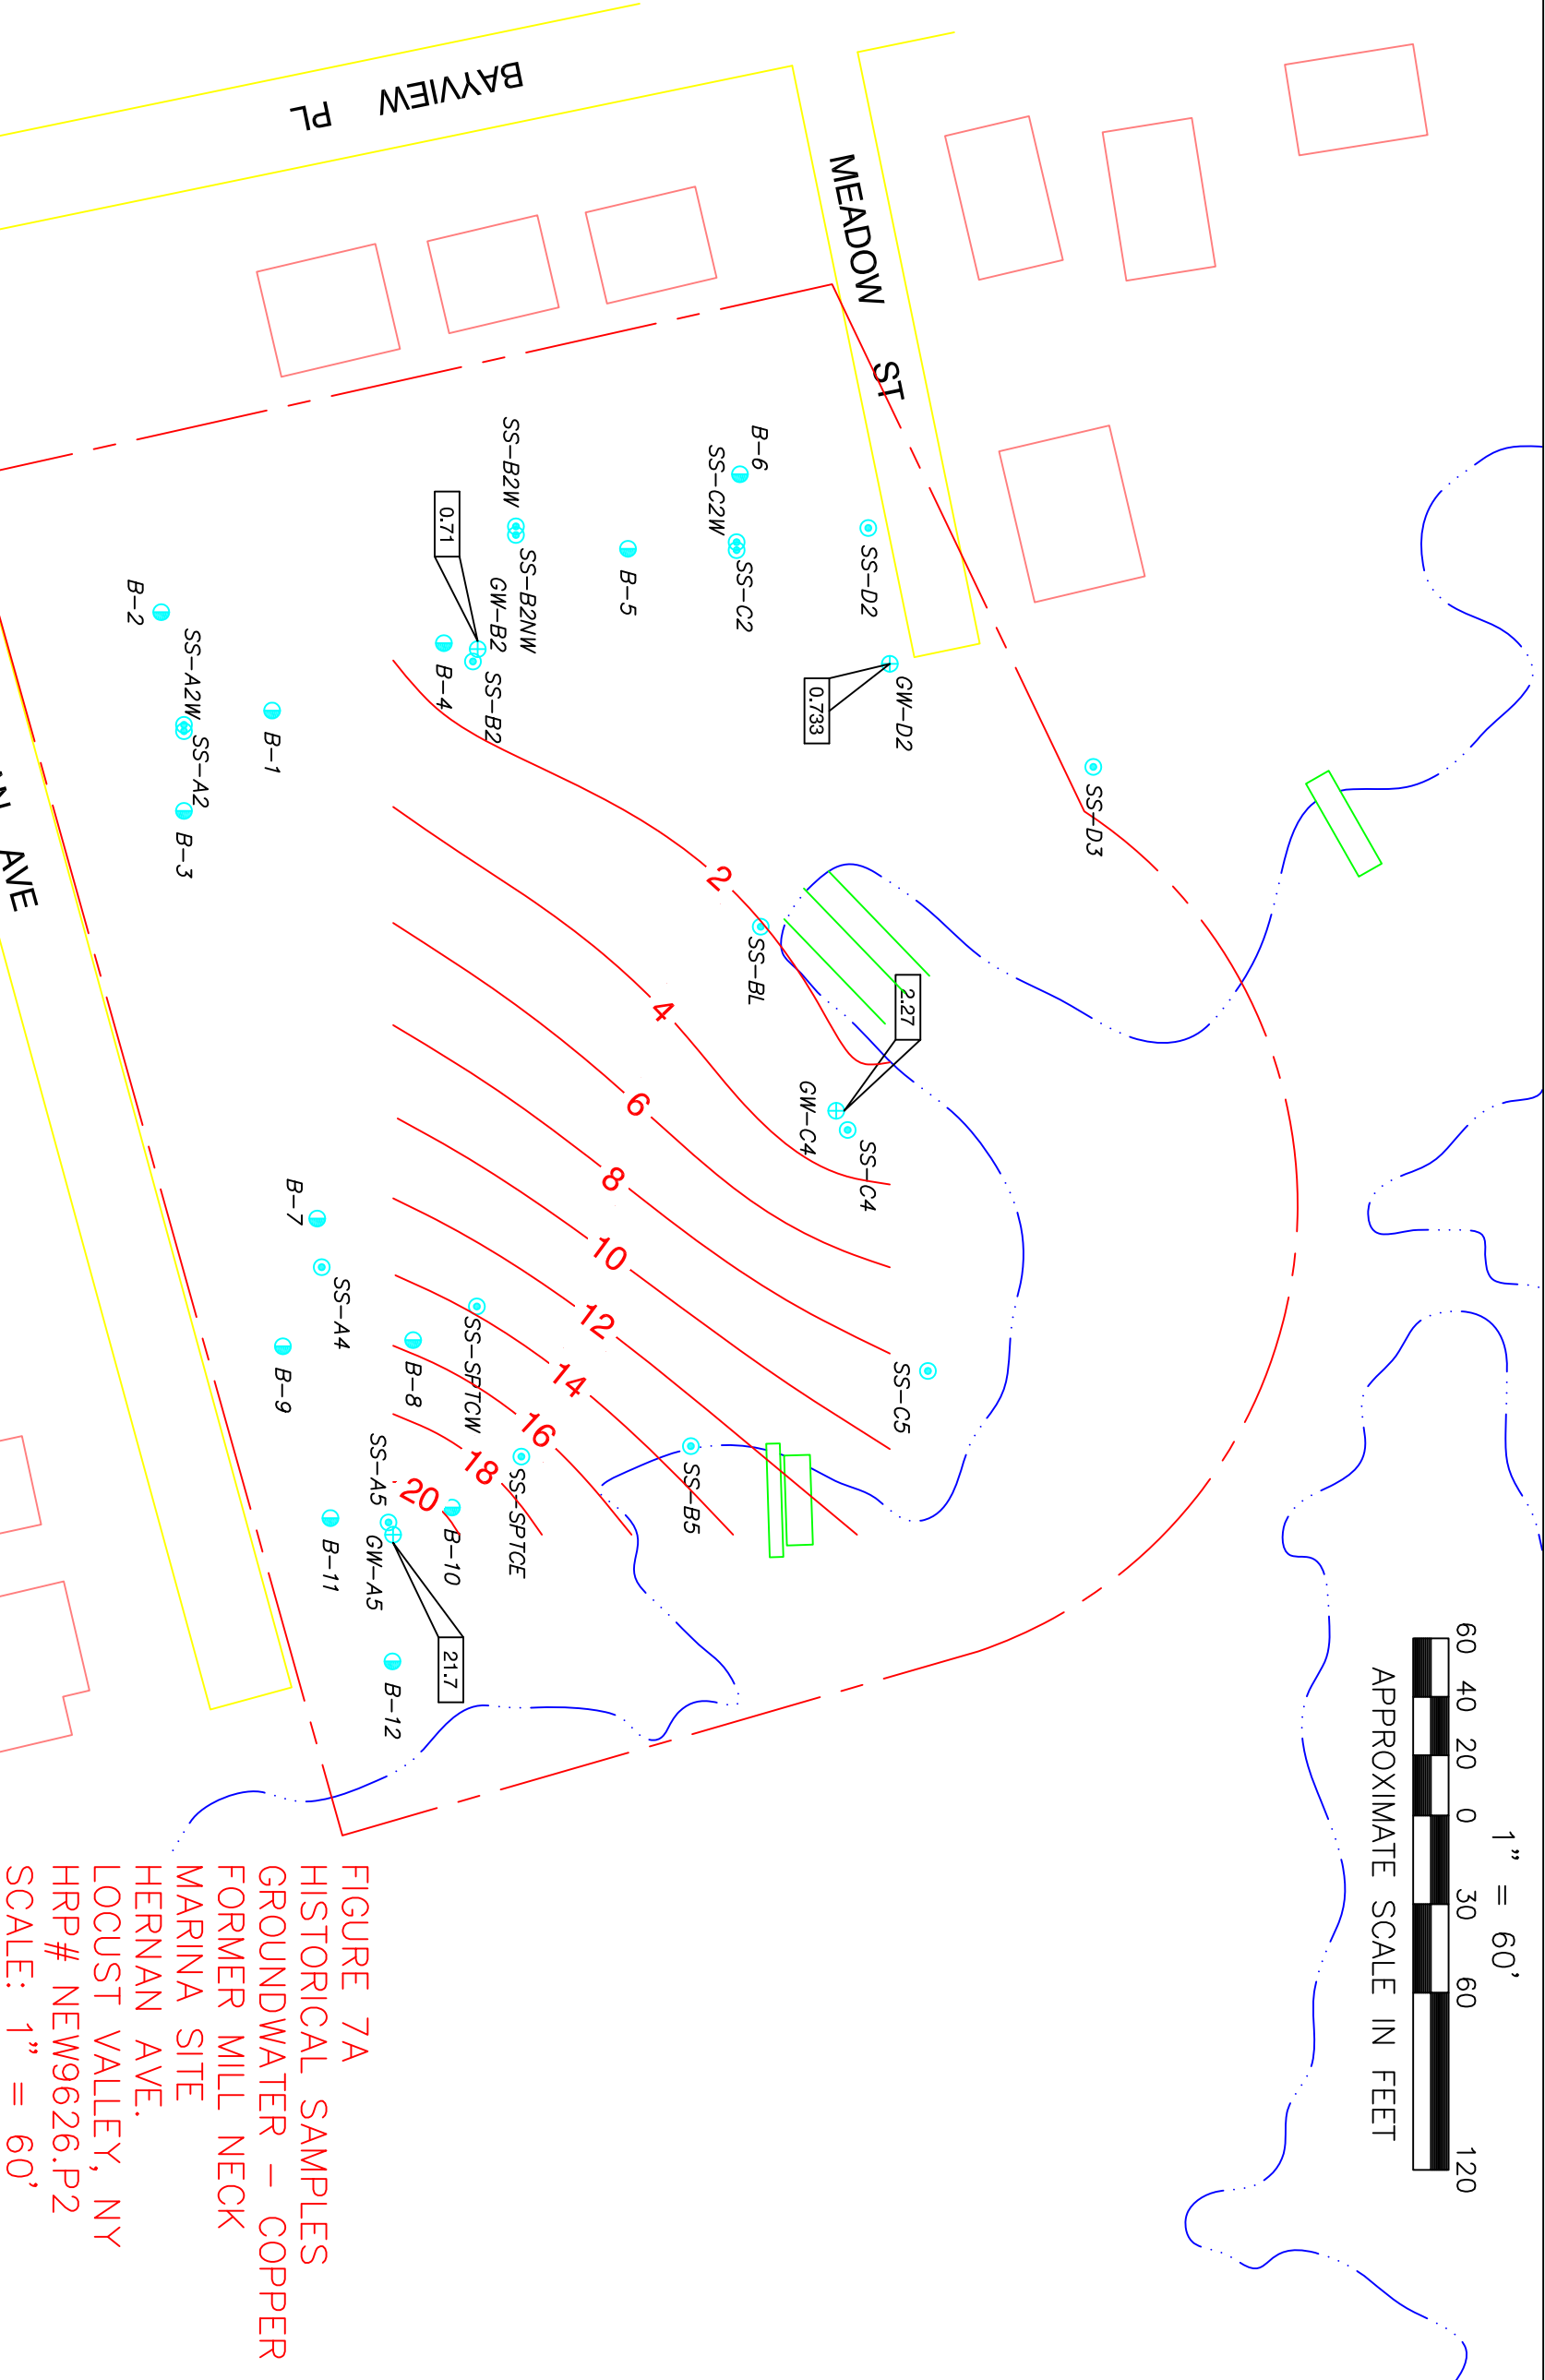
FIGURE 7A
HISTORICAL SAMPLES
GROUNDWATER – COPPER
FORMER MILL NECK
MARINA SITE
HERNAN AVE.
LOCUST VALLEY, NY
HRP# NEW9626.P2
SCALE: 1" = 60'
