# **REMEDIATION REPORT**

***71 Clinton Road  
Garden City, New York***

**October 2003**

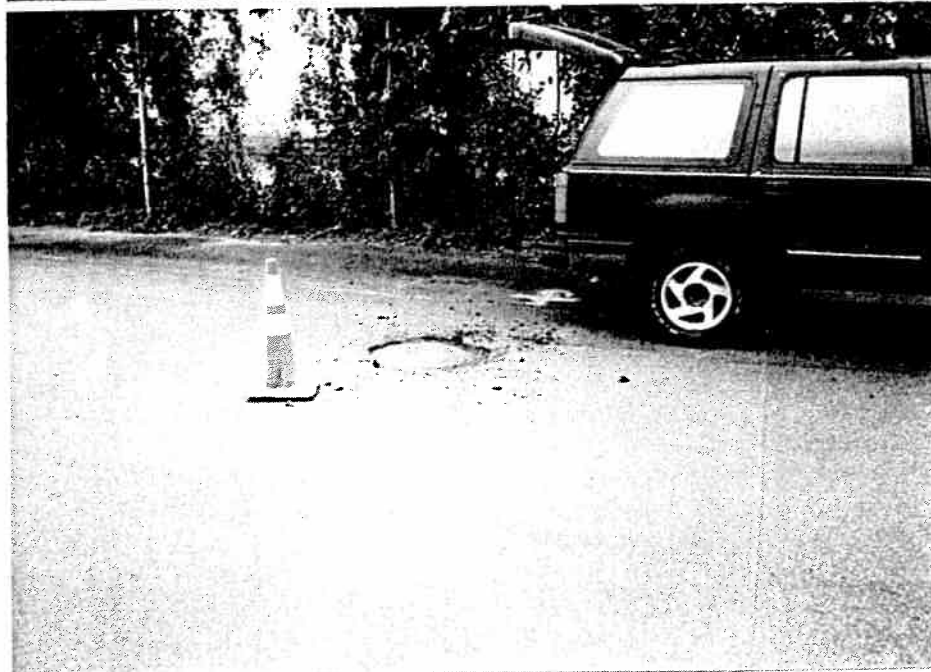
Photo 4: Former Cesspool

The results from the samples collected from the cesspools showed concentrations of metals and PAHs in excess of the RSCOs. Following discussions with the NCDOH, CEG subcontracted ECS to remediate the two cesspools. Both pools were initially approximately 26 feet deep and were dry. A hard, dark layer of sediment approximately six feet thick was removed by ECS from each former cesspool on October 23, 2002. Less dense, native sand was encountered under the layer of sediment. The excavated material was transported off site by RGM/Earthcare for disposal as non-hazardous waste. The waste disposal manifest is included as Appendix E.

The results of the endpoint samples indicated that the regulatory cleanup objectives had been achieved (i.e., there were no compounds detected in the samples above the RSCOs). Following NCDOH and USEPA approval, the cesspools were backfilled with clean sand by ECS. The manhole covers were subsequently removed by Action Remediation and permanently sealed with pre-cast concrete covers.

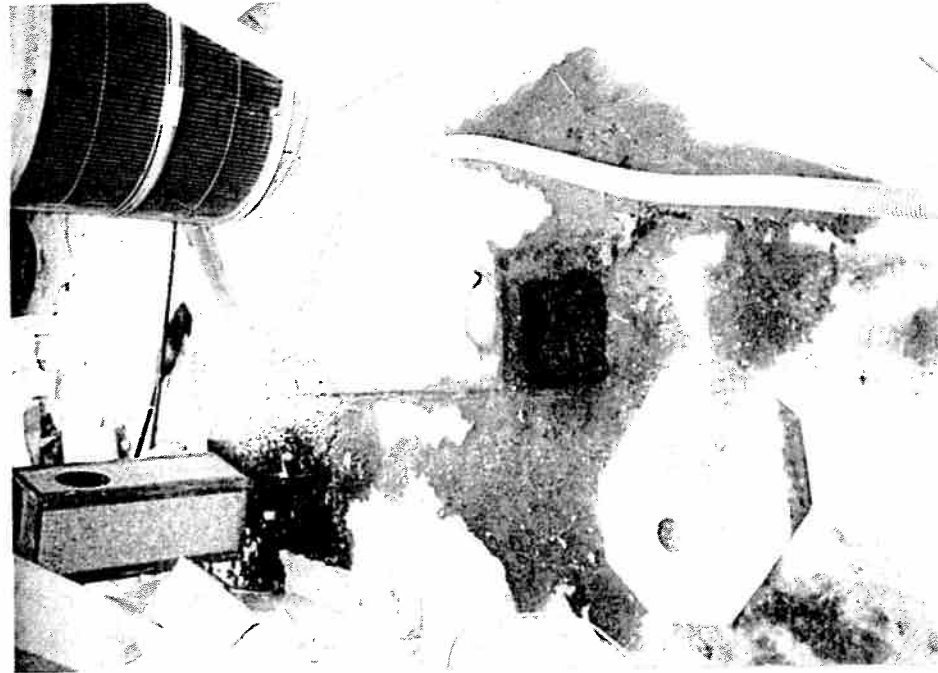
Photo 6: Floor Drain in Former Boiler Room

Following testing and tracing of the piping network associated with the former boiler room, CEG had the floor drains and the toilet drain sealed with concrete. As mentioned above, the former boiler blowdown pits were also sealed. The roof drains remain connected to drywell BDW-1.

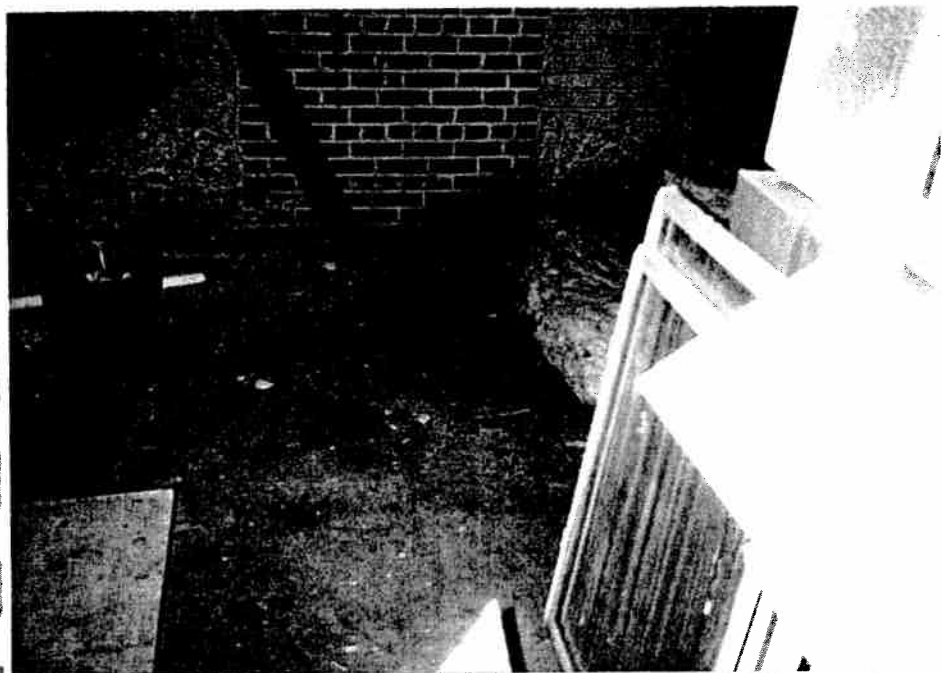
The two blowdown pits are located inside the former boiler room in Building No. 7. The initial samples collected from the pits by CEG on September 26, 2002 showed levels of SVOCs and metals above the New York State Recommended Soil Cleanup Objectives (RSCOs). Total petroleum hydrocarbons (TPH) were also detected in both samples. The results are summarized in Table 1 and the laboratory analytical report is included as Appendix B.

Photo 7: Blowdown Pit in Former Boiler Room

Photo 8: Blowdown Pit in Former Boiler Room

During October 2002, the blowdown pits were excavated by ECS to the extent feasible using hand tools (i.e., shovels and pails) and a "super sucker" vacuum guzzler with an extended hose hoisted through the open window. Approximately 1 cubic yard of soil was removed. Post-remediation samples were collected from each pit. The levels of mercury detected in the post-remediation samples from pits BDP-1 and BDP-2 were 1.75 parts per million (ppm) and 1.03 ppm, respectively. The laboratory report for the blowdown pit post-remediation samples is included as Appendix C and the results are summarized in Table 1.

Mercury was not detected in either of the samples collected by CEG. Based upon the sampling results and discussions with the NCDOH, both pits were abandoned in place by filling them completely with clean fill from an off site source. The openings in the floor for the former pits were sealed with concrete.

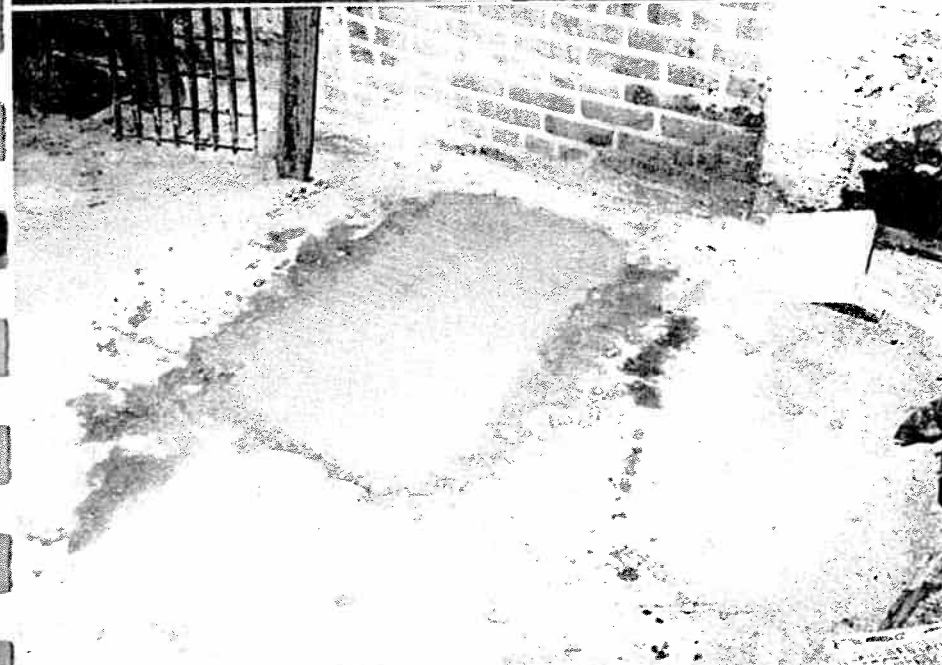
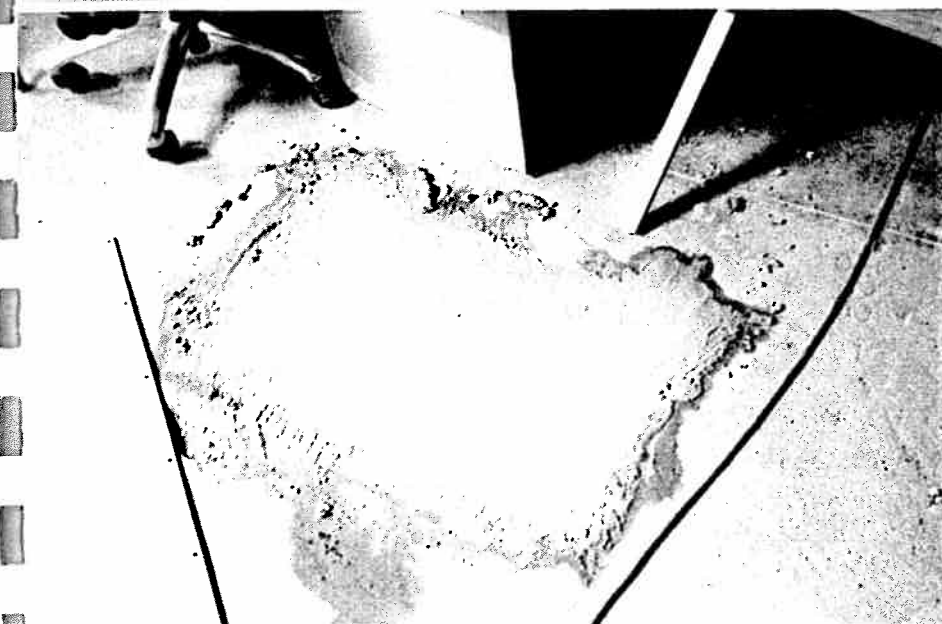
Photo 9: Sealed Blowdown Pit

Photo 10: Sealed Blowdown Pit

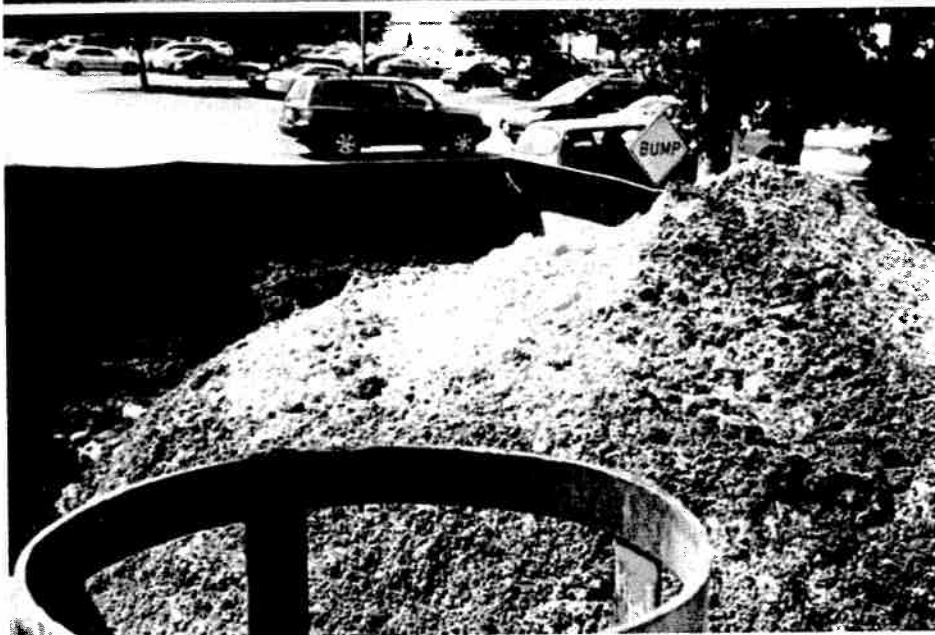
CEG collected post-excavation samples from the pools following removal of sediment to the extent practicable using the guzzler. A hard, layer of dark-stained sediment in CP/LP-1 could not be retrieved by the guzzler. The results from the endpoint samples collected by CEG are presented in Table 4. The laboratory results are presented in Appendix M.

Photo 13: Sediment From Leaching Pool

Based upon discussions with the NCDOH, CEG agreed to further remediate leaching pool CP/LP-1. CEG had Action use an orange-peel shovel to break up and remove the hard layer of dark sediment from the pool on September 11, 2003. Less than 2,000 gallons of water were vacuumed from the pool prior to sediment excavation (Appendix N). Action removed approximately 5 cubic yards of additional sediment and indigenous soil was encountered at the bottom of the pool. CEG collected an endpoint sample that was analyzed for VOCs and metals with the agreement of the NCDOH. The results of the final endpoint sample from CP/LP-1 are included in Table 4 and the laboratory report is provided in Appendix O.

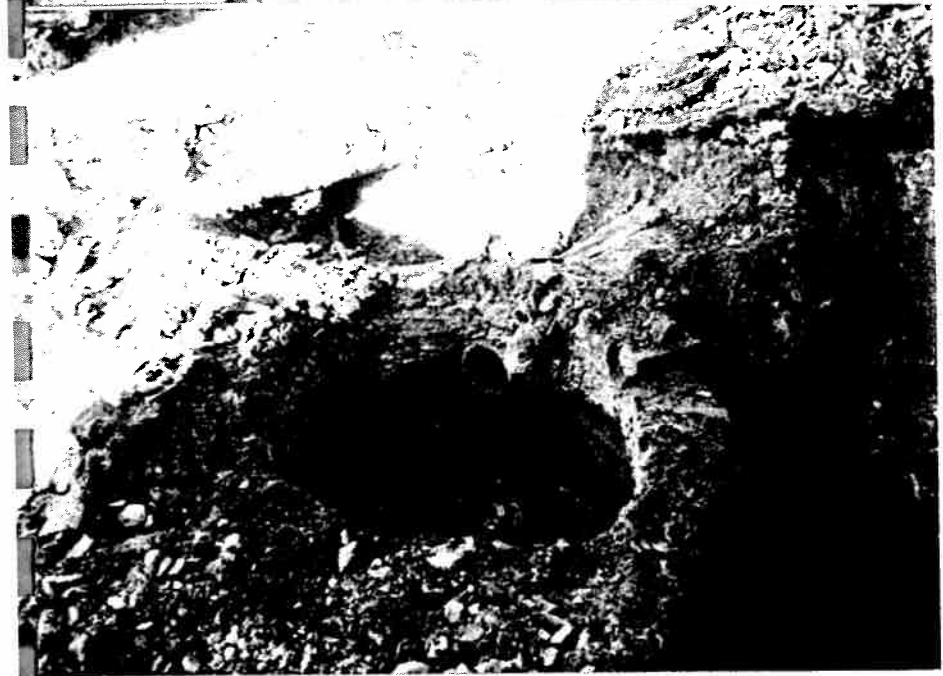
Photo 15: Distribution Pool Sidewalls

CEG collected four sidewall samples (N DP-1, S DP-1, E DP-1 and W DP-1) and a bottom sample (B DP-1) from the excavation. The samples were also screened with a photo-ionization detector (PID). In accordance with discussions with the NCDOH, CEG submitted the samples for metals. The three samples exhibiting the highest PID readings were also submitted for laboratory analysis for VOCs. The laboratory report is included as Appendix I. The analytical results are summarized in Table 2.
