**First Quarter 2020  
Quarterly Monitoring Report  
Former Zoe Chemical Site  
1801 Falmouth Avenue  
New Hyde Park, New York  
Site No. 1-30-211**

**April 2020**

Re: **Quarterly Monitoring Report—First Quarter 2020**  
**Former Zoe Chemical Site**  
**1801 Falmouth Avenue, New Hyde Park, N.Y.**  
**NYSDEC Site No.: 1-30-211**

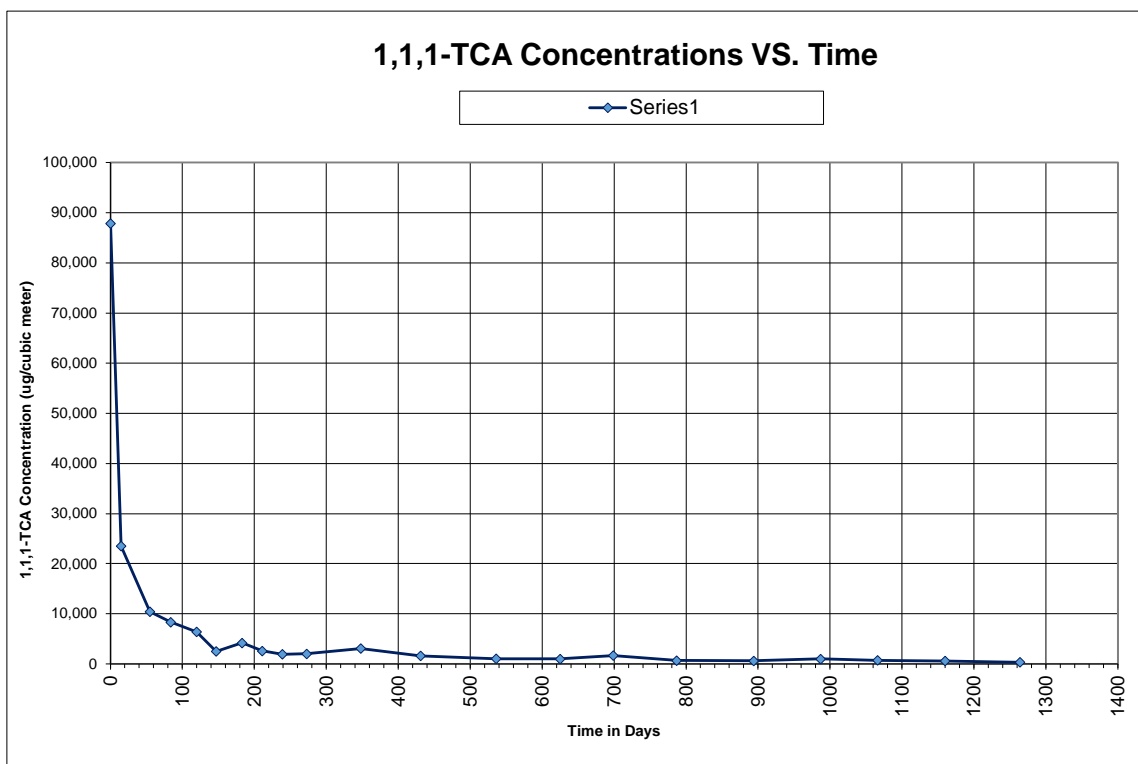
Table 2

**Untreated Soil Vapor** – The first soil vapor sample collected from the system was conducted on September 21, 2016. The initial untreated soil vapor sample contained a TCA concentration of 87,800 ug/m<sup>3</sup>. At the end of the fourth quarter 2016, the concentration of TCA was 8,350 ug/m<sup>3</sup>. At the end of the fourth quarter 2017, the concentration of TCA was 1,630 ug/m<sup>3</sup>. At the end of the fourth quarter 2018, the concentration of TCA was 693 ug/m<sup>3</sup>. At the end of the fourth quarter 2019, the concentration of TCA was 589 ug/m<sup>3</sup>. The most recent sample collected on March 31, 2020, detected a TCA concentration of 381 ug/m<sup>3</sup>.

Results of the untreated soil vapor sampling program are summarized on Table 2. In addition, plots of the laboratory results versus days in operation are included.
