Re **Soil Remediation Report**
Deutsch Relays Site #152003
65 Daly Road, East Northport, NY
FPM File No. 977-22-107 (04)

**FIGURE 1
SOIL REMEDIATION RESULTS**

FORMER DEUSCH RELAYS SITE
65 DALY ROAD
EAST NORTHPORT, NEW YORK

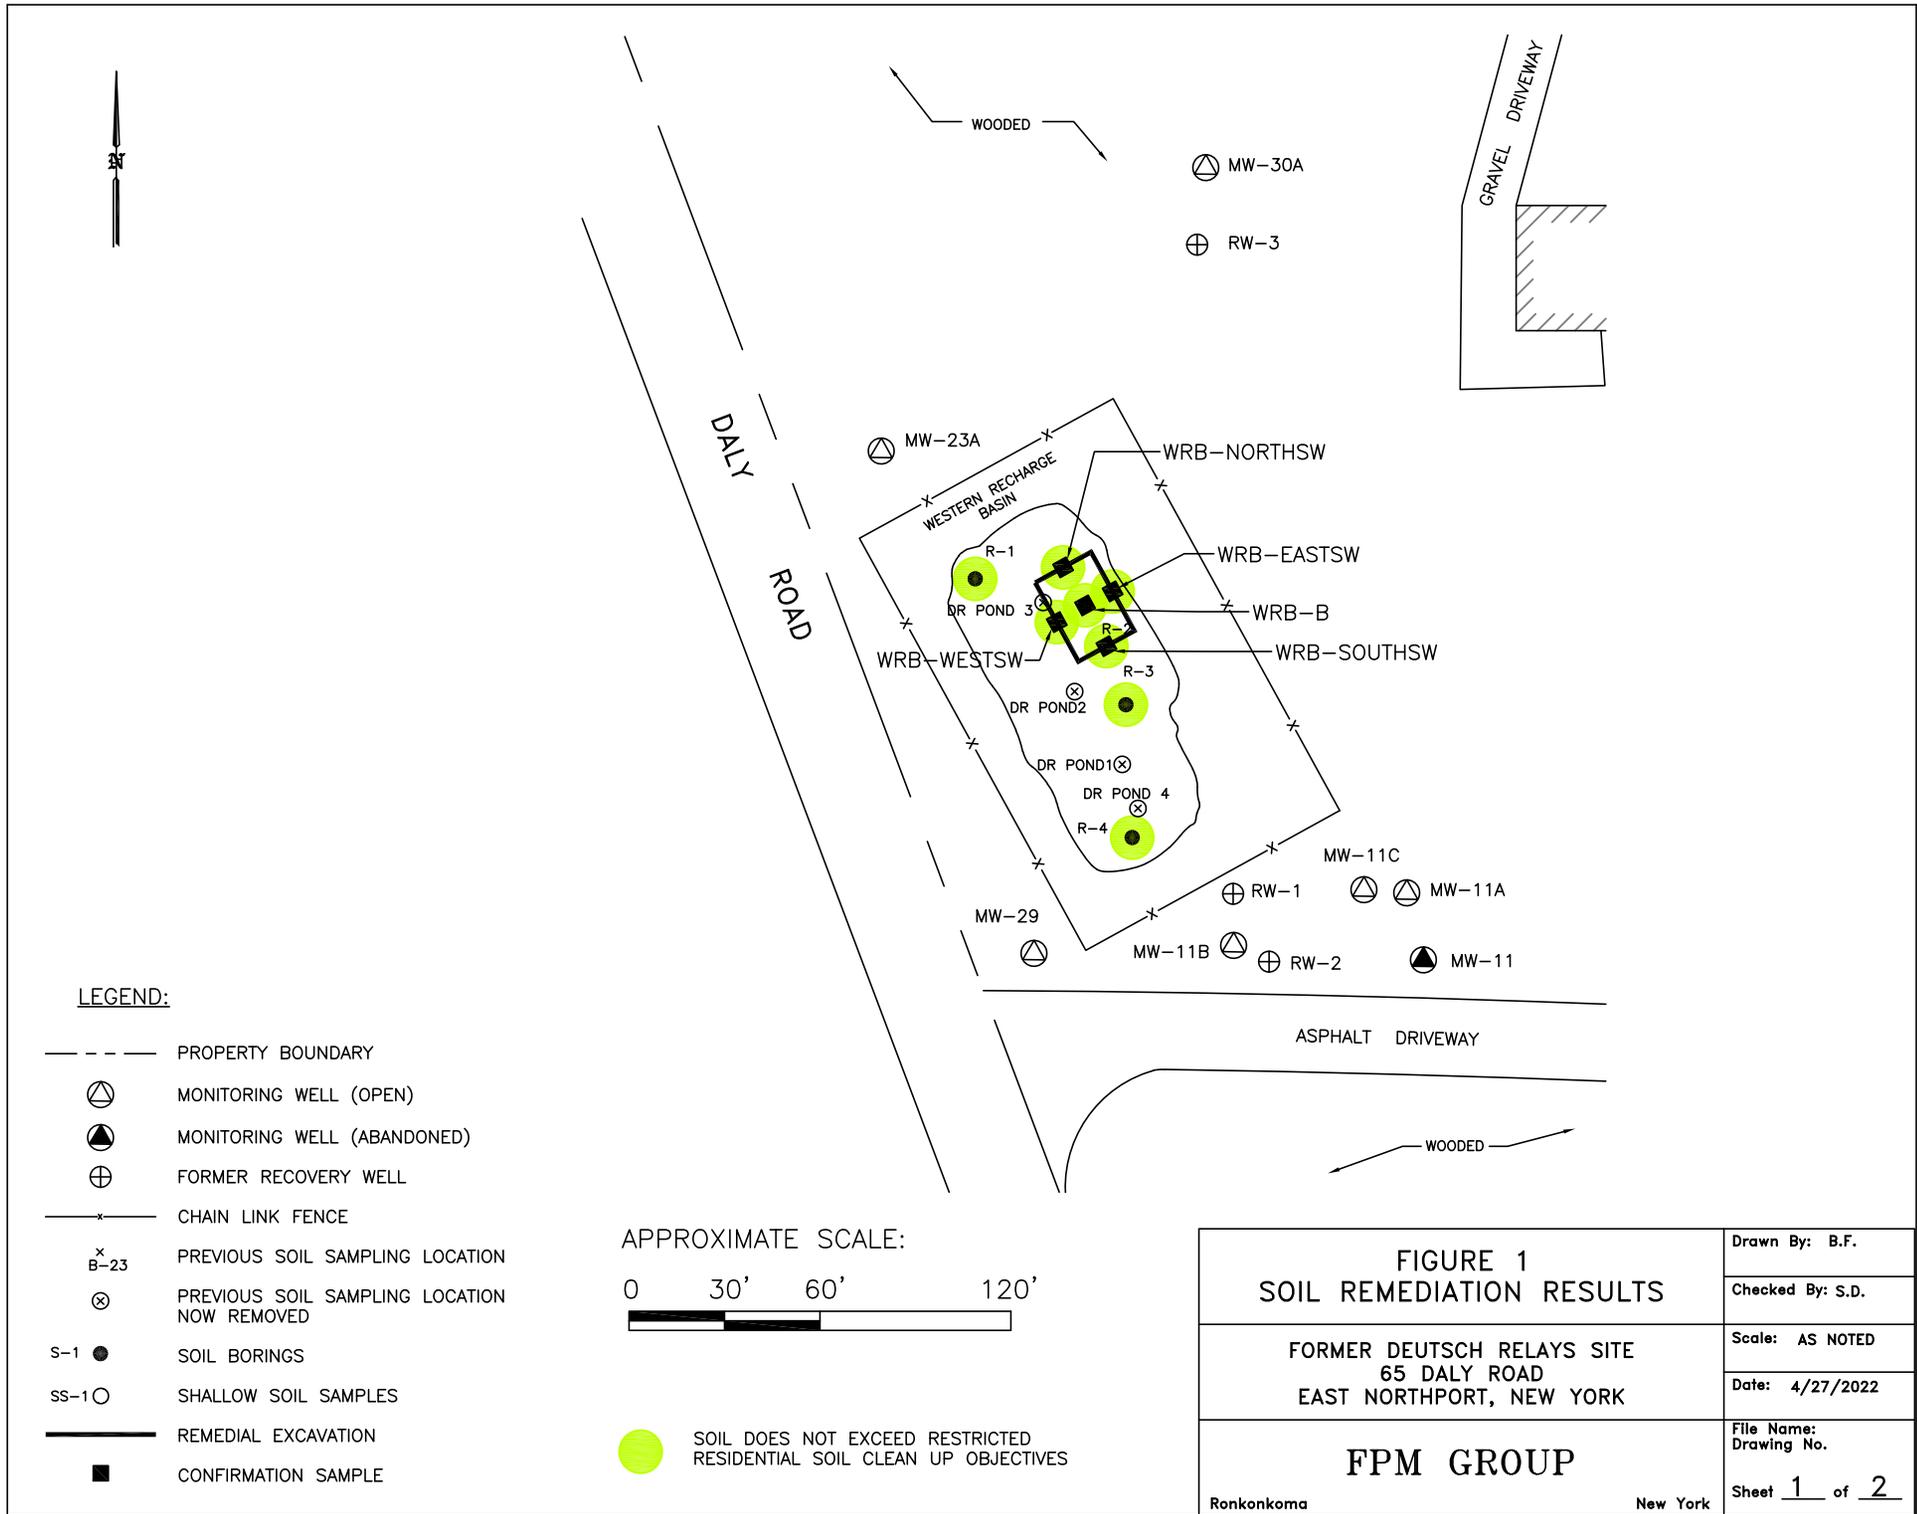
● SOIL DOES NOT EXCEED RESTRICTED RESIDENTIAL SOIL CLEAN UP OBJECTIVES

The remedial areas are shown on the attached Figures 1 and 2. A photolog documenting the remedial activities is included in Attachment A.

As shown on Table 1 (attached) the results from the confirmatory samples did not exhibit any exceedances of the NYSDEC SCOs for restricted residential use in any of the remedial areas. These results are consistent with the QEP's excavation observations and screening results during excavation activities. The data assessment documented in the DUSR indicates that the data may be relied upon for assessment of the completion of soil remediation.

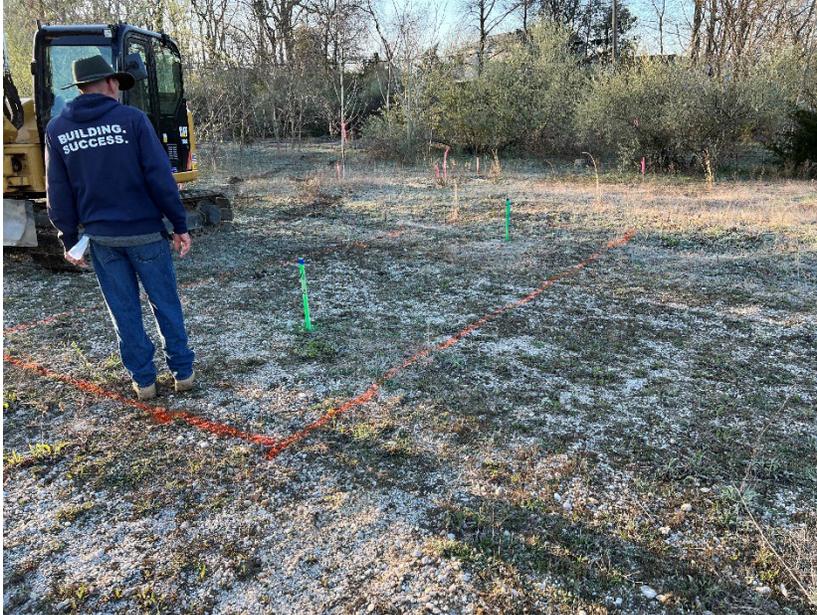
Below: The former boring locations were surveyed and staked and each soil remediation area was clearly marked prior to the start of excavation.

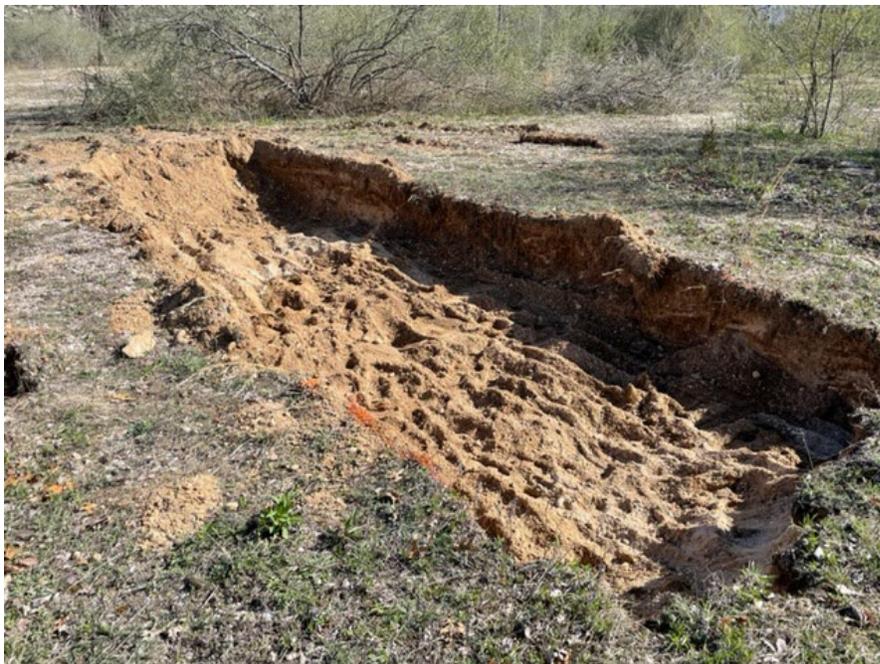
Below: Excavated area of former locations #1 and #2, beneath former plating shop floor.

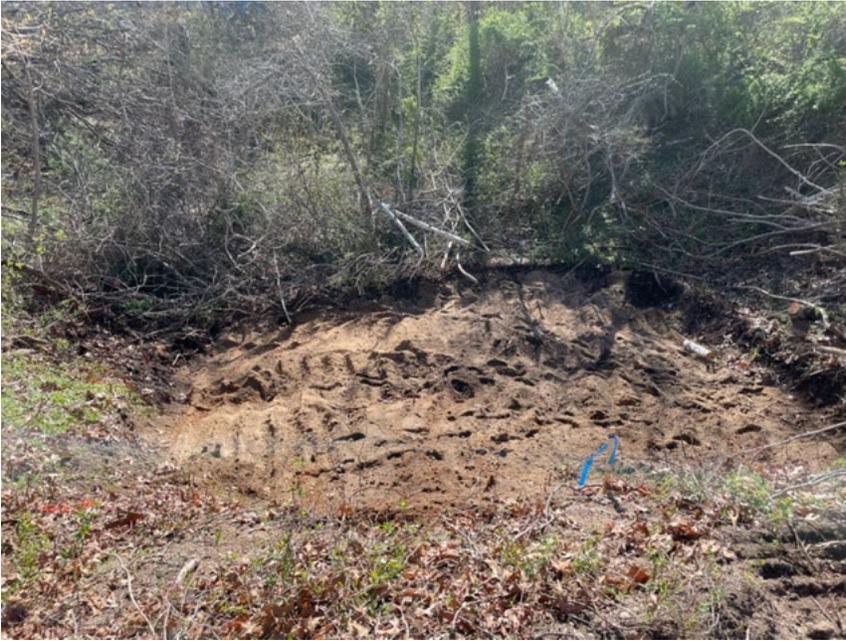
Below: Former northeastern recharge basin area (R-5 location) after excavation.

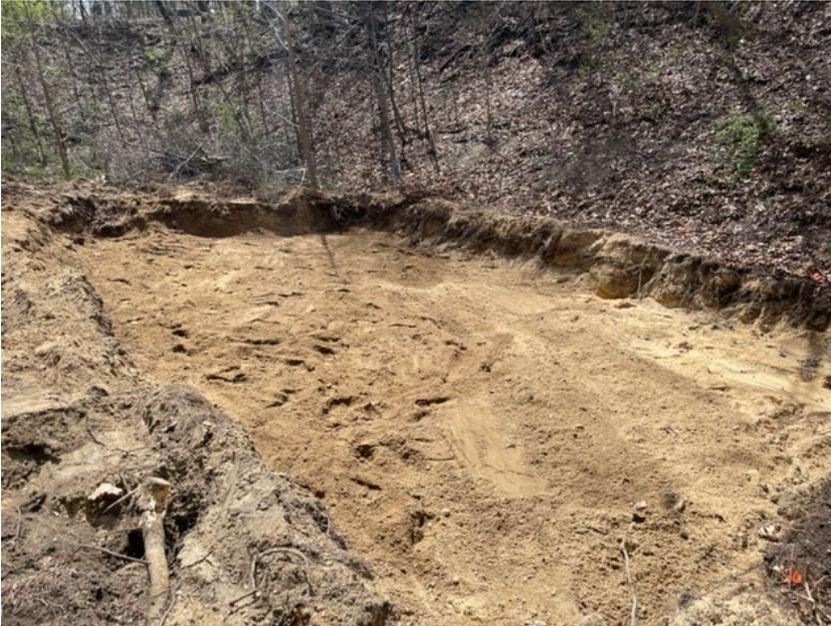
Below: Completed excavation in the western recharge basin (former R-5 location).

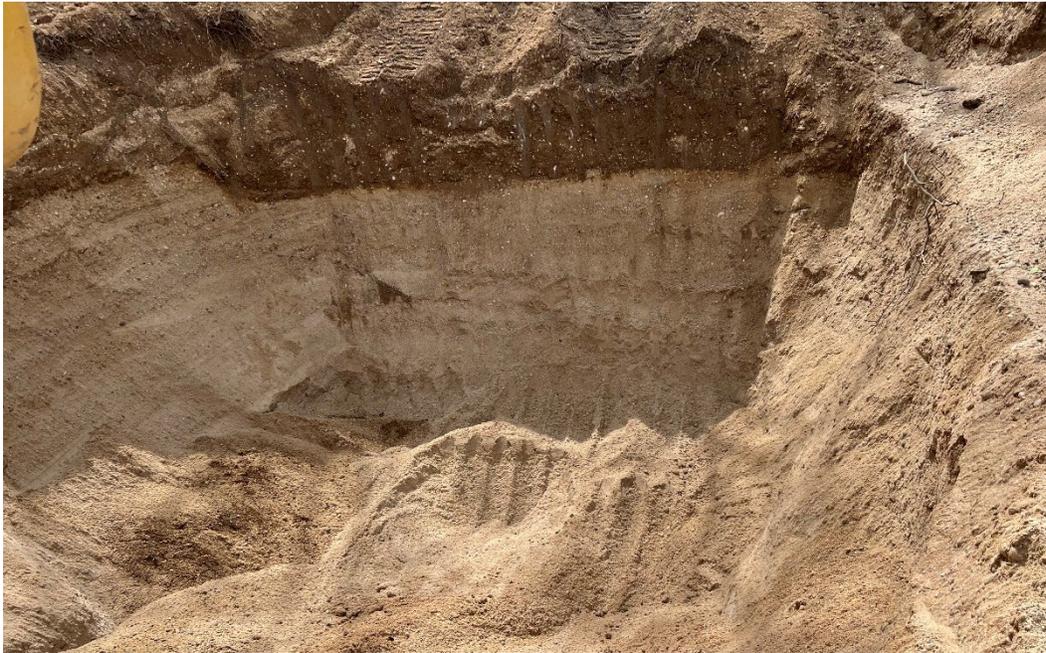
Below: The completed excavation in the former sludge drying beds area (former S-16 location).

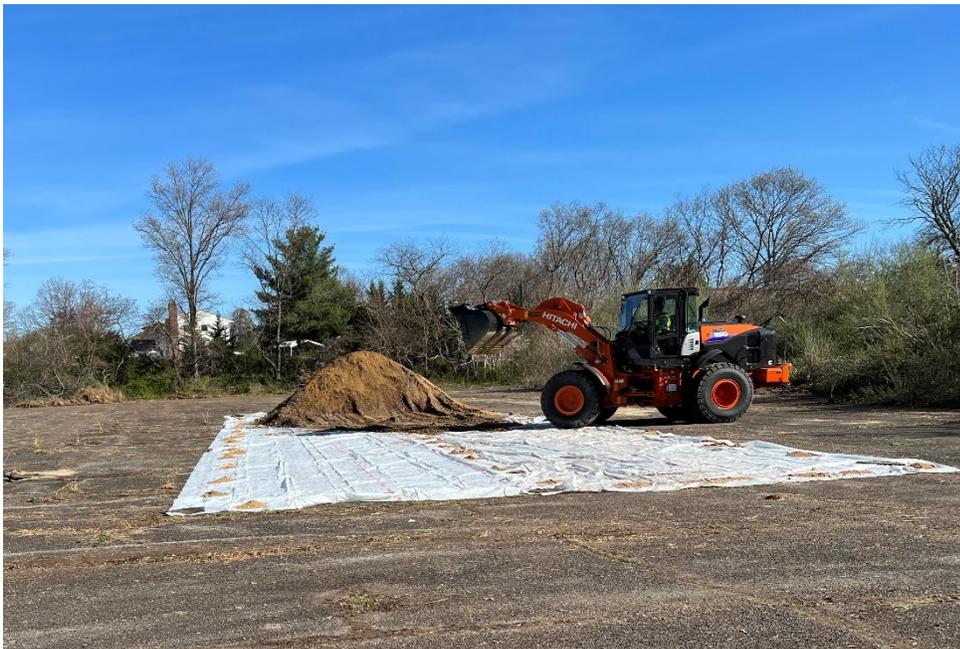
Below: The excavated soil was staged in the former parking lot area on poly sheeting and was covered by poly sheeting pending loadout.

As the remedial areas were somewhat distant from each other and difficult to access via truck, a central stockpile area was established where the excavated soil from each remedial area could be staged in an accessible location for loading. The stockpile area was set up in the former employee parking lot, which is fully paved, and the selected location was away from storm drains. Poly sheeting was placed on the pavement and all soil removed from the excavations was transported to this location, placed on the poly sheeting, and covered by poly sheeting pending loading.

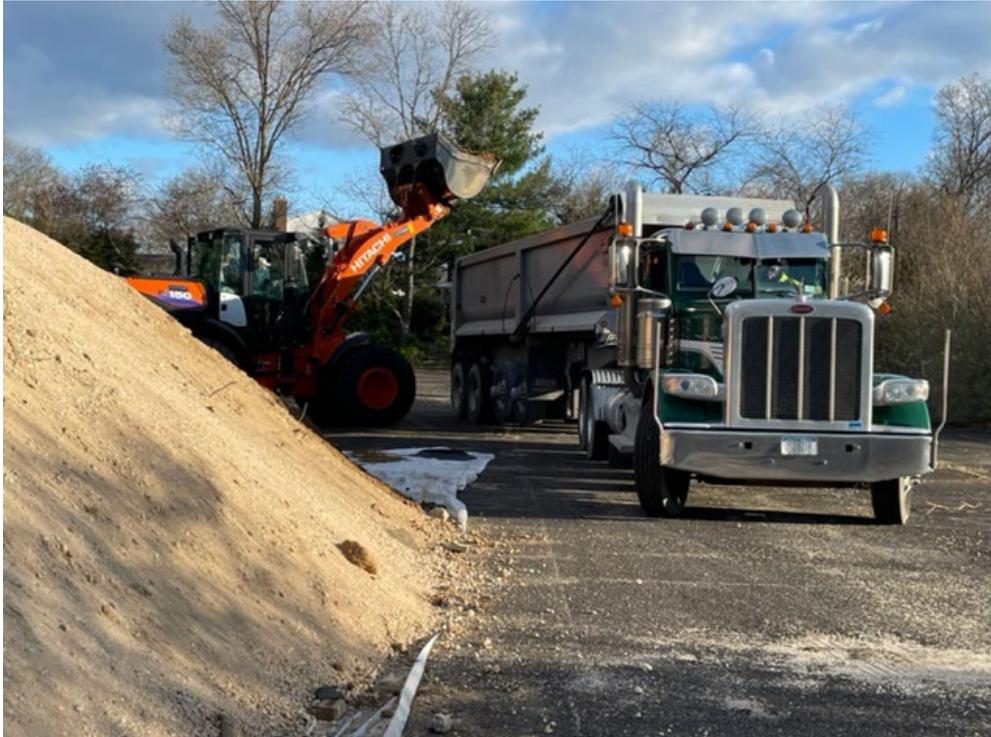
Below: Loadout of stockpiled soil onto Bove Industries truck for transport to Posillico Wash Plant.

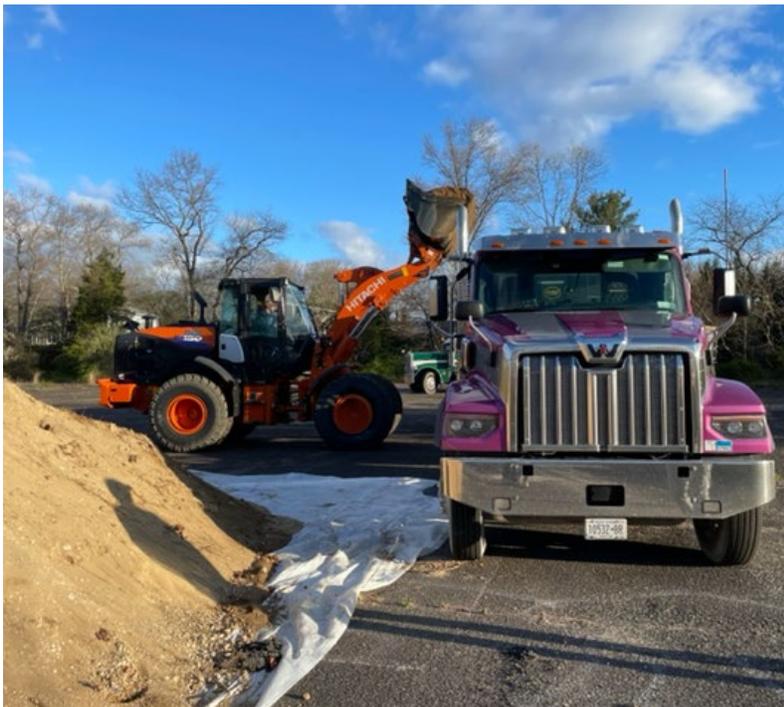
Below: Matos T.C. truck being loaded with soil for the Posillico facility.

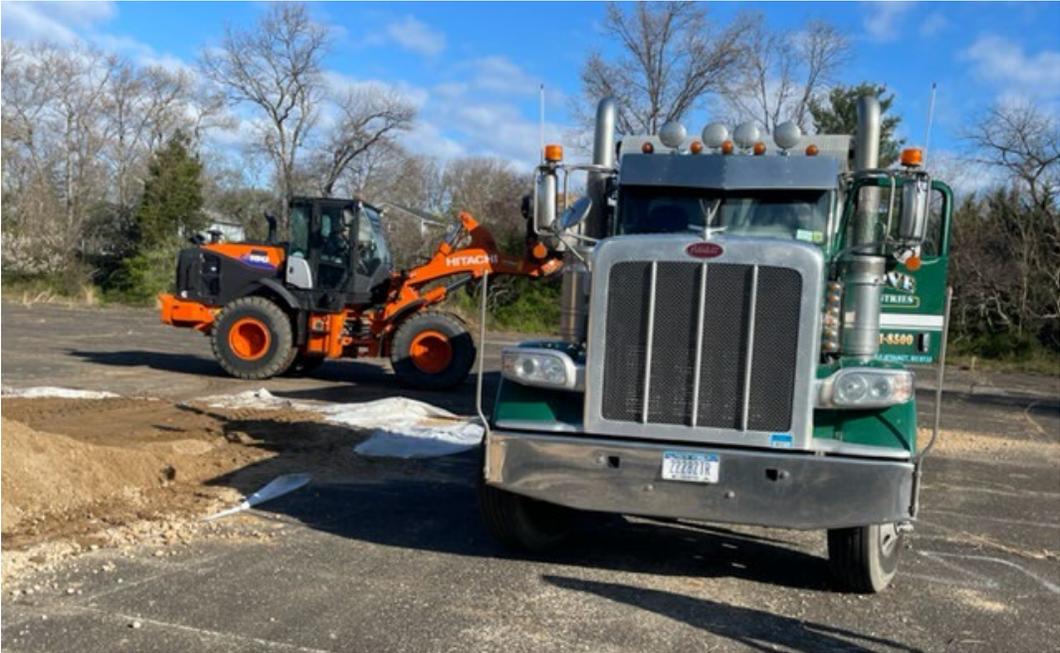
Below: Loading of Bove truck for soil transport to the Posillico Wash Plant.
