Photolog of Remedial Activities
June 7, 2022
Liberty Industrial Finishing Site
500-550 Suffolk Avenue, Brentwood, NY

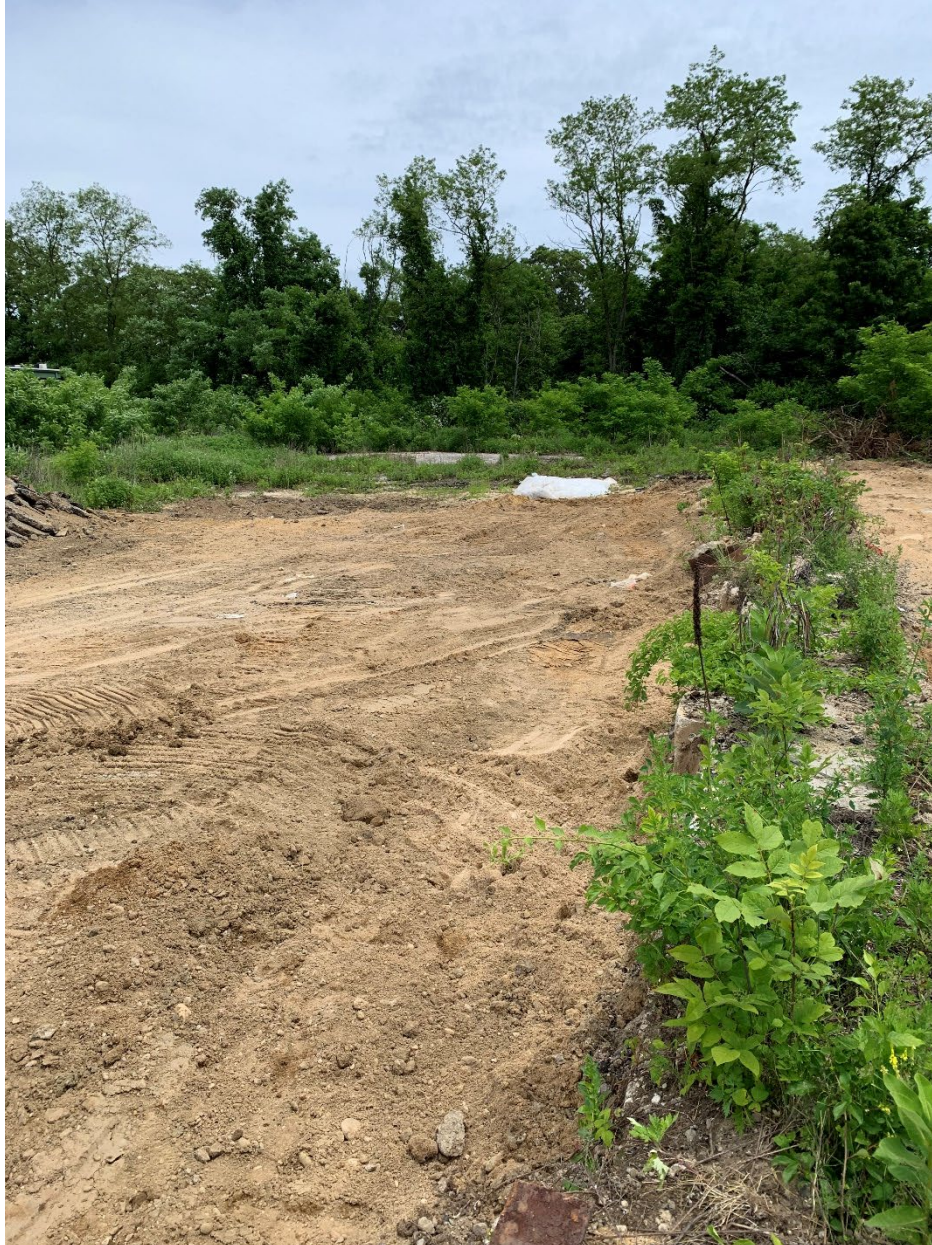
Below: View of former impacted soil stockpile area. Eight dump truck loads of this soil were removed on 6/7/22 and transported for disposal at the ACUA landfill, which completely removed the stockpile.

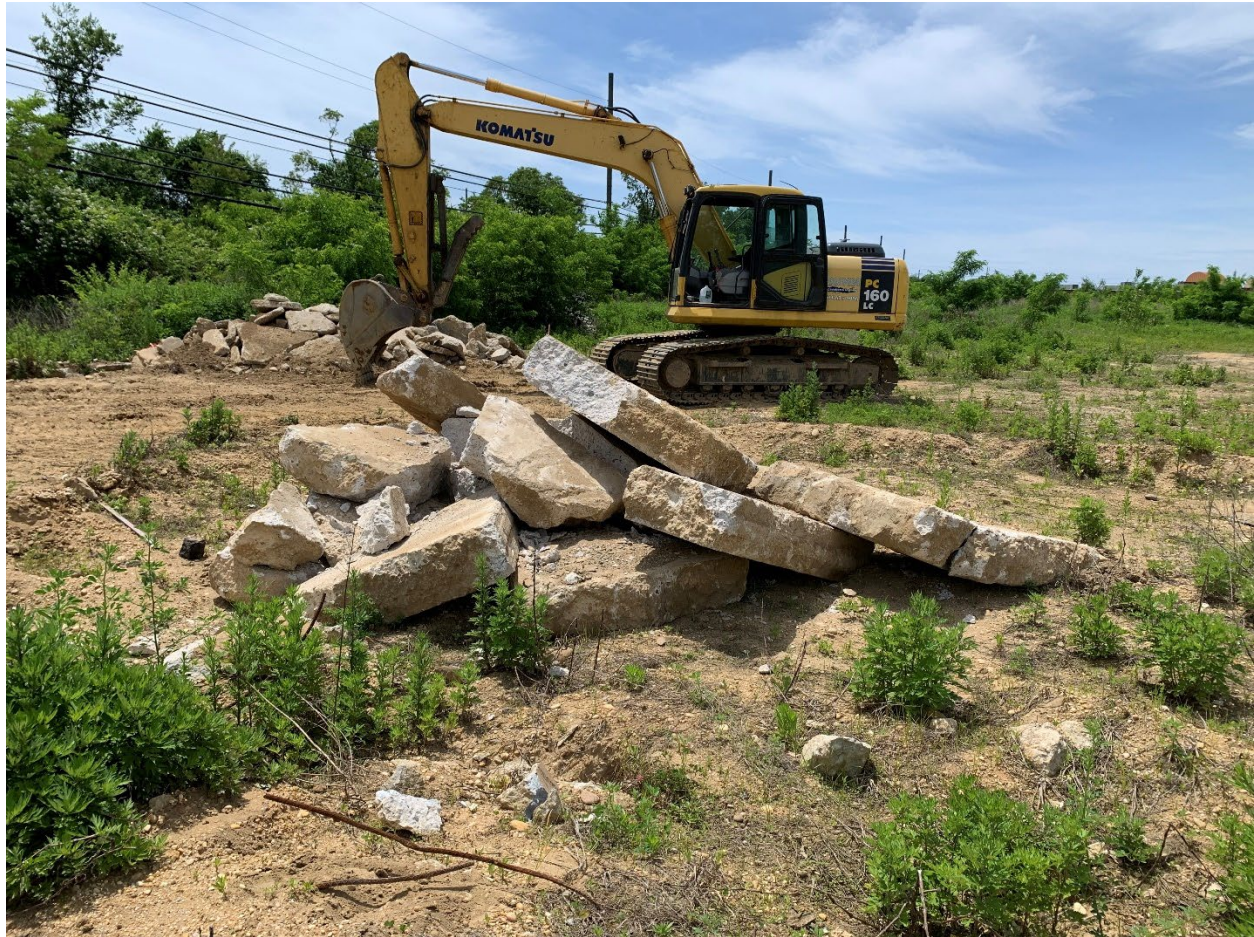
Below: View of concrete chunks removed from the permanently-capped area. This concrete was reported to originate from a platform and stairs at the rear of the former building, which were demolished at the time that the tank remediation and abandonment were conducted.

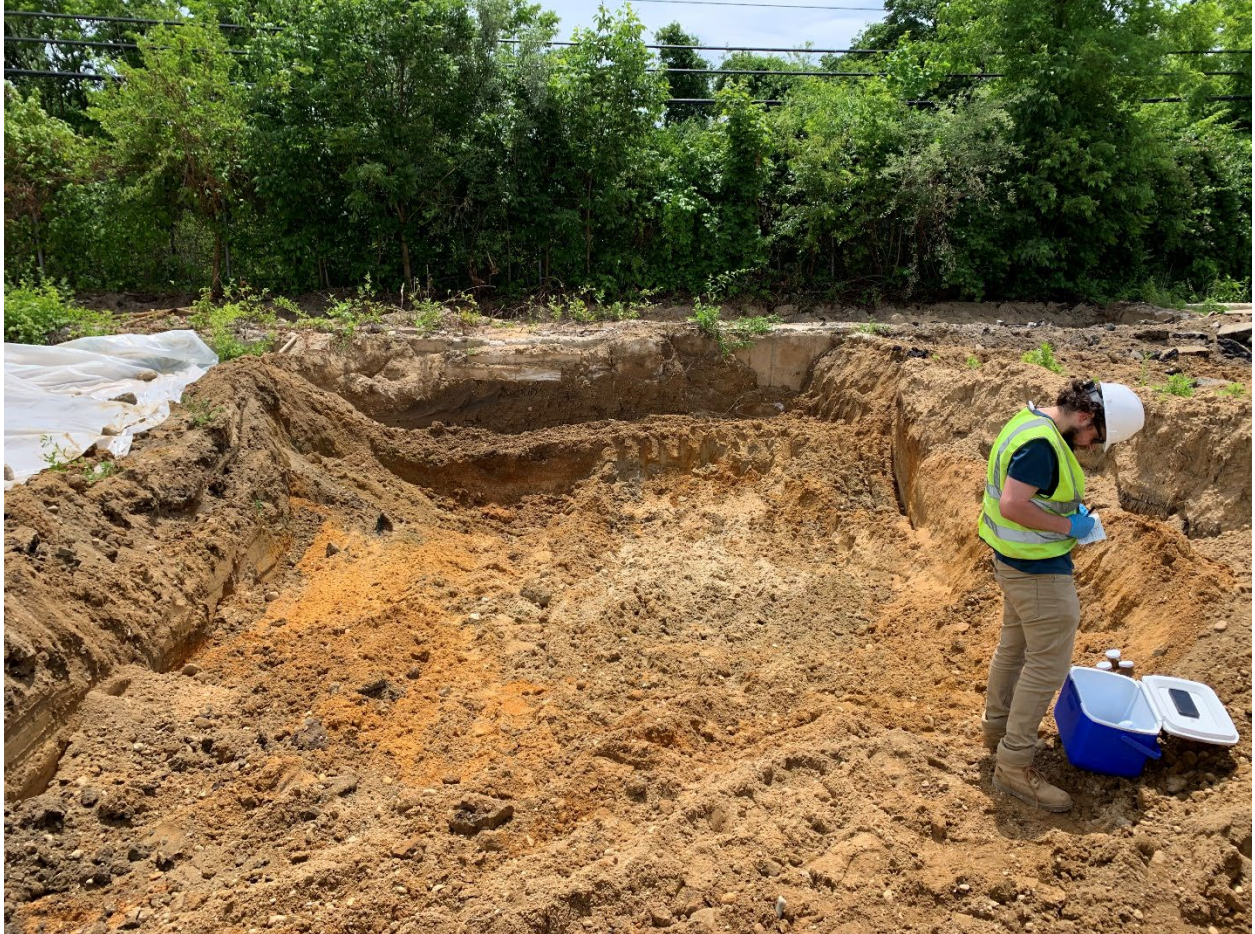
Below: Former temporarily-capped area after removal of additional soil from the north and south ends . This area is now approximately 20 feet wide, 35 feet long, and between 3 and 5 feet deep. View is looking south at the former foundation adjoining the abandoned tank area. Confirmatory samples were collected from the floor and north wall of the enlarged excavation.

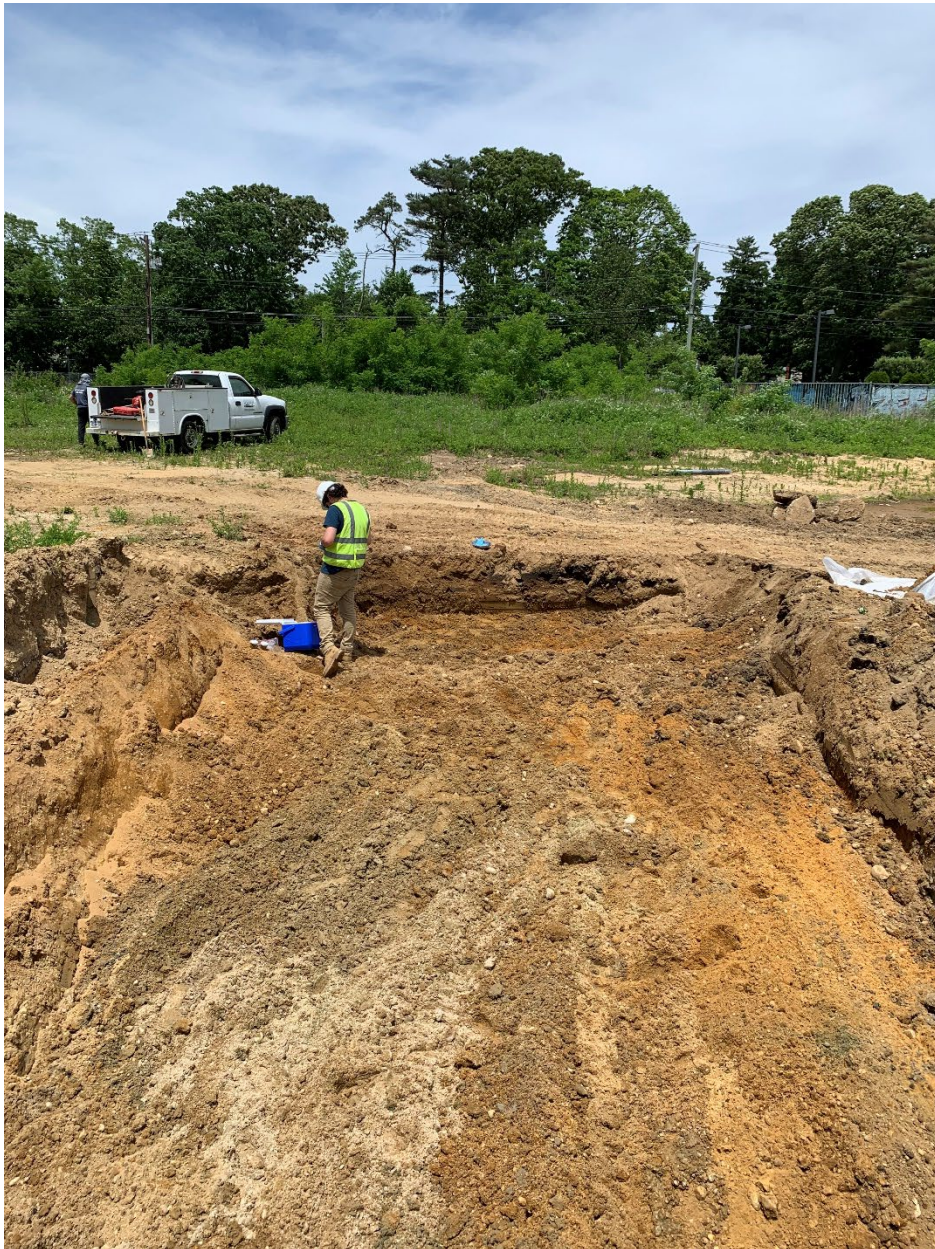
Below: View looking north at the enlarged excavation.
